Expertise

Protocol number: 46484948  
Order No. / Reference: 26585215  
Inspection date: 14 Jul 2026

Manufacturer: Volkswagen

Model: Touran 1.5 TSI ACT OPF Comfortline

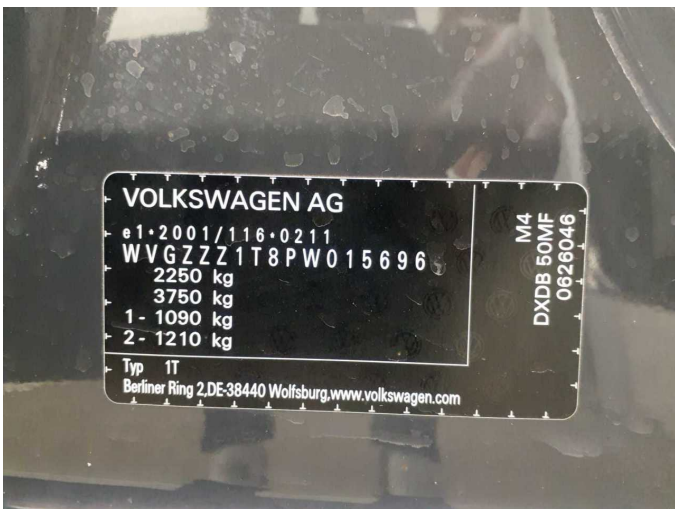
Figure 11: VIN

| VIN comparison | The vehicle identification number (VIN) was read from the vehicle and its conformity with the submitted documents was confirmed by the undersigned during the inspection. |

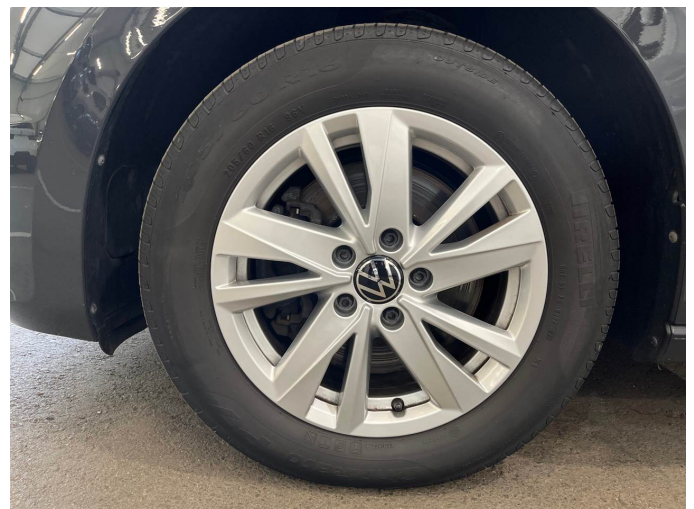
Figure 12: Mounted tyres

| Tyres | | | | |
|---|---|---|---|---|
| 1) | 205/60 R16 96V | Summer tyres on Light alloy | Pirelli | 6mm / 6mm |
| 2) | 205/60 R16 96V | Summer tyres on Light alloy | Pirelli | 5mm / 5mm |

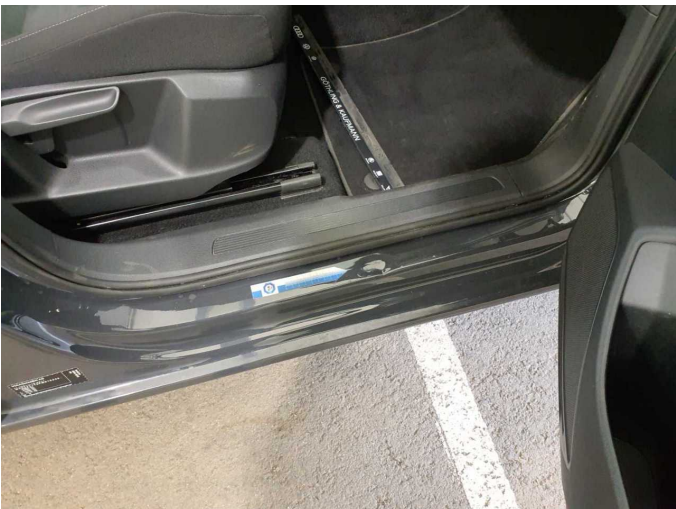
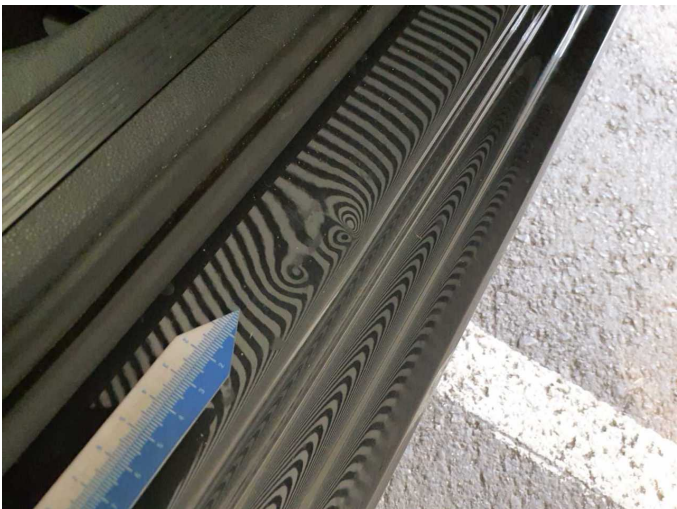
| No. | Component group | Description |
|---|---|---|
| 1 | Sill - right side | Sill - dent(s) - Smooth repair work |

Damage 1: Sill - right side: Sill - dent(s) - Smooth repair work

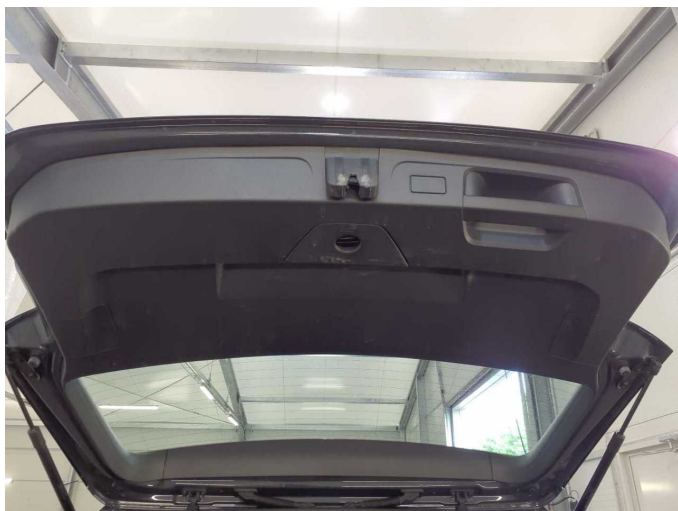
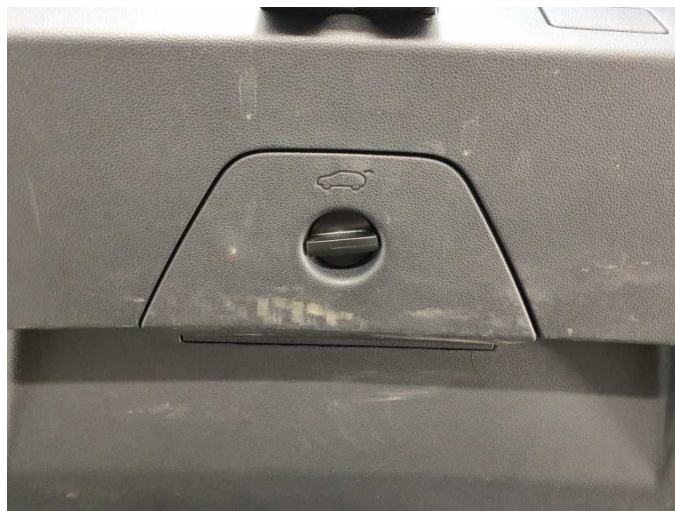
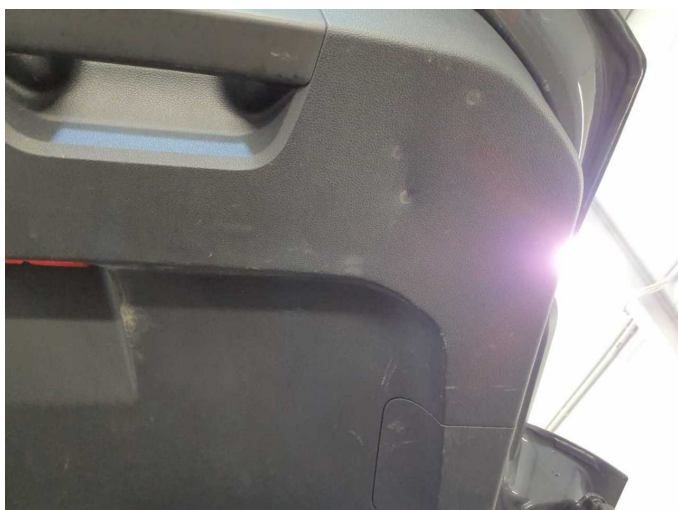
| No. | Component group | Description |
|---|---|---|
| 1 | Trim / covers | Boot lid - interior trim - Scratch(es) - No deduction |

**Wear and tear 1:** Trim / covers: Boot lid - interior trim - Scratch(es) - No deduction

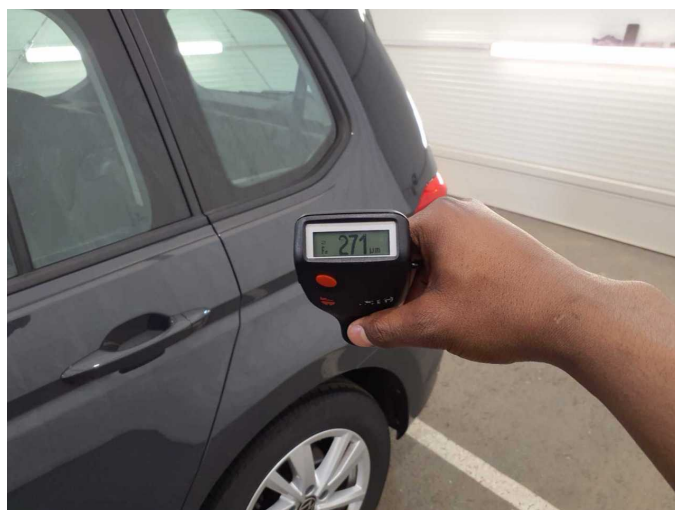
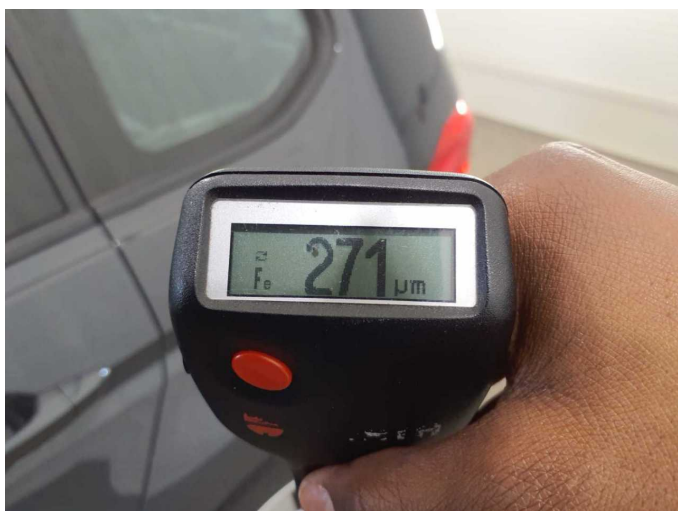
- 1 Side panel - rear left side, Professionally carried out, Invoice of repair done Non-existent
- 2 Side panel - rear right side, Professionally carried out, Invoice of repair done Non-existent

| Side panel - rear left side | 271 µm | Side panel - rear right side | 231 µm |

**Repainting 1:** Side panel - rear left side

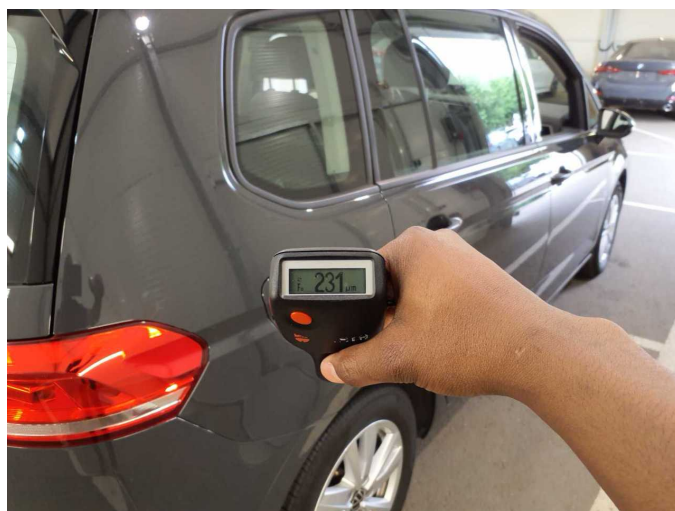
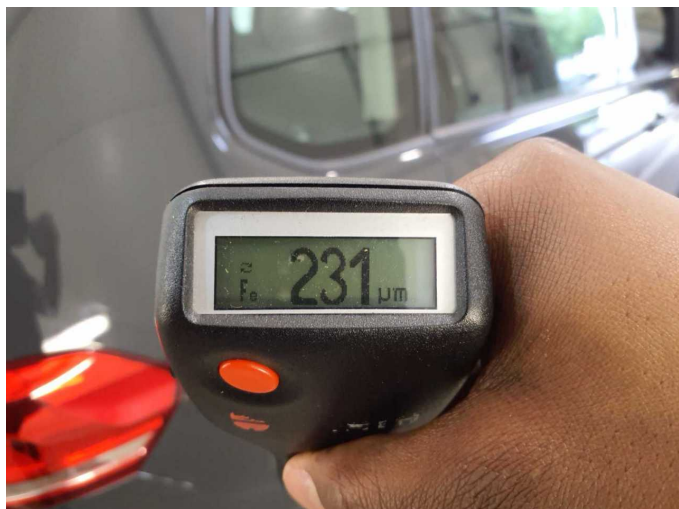
**Repainting 2:** Side panel - rear right side
