Expertise

Protocol number: 46480346  
Order No. / Reference: 26649788  
Inspection date: 13 Jul 2026

Manufacturer: Skoda  
VIN: TMBJC7NY0PF049225

Model: Enyaq iV 80

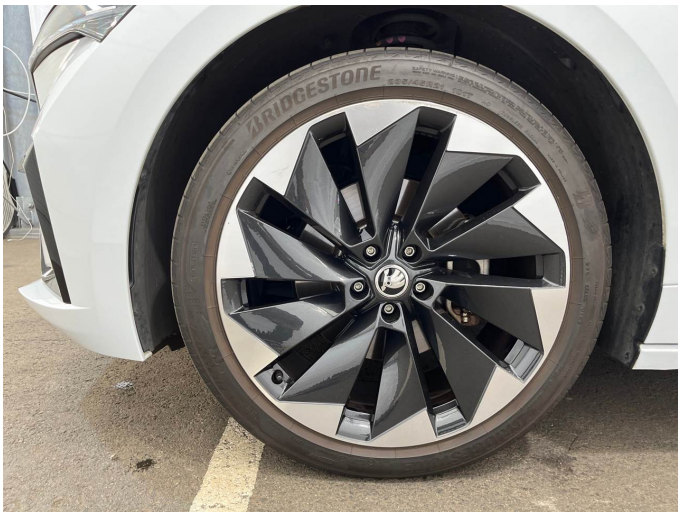
Figure 12: Mounted tyres

| # | Tyre size | Type of tyre | Manufacturer | Tread depth |
|---|---|---|---|---|
| 1) | 235/45 R21 101T | Summer tires (with run-flat tires) on Light alloy | Bridgestone | 5mm / 5mm |
| 2) | 255/40 R21 102T | Summer tires (with run-flat tires) on Light alloy | Bridgestone | 4mm / 4mm |

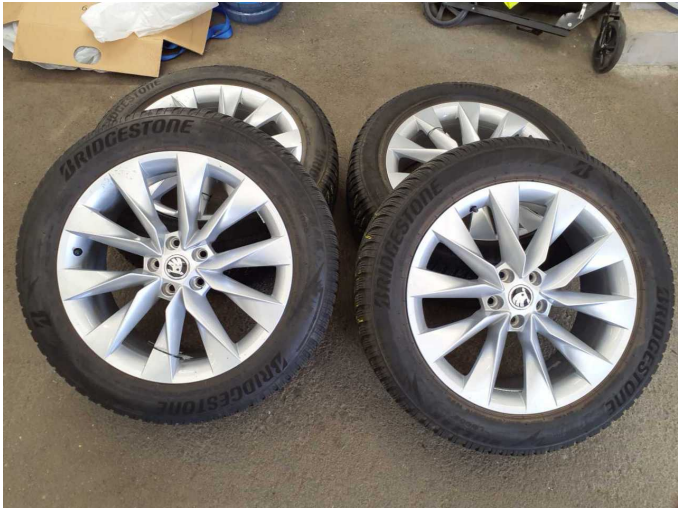
Figure 15: Additional tyres

| # | Tyre size | Type of tyre | Manufacturer | Tread depth |
|---|---|---|---|---|
| 1) | 235/55 R19 105V | Winter tyres on Light alloy | Bridgestone | 7mm / 7mm |
| 2) | 255/50 R19 107V | Winter tyres on Light alloy | Bridgestone | 5mm / 5mm |

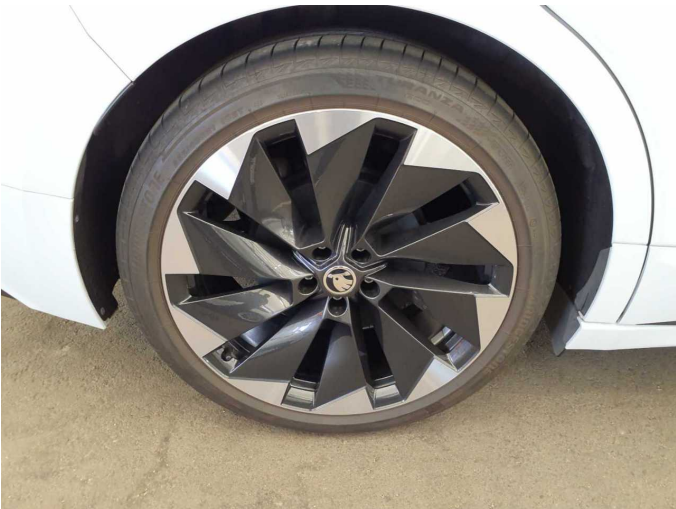
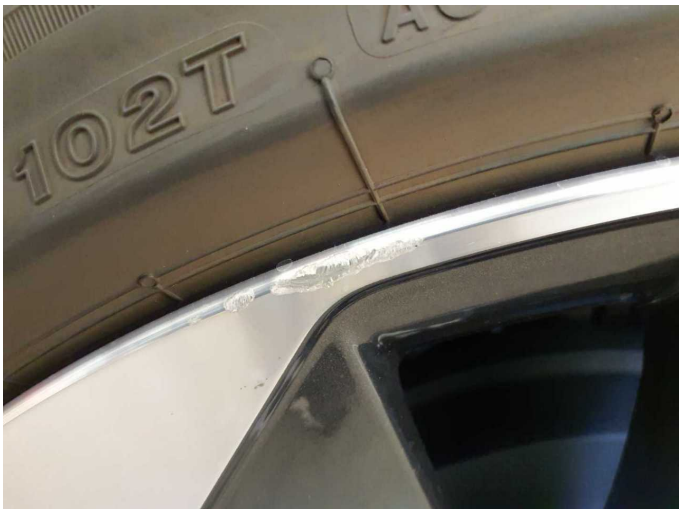
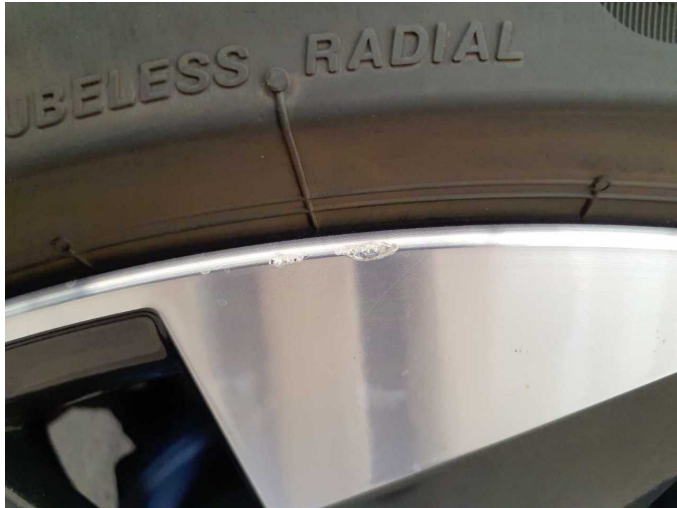
| No. | Component group | Description |
|---|---|---|
| 1 | Wheel / tyres | Alloy rim - rear right side - Scratch(es) - Loss in value |

Damage 1: Wheel / tyres: Alloy rim - rear right side - Scratch(es) - Loss in value

**Damage 1:** Wheel / tyres: Alloy rim - rear right side - Scratch(es) - Loss in value

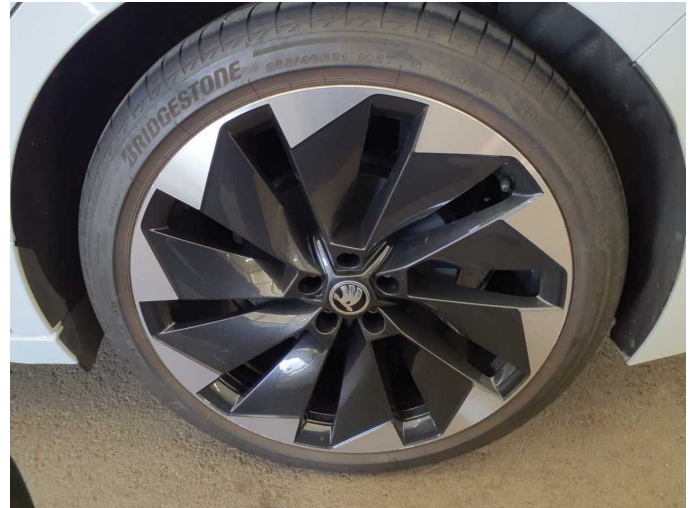
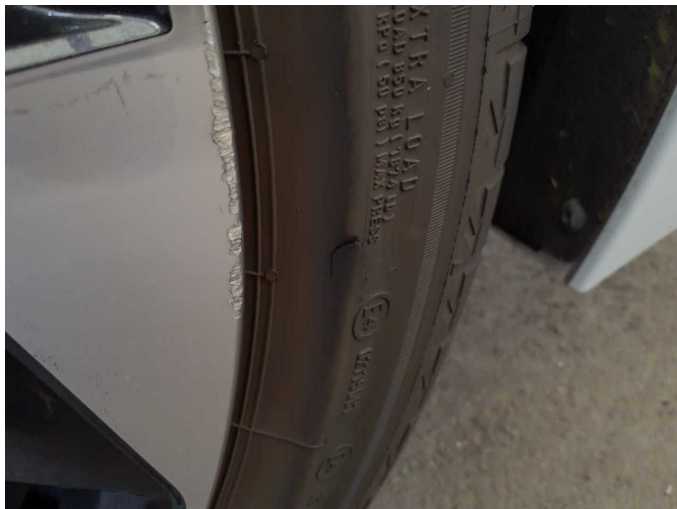
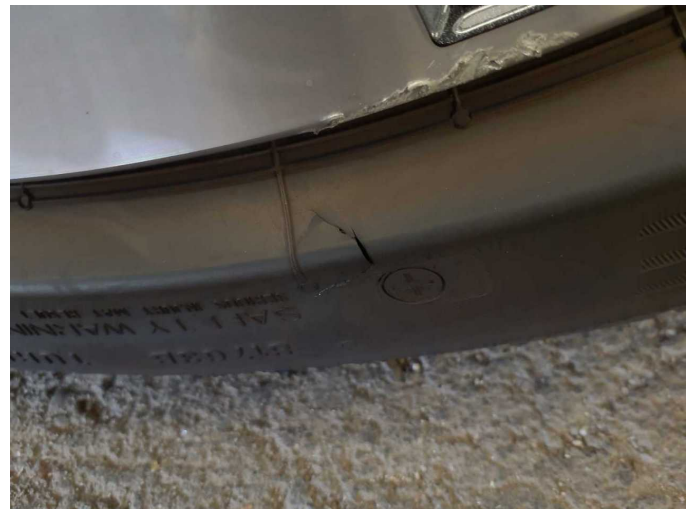
| No. | Component group | Description |
|---|---|---|
| 2 | Wheel / tyres | Tyre - rear left side - Broken / torn - Replace |

**Damage 2:** Wheel / tyres: Tyre - rear left side - Broken / torn - Replace

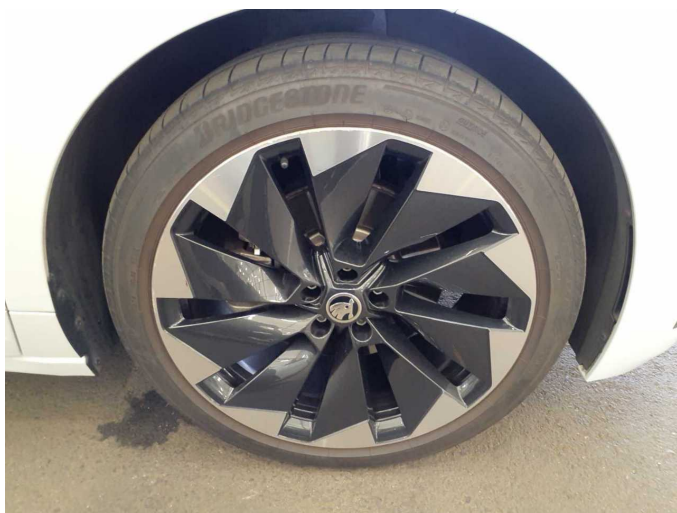
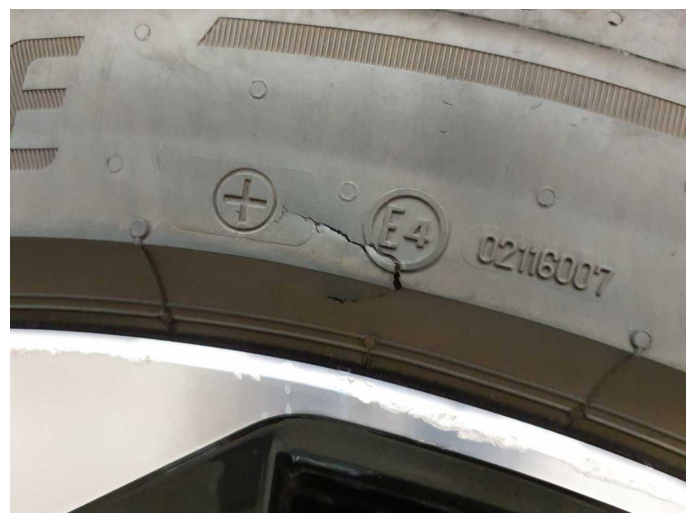
| No. | Component group | Description |
|---|---|---|
| 3 | Wheel / tyres | Tyre - front right side - Broken / torn - Replace |

**Damage 3:** Wheel / tyres: Tyre - front right side - Broken / torn - Replace

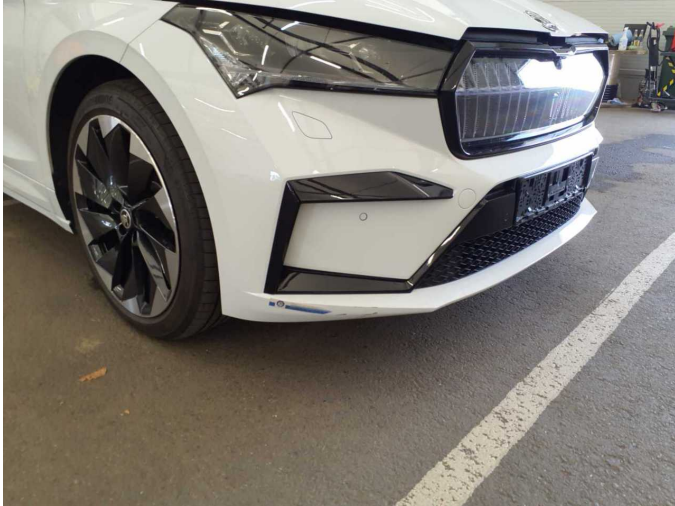
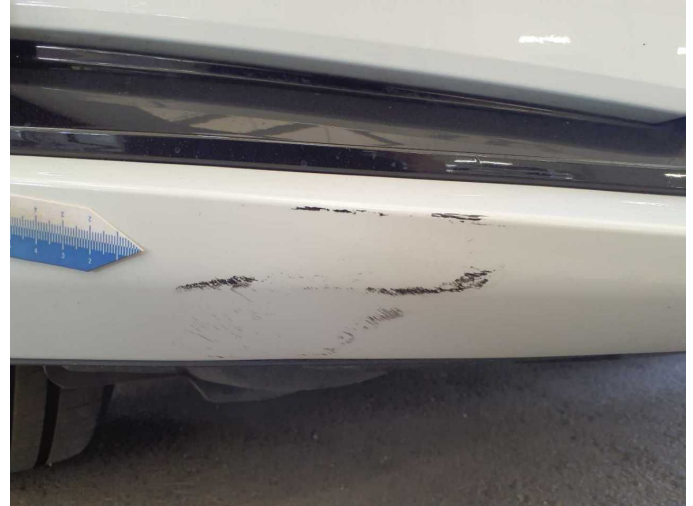
| No. | Component group | Description |
|---|---|---|
| 4 | Front bumper | Front bumper - Scratch(es) - Paint |

**Damage 4:** Front bumper: Front bumper - Scratch(es) - Paint

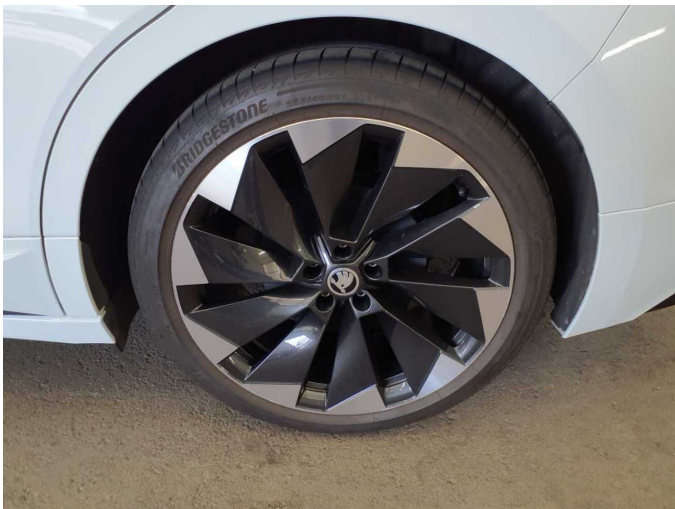
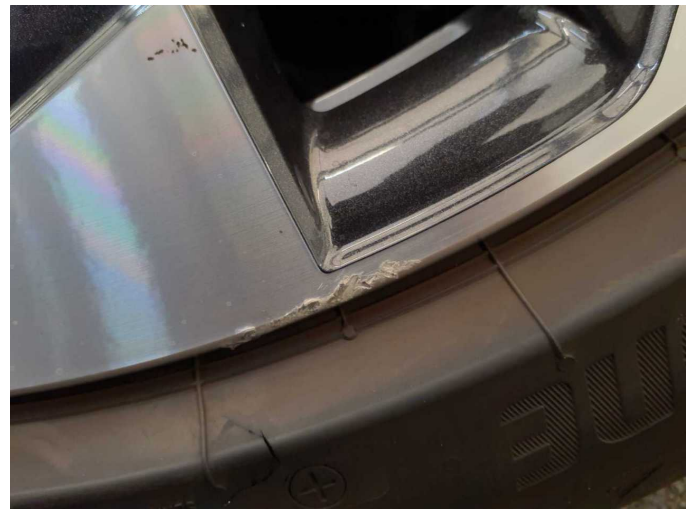
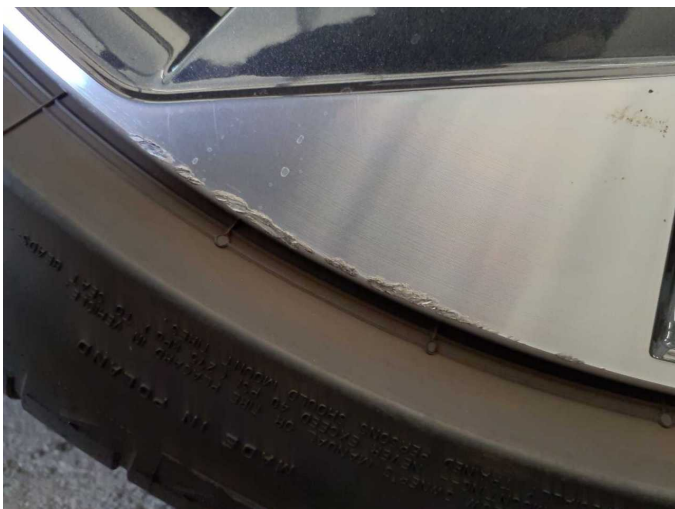
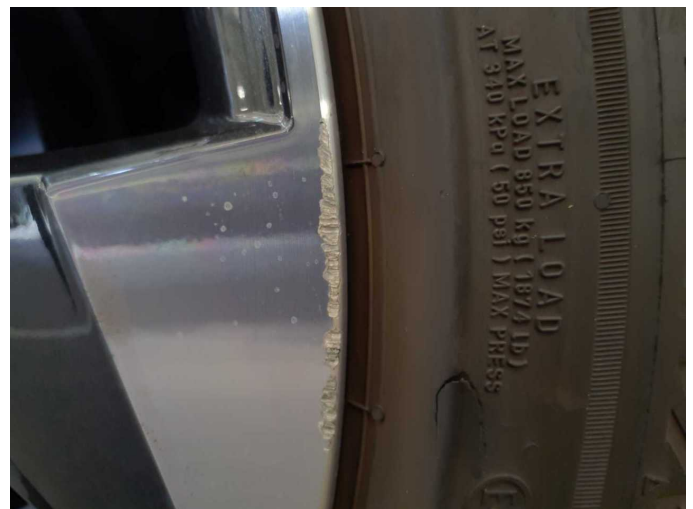
| No. | Component group | Description |
|---|---|---|
| 5 | Wheel / tyres | Alloy rim - rear left side (Materialabtrag) - Scratched - Replace |

**Damage 5:** Wheel / tyres: Alloy rim - rear left side (Materialabtrag) - Scratched - Replace

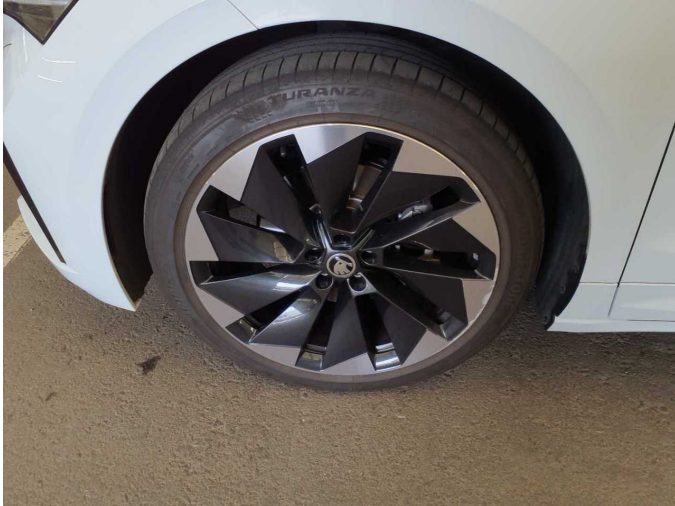
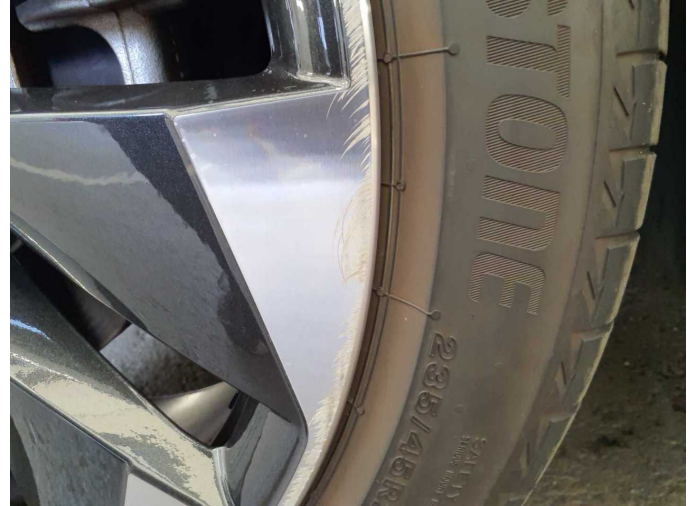
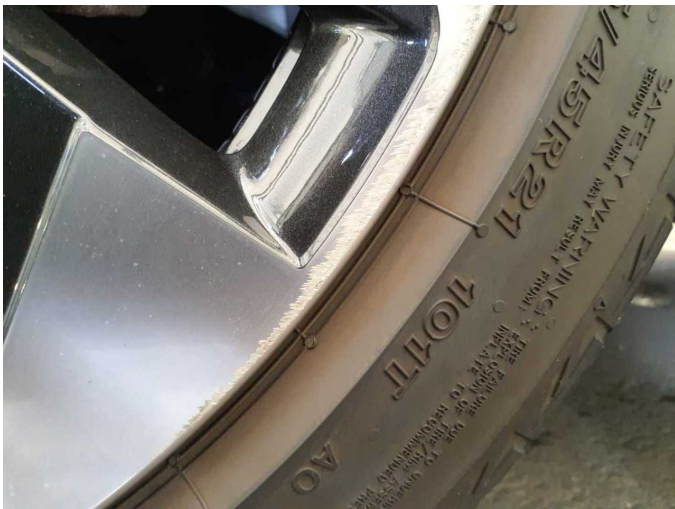
| No. | Component group | Description |
|---|---|---|
| 6 | Wheel / tyres | Alloy rim - front left side - Scratched - Replace |

**Damage 6:** Wheel / tyres: Alloy rim - front left side - Scratched - Replace

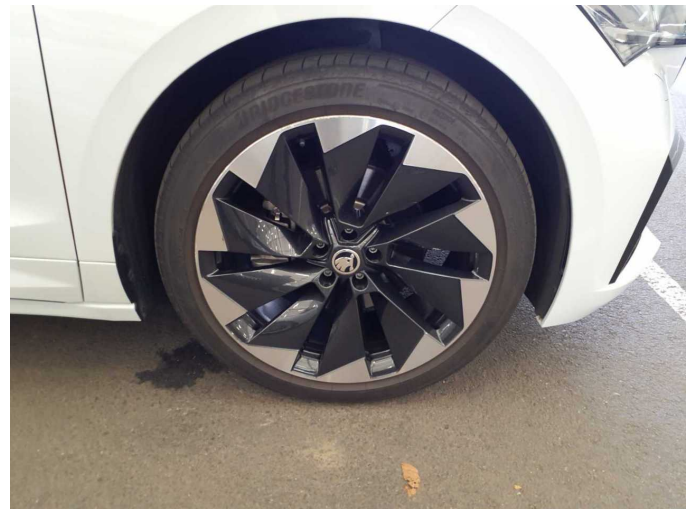
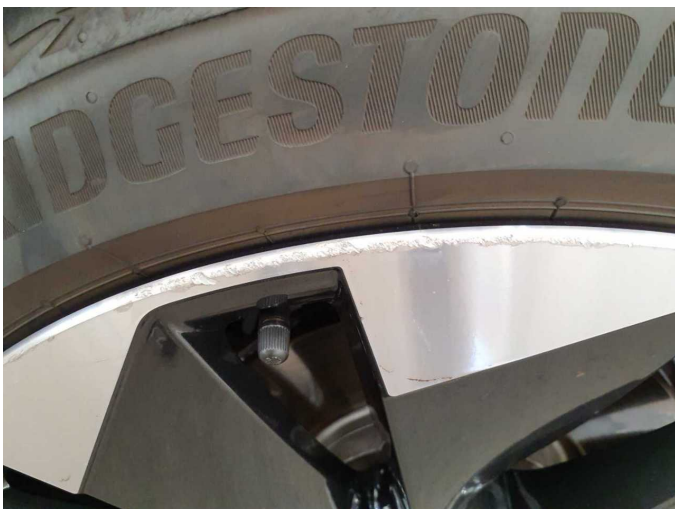
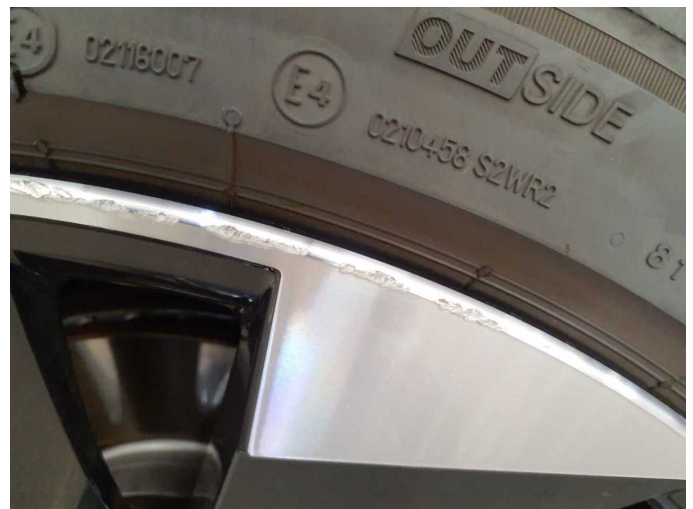
| No. | Component group | Description |
|---|---|---|
| 7 | Wheel / tyres | Alloy rim - front right side (Materialabtrag) - Scratched - Replace |

**Damage 7:** Wheel / tyres: Alloy rim - front right side (Materialabtrag) - Scratched - Replace

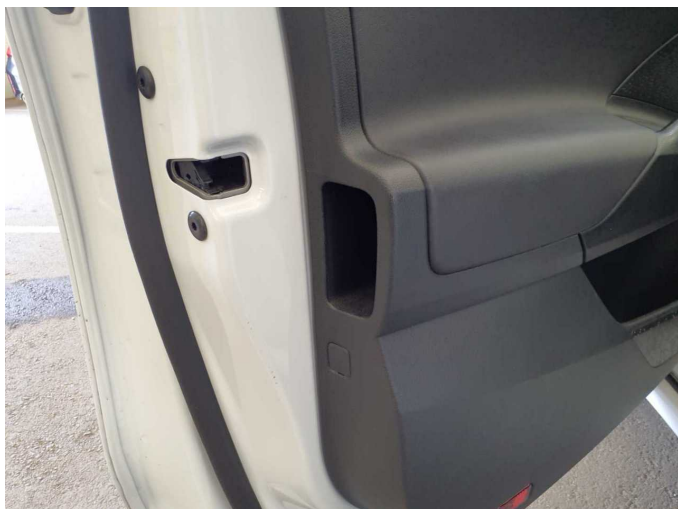
Equipment - Umbrella

**Missing part 1:** Equipment: Umbrella - Missing - Replace
