Expertise

Protocol number: 46570335  
Order No. / Reference: 26712702  
Inspection date: 15 Jul 2026

Manufacturer: Volvo

Model: XC90 T8 AWD Recharge Ultimate Bright

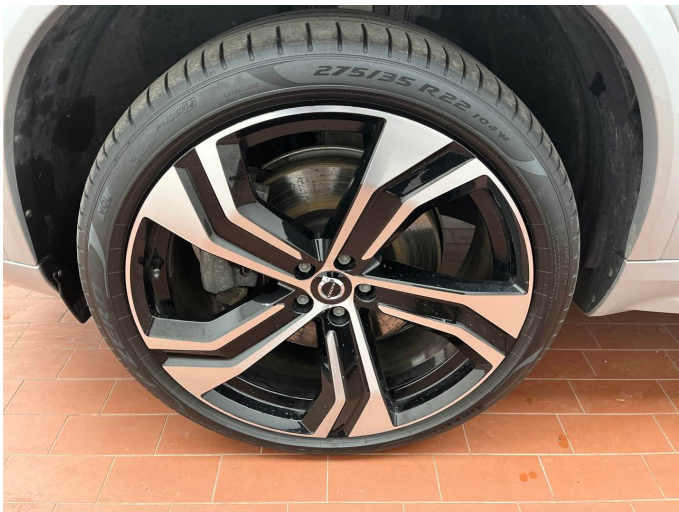
Figure 12: Mounted tyres

| # | Tyre size | Type of tyre | Manufacturer | Tread depth |
|---|---|---|---|---|
| 1) | 275/35 R22 104W | Summer tyres on Light alloy | Pirelli | 5mm / 5mm |
| 2) | 275/35 R22 104W | Summer tyres on Light alloy | Pirelli | 4mm / 4mm |

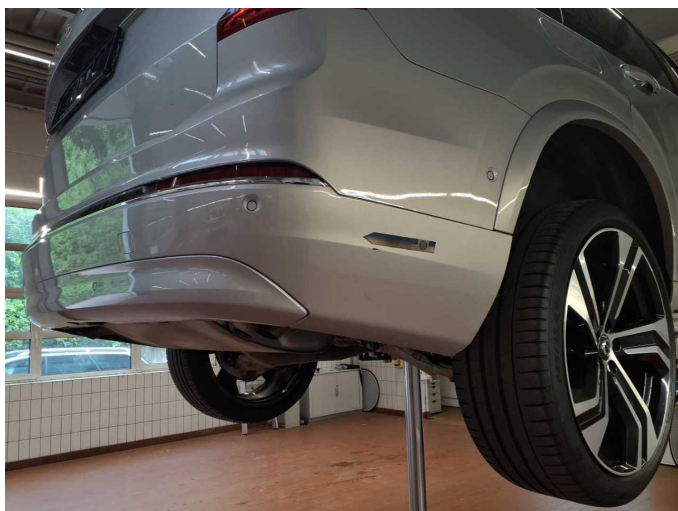
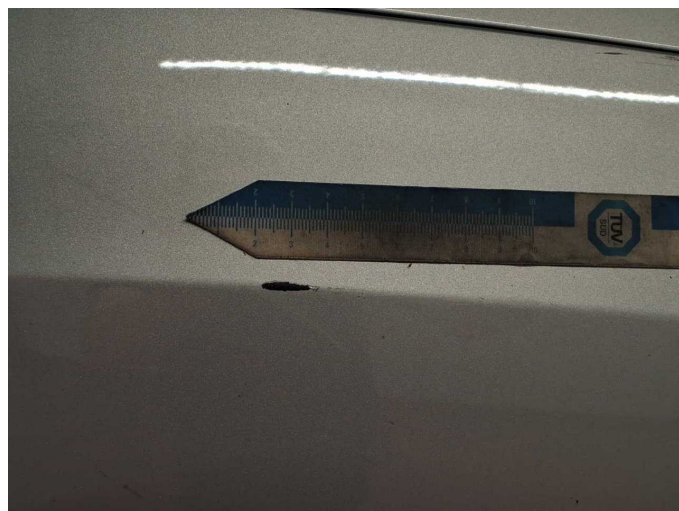
| No. | Component group | Description |
|---|---|---|
| 4 | Rear bumper | Spoiler - Scratch(es) - Smart repair |

**Damage 4:** Rear bumper: Spoiler - Scratch(es) - Smart repair

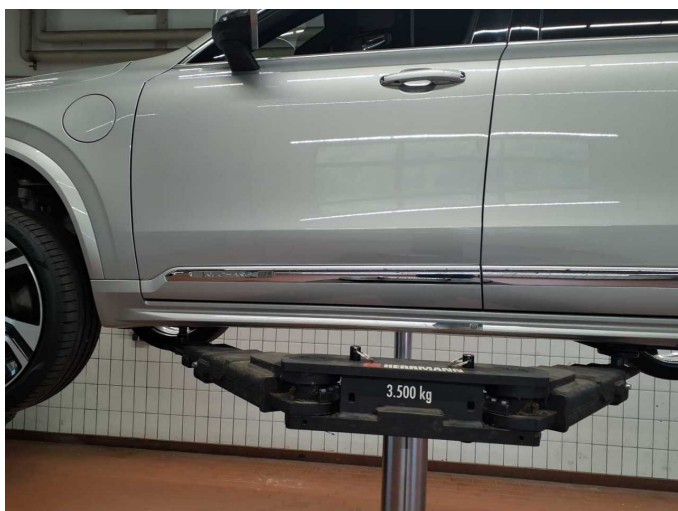
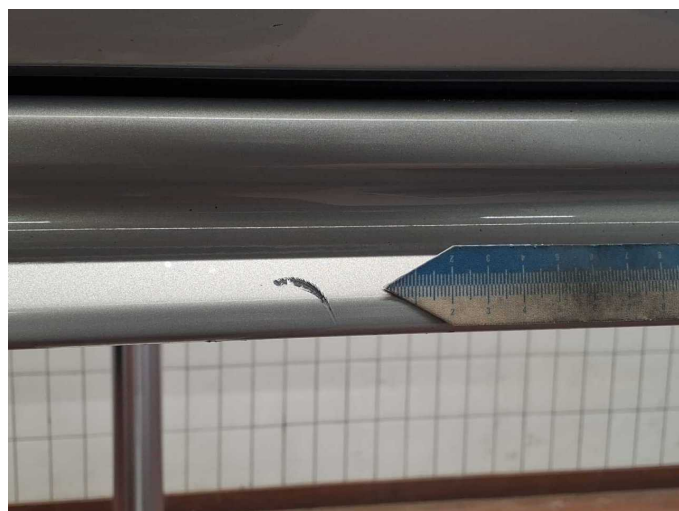
| No. | Component group | Description |
|---|---|---|
| 5 | Sill - left side | Trim - Scratch(es) - Smart repair |

**Damage 5:** Sill - left side: Trim - Scratch(es) - Smart repair

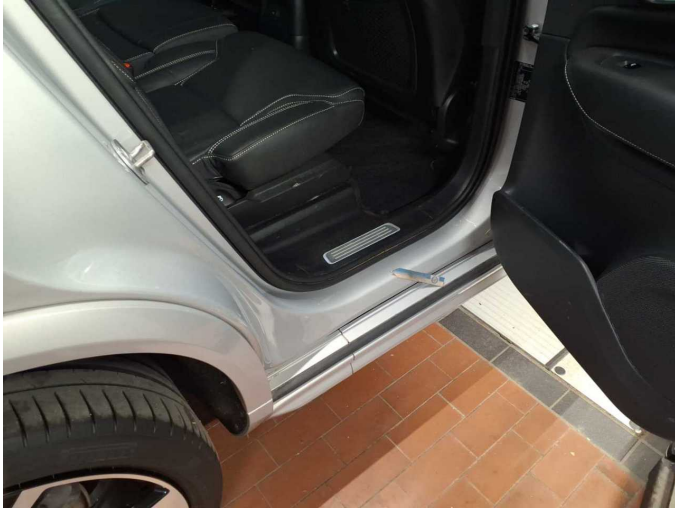
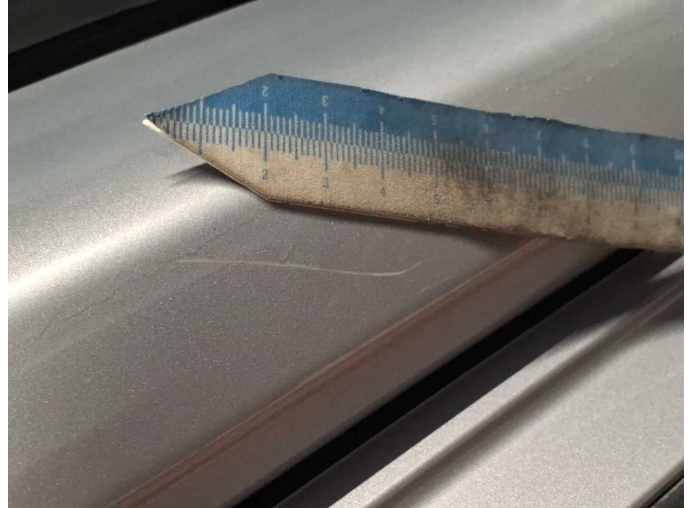
| No. | Component group | Description |
|---|---|---|
| 6 | Side panel - rear right side | Sill - Scratch(es) - Smart repair |

**Damage 6:** Side panel - rear right side: Sill - Scratch(es) - Smart repair

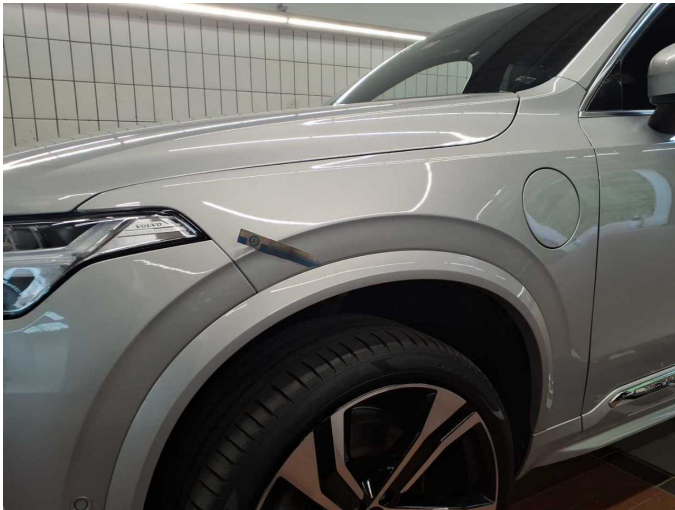
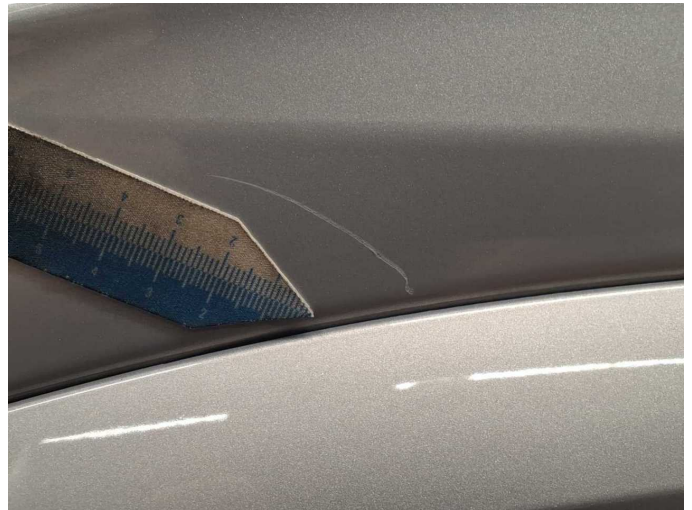
| No. | Component group | Description |
|---|---|---|
| 7 | Mudguard - left side | Mudguard - left side - Scratch(es) - Smart repair |

**Damage 7:** Mudguard - left side: Mudguard - left side - Scratch(es) - Smart repair

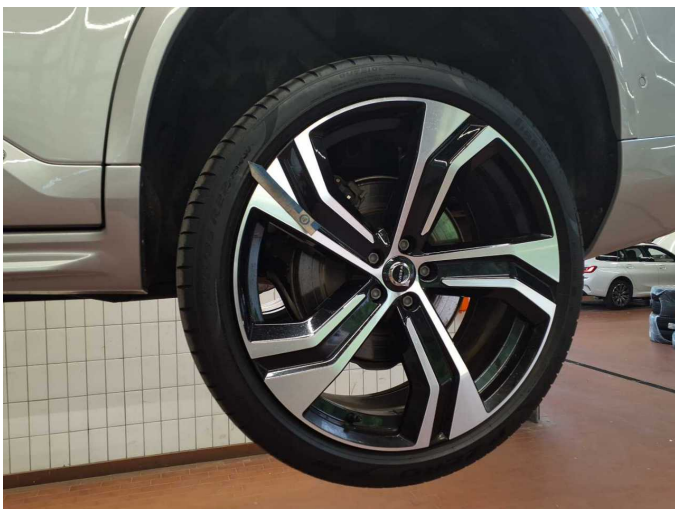
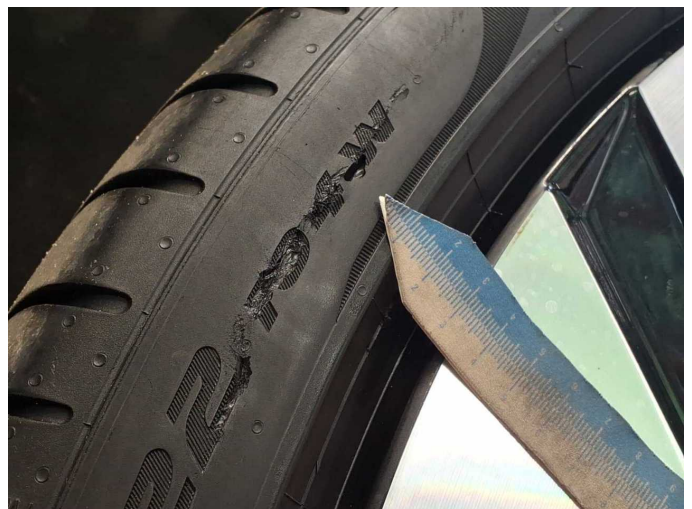
| No. | Component group | Description |
|---|---|---|
| 9 | Wheel / tyres | Tyre - rear left side - Broken / torn - Replace |

**Damage 9:** Wheel / tyres: Tyre - rear left side - Broken / torn - Replace

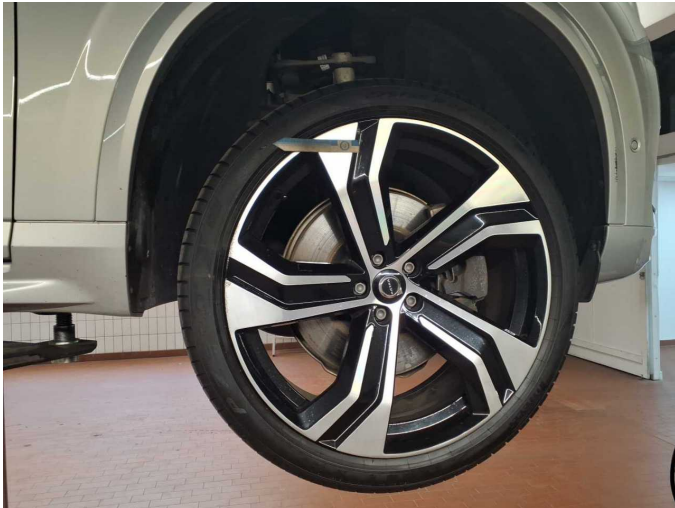
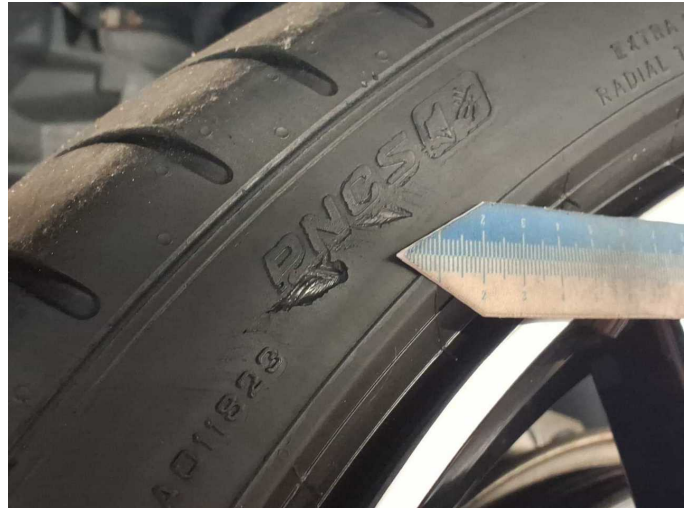
| No. | Component group | Description |
|---|---|---|
| 10 | Wheel / tyres | Tyre - front right side - Broken / torn - Replace |

**Damage 10:** Wheel / tyres: Tyre - front right side - Broken / torn - Replace

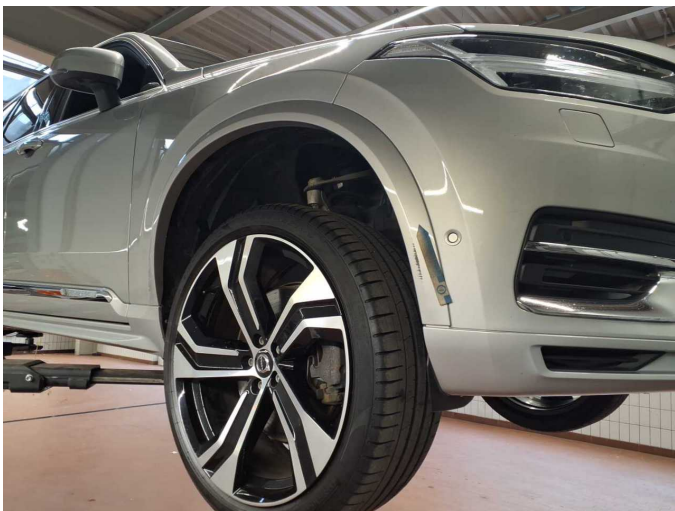
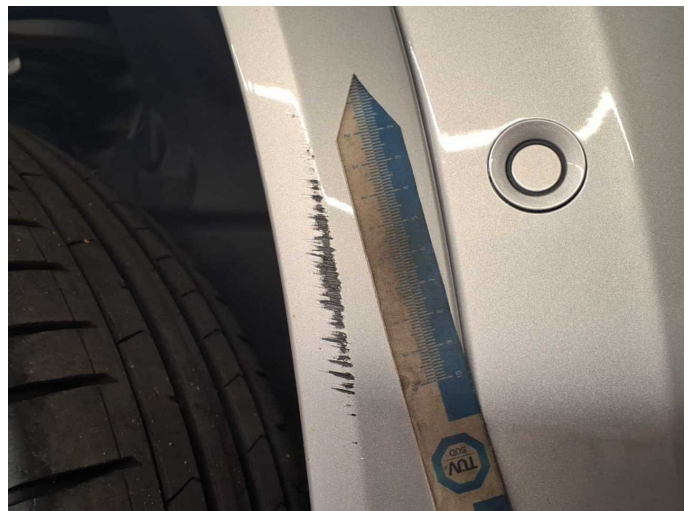
| No. | Component group | Description |
|---|---|---|
| 11 | Mudguard - right side | Wheel well extension - Scratched - Paint |

**Damage 11:** Mudguard - right side: Wheel well extension - Scratched - Paint

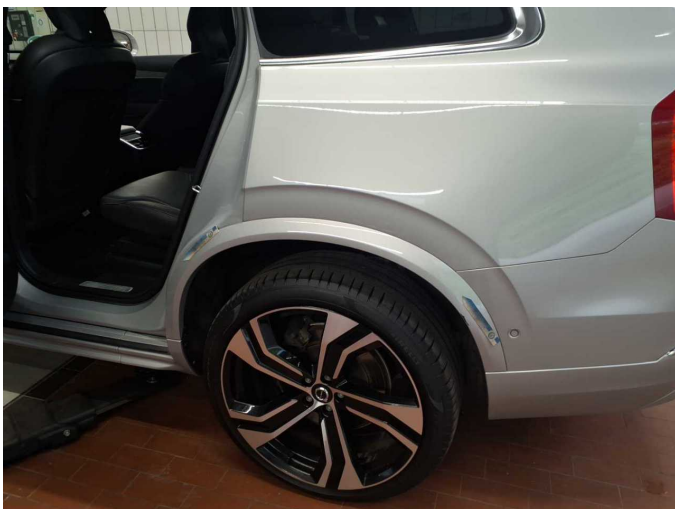
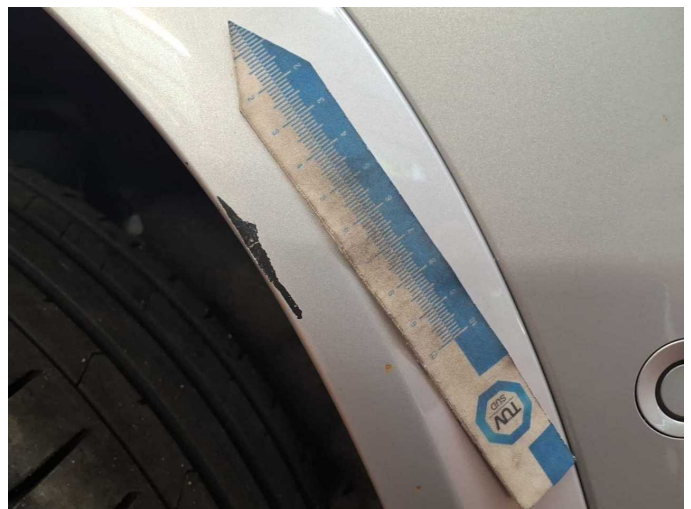
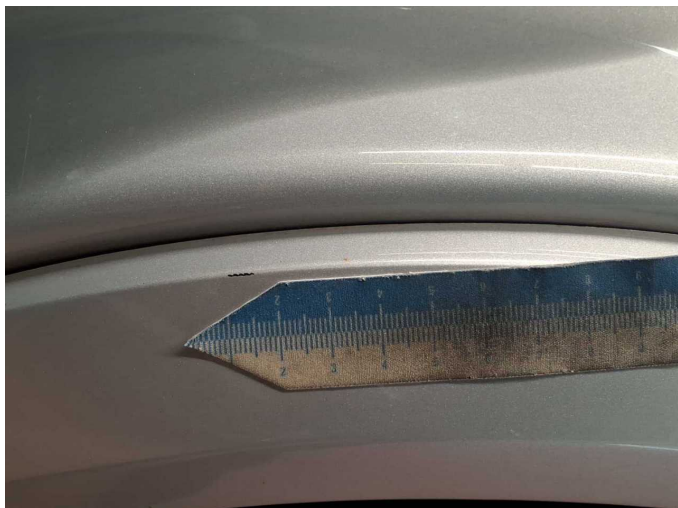
| No. | Component group | Description |
|---|---|---|
| 12 | Side panel - rear left side | Wheel well extension - Scratched - Paint |

**Damage 12:** Side panel - rear left side: Wheel well extension - Scratched - Paint

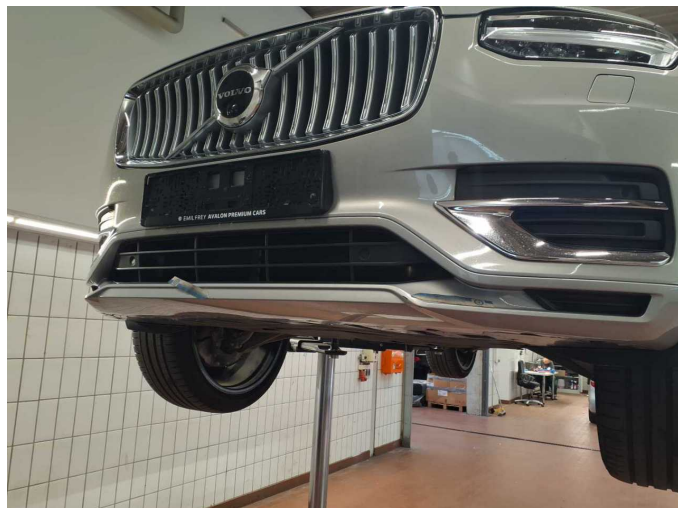
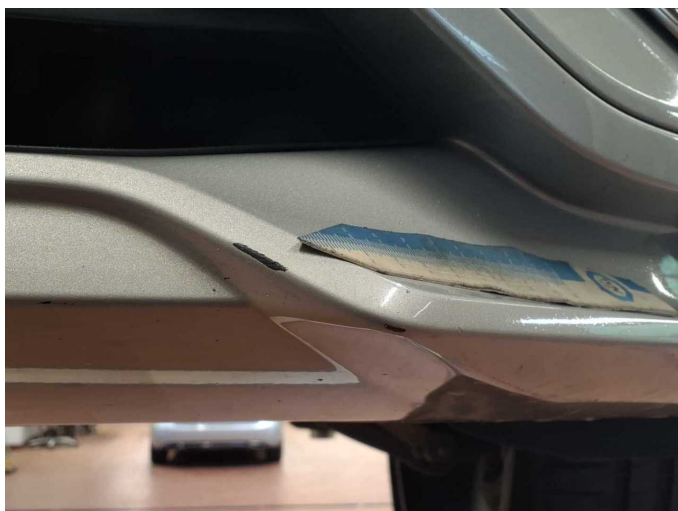
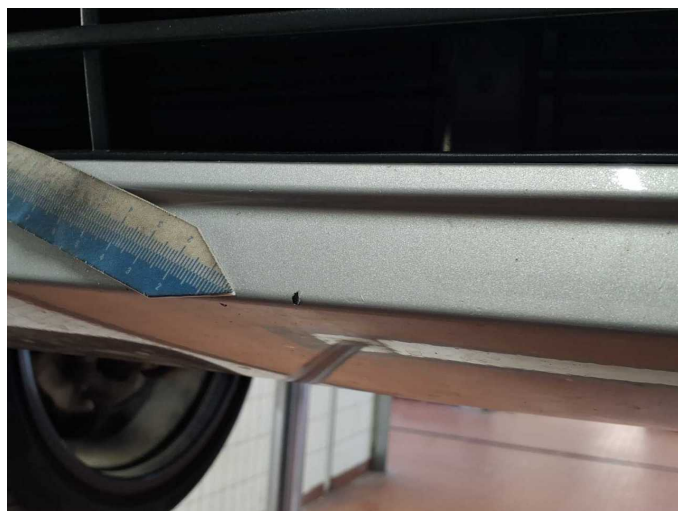
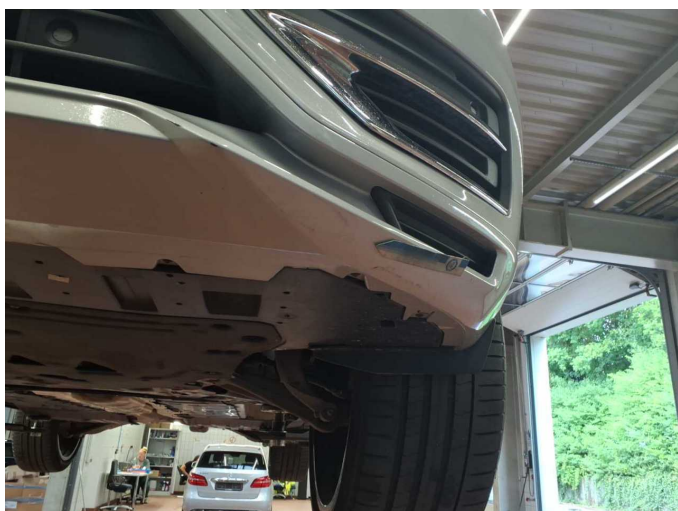
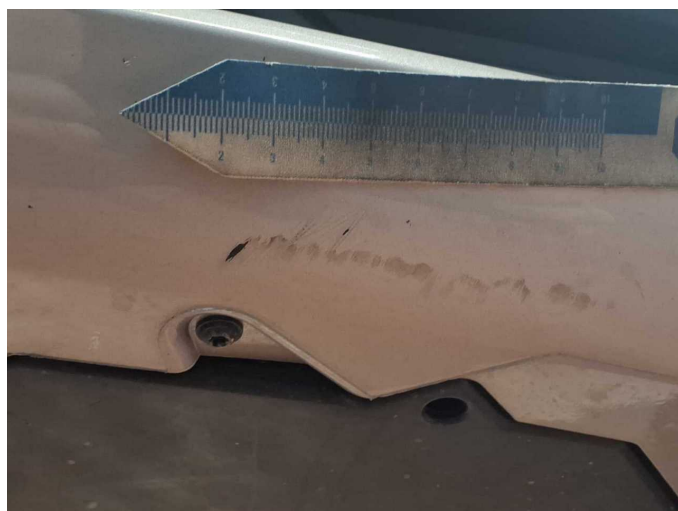
| No. | Component group | Description |
|---|---|---|
| 13 | Front bumper | Spoiler - Scratched - Paint |

**Damage 13:** Front bumper: Spoiler - Scratched - Paint

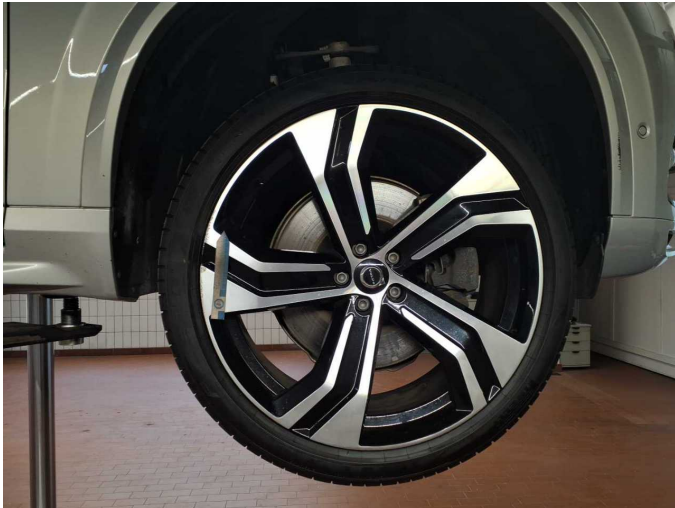
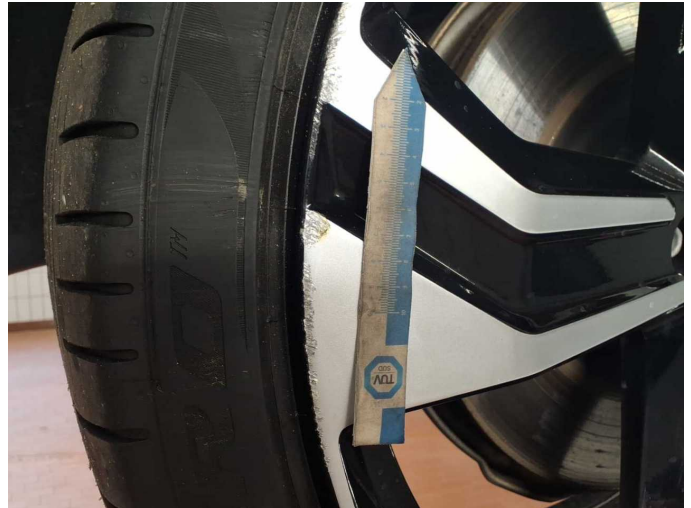
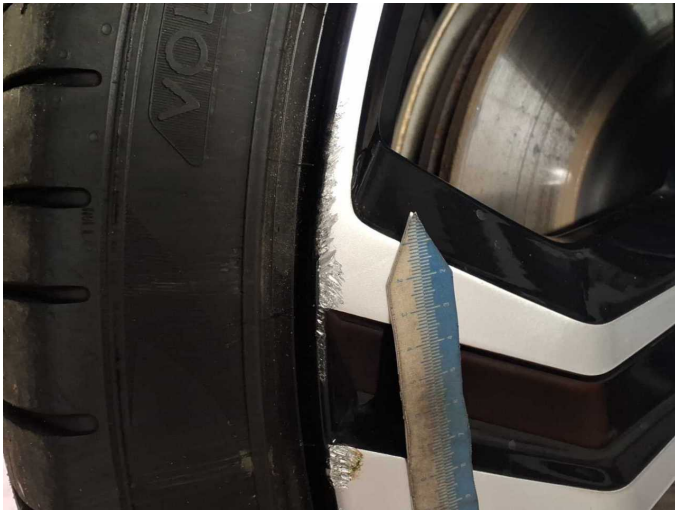
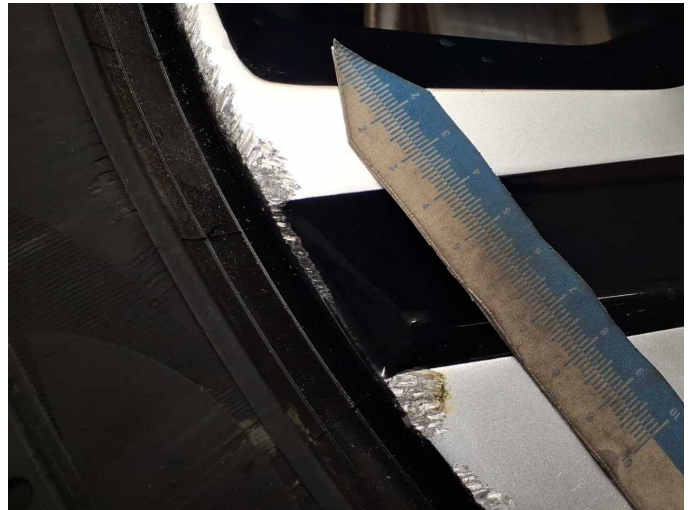
| No. | Component group | Description |
|---|---|---|
| 14 | Wheel / tyres | Alloy rim - front right side - Scratched - Replace |

**Damage 14:** Wheel / tyres: Alloy rim - front right side - Scratched - Replace

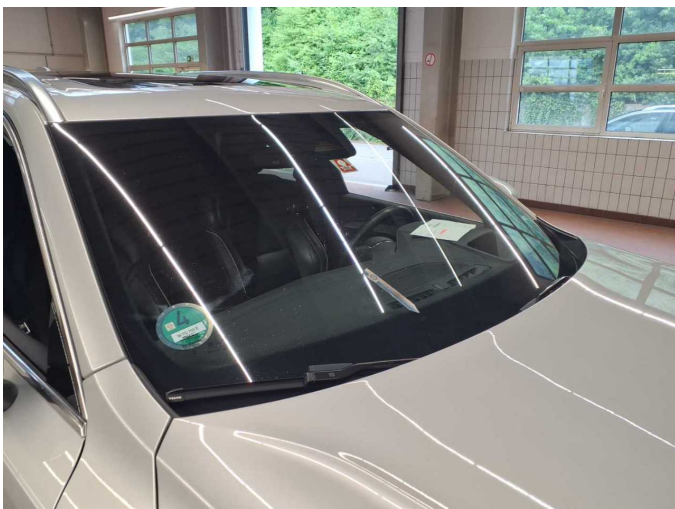
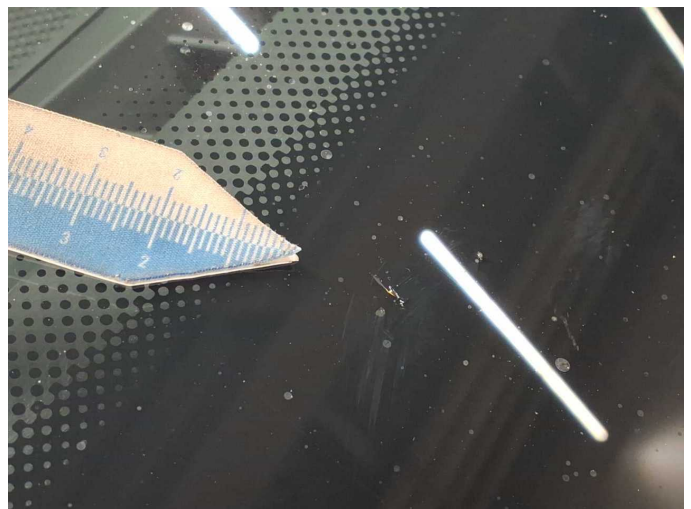
| No. | Component group | Description |
|---|---|---|
| 15 | Vehicle glazing | Windscreen - Stone chips - Replace |

**Damage 15:** Vehicle glazing: Windscreen - Stone chips - Replace

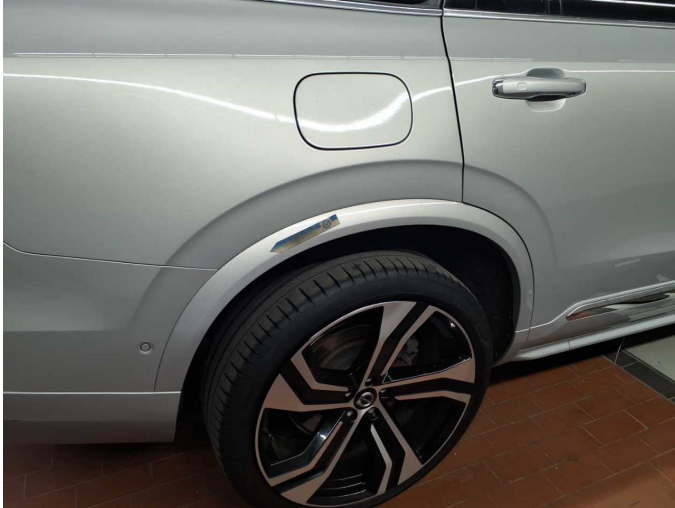
| No. | Component group | Description |
|---|---|---|
| 1 | Side panel - rear right side | Wheel well extension - Scratch(es) - No deduction |

**Wear and tear 1:** Side panel - rear right side: Wheel well extension - Scratch(es) - No deduction

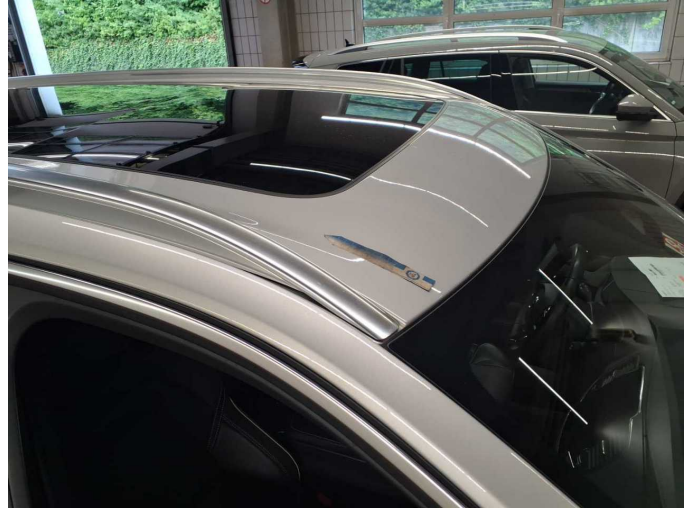
| No. | Component group | Description |
|---|---|---|
| 2 | Roof | Roof - Scratch(es) - No deduction |

**Wear and tear 2:** Roof: Roof - Scratch(es) - No deduction
