Expertise

Protocol number: 46649261  
Order No. / Reference: 26674107  
Inspection date: 22 Jul 2026

Manufacturer: Mercedes-Benz  
VIN: W1N4N1CB5PJ503851

Model: GLA 200 d 8G-DCT Progressive

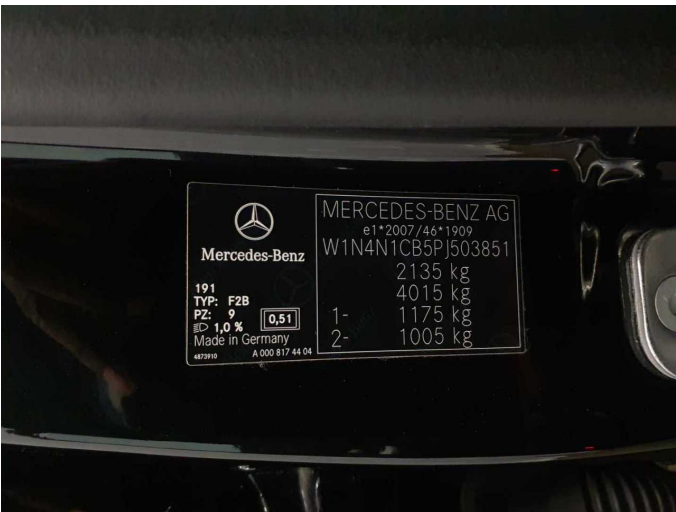
Figure 11: VIN

| VIN comparison | The vehicle identification number (VIN) was read from the vehicle and its conformity with the submitted documents was confirmed by the undersigned during the inspection. |

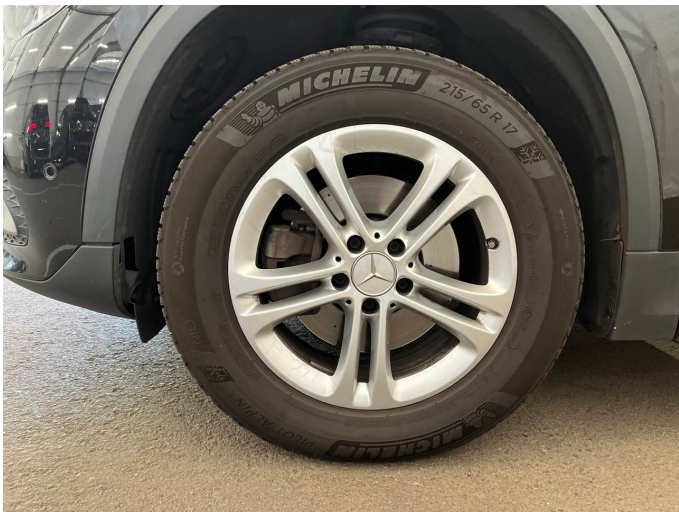
Figure 12: Mounted tyres

| # | Tyre size | Type of tyre | Manufacturer | Tread depth |
|---|---|---|---|---|
| 1) | 215/65 R17 99H | Winter tyres on Light alloy | Michelin | 6mm / 6mm |
| 2) | 215/65 R17 99H | Winter tyres on Light alloy | Michelin | 5mm / 5mm |

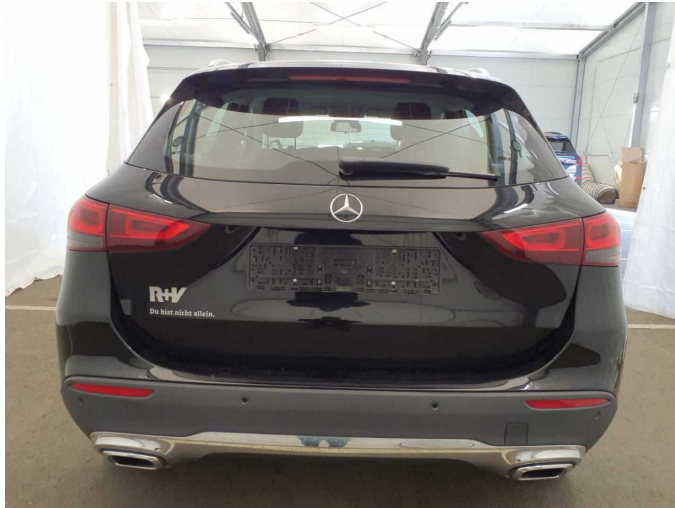
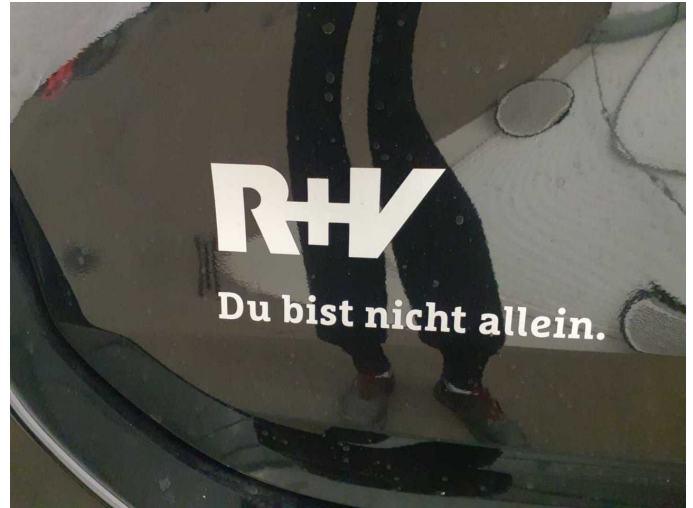
**Damage 1:** Boot lid / rear door: Boot lid - Glued / labelled - De-glue / neutralise

| No. | Component group | Description |
|---|---|---|
| 1 | Boot lid / rear door | Boot lid - Glued / labelled - De-glue / neutralise |

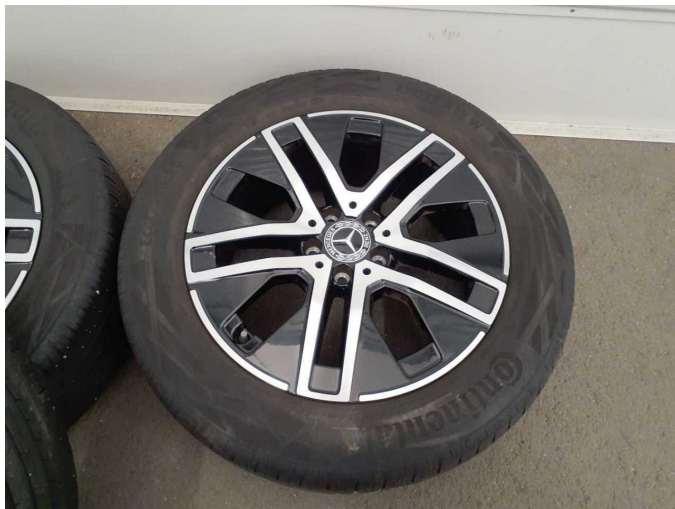
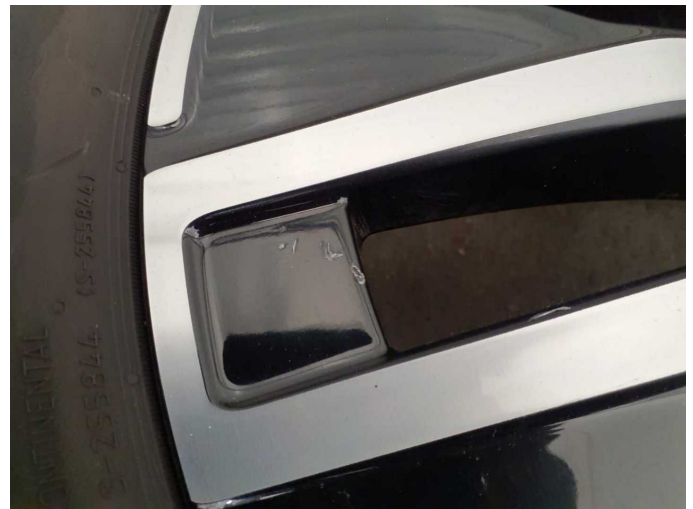
**Damage 2:** 2nd wheel set: 1 alloy rim - Scratch(es) - Loss in value

| No. | Component group | Description |
|---|---|---|
| 2 | 2nd wheel set | 1 alloy rim - Scratch(es) - Loss in value |

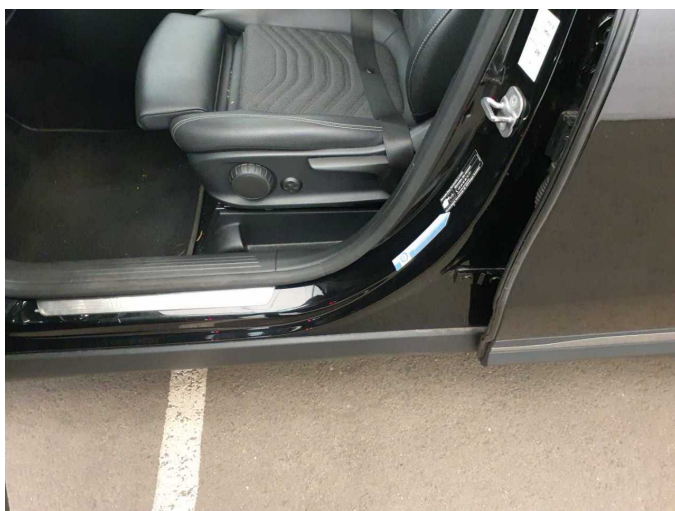
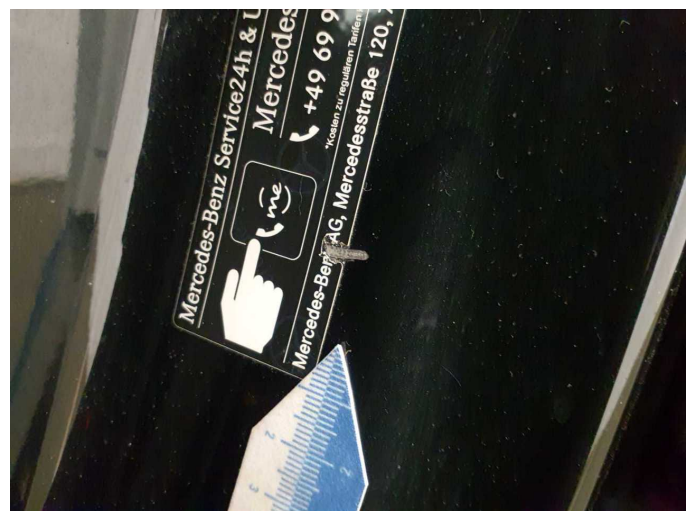
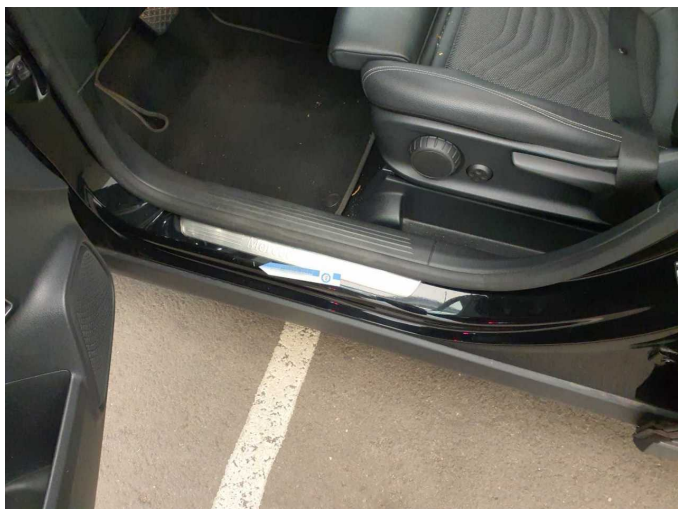
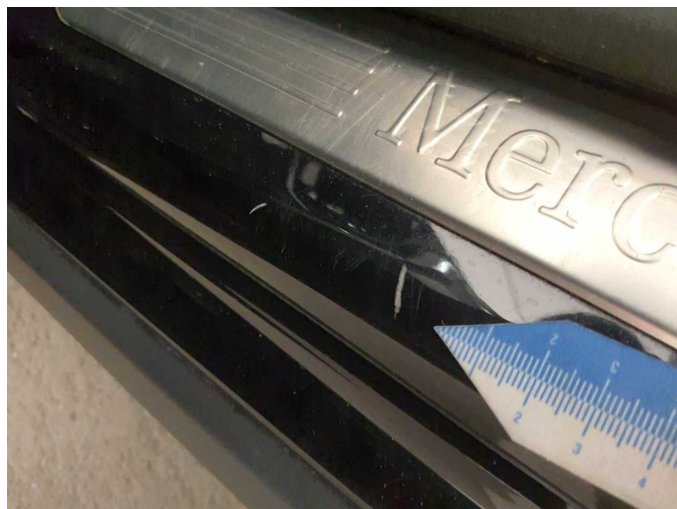
**Damage 3:** Sill - left side: Sill - Scratch(es) - Smart repair

| No. | Component group | Description |
|---|---|---|
| 3 | Sill - left side | Sill - Scratch(es) - Smart repair |

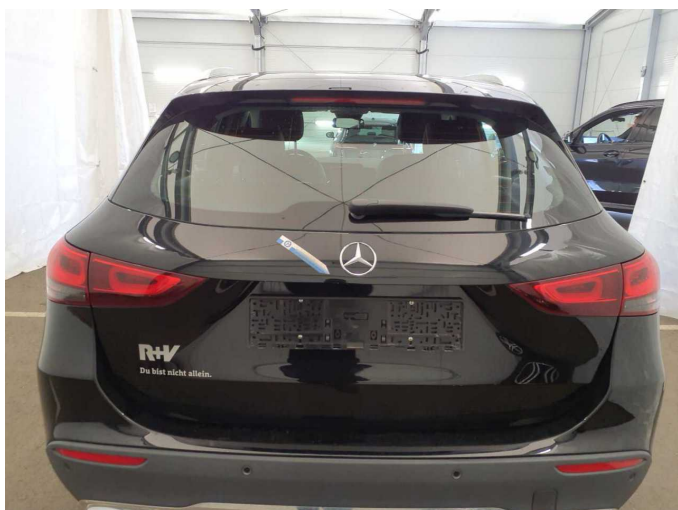
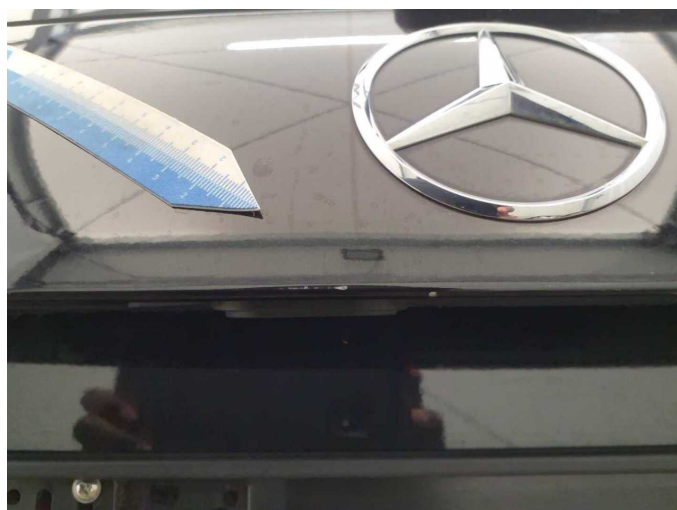
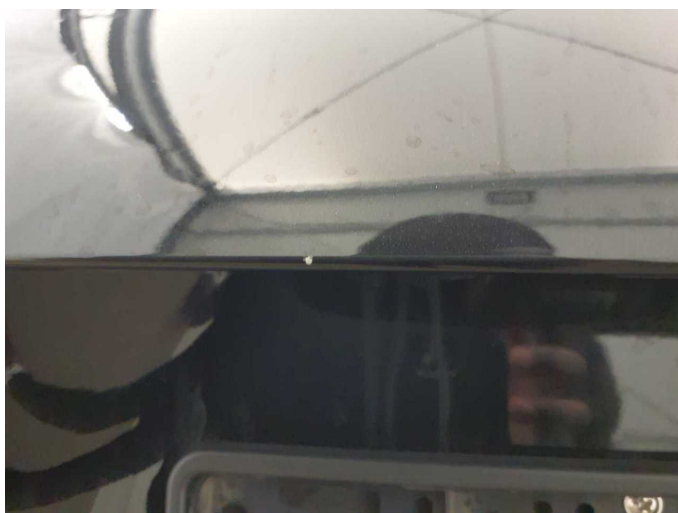
**Damage 4:** Boot lid / rear door: Boot lid - Scratch(es) - Smart repair

| No. | Component group | Description |
|---|---|---|
| 4 | Boot lid / rear door | Boot lid - Scratch(es) - Smart repair |
