Expertise

Protocol number: 46797544  
Order No. / Reference: 26650895  
Inspection date: 28 Jul 2026

Manufacturer: Ford

Model: Mondeo Turnier 2.0 EcoBlue Aut. Titanium

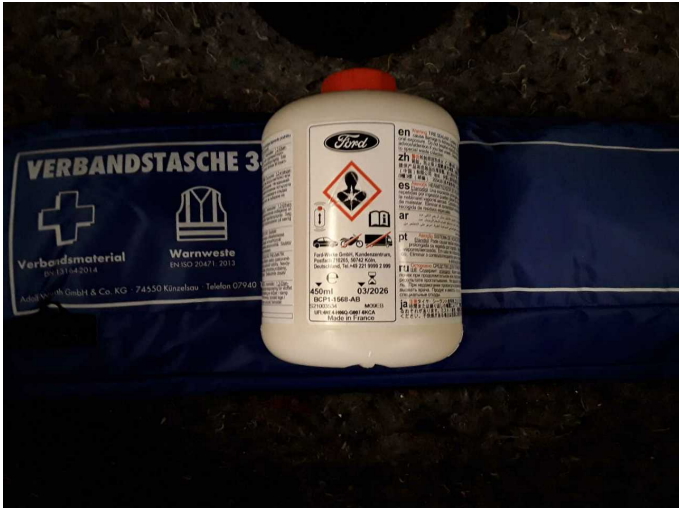
| No. | Component group | Description |
|---|---|---|
| 1 | Equipment | Tirefit filler - Expired - Replace |

Damage 1: Equipment: Tirefit filler - Expired - Replace

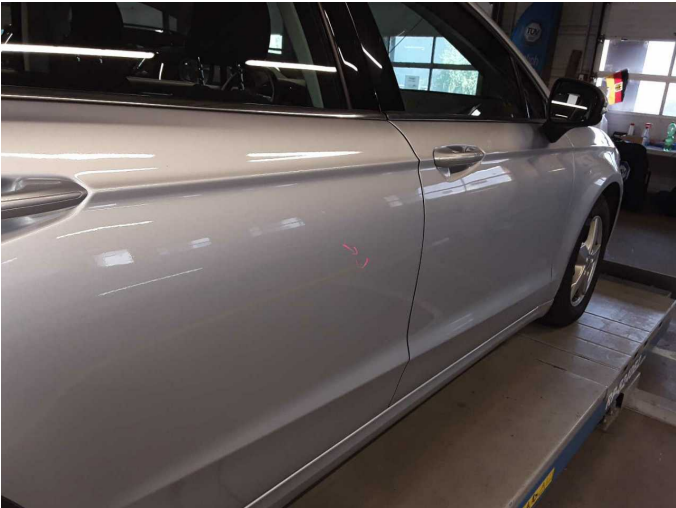
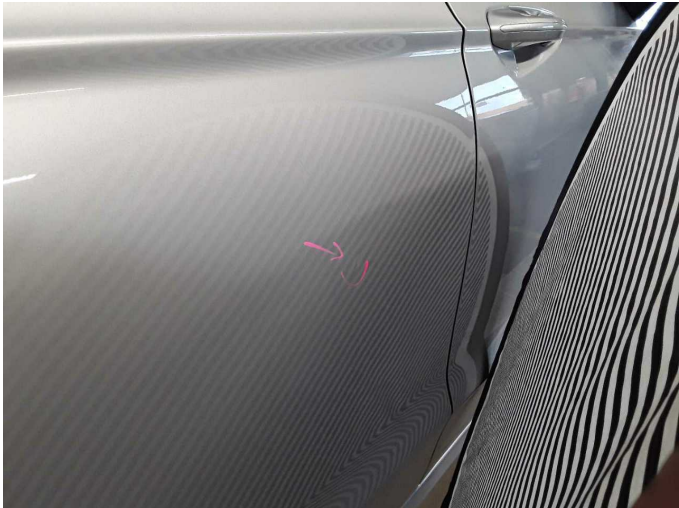
| No. | Component group | Description |
|---|---|---|
| 2 | Door - rear right side | Door - dent(s) - Smooth repair work |

Damage 2: Door - rear right side: Door - dent(s) - Smooth repair work

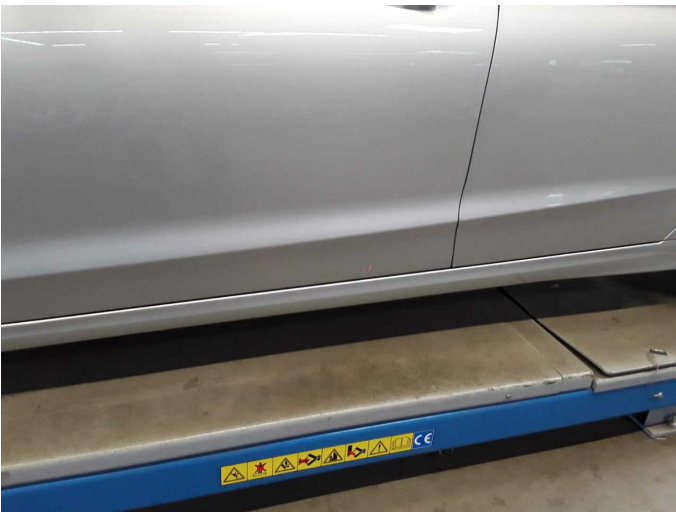
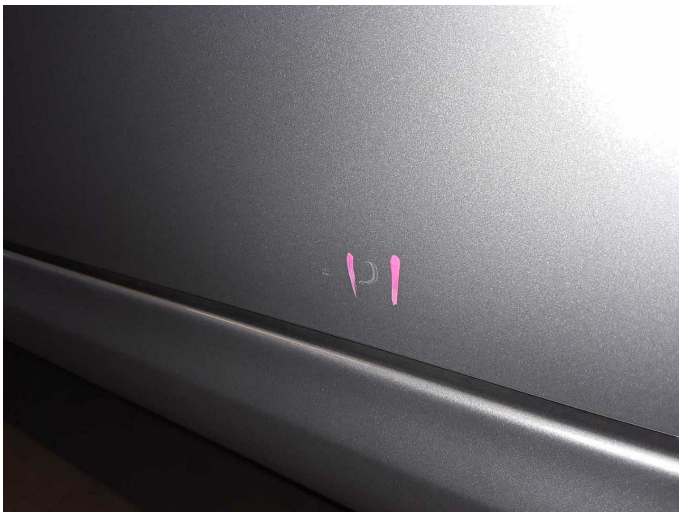
| No. | Component group | Description |
|---|---|---|
| 3 | Door - front left side | Door - Scratch(es) - Paint |

Damage 3: Door - front left side: Door - Scratch(es) - Paint

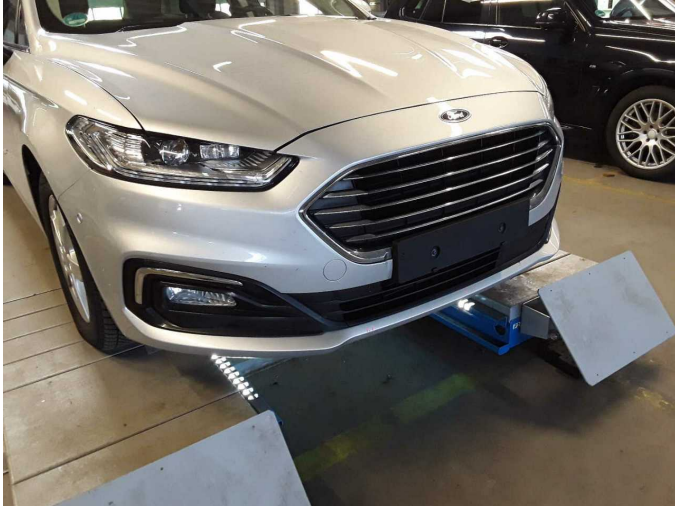
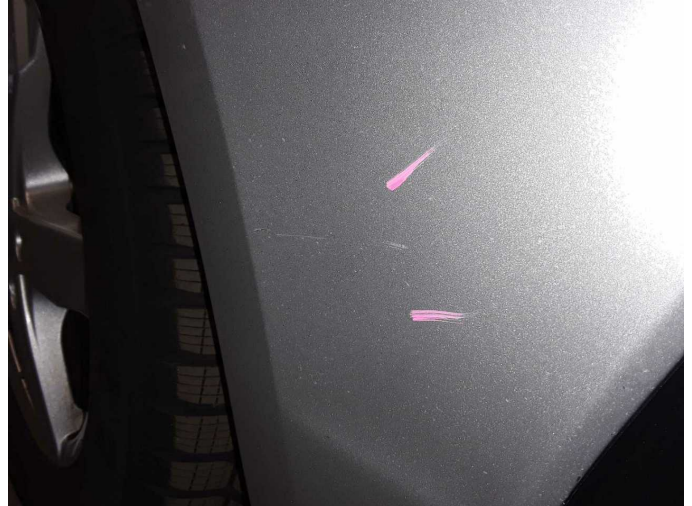
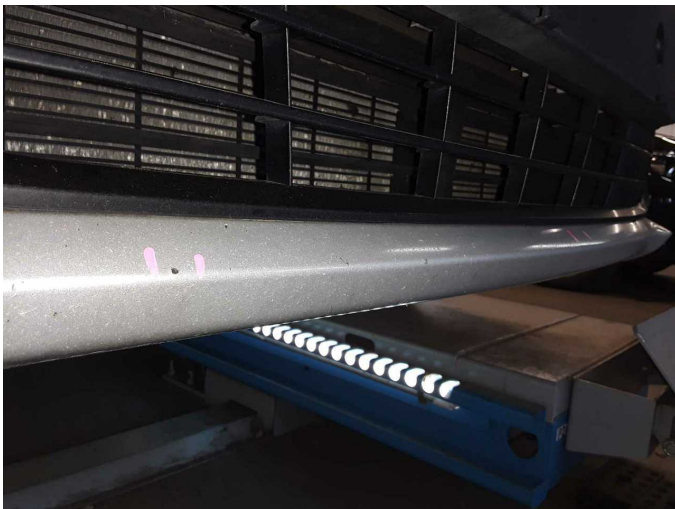
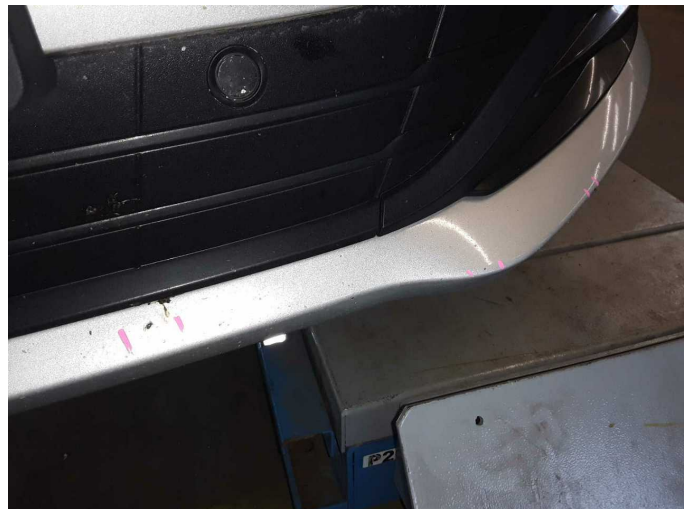
| No. | Component group | Description |
|---|---|---|
| 4 | Front bumper | Front bumper - Scratch(es) - Paint |

**Damage 4:** Front bumper: Front bumper - Scratch(es) - Paint

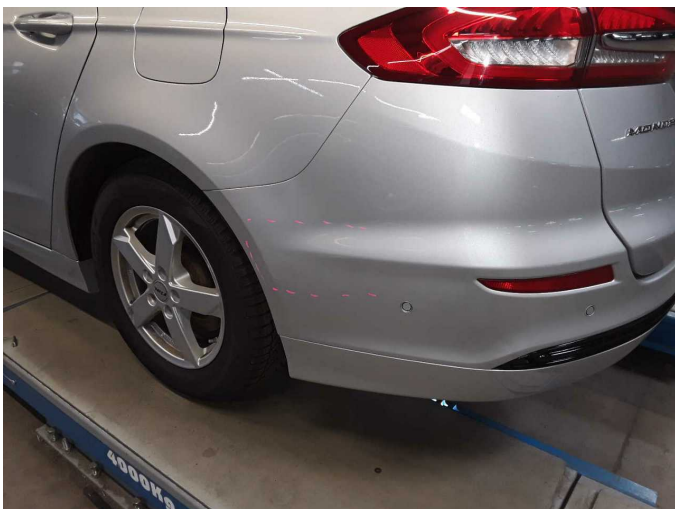
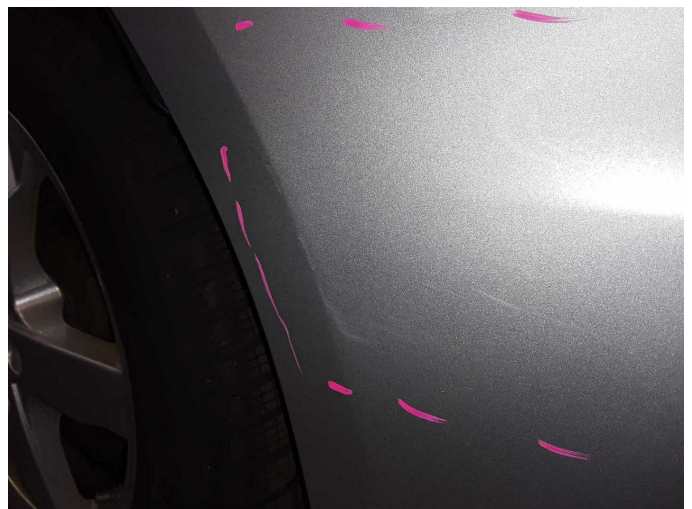
| No. | Component group | Description |
|---|---|---|
| 5 | Rear bumper | Rear bumper - Scratch(es) - Paint |

**Damage 5:** Rear bumper: Rear bumper - Scratch(es) - Paint

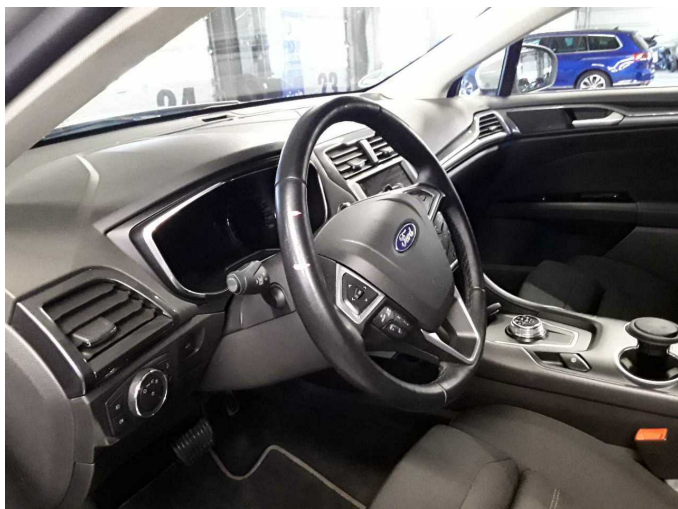
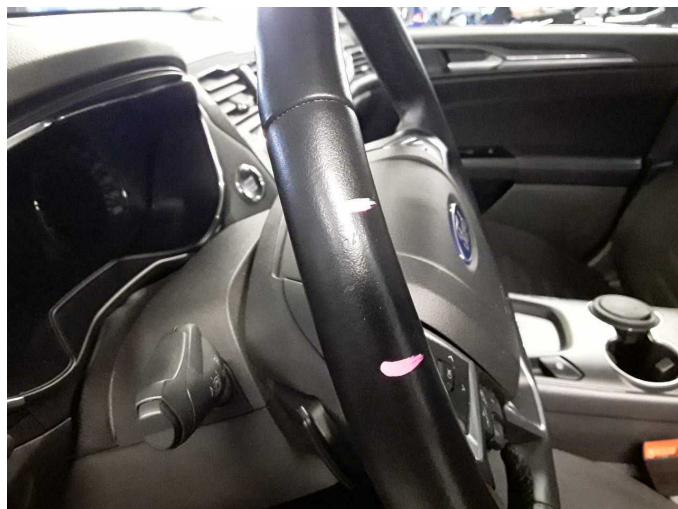
| No. | Component group | Description |
|---|---|---|
| 1 | Steering system | Steering wheel - Scratch(es) - No deduction |

**Wear and tear 1:** Steering system: Steering wheel - Scratch(es) - No deduction
