Expertise

Protocol number: 46400805  
Order No. / Reference: 26605142  
Inspection date: 8 Jul 2026

Model: Grand Tourneo Connect 1.5 EcoBlue Aut. Start/Stop Trend

VIN: WF0UXXWPGUNL42077

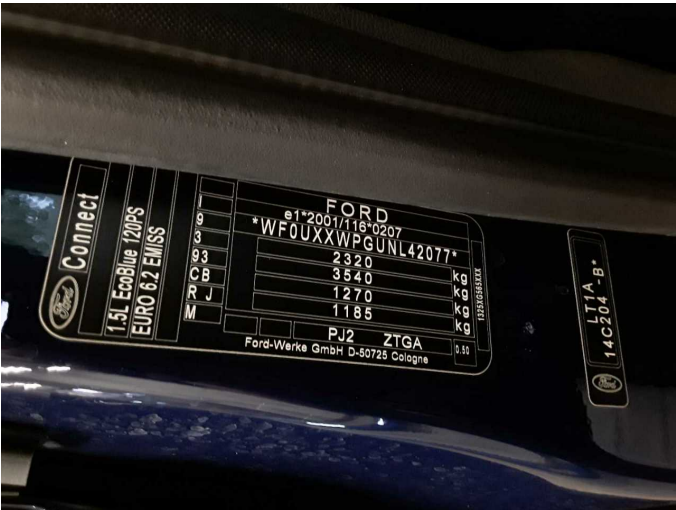
Figure 11: VIN

| VIN comparison | The vehicle identification number (VIN) was read from the vehicle and its conformity with the submitted documents was confirmed by the undersigned during the inspection. |

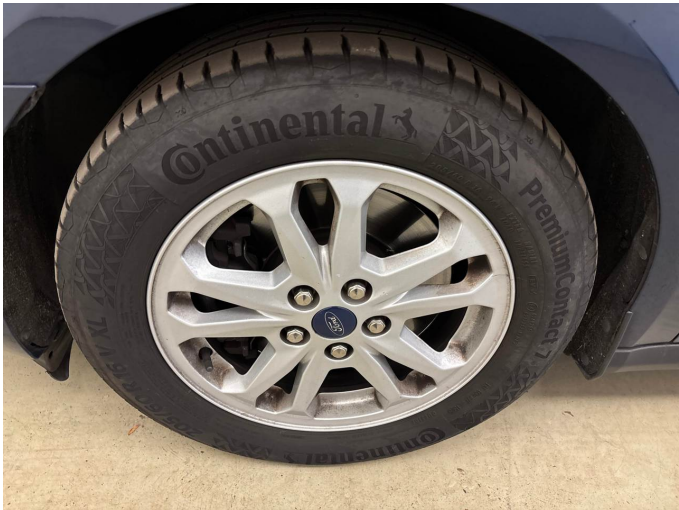
Figure 12: Mounted tyres

| Tyres | | | | |
|---|---|---|---|---|
| 1) | 205/60 R16 96V | Summer tyres on Light alloy | Continental | 4mm / 4mm |
| 2) | 205/60 R16 96V | Summer tyres on Light alloy | Continental | 4mm / 4mm |

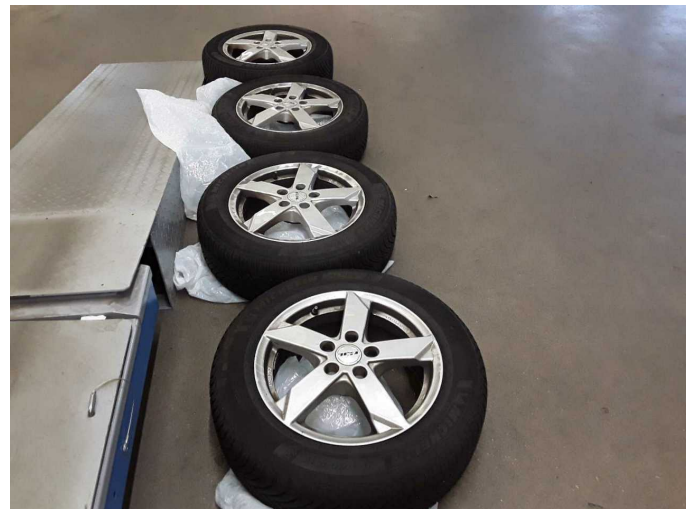
Figure 16: Additional tyres

| Tyres | | | | |
|---|---|---|---|---|
| 1) | 205/60 R16 96H | Winter tyres on Light alloy | Michelin | 5mm / 5mm |
| 2) | 205/60 R16 96H | Winter tyres on Light alloy | Michelin | 5mm / 5mm |

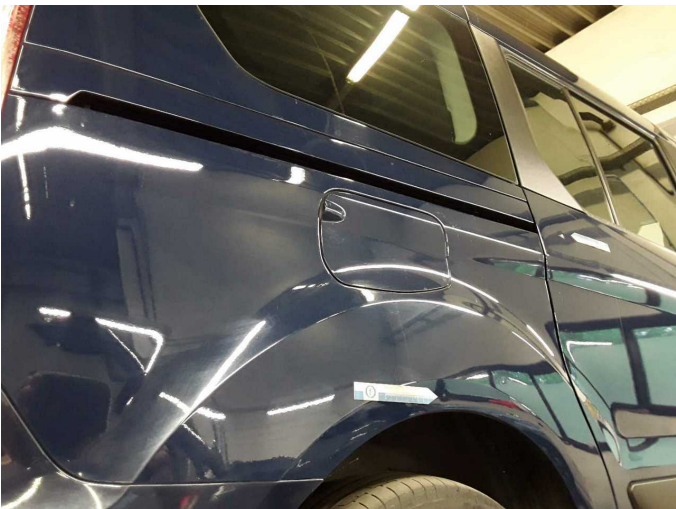
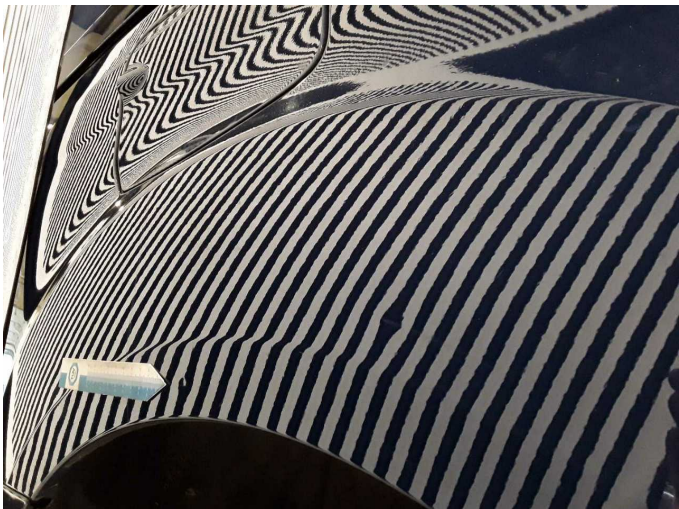
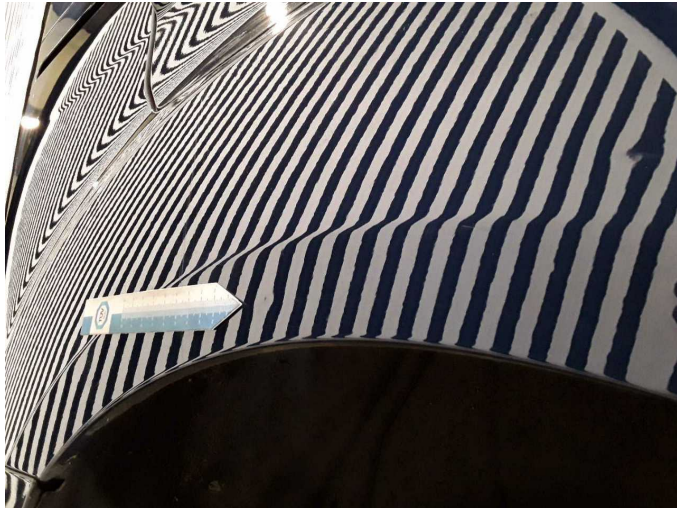
| No. | Component group | Description |
|---|---|---|
| 1 | Side panel - rear right side | Side panel - dent(s) - Smooth repair work |

Damage 1: Side panel - rear right side: Side panel - dent(s) - Smooth repair work

**Damage 1:** Side panel - rear right side: Side panel - dent(s) - Smooth repair work

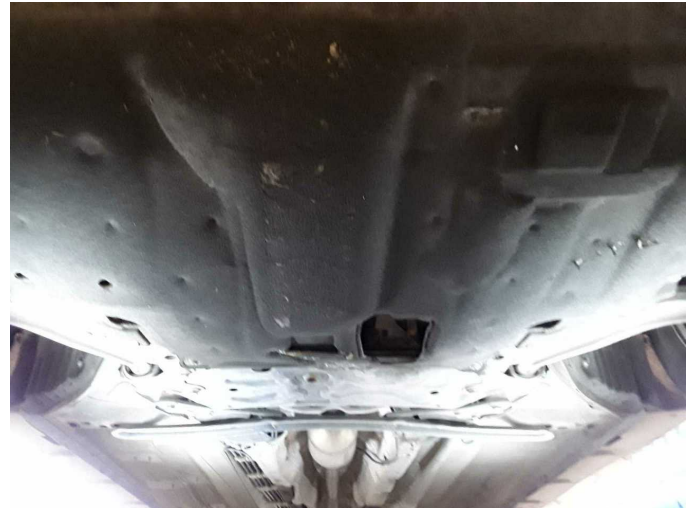
| No. | Component group | Description |
|---|---|---|
| 2 | Engine | Engine - Leaking - Diagnosed and repair if necessary |

**Damage 2:** Engine: Engine - Leaking - Diagnosed and repair if necessary

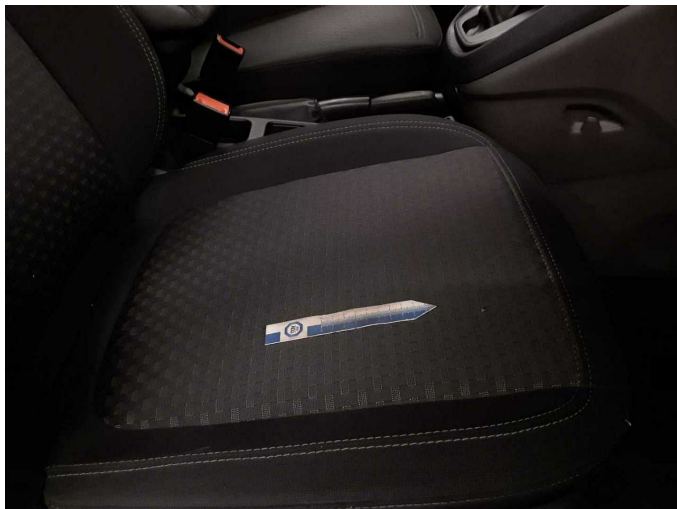
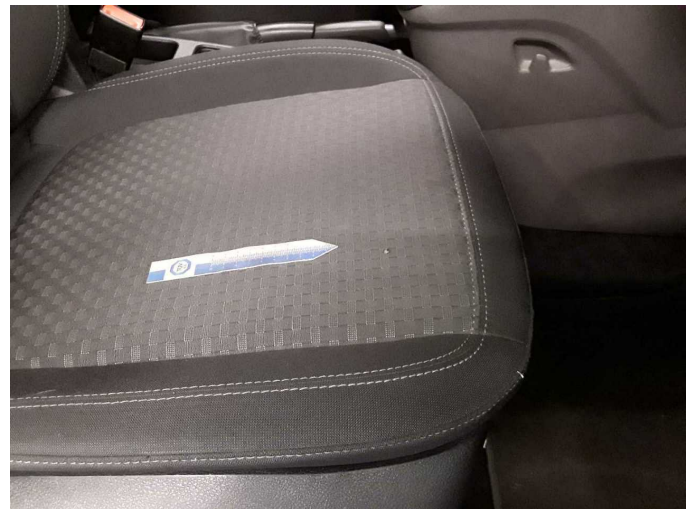
| No. | Component group | Description |
|---|---|---|
| 3 | Seat - front | Seat cover - right side - Burn hole (cigarettes) - Smart repair |

**Damage 3:** Seat - front: Seat cover - right side - Burn hole (cigarettes) - Smart repair

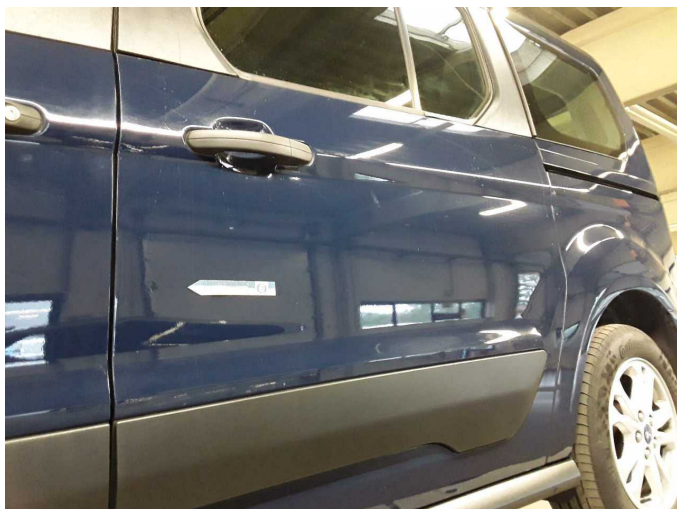
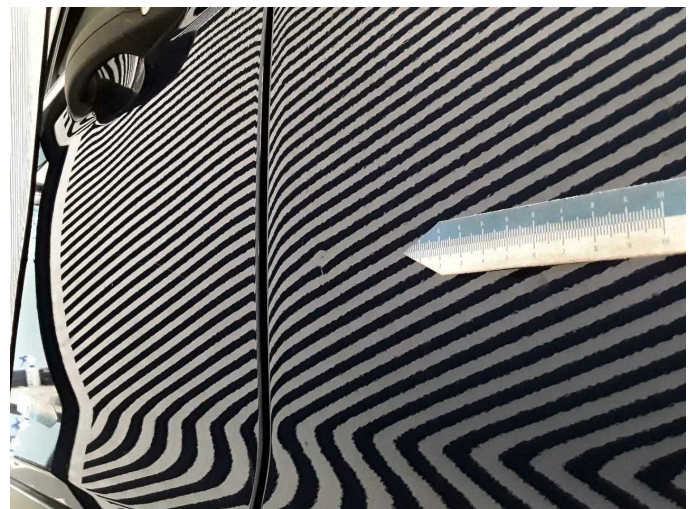
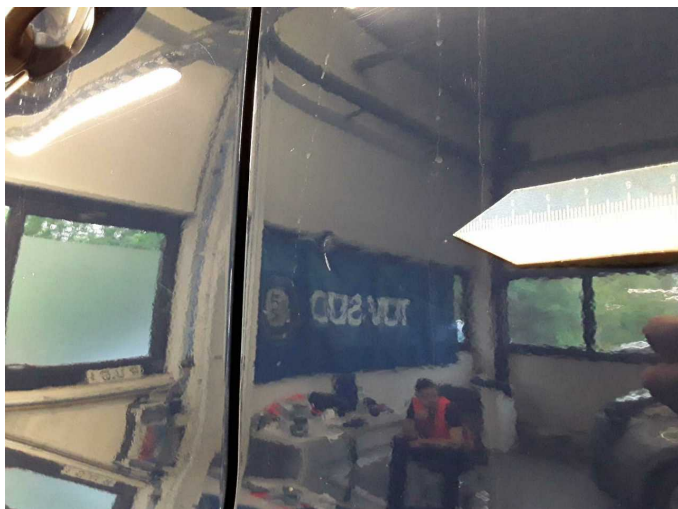
| No. | Component group | Description |
|---|---|---|
| 4 | Door - rear left side | Door - Dent / paintcoat damage - Smart repair |

**Damage 4:** Door - rear left side: Door - Dent / paintcoat damage - Smart repair

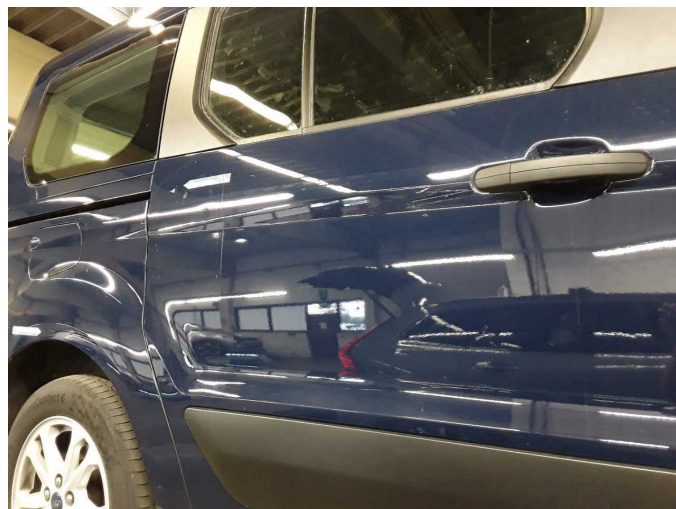
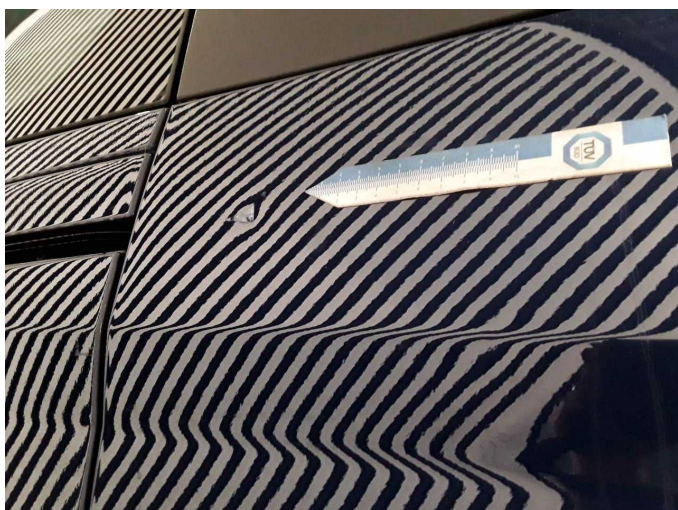
| No. | Component group | Description |
|---|---|---|
| 5 | Door - rear right side | Door - Dent / paintcoat damage - Smart repair |

**Damage 5:** Door - rear right side: Door - Dent / paintcoat damage - Smart repair

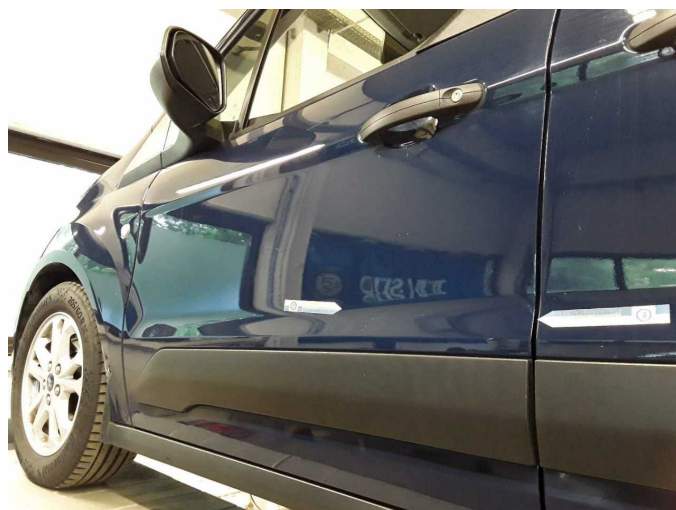
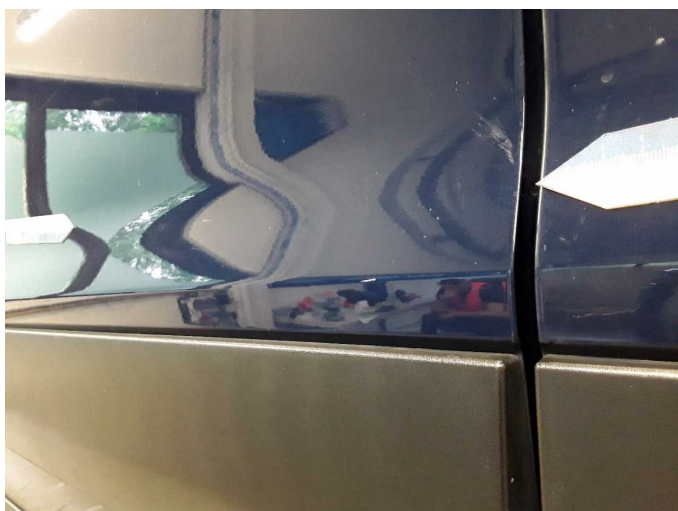
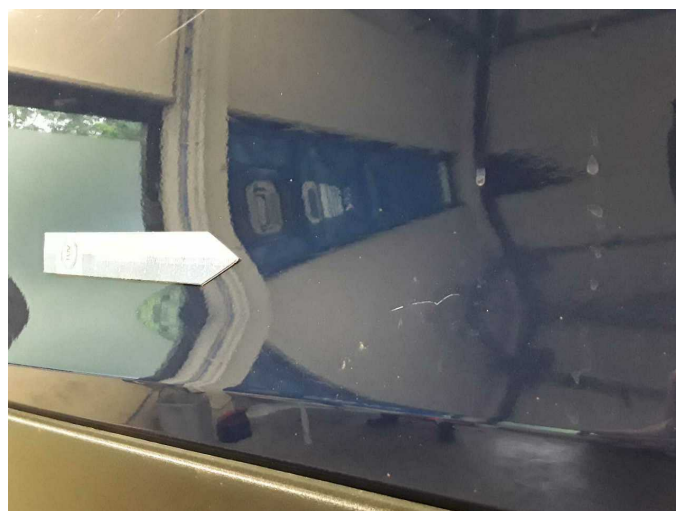
| No. | Component group | Description |
|---|---|---|
| 6 | Door - front left side | Door - Scratch(es) - Paint |

**Damage 6:** Door - front left side: Door - Scratch(es) - Paint

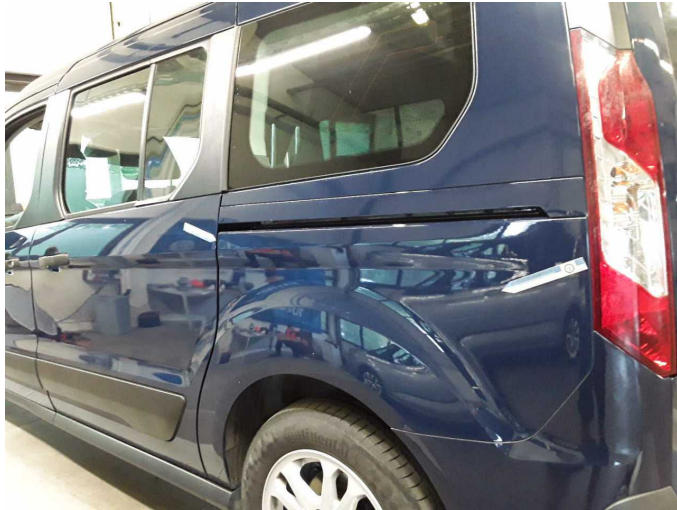
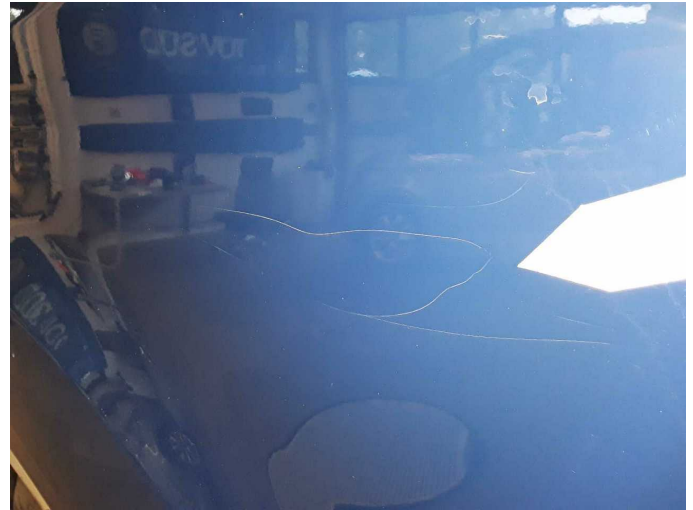
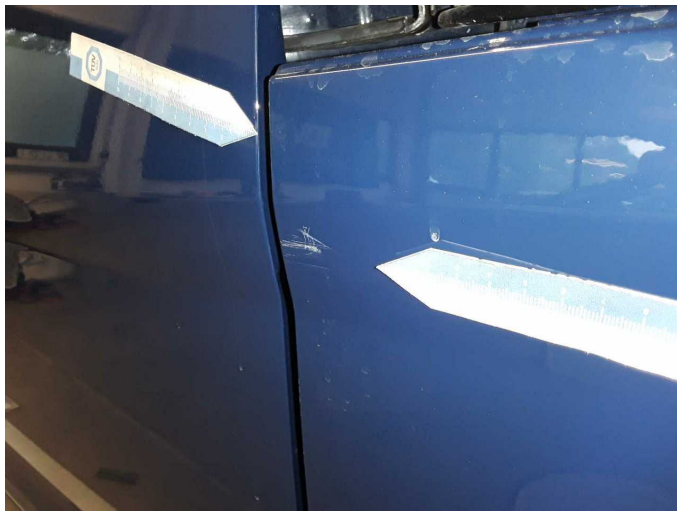
| No. | Component group | Description |
|---|---|---|
| 7 | Side panel - rear left side | Side panel - Scratch(es) - Paint |

**Damage 7:** Side panel - rear left side: Side panel - Scratch(es) - Paint
