Expertise

Protocol number: 46409536  
Order No. / Reference: 26527754  
Inspection date: 8 Jul 2026

Manufacturer: Volvo

Model: XC60 T8 AWD Recharge Ultimate Dark

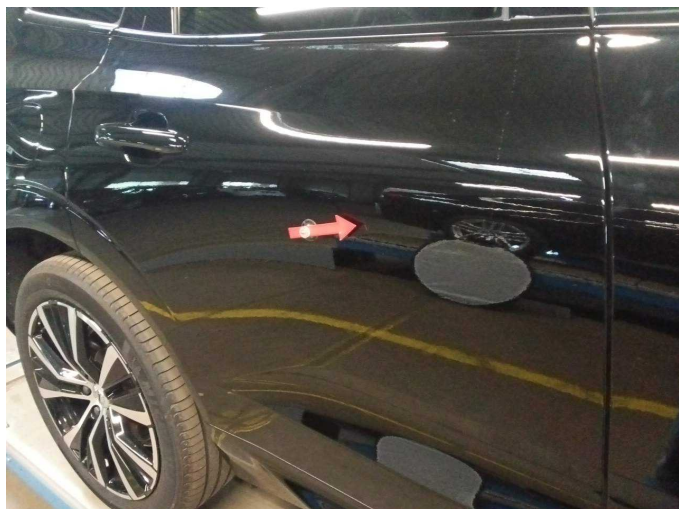
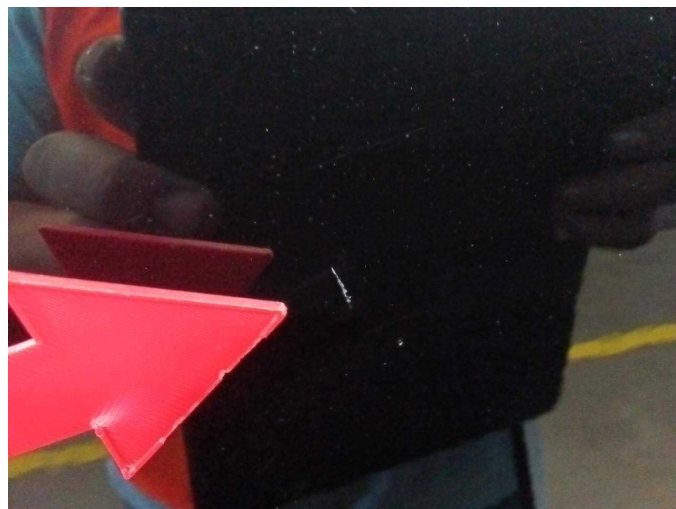
| No. | Component group | Description |
|---|---|---|
| 1 | Door - rear right side | Door - Scratch(es) - Smart repair |

**Damage 1:** Door - rear right side: Door - Scratch(es) - Smart repair

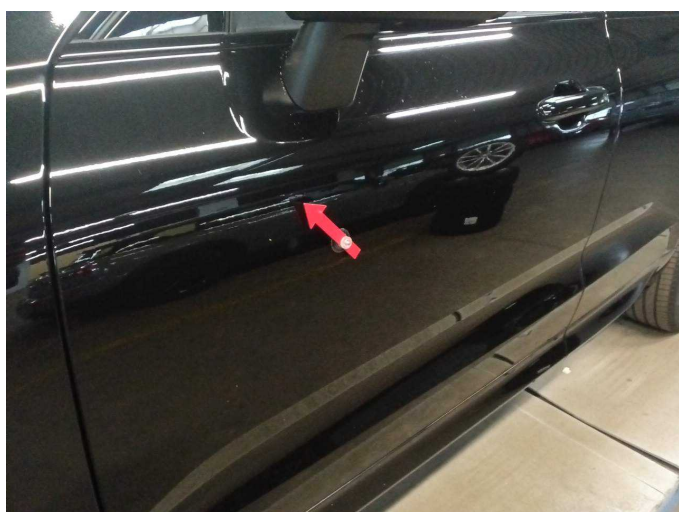
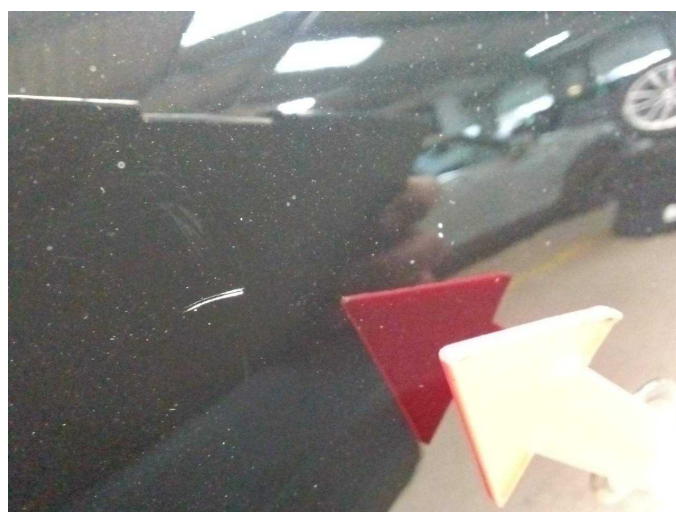
| No. | Component group | Description |
|---|---|---|
| 2 | Door - front left side | Door - Scratch(es) - Smart repair |

**Damage 2:** Door - front left side: Door - Scratch(es) - Smart repair

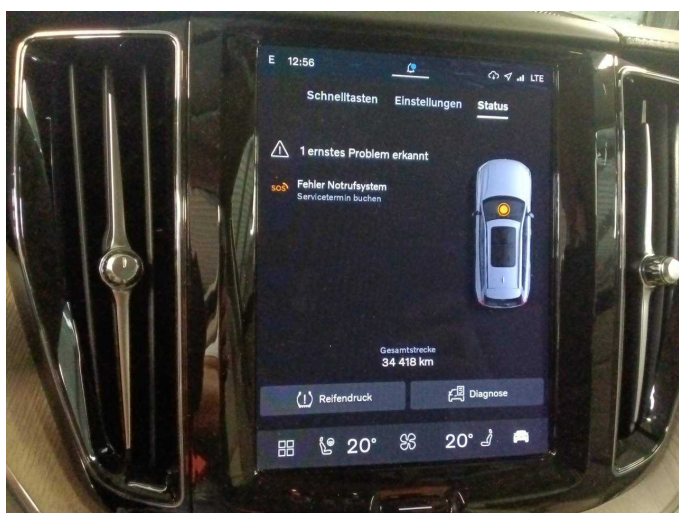
| No. | Component group | Description |
|---|---|---|
| 3 | Misc. | Misc. (Fehler Notrufsystem) - on - Perform diagnosis |

**Damage 3:** Misc.: Misc. (Fehler Notrufsystem) - on - Perform diagnosis

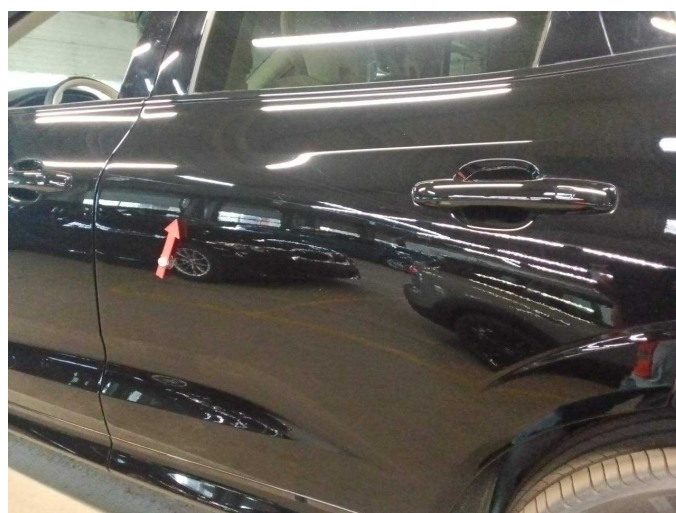
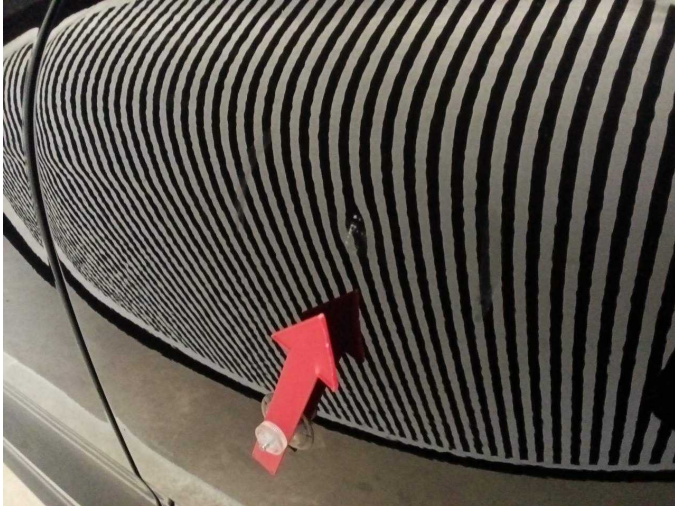
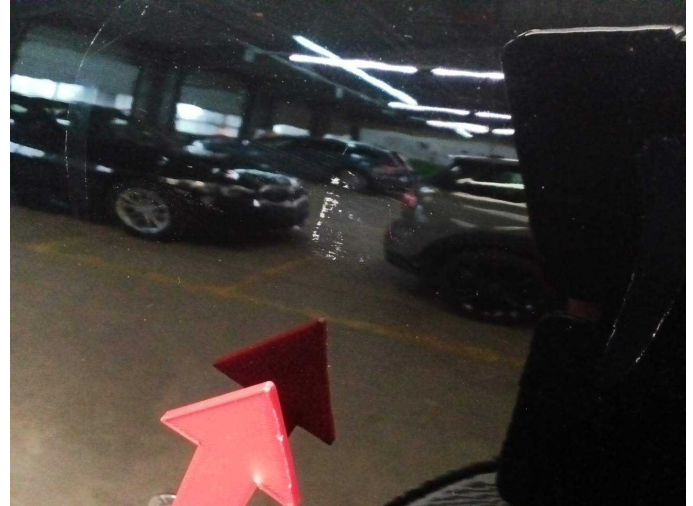
| No. | Component group | Description |
|---|---|---|
| 4 | Door - rear left side | Door - Dent / paintcoat damage - Smart repair |

**Damage 4:** Door - rear left side: Door - Dent / paintcoat damage - Smart repair

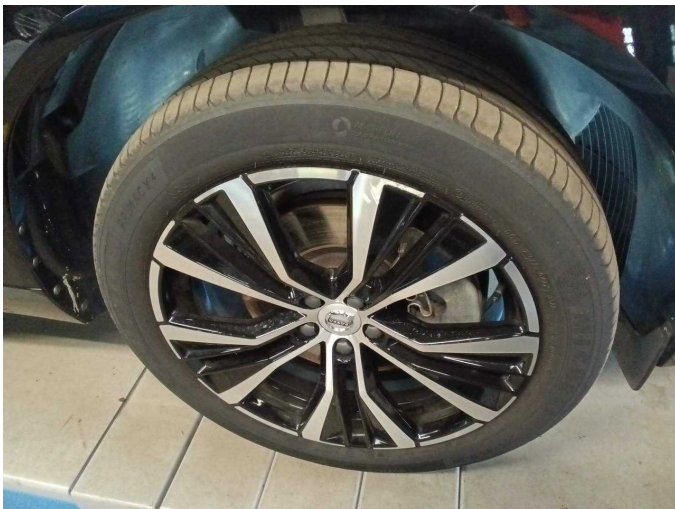
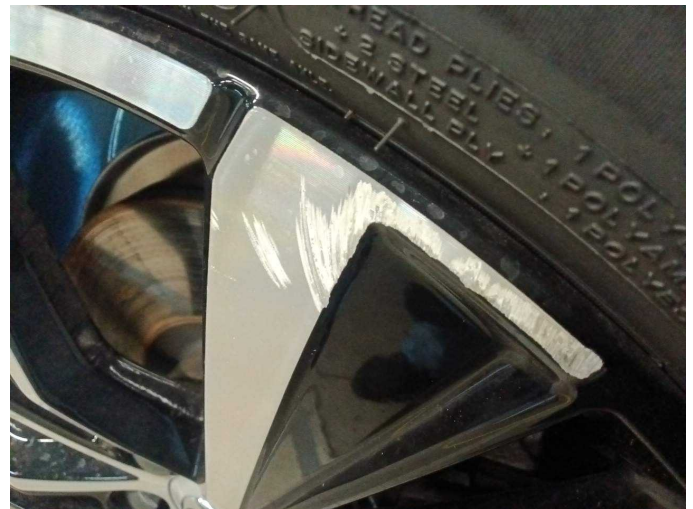
| No. | Component group | Description |
|---|---|---|
| 5 | Wheel / tyres | Alloy rim - front right side - Scratched - Loss in value |

**Damage 5:** Wheel / tyres: Alloy rim - front right side - Scratched - Loss in value

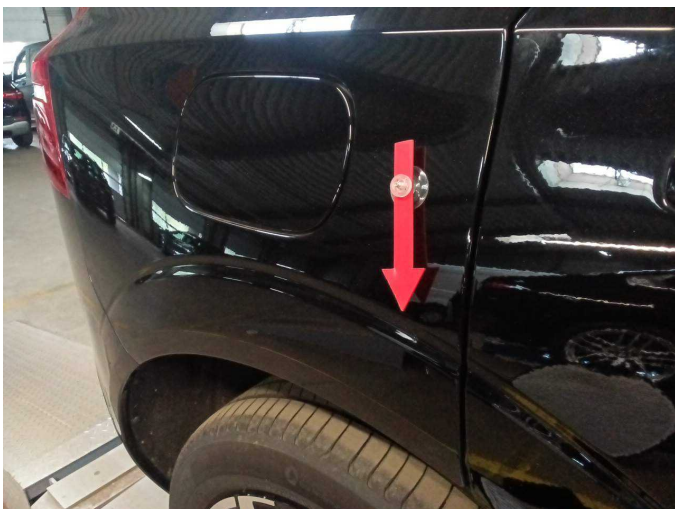
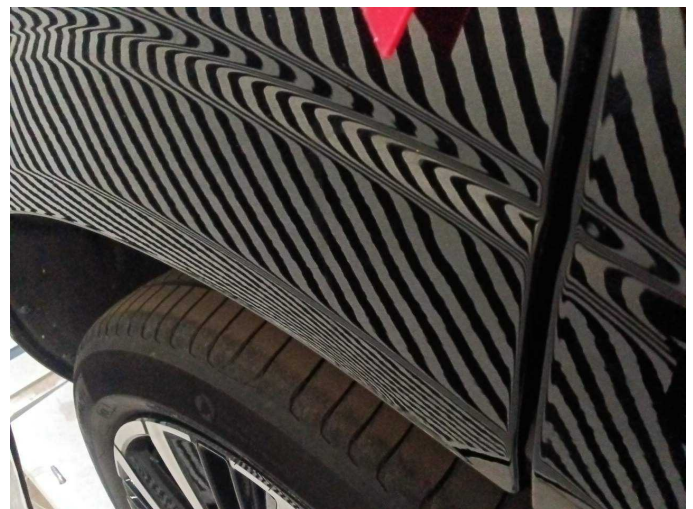
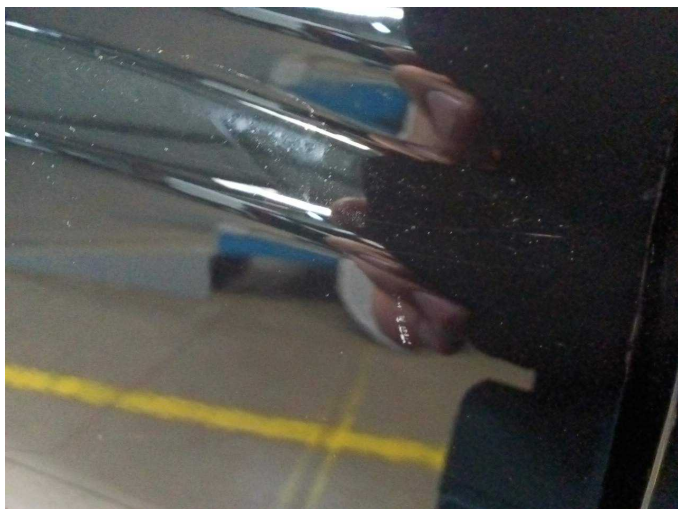
| No. | Component group | Description |
|---|---|---|
| 1 | Side panel - rear right side | Side panel - dent(s) - No deduction |

**Wear and tear 1:** Side panel - rear right side: Side panel - dent(s) - No deduction

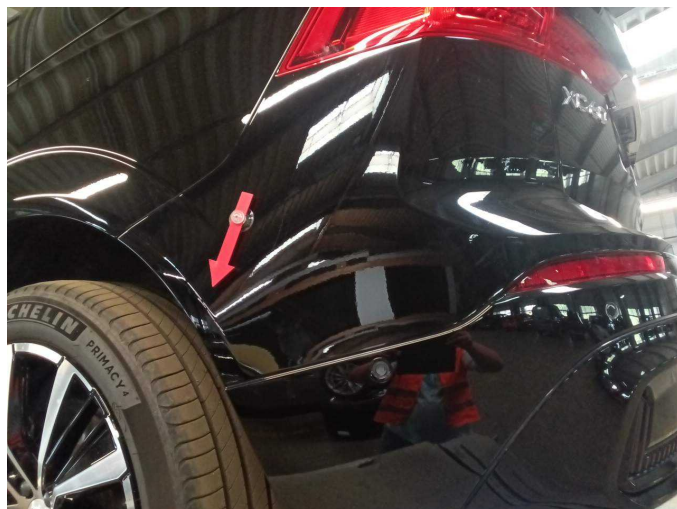
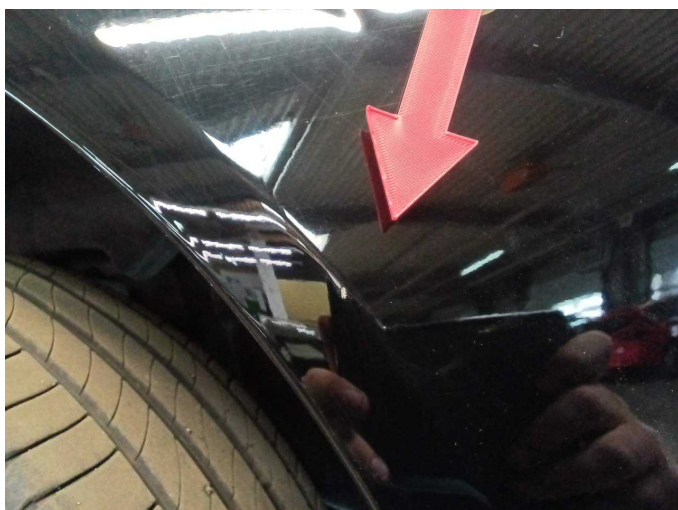
| No. | Component group | Description |
|---|---|---|
| 2 | Rear bumper | Rear bumper - Scratch(es) - No deduction |

**Wear and tear 2:** Rear bumper: Rear bumper - Scratch(es) - No deduction

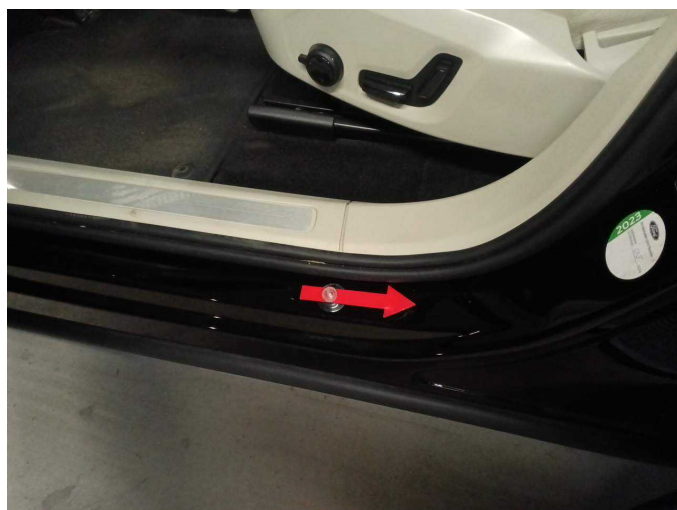
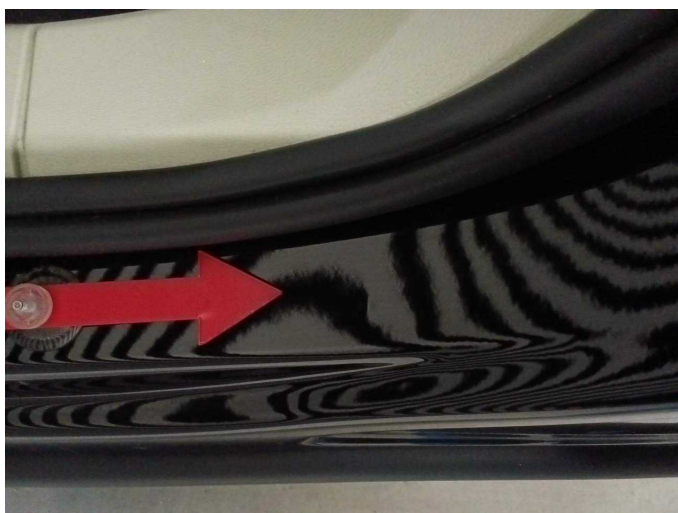
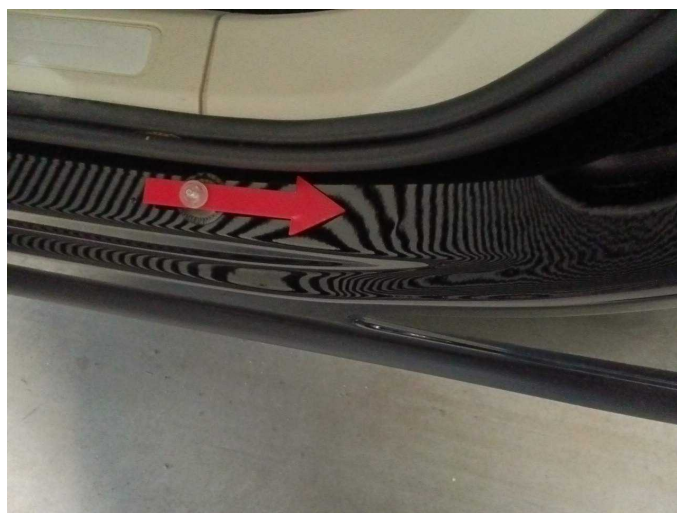
| No. | Component group | Description |
|---|---|---|
| 3 | Sill - left side | Sill - dent(s) - No deduction |

**Wear and tear 3:** Sill - left side: Sill - dent(s) - No deduction

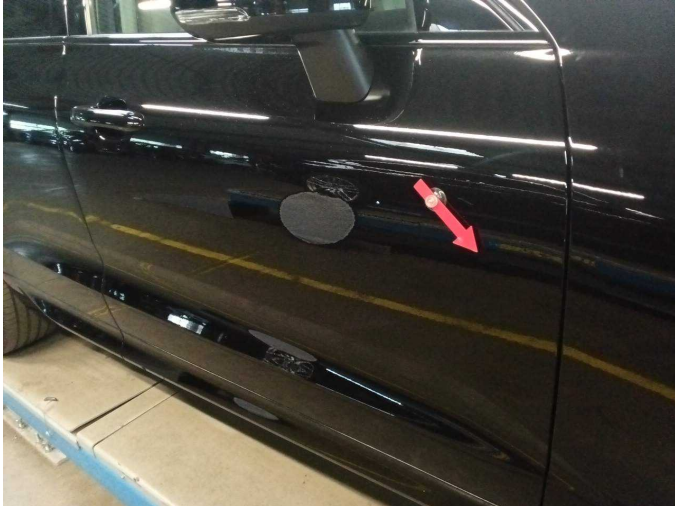
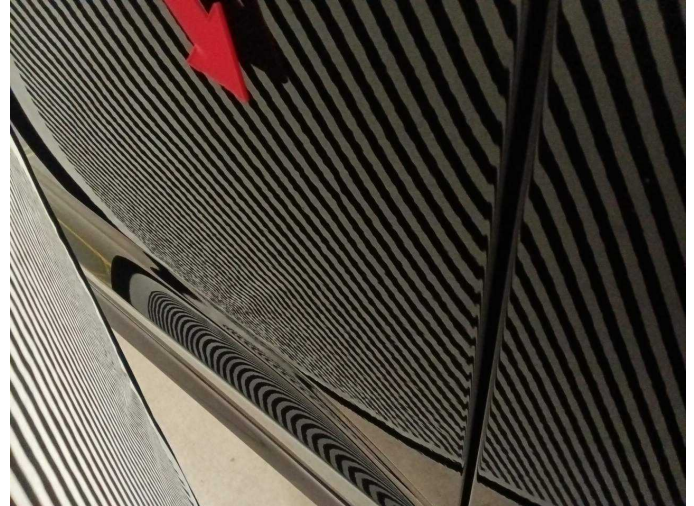
| No. | Component group | Description |
|---|---|---|
| 4 | Door - front right side | Door - dent(s) - No deduction |

**Wear and tear 4:** Door - front right side: Door - dent(s) - No deduction
