Expertise

Manufacturer: Audi

Model: A1 35 TFSI Sportback S tronic

VIN: WAUZZZGB0SR014971

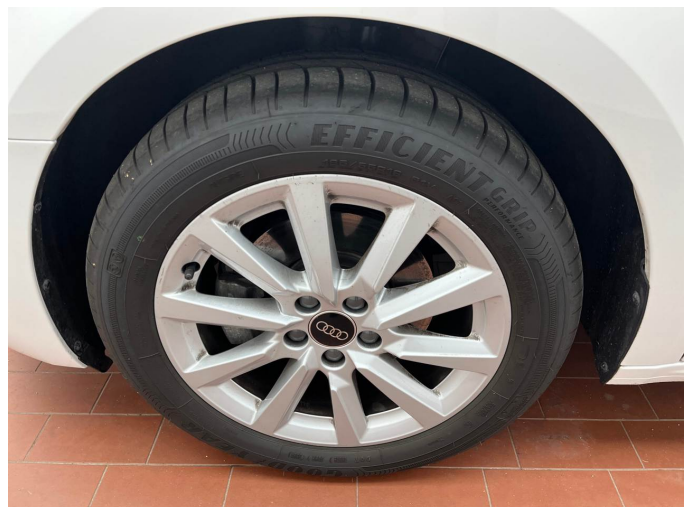
| # | Tyre size | Type of tyre | Manufacturer | Tread depth |
|---|---|---|---|---|
| 1) | 195/55 R16 91V | Summer tyres on Light alloy | Goodyear | 7mm / 7mm |
| 2) | 195/55 R16 91V | Summer tyres on Light alloy | Goodyear | 6mm / 6mm |

Figure 12: Mounted tyres

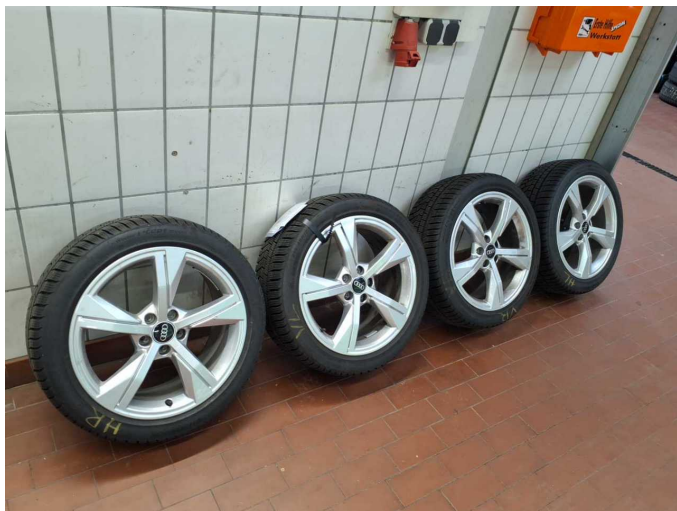
| # | Tyre size | Type of tyre | Manufacturer | Tread depth |
|---|---|---|---|---|
| 1) | 215/45 R17 91W | Winter tyres on Light alloy | Hankook | 5mm / 5mm |
| 2) | 215/45 R17 91W | Winter tyres on Light alloy | Hankook | 7mm / 7mm |

Figure 15: Additional tyres

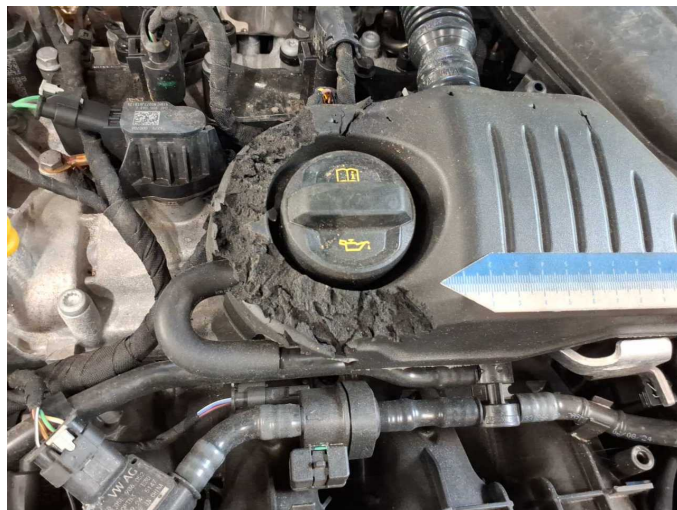
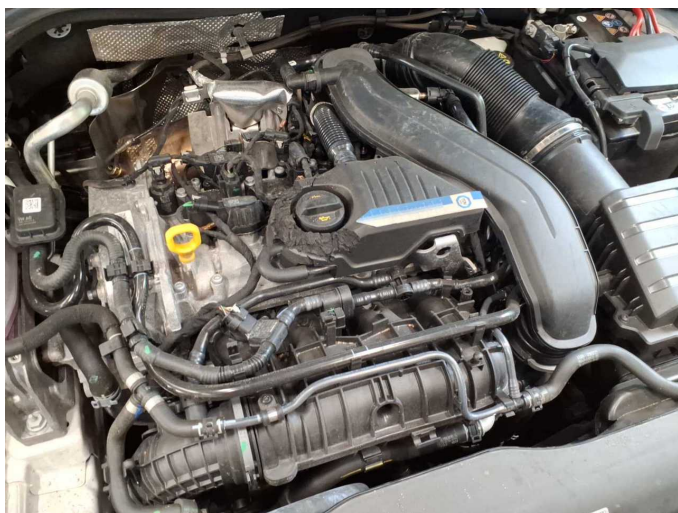
| No. | Component group | Description |
|---|---|---|
| 1 | Engine | Engine cover - Damage caused by marten / rodent - Replace |

**Damage 1:** Engine: Engine cover - Damage caused by marten / rodent - Replace

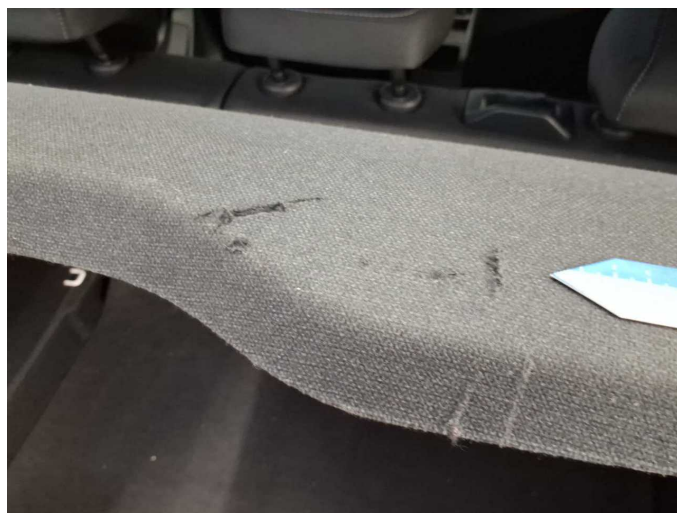
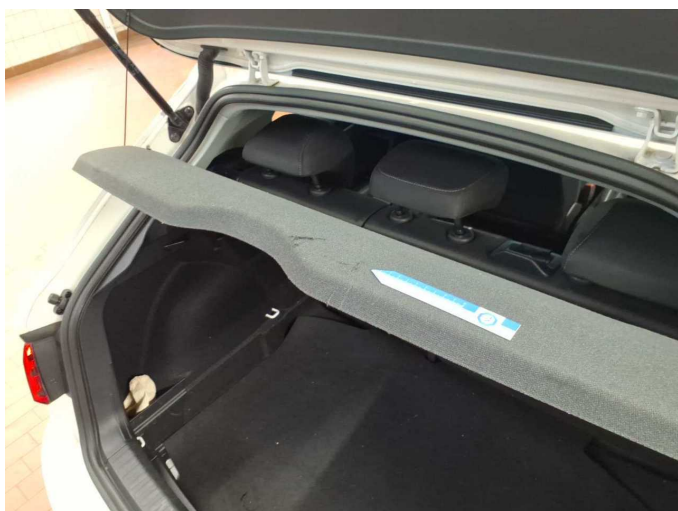
| No. | Component group | Description |
|---|---|---|
| 2 | Interior | Rear shelf - Broken / torn - Replace |

**Damage 2:** Interior: Rear shelf - Broken / torn - Replace

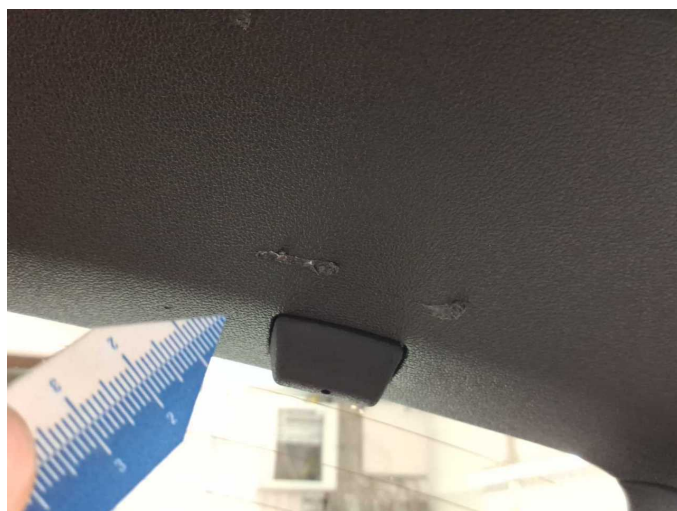
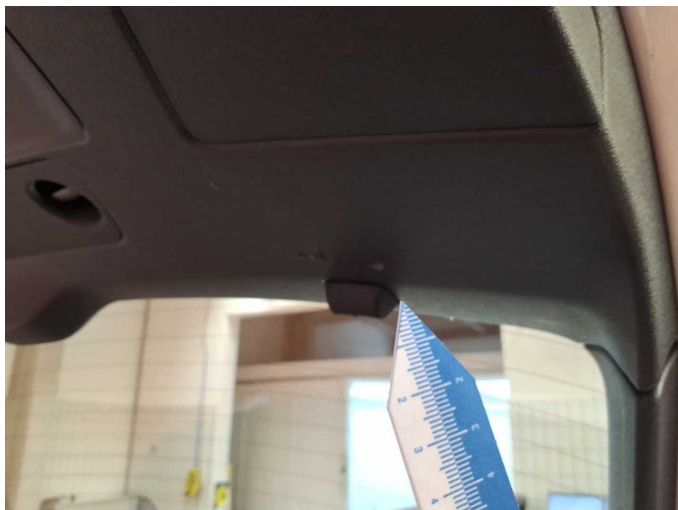
| No. | Component group | Description |
|---|---|---|
| 3 | Trim / covers | Boot lid - interior trim - Scratch(es) - Replace |

**Damage 3:** Trim / covers: Boot lid - interior trim - Scratch(es) - Replace

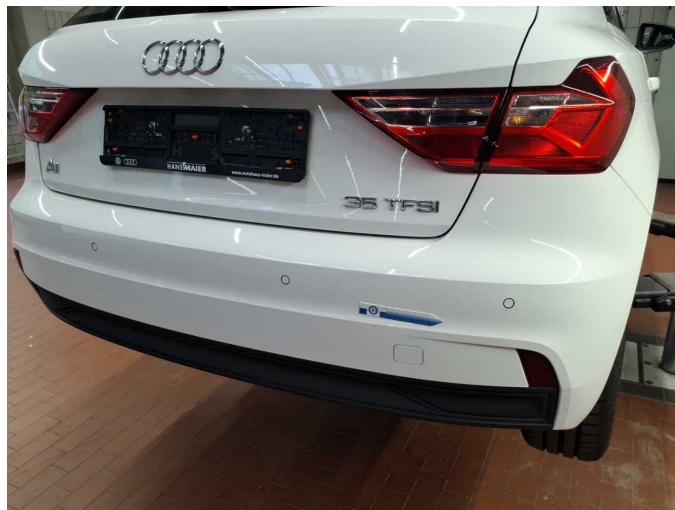
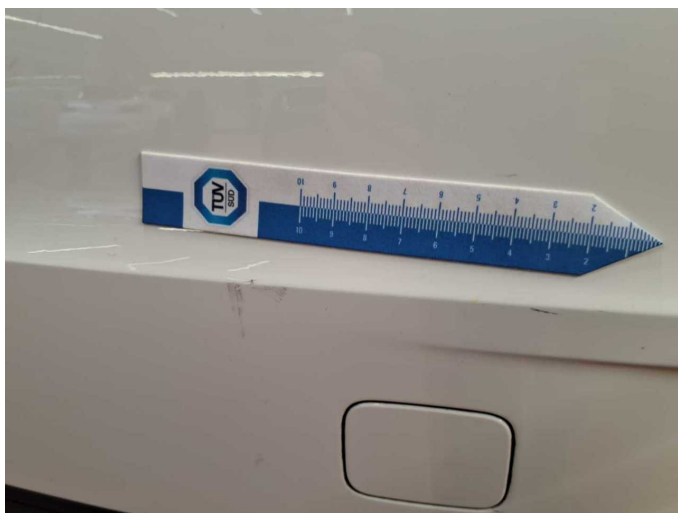
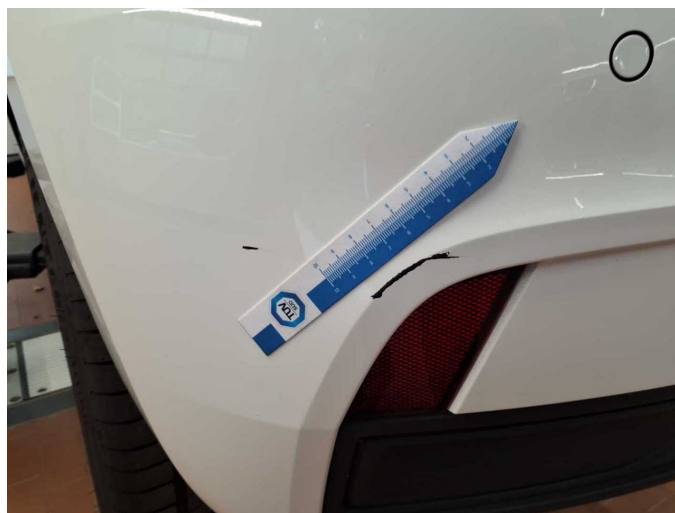
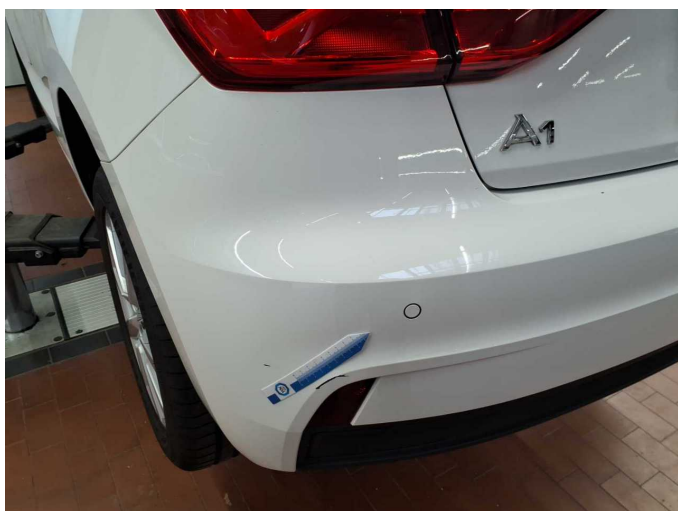
| No. | Component group | Description |
|---|---|---|
| 4 | Rear bumper | Rear bumper - Scratch(es) - Paint |

**Damage 4:** Rear bumper: Rear bumper - Scratch(es) - Paint

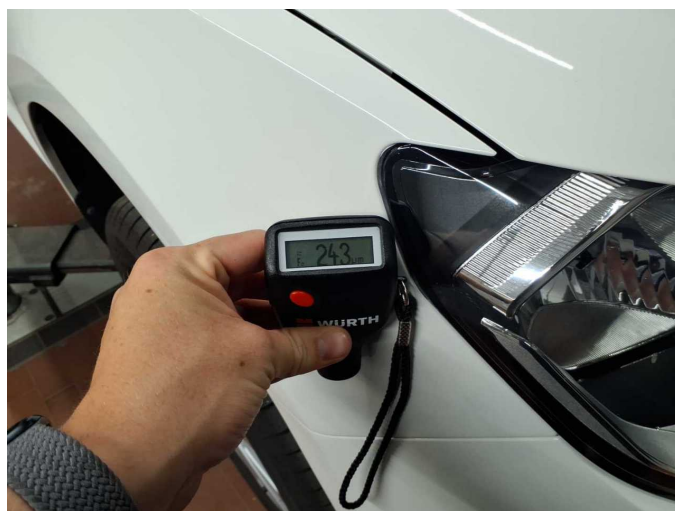
| No. | Repainting |
|---|---|
| 1 | Mudguard - right side, Professionally carried out, Invoice of repair done Non-existent |

| Mudguard - right side | 243 µm |

**Repainting 1:** Mudguard - right side
