Expertise

Protocol number: 46114167  
Order No. / Reference: 26490369  
Inspection date: 24 Jun 2026

Manufacturer: Volkswagen

Model: Tiguan Allspace 2.0 TSI OPF 4Motion DSG Elegance

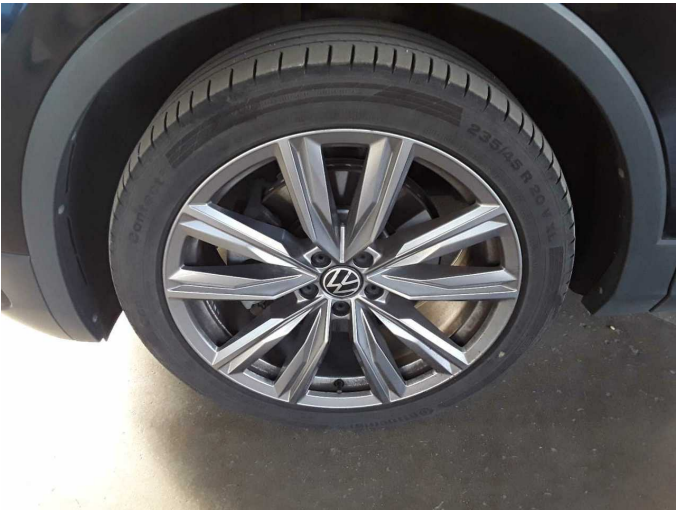
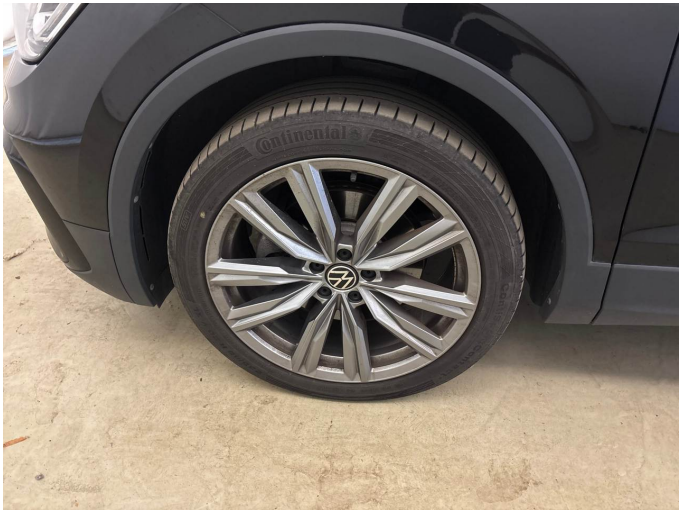
| # | Tyre size | Type of tyre | Manufacturer | Tread depth |
|---|---|---|---|---|
| 1) | 235/45 R20 100V | Summer tyres on Light alloy | Continental | 4mm / 4mm |
| 2) | 235/45 R20 100V | Summer tyres on Light alloy | Pirelli | 4mm / 4mm |

Figure 11: Mounted tyres

Figure 12: Mounted tyres

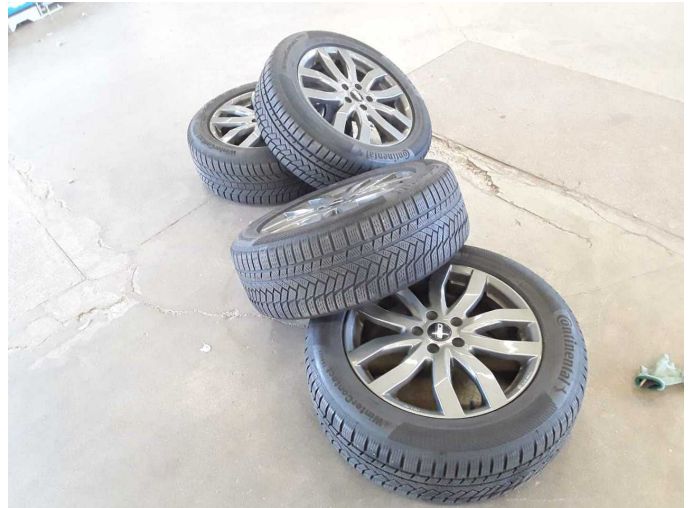
| # | Tyre size | Type of tyre | Manufacturer | Tread depth |
|---|---|---|---|---|
| 1) | 235/55 R18 100H | Winter tyres on Light alloy | Continental | 5mm / 5mm |
| 2) | 235/55 R18 100H | Winter tyres on Light alloy | Continental | 5mm / 5mm |

Figure 14: Additional tyres

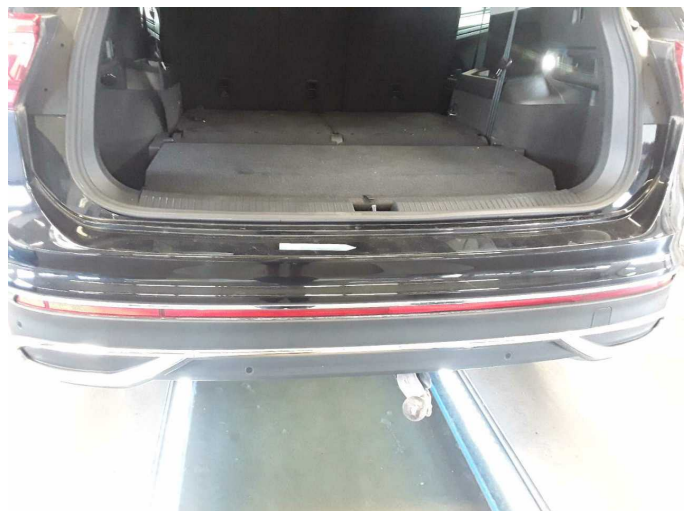
Damage 1: Rear bumper: Rear bumper - Scratch(es) - Smart repair

| No. | Component group | Description |
|---|---|---|
| 1 | Rear bumper | Rear bumper - Scratch(es) - Smart repair |

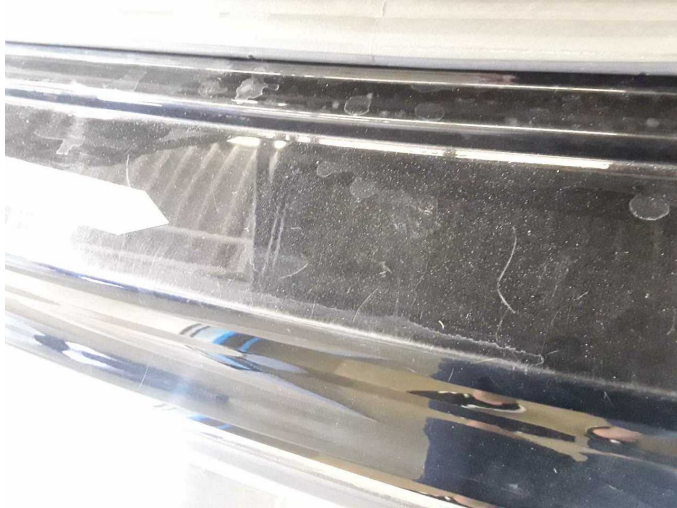
**Damage 1:** Rear bumper: Rear bumper - Scratch(es) - Smart repair

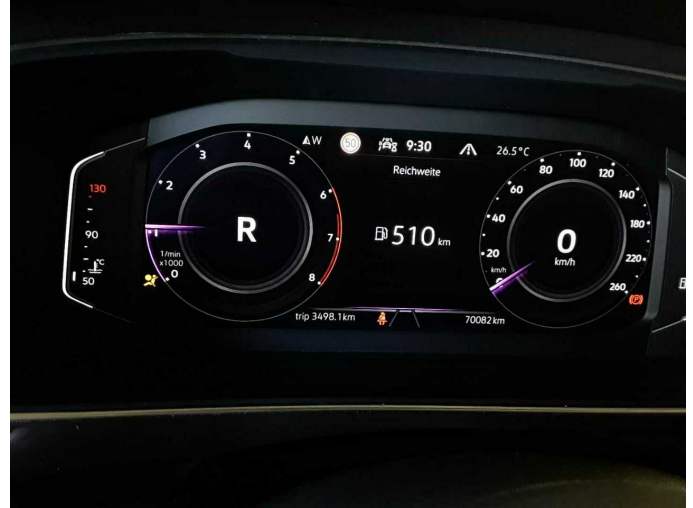
**Damage 2:** Airbag systems: Airbag - front left side - on - Diagnosed and repair if necessary

| No. | Component group | Description |
|---|---|---|
| 2 | Airbag systems | Airbag - front left side - on - Diagnosed and repair if necessary |

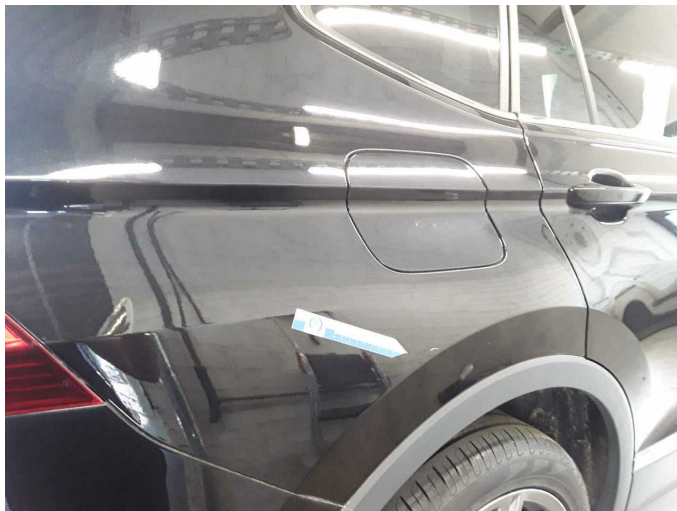
**Damage 3:** Side panel - rear right side: Side panel - Dent / paintcoat damage - Repair and paint

| No. | Component group | Description |
|---|---|---|
| 3 | Side panel - rear right side | Side panel - Dent / paintcoat damage - Repair and paint |

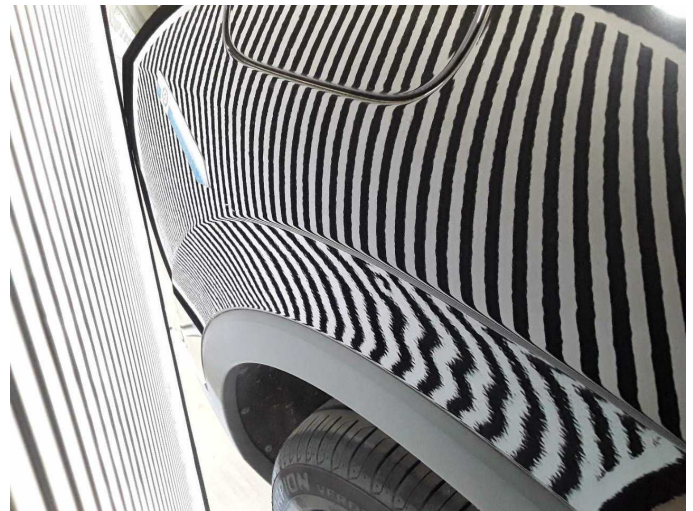
**Damage 3:** Side panel - rear right side: Side panel - Dent / paintcoat damage - Repair and paint

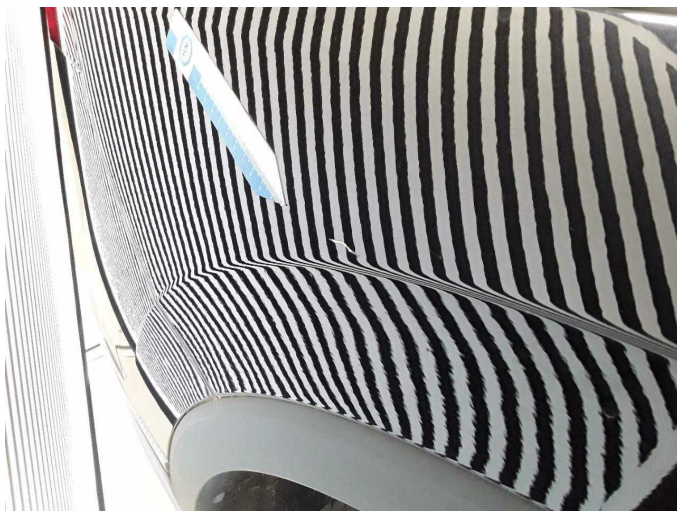
**Damage 3:** Side panel - rear right side: Side panel - Dent / paintcoat damage - Repair and paint

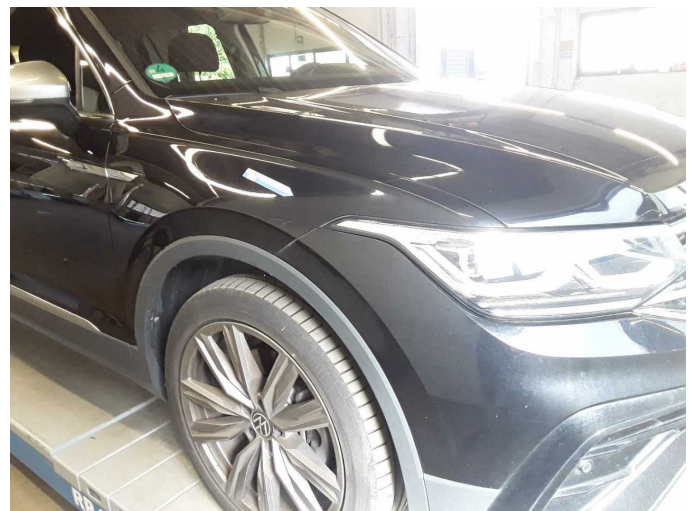
**Damage 4:** Mudguard - right side: Mudguard - right side - Dent / paintcoat damage - Repair and paint

| No. | Component group | Description |
|---|---|---|
| 4 | Mudguard - right side | Mudguard - right side - Dent / paintcoat damage - Repair and paint |

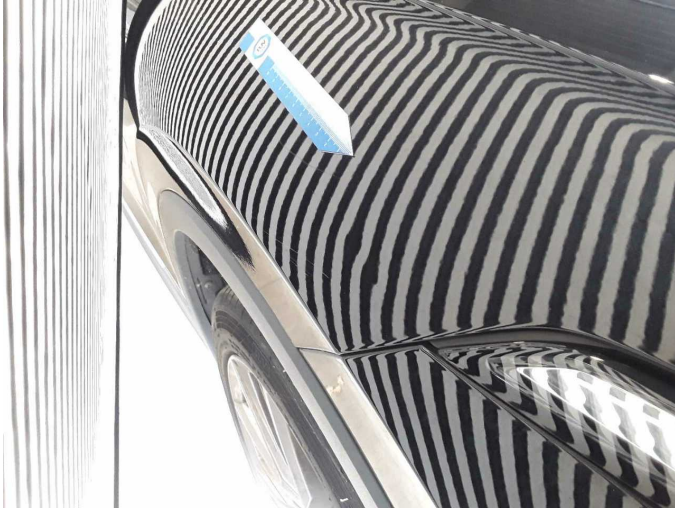
**Damage 4:** Mudguard - right side: Mudguard - right side - Dent / paintcoat damage - Repair and paint

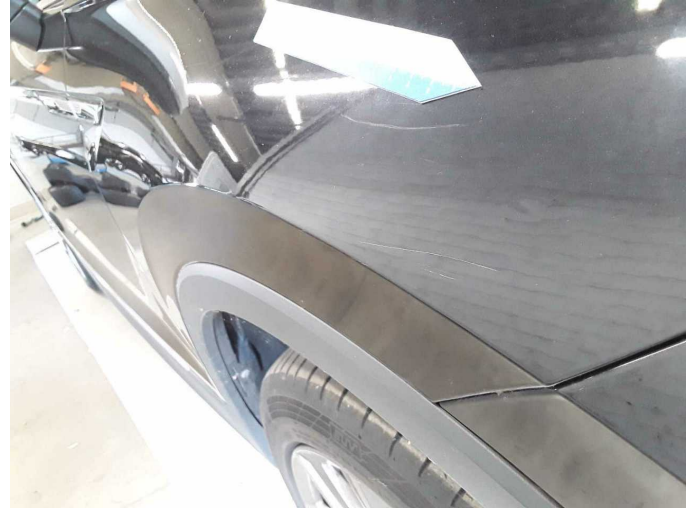
**Damage 4:** Mudguard - right side: Mudguard - right side - Dent / paintcoat damage - Repair and paint

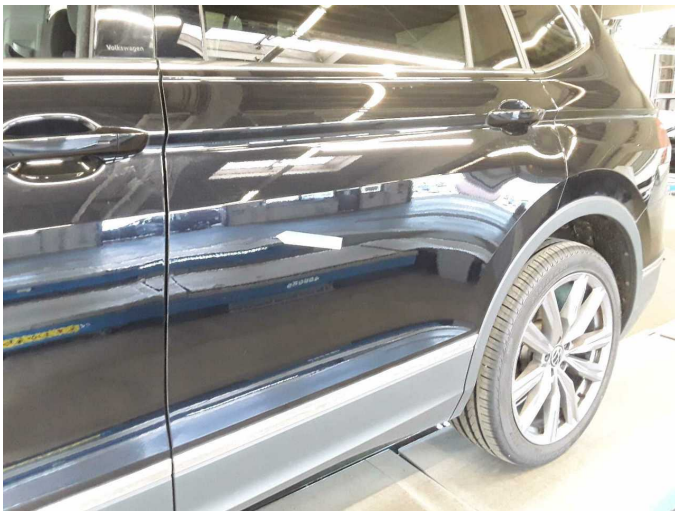
**Damage 5:** Door - rear left side: Door - Deformed - Repair and paint

| No. | Component group | Description |
|---|---|---|
| 5 | Door - rear left side | Door - Deformed - Repair and paint |

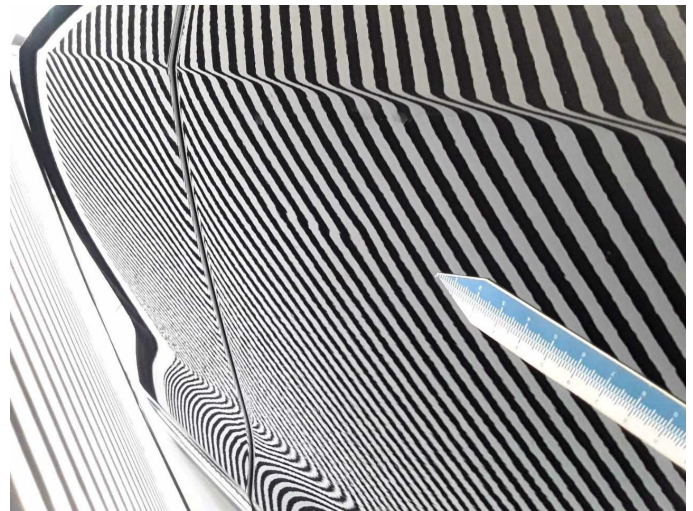
**Damage 5:** Door - rear left side: Door - Deformed - Repair and paint

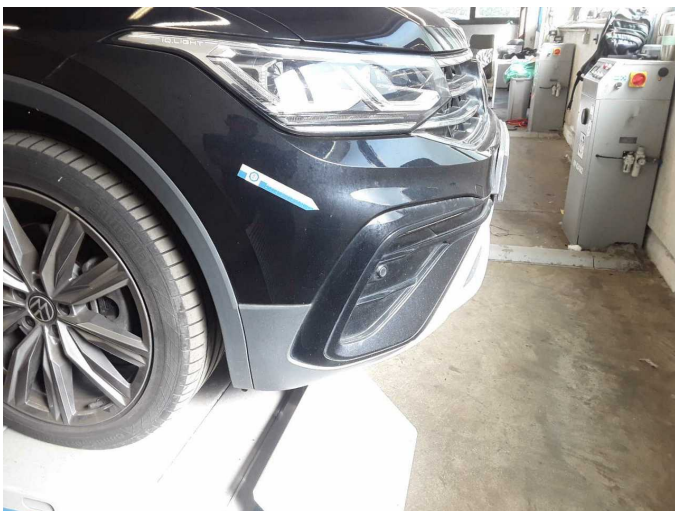
**Damage 6:** Front bumper: Front bumper - Scratch(es) - Paint

| No. | Component group | Description |
|---|---|---|
| 6 | Front bumper | Front bumper - Scratch(es) - Paint |

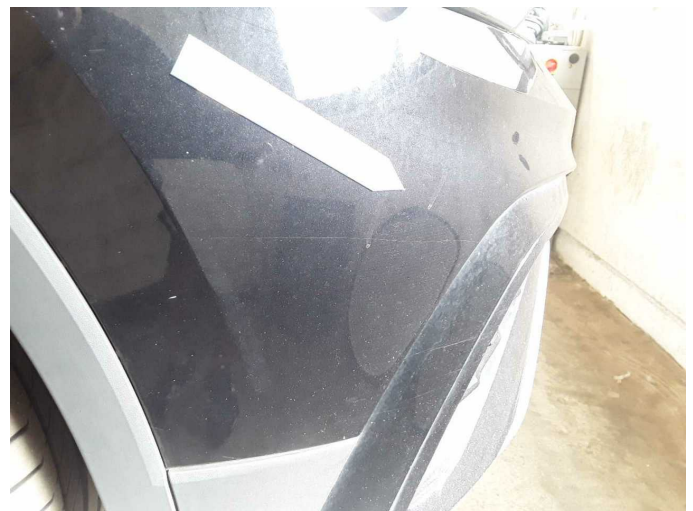
**Damage 6:** Front bumper: Front bumper - Scratch(es) - Paint

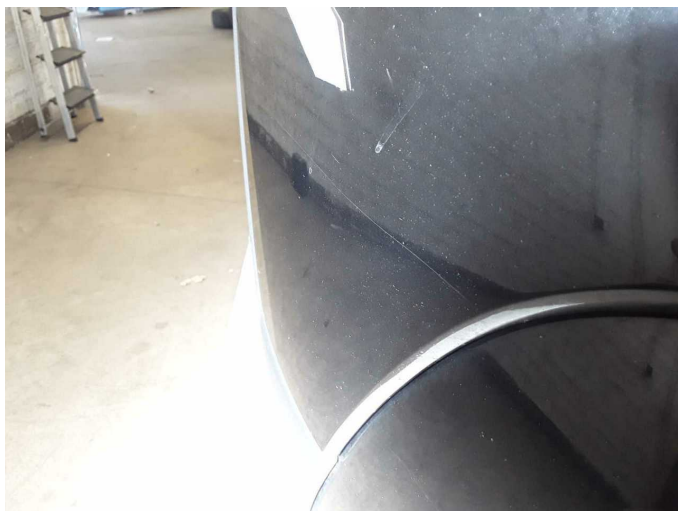
**Damage 6:** Front bumper: Front bumper - Scratch(es) - Paint

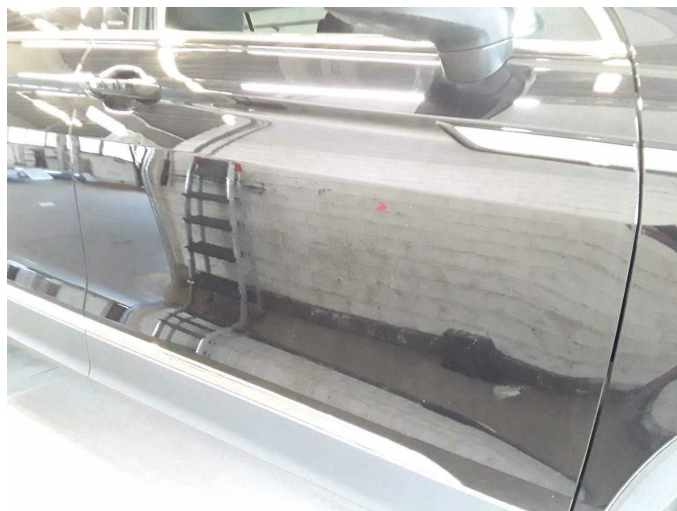
**Damage 7:** Door - front right side: Door - Dent / paintcoat damage - Repair and paint

| No. | Component group | Description |
|---|---|---|
| 7 | Door - front right side | Door - Dent / paintcoat damage - Repair and paint |

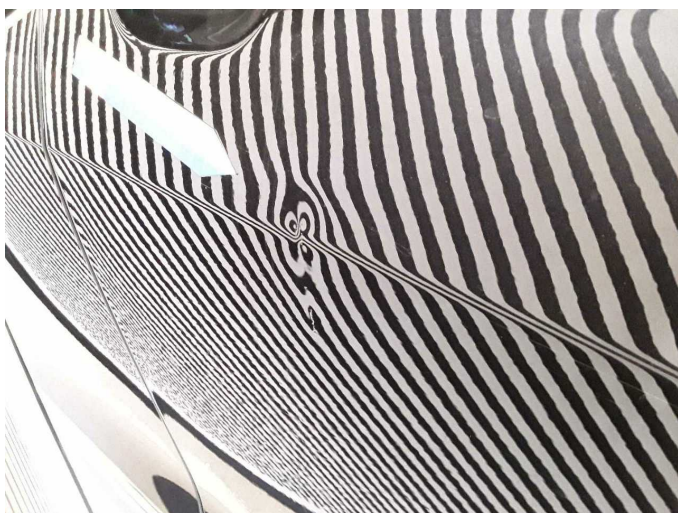
**Damage 7:** Door - front right side: Door - Dent / paintcoat damage - Repair and paint

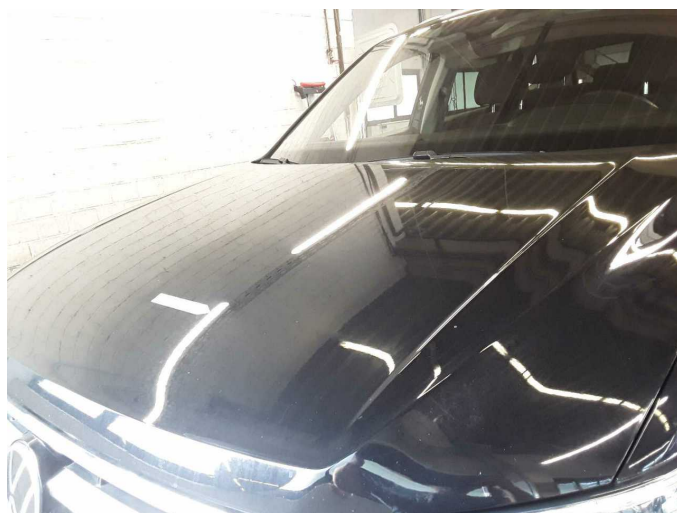
| No. | Component group | Description |
|---|---|---|
| 1 | Bonnet | Bonnet - Stone chips - No deduction |

**Wear and tear 1:** Bonnet: Bonnet - Stone chips - No deduction

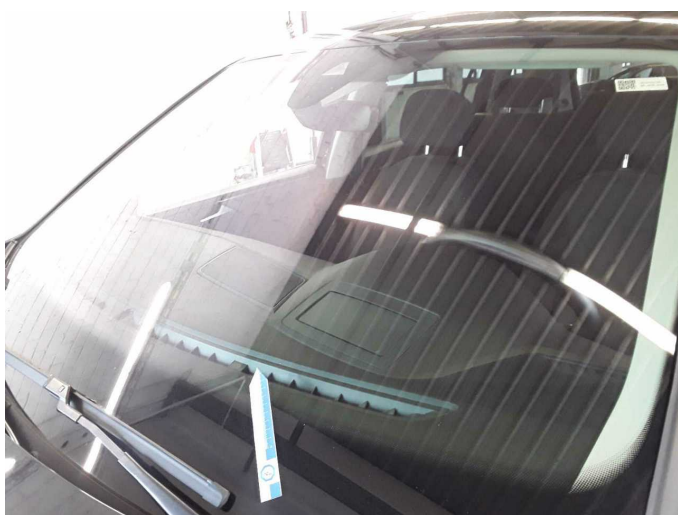
| No. | Component group | Description |
|---|---|---|
| 2 | Vehicle glazing | Windscreen - Stone chips - No deduction |

**Wear and tear 2:** Vehicle glazing: Windscreen - Stone chips - No deduction

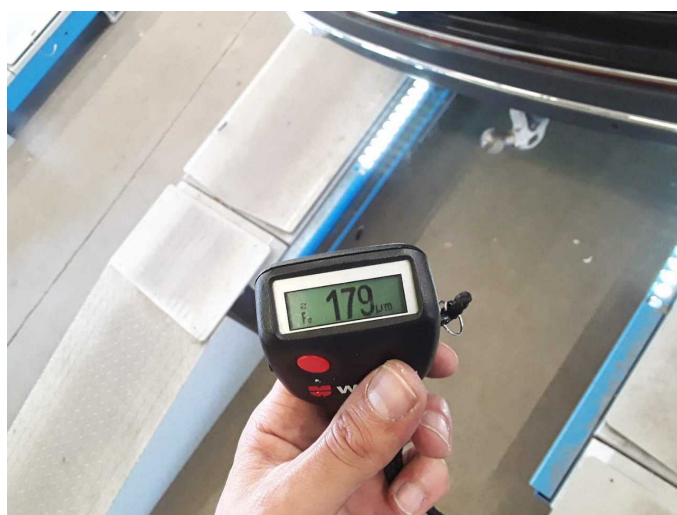
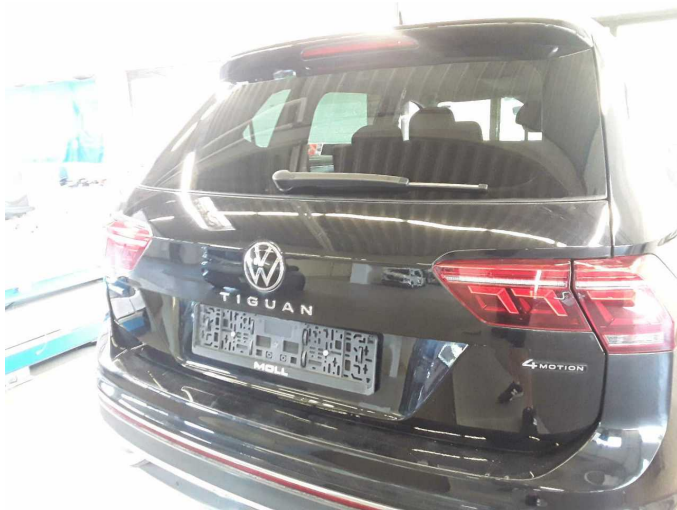
1 Boot lid / rear door, Professionally carried out, Invoice of repair done Non-existent

Boot lid / rear door 179 µm |

**Repainting 1:** Boot lid / rear door
