Expertise

Protocol number: 46195698
Order No. / Reference: 26577641
Inspection date: 26 Jun 2026

Manufacturer: Opel

Model: Insignia Grand Sport 2.0 Diesel Automatik Business

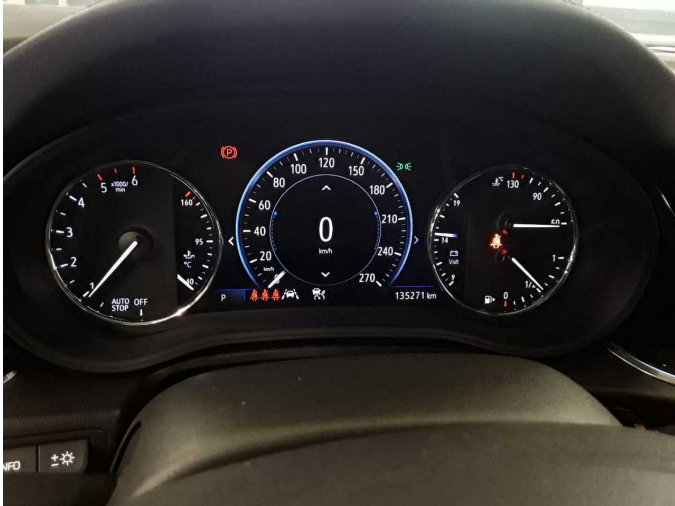
Figure 7: Instrument cluster

Mileage (Read) 135,271 km

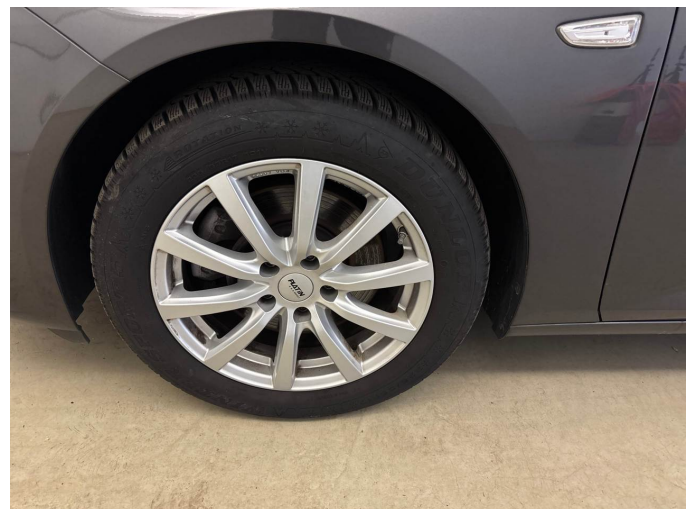
Figure 12: Mounted tyres

#	Tyre size	Type of tyre	Manufacturer	Tread depth
1)	225/55 R17 101V	Winter tyres on Light alloy	Dunlop	5mm / 5mm
2)	225/55 R17 101V	Winter tyres on Light alloy	Dunlop	5mm / 5mm

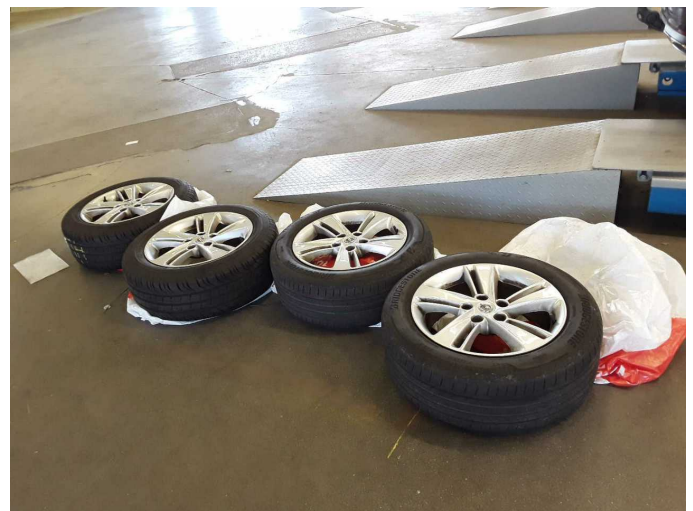
Figure 16: Additional tyres

#	Tyre size	Type of tyre	Manufacturer	Tread depth
1)	225/55 R17 97W	Summer tyres on Light alloy	Bridgestone	4mm / 4mm
2)	225/55 R17 97W	Summer tyres on Light alloy	Continental	5mm / 5mm

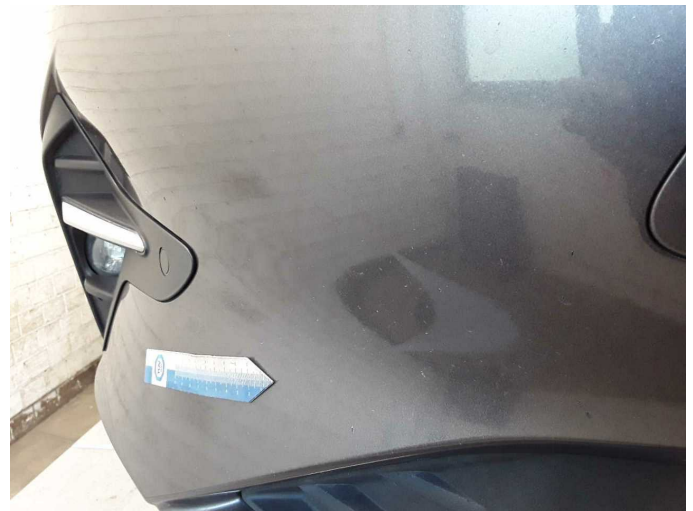
Wear and tear 3: Front bumper: Front bumper - Stone chips - No deduction

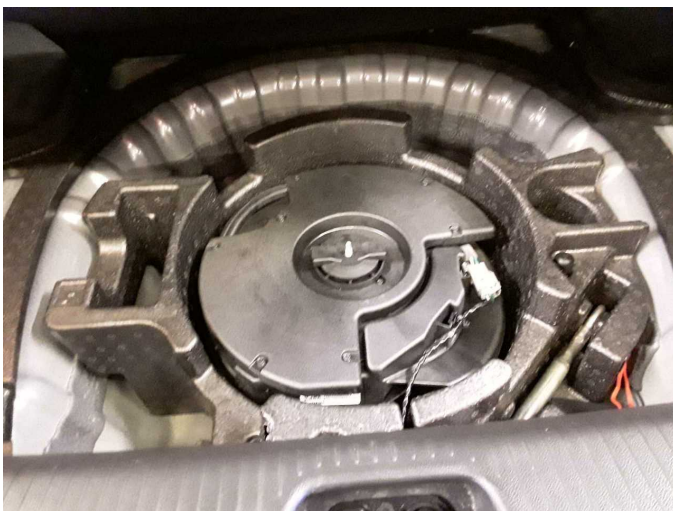
Missing part 1: Equipment: Tirefit complete - Missing - Replace

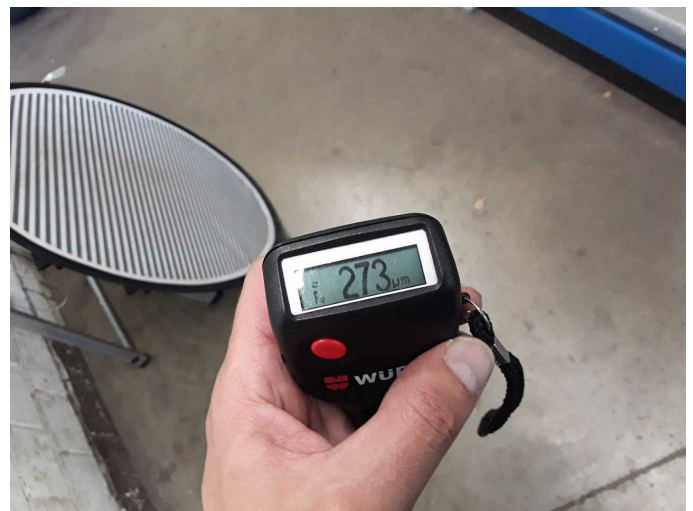
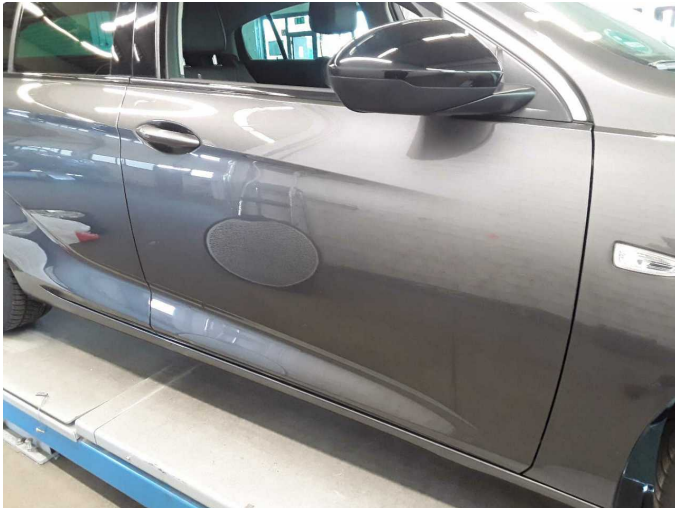
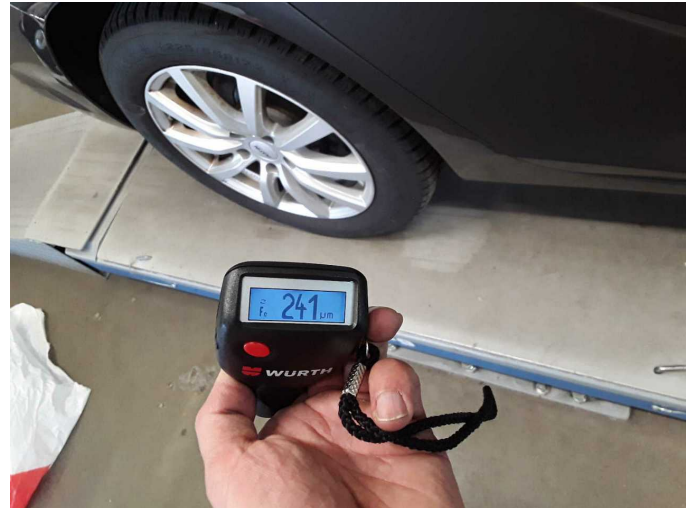
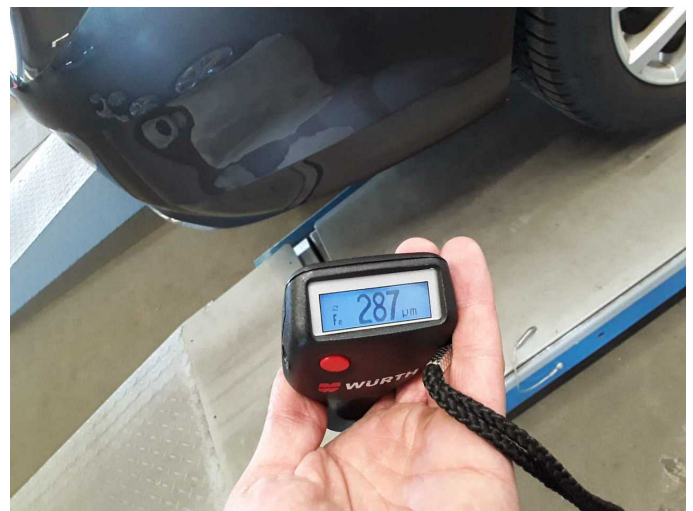
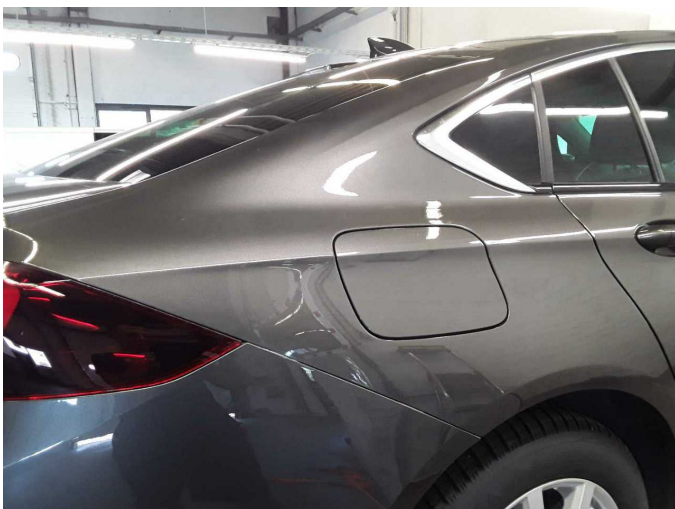
No.	Previous damage	Extent of damage (Net)
1	Roof, Side - left, Side right, Professionally repaired, Invoice of repair done Non-existent

No.	Repainting
1	Roof, Side panel - rear right side, Door - rear left side, Door - rear right side, Door - front left side, Door - front right side, Professionally carried out, Invoice of repair done Non-existent

Roof	301 µm	Boot lid / rear door	301 µm
Side panel - rear right side	287 µm	Door - rear left side	167 µm
Door - rear right side	241 µm	Door - front left side	266 µm
Door - front right side	273 µm

Professionally repaired previous damages were found at the vehicle.

Repainting 1: Roof, Side panel - rear right side, Door - rear left side, Door - rear right side, Door - front left side, Door - front right side

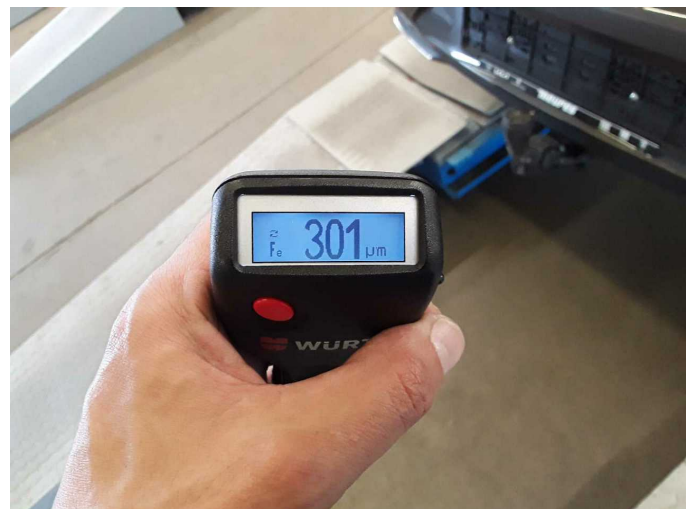
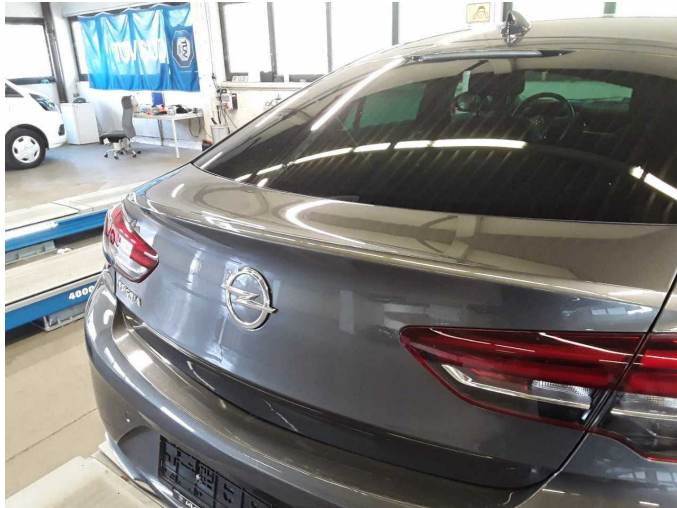
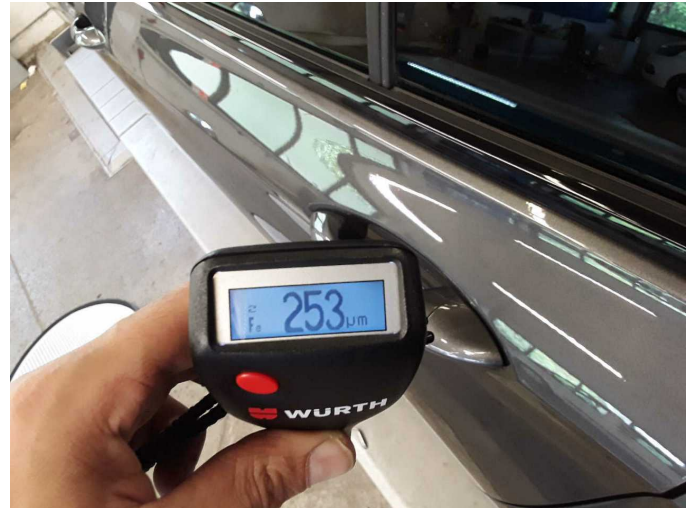
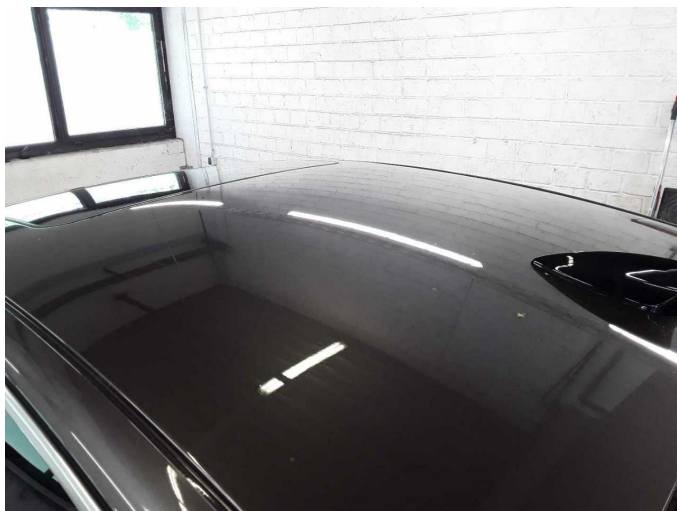
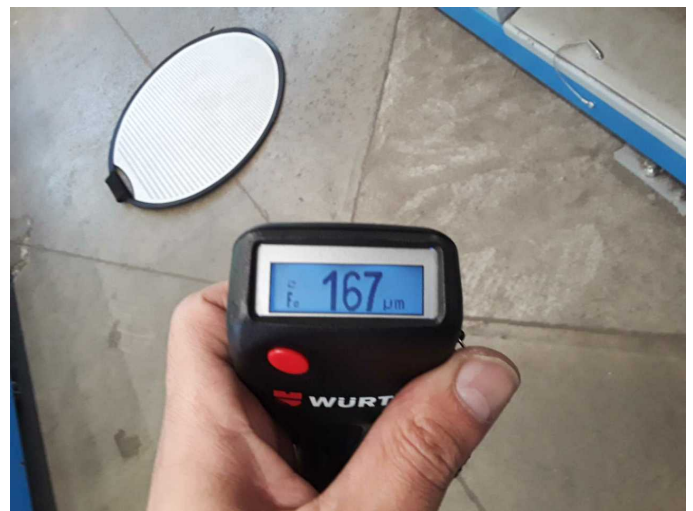
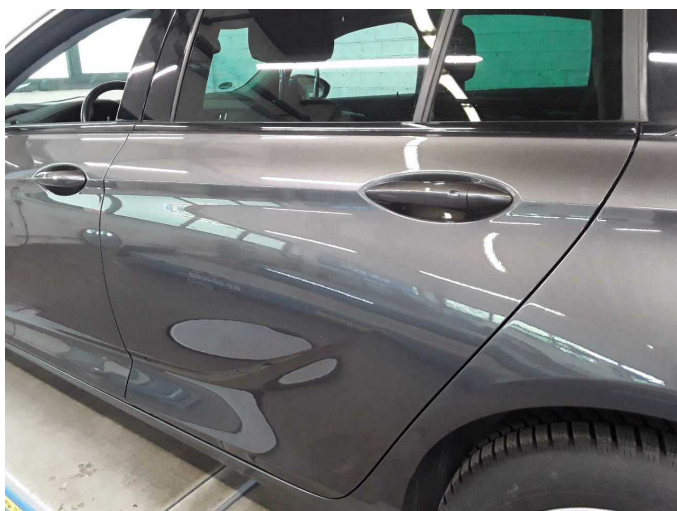
Repainting 1: Roof, Side panel - rear right side, Door - rear left side, Door - rear right side, Door - front left side, Door - front right side

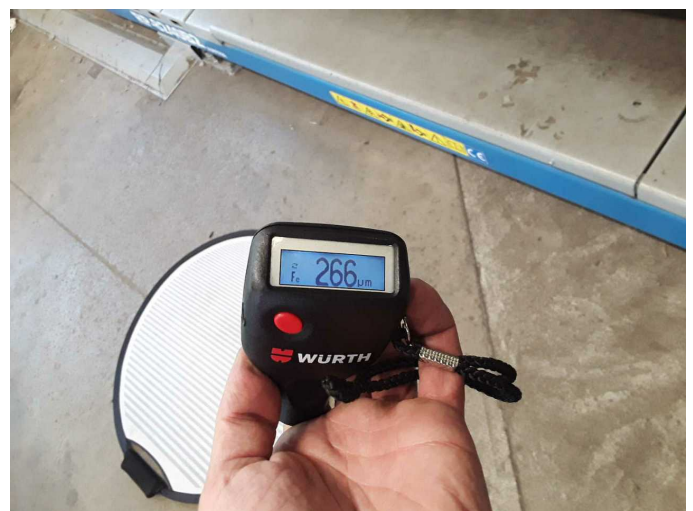
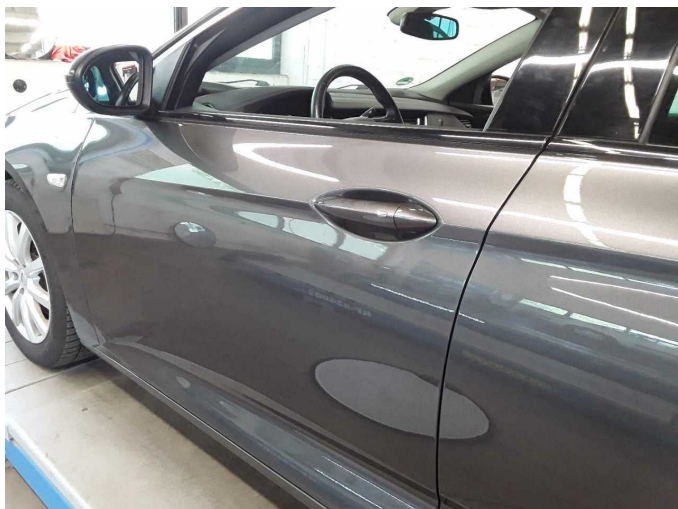
Repainting 1: Roof, Side panel - rear right side, Door - rear left side, Door - rear right side, Door - front left side, Door - front right side
