Expertise

Protocol number: 46534026  
Order No. / Reference: 26732869  
Inspection date: 14 Jul 2026

Model: A5 Sportback 35 TDI S tronic advanced

VIN: WAUZZZF51NA021989

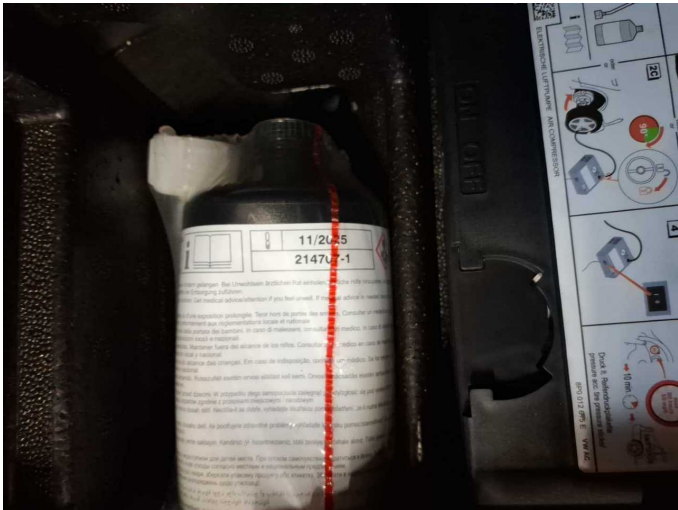
| No. | Component group | Description |
|---|---|---|
| 3 | Equipment | Tirefit filler - Due - Replace |

Damage 3: Equipment: Tirefit filler - Due - Replace

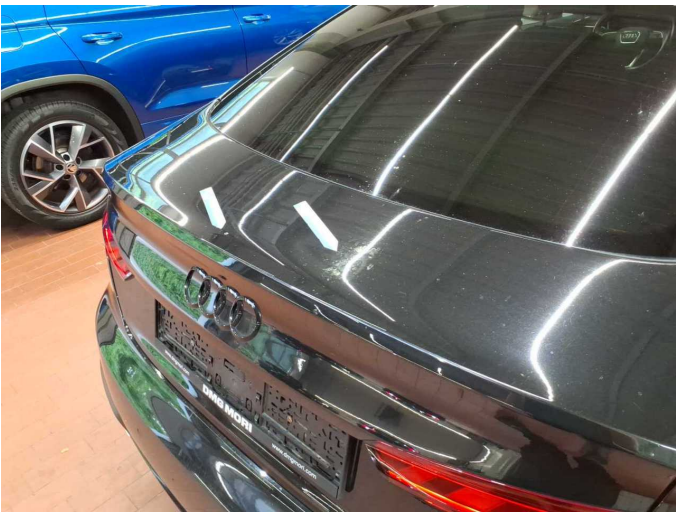
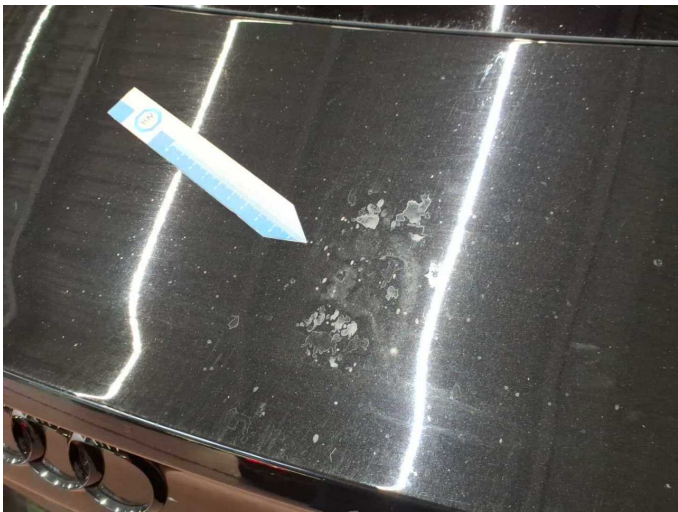
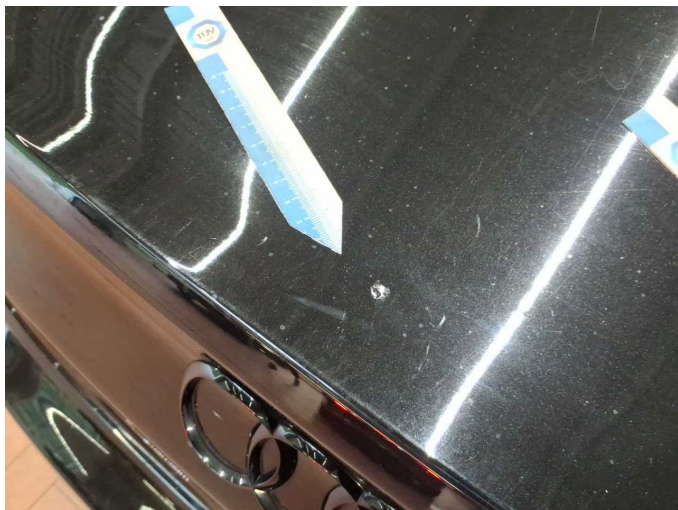
| No. | Component group | Description |
|---|---|---|
| 4 | Boot lid / rear door | Boot lid - Soiled - Conditioning |

Damage 4: Boot lid / rear door: Boot lid - Soiled - Conditioning

**Damage 4:** Boot lid / rear door: Boot lid - Soiled - Conditioning

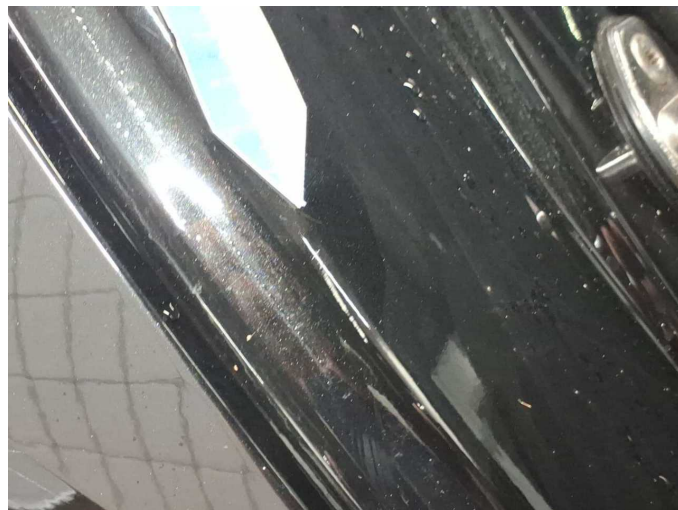
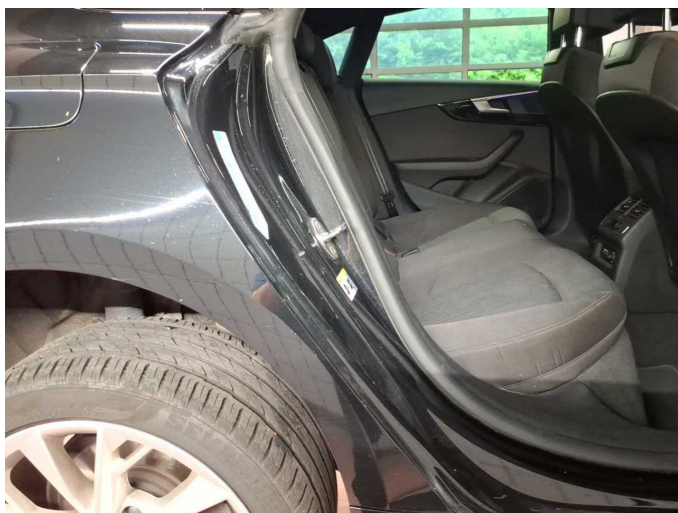
| No. | Component group | Description |
|---|---|---|
| 5 | Side panel - rear right side | Sill - Scratch(es) - Smart repair |

**Damage 5:** Side panel - rear right side: Sill - Scratch(es) - Smart repair

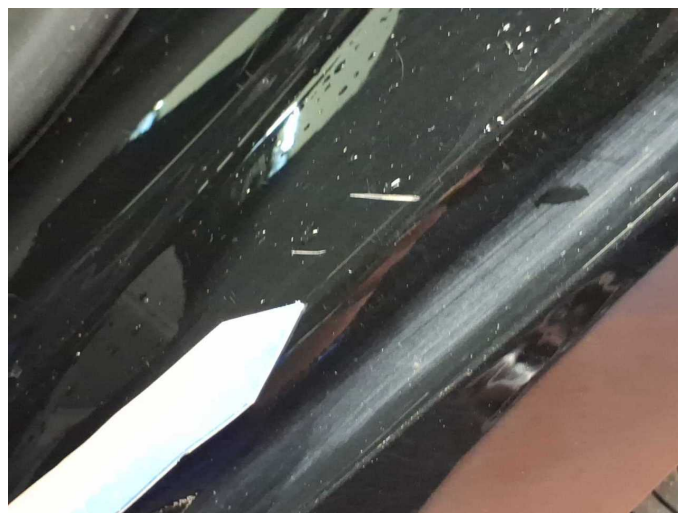
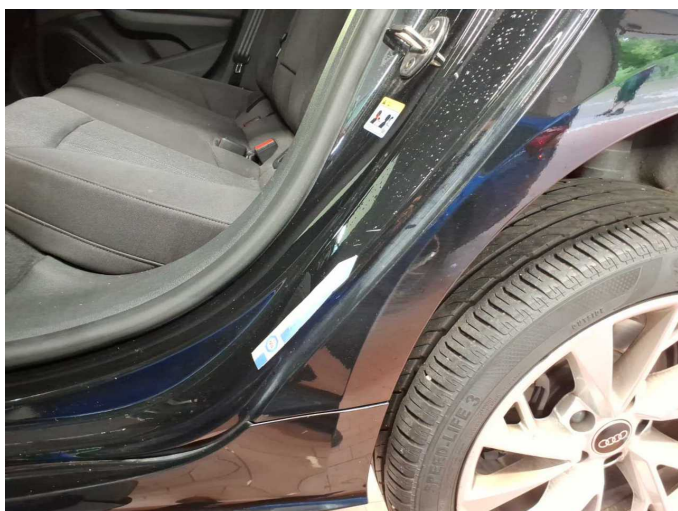
| No. | Component group | Description |
|---|---|---|
| 6 | Side panel - rear left side | Sill - Scratch(es) - Smart repair |

**Damage 6:** Side panel - rear left side: Sill - Scratch(es) - Smart repair

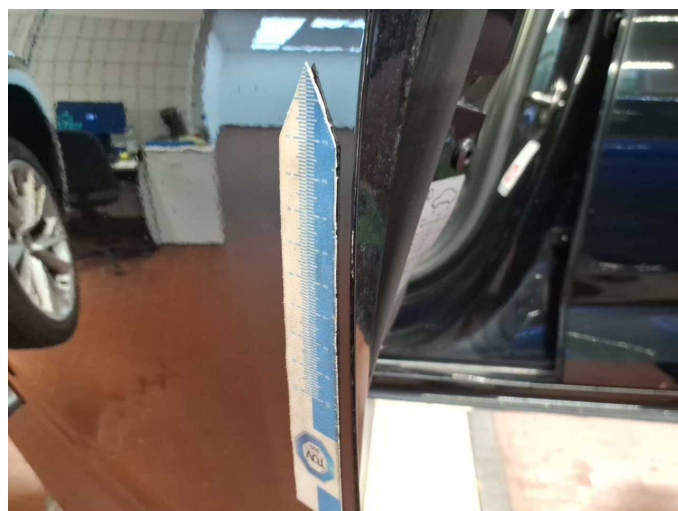
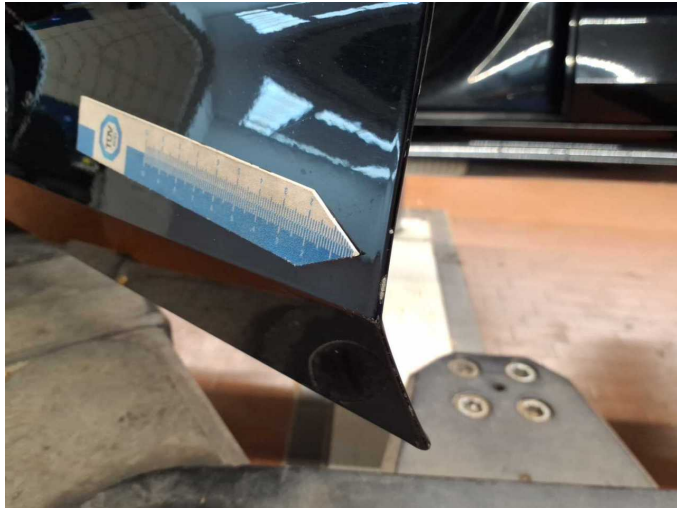
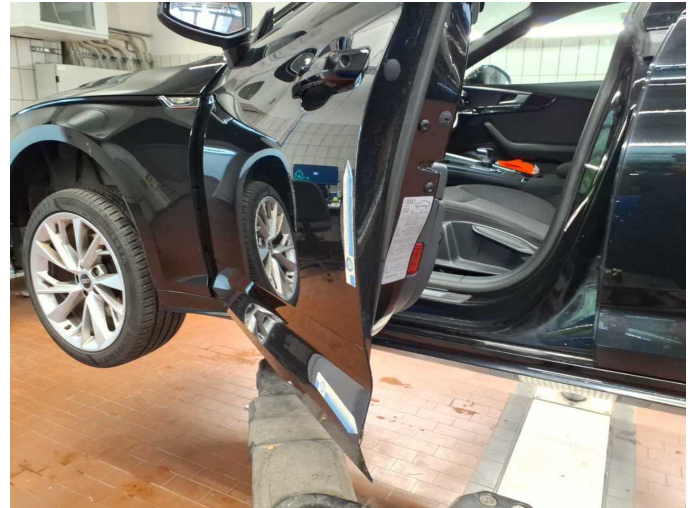
| No. | Component group | Description |
|---|---|---|
| 7 | Door - front left side | Door edge - Scratch(es) - Smart repair |

**Damage 7:** Door - front left side: Door edge - Scratch(es) - Smart repair

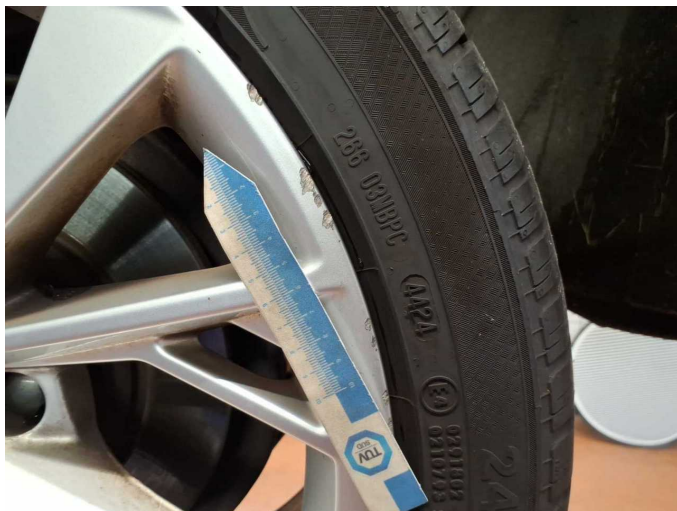
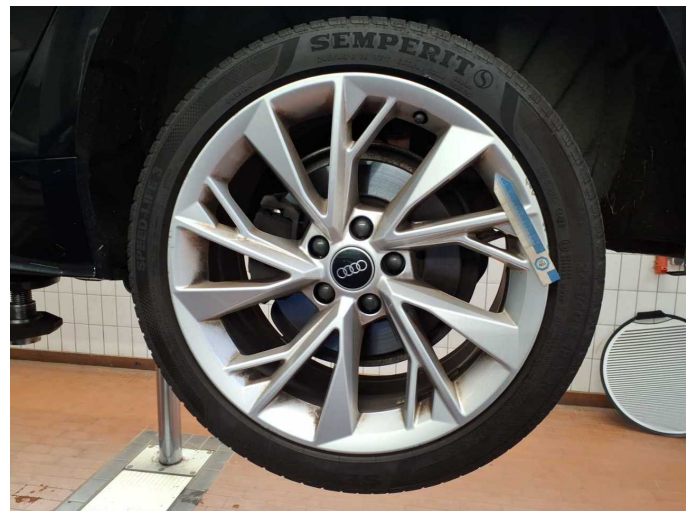
| No. | Component group | Description |
|---|---|---|
| 8 | Wheel / tyres | Alloy rim - rear left side - Scratched - Loss in value |

**Damage 8:** Wheel / tyres: Alloy rim - rear left side - Scratched - Loss in value

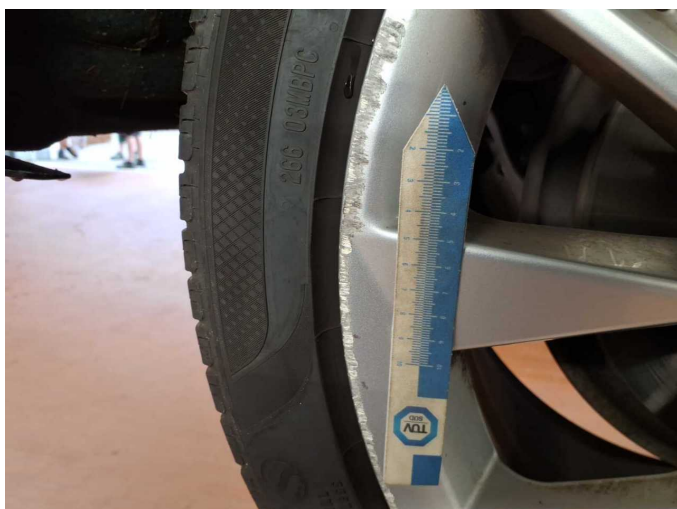
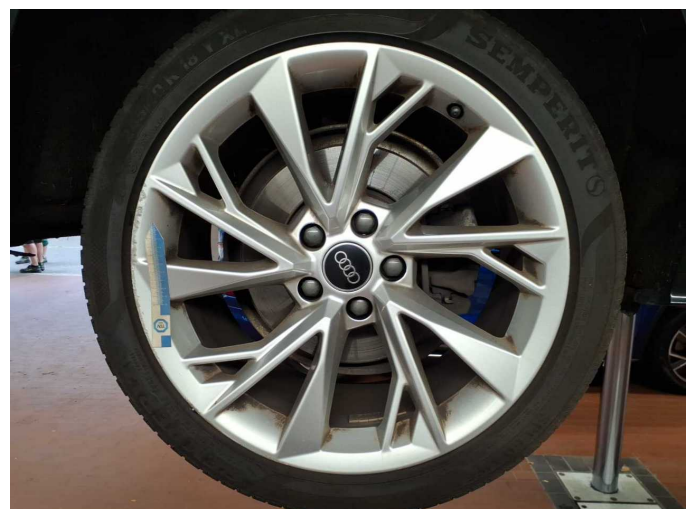
| No. | Component group | Description |
|---|---|---|
| 9 | Wheel / tyres | Alloy rim - rear right side - Scratched - Loss in value |

**Damage 9:** Wheel / tyres: Alloy rim - rear right side - Scratched - Loss in value

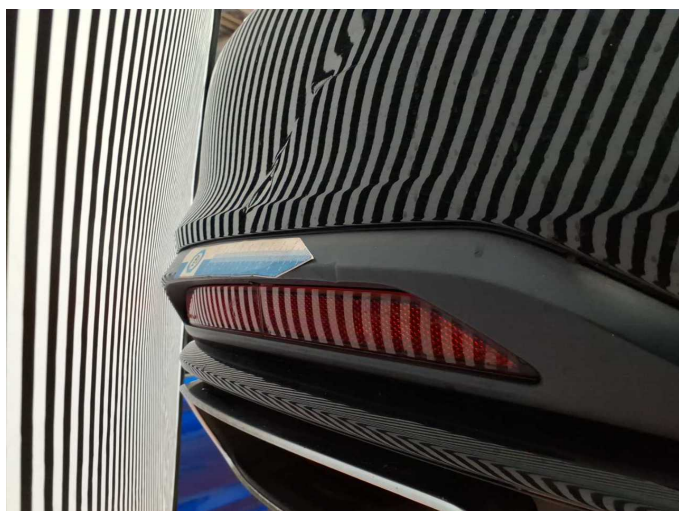
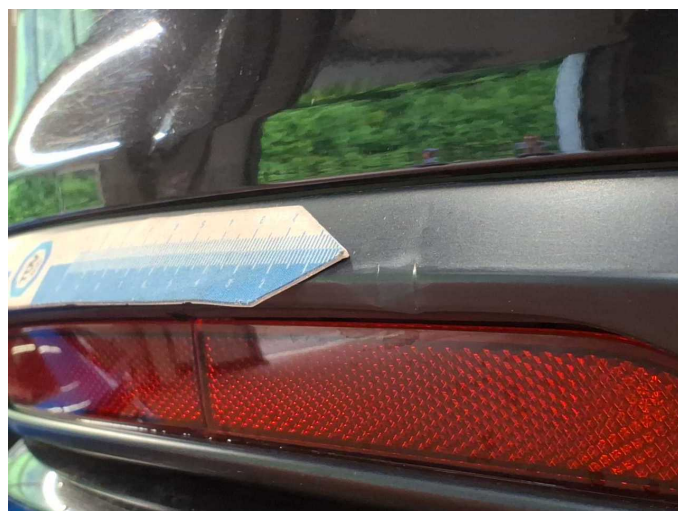
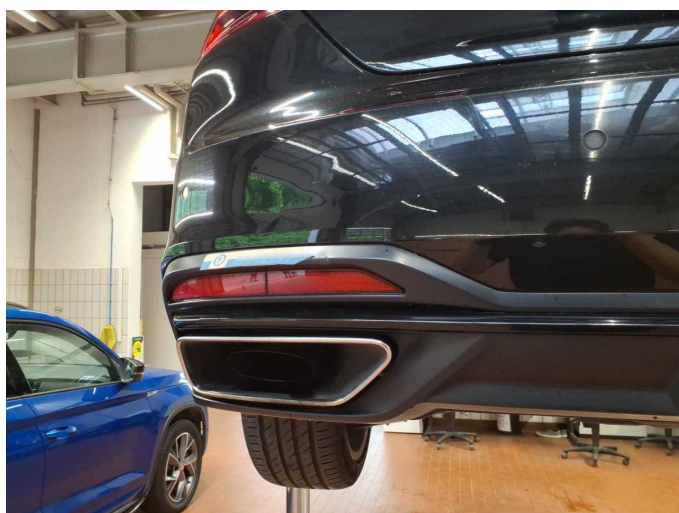
| No. | Component group | Description |
|---|---|---|
| 10 | Rear bumper | Spoiler - dent(s) - Replace |

**Damage 10:** Rear bumper: Spoiler - dent(s) - Replace

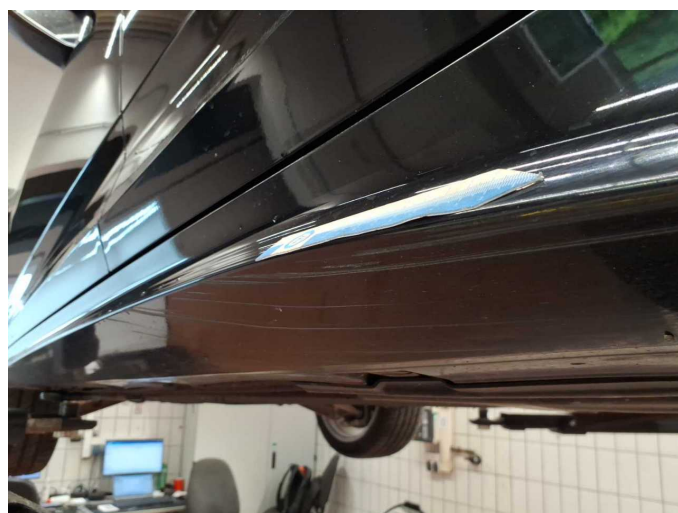
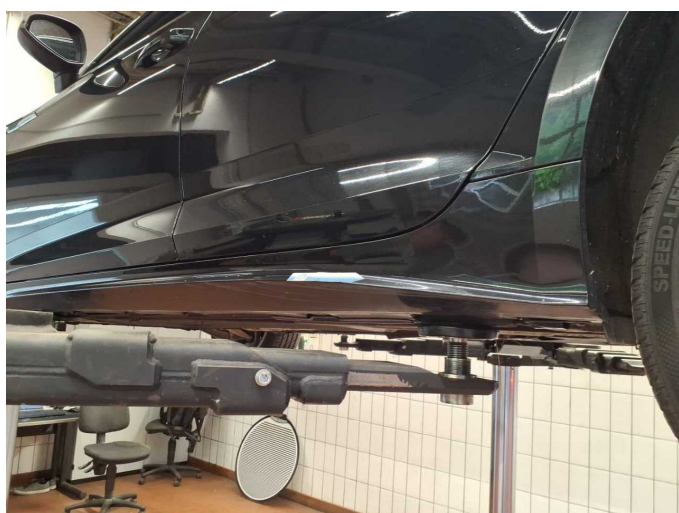
**Damage 11:** Sill - left side: Trim - Scratched - Paint

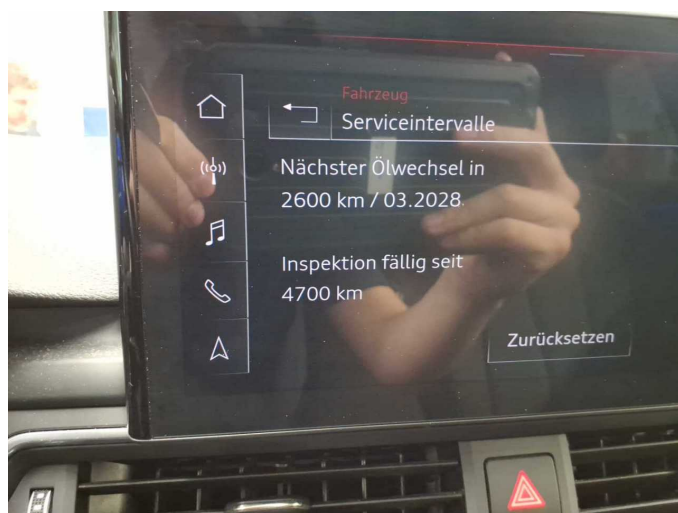
**Damage 12:** Misc.: Inspection / maintenance - Due - Perform

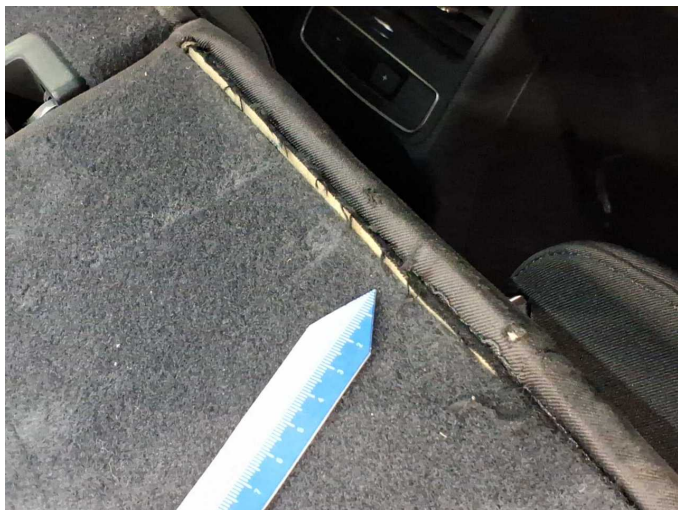
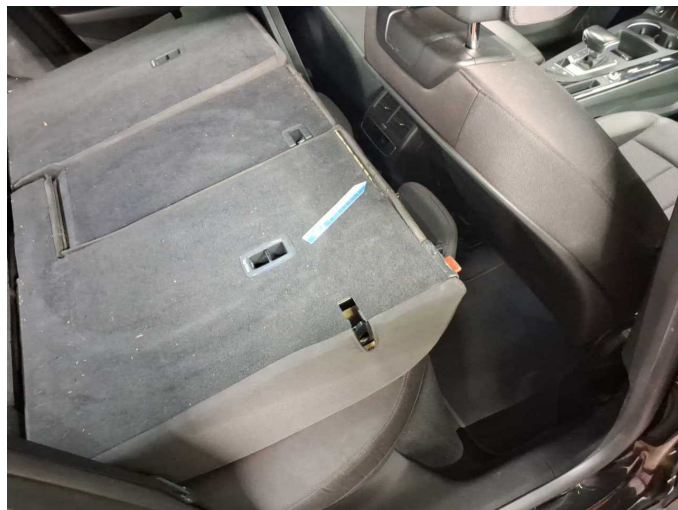
| No. | Component group | Description |
|---|---|---|
| 13 | Seat - rear | Backrest cover - Broken / torn - Replace |

**Damage 13:** Seat - rear: Backrest cover - Broken / torn - Replace

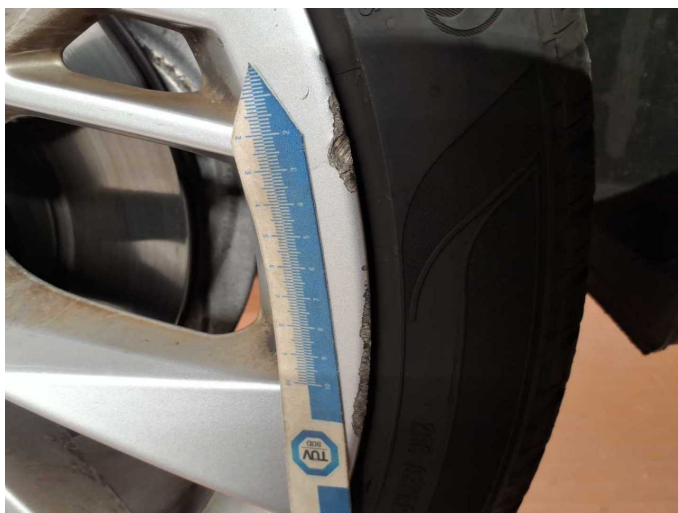
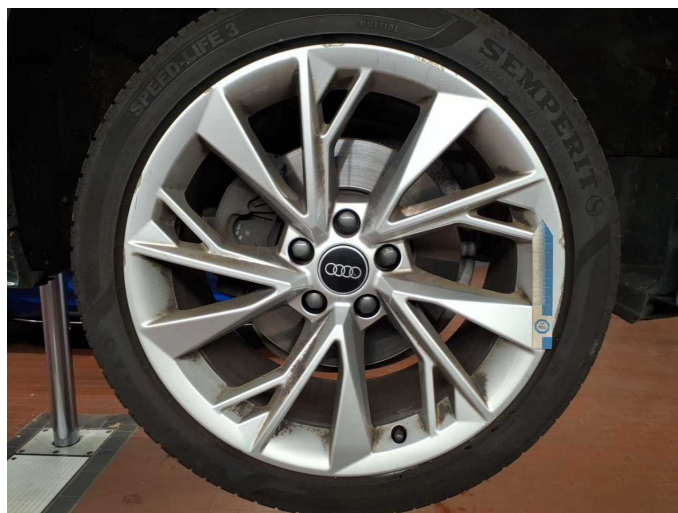
| No. | Component group | Description |
|---|---|---|
| 14 | Wheel / tyres | Alloy rim - front right side - Scratched - Replace |

**Damage 14:** Wheel / tyres: Alloy rim - front right side - Scratched - Replace

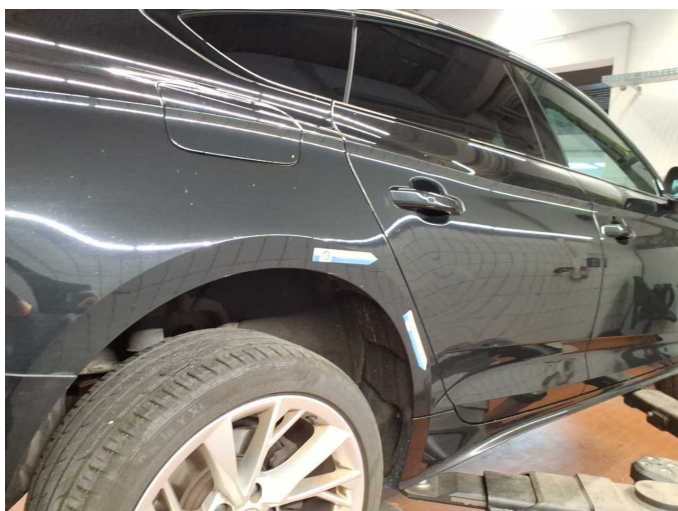
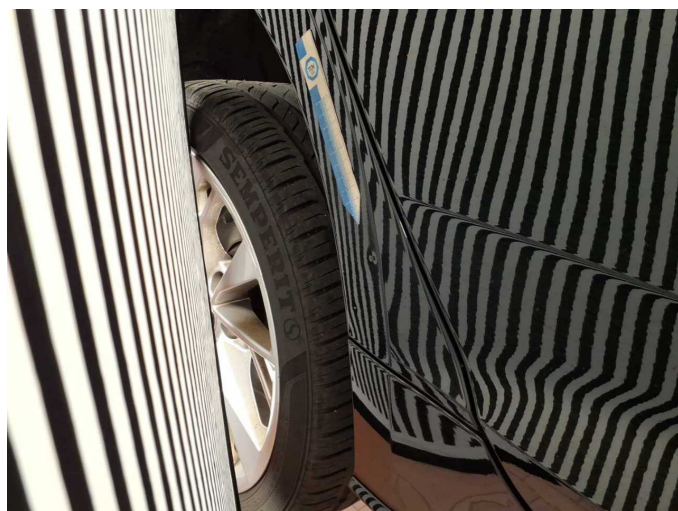
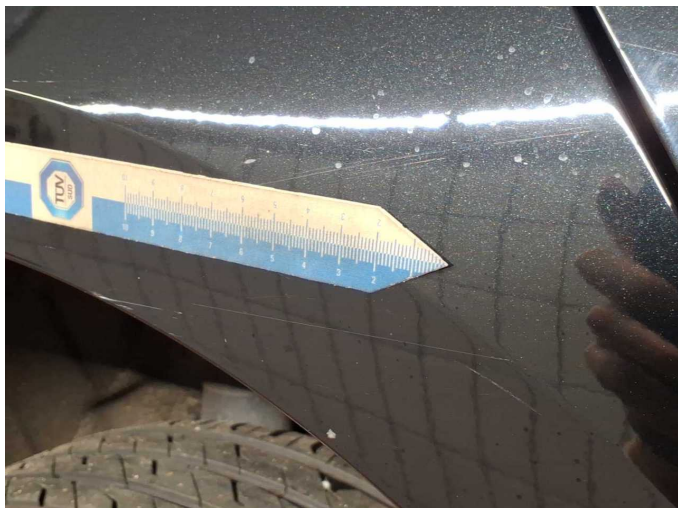
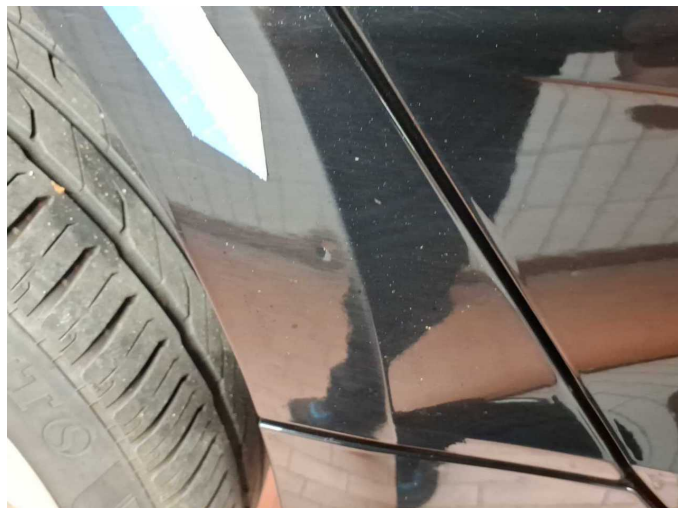
| No. | Component group | Description |
|---|---|---|
| 15 | Side panel - rear right side | Side panel - Dent / paintcoat damage - Repair and paint |

**Damage 15:** Side panel - rear right side: Side panel - Dent / paintcoat damage - Repair and paint

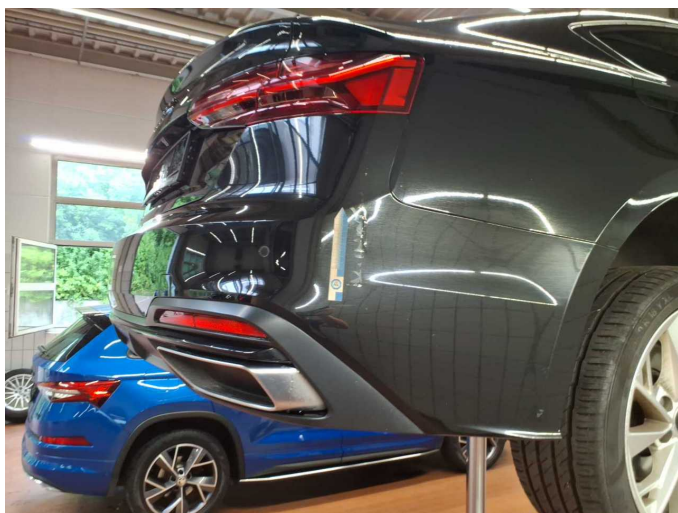
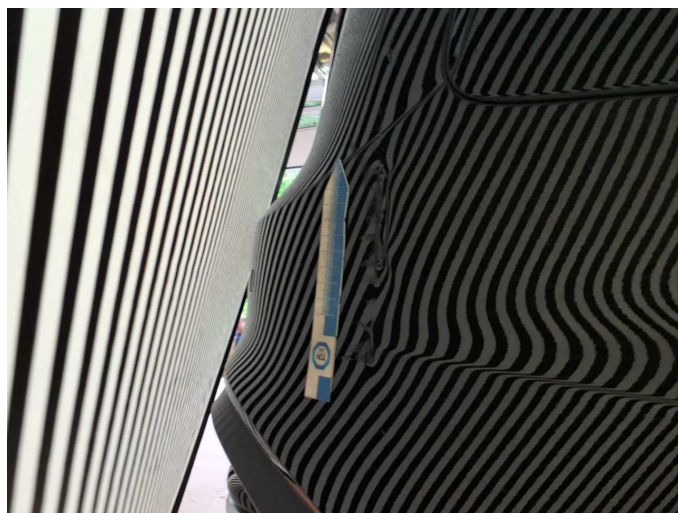
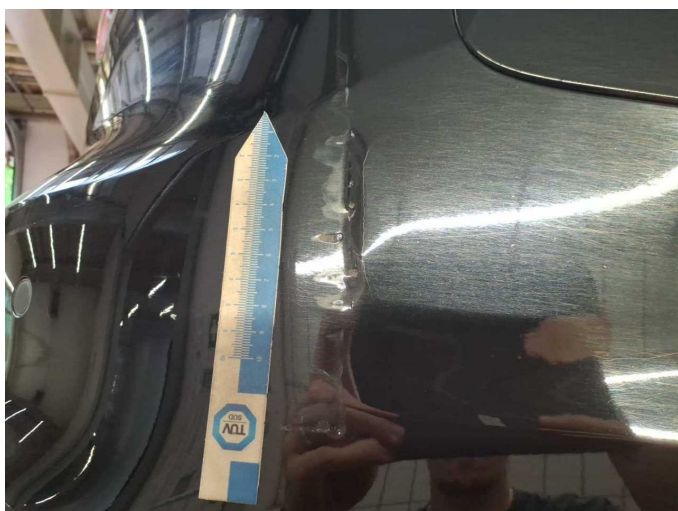
| No. | Component group | Description |
|---|---|---|
| 16 | Rear bumper | Rear bumper - Dent / paintcoat damage - Repair and paint |

**Damage 16:** Rear bumper: Rear bumper - Dent / paintcoat damage - Repair and paint

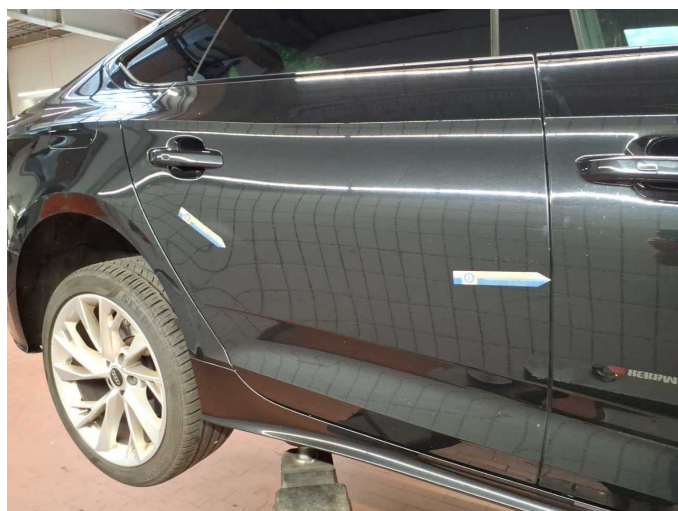
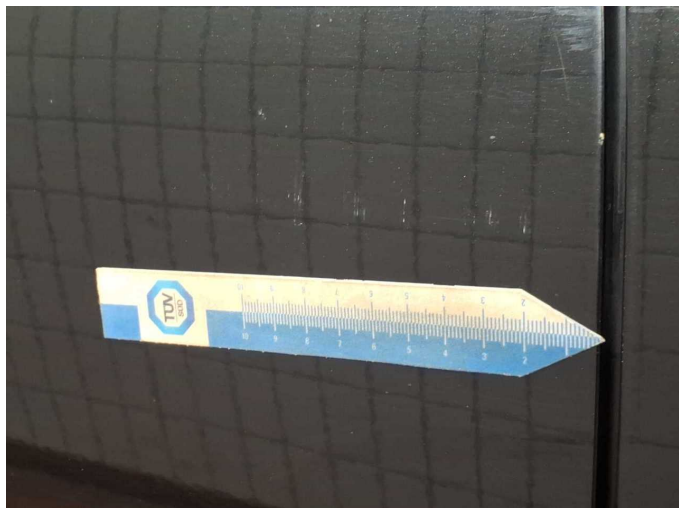
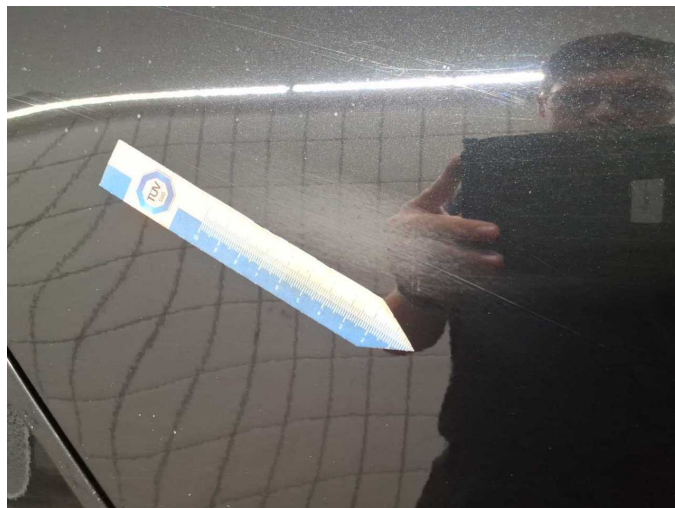
**Damage 17:** Door - rear right side: Door - Scratch(es) - Paint

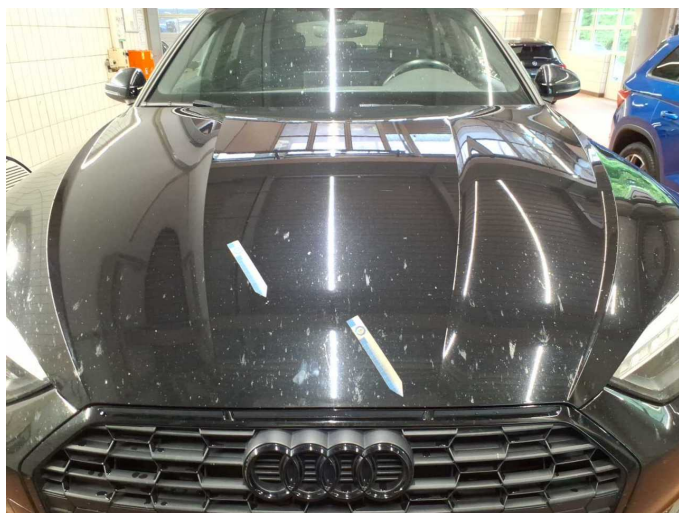
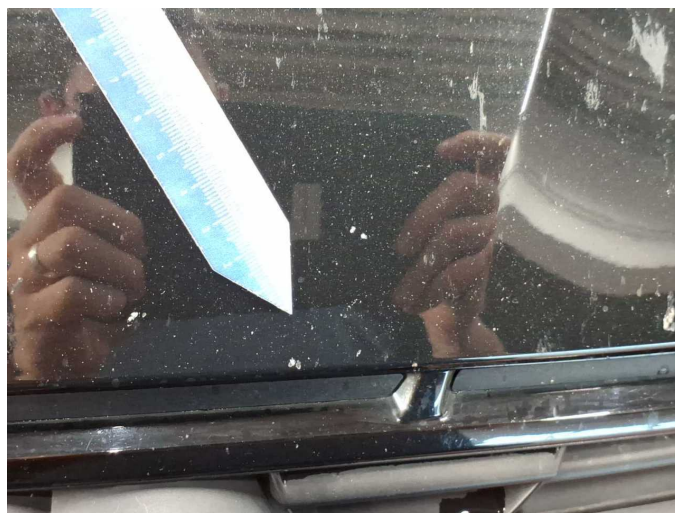
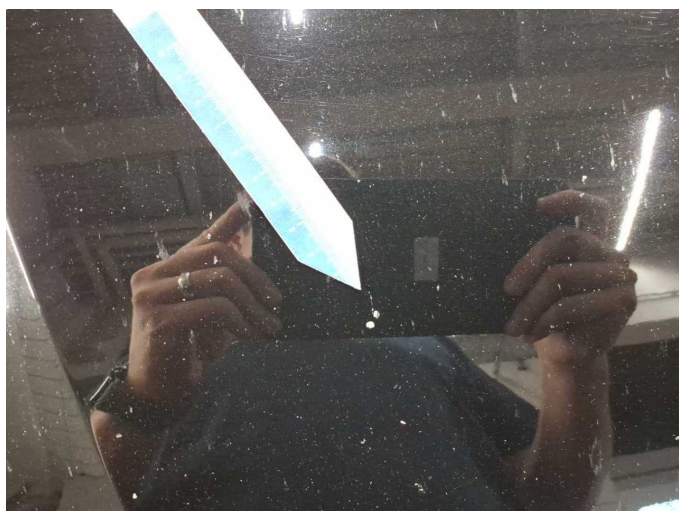
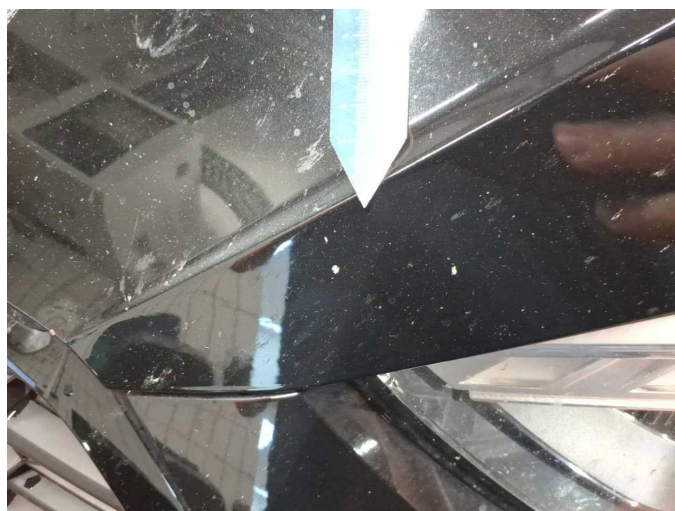
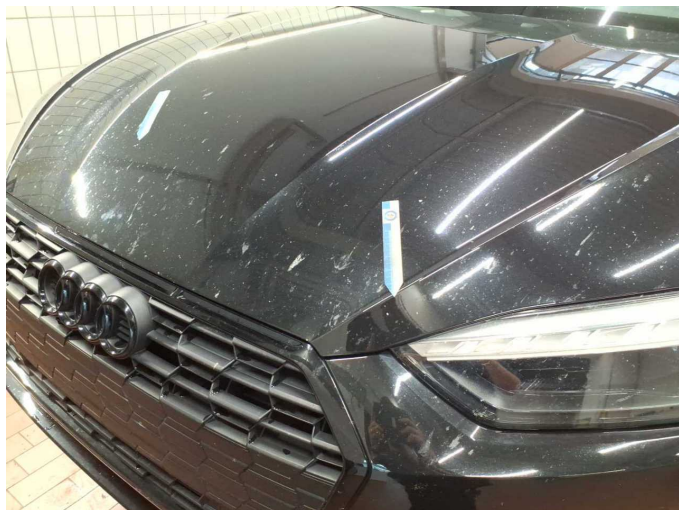
**Damage 18:** Bonnet: Bonnet - Stone chips - Paint

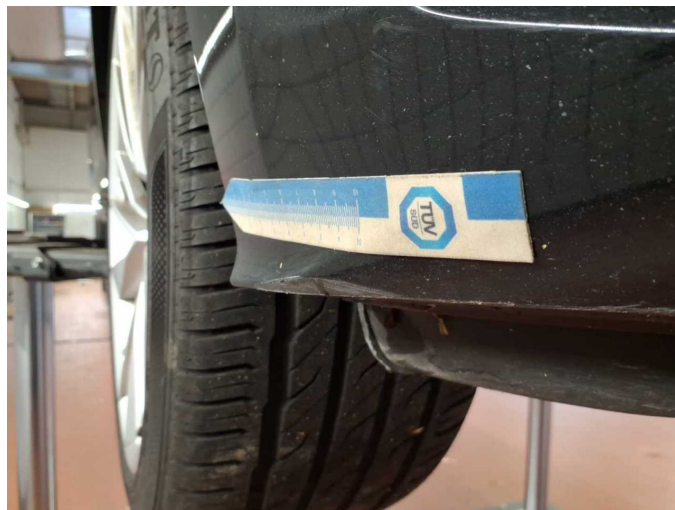
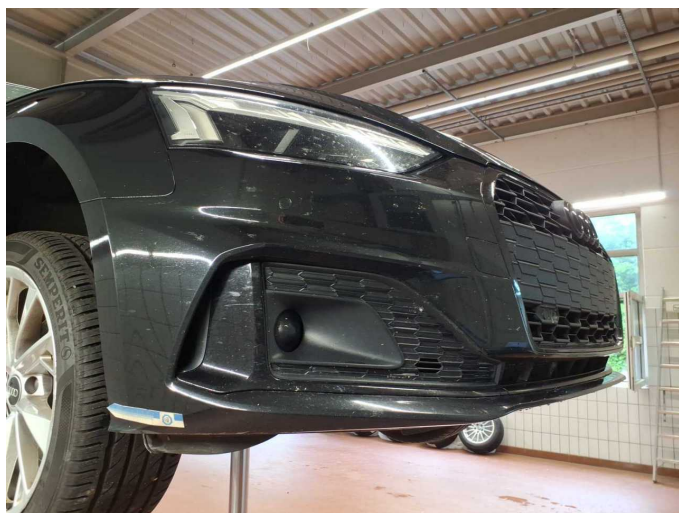
**Damage 19:** Front bumper: Front bumper - Scratched - Paint

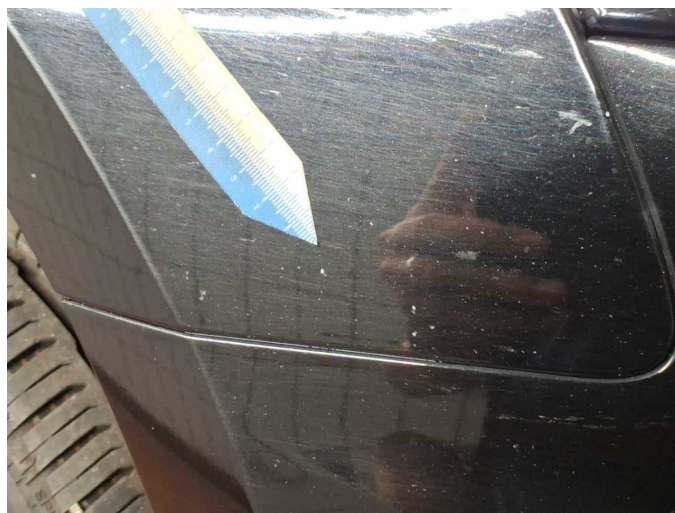
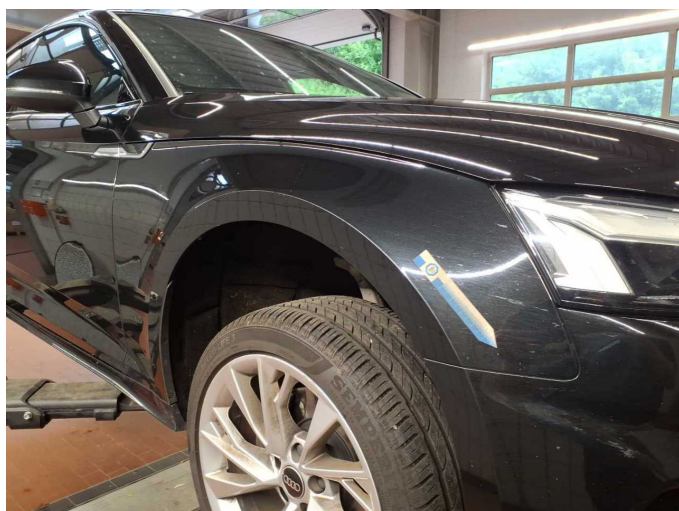
**Wear and tear 1:** Mudguard - right side: Mudguard - right side - Stone chips - No deduction

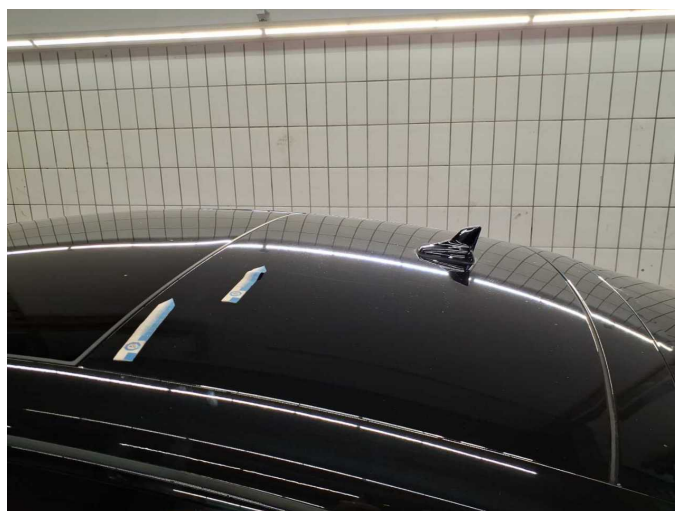
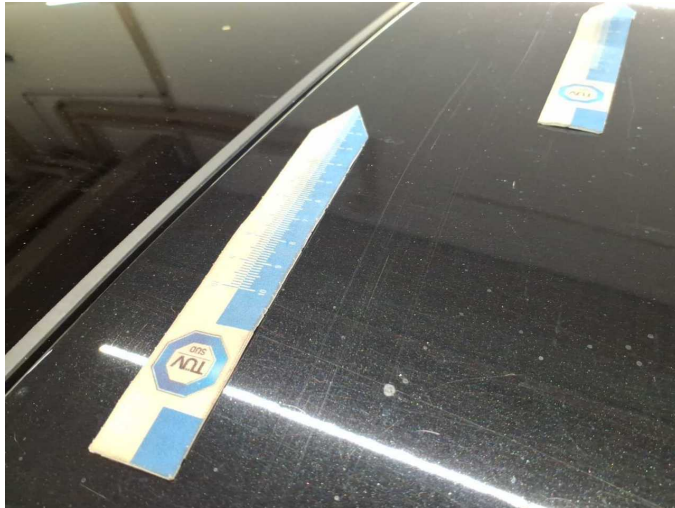
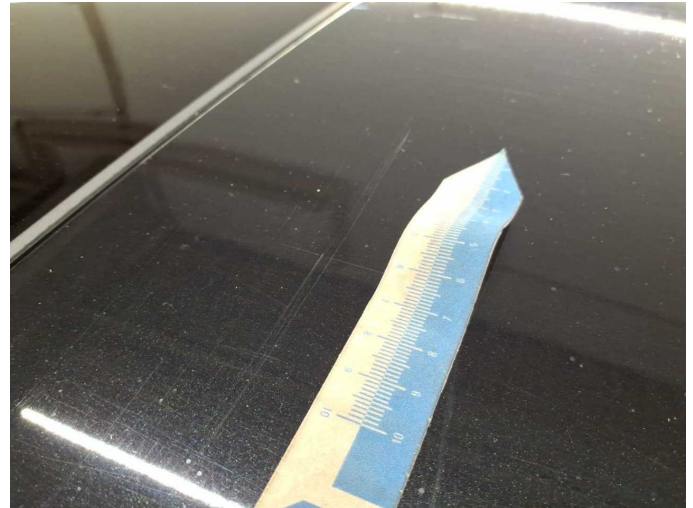
**Wear and tear 3:** Roof: Roof - Scratch(es) - No deduction

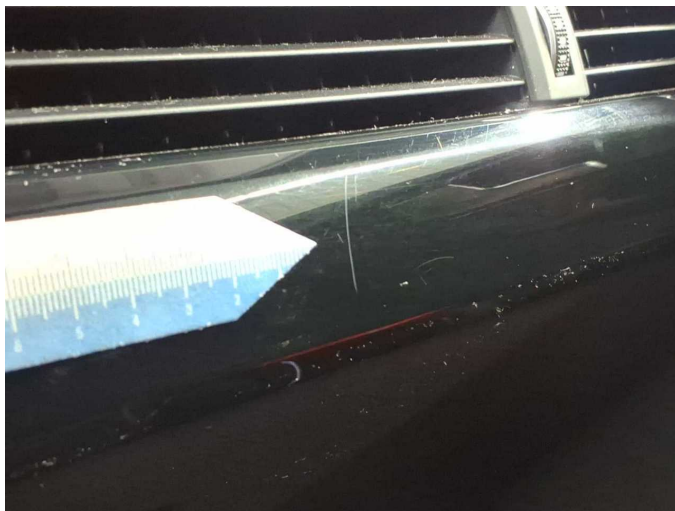
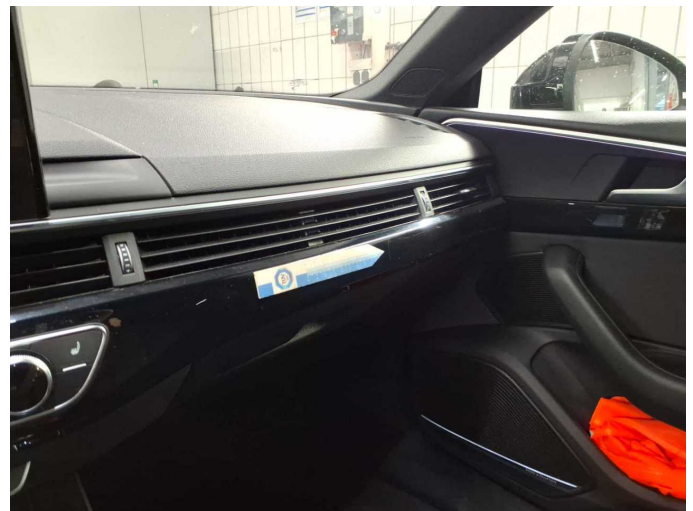
**Wear and tear 4:** Instrument panel: Cover - Scratch(es) - No deduction
