Expertise

Protocol number: 46220259  
Order No. / Reference: 26554009  
Inspection date: 29 Jun 2026

Manufacturer: Ford

Model: Mustang Mach-E

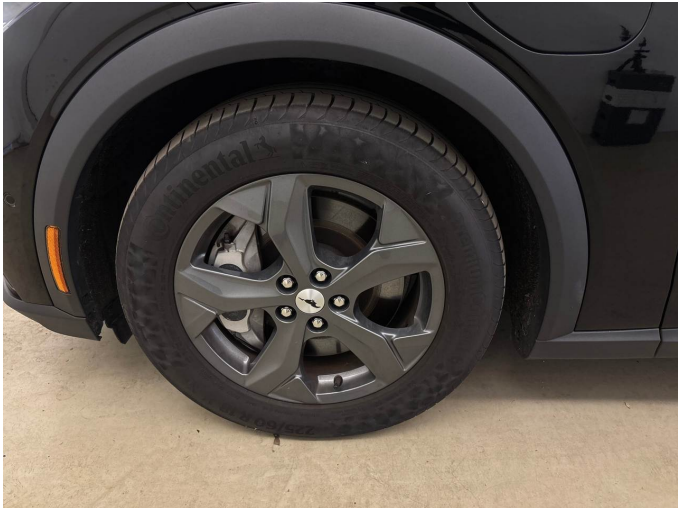
Figure 13: Mounted tyres

| Tyres | | | |
|---|---|---|---|
| 1) | 225/60 R18 104V | Summer tyres on Light alloy | 4mm / 4mm |
| 2) | 225/60 R18 104V | Summer tyres on Light alloy | 4mm / 4mm |

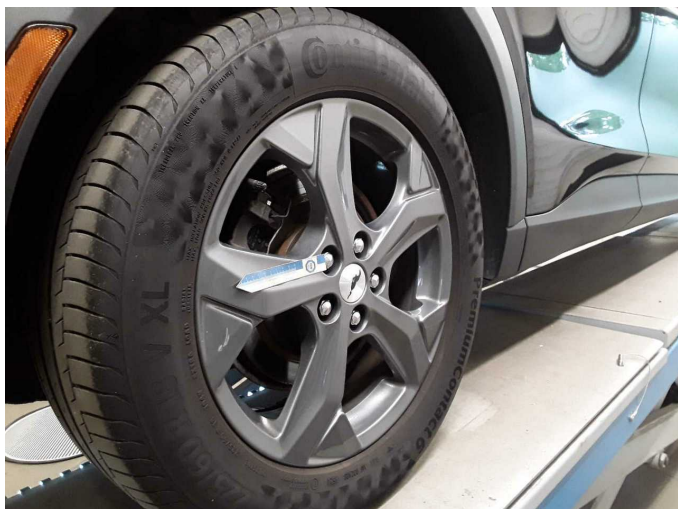
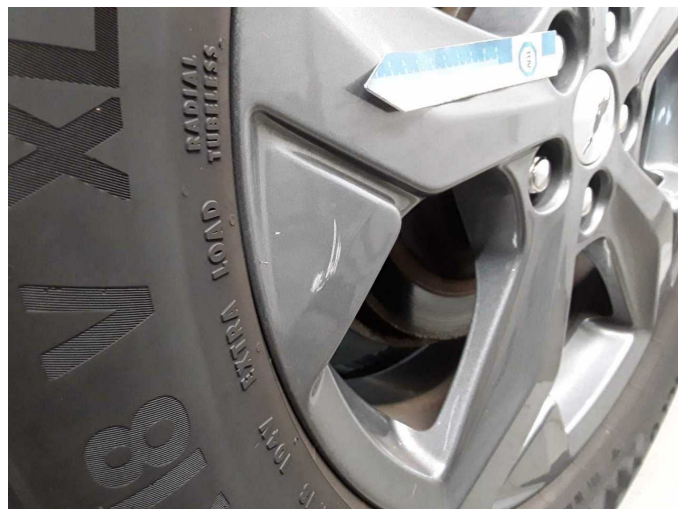
| No. | Component group | Description |
|---|---|---|
| 1 | Wheel / tyres | Alloy rim - rear right side - Scratch(es) - Smart repair |

**Damage 1:** Wheel / tyres: Alloy rim - rear right side - Scratch(es) - Smart repair

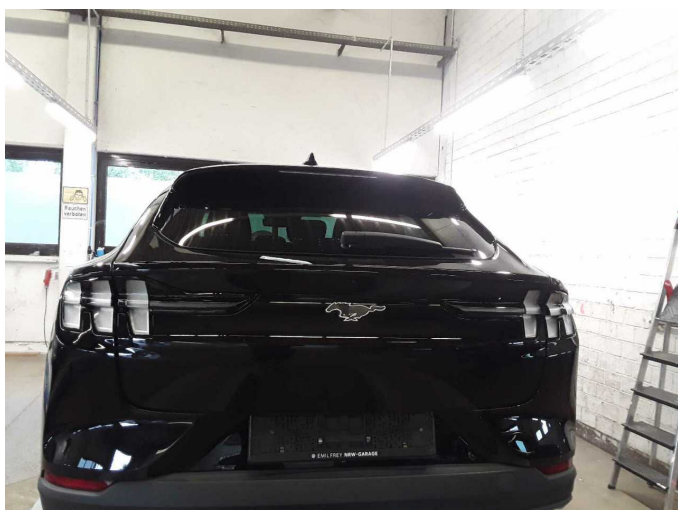
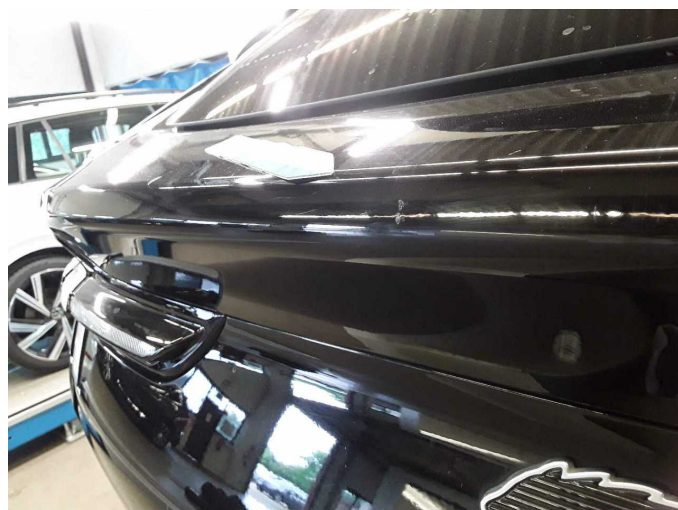
| No. | Component group | Description |
|---|---|---|
| 2 | Boot lid / rear door | Boot lid - Scratch(es) - Smart repair |

**Damage 2:** Boot lid / rear door: Boot lid - Scratch(es) - Smart repair

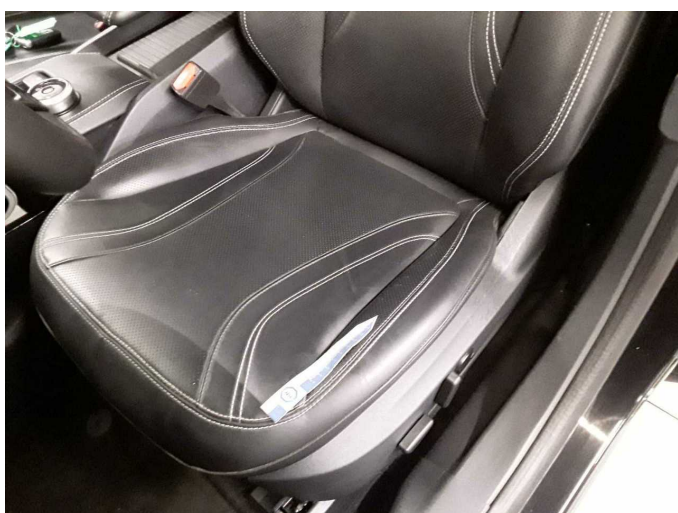
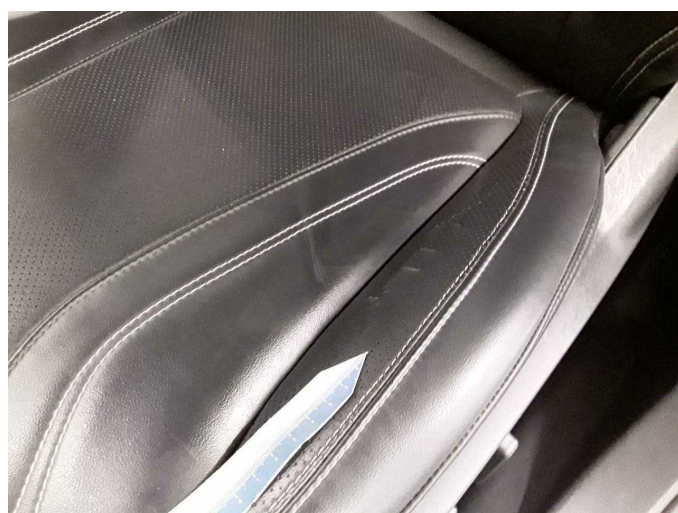
| No. | Component group | Description |
|---|---|---|
| 3 | Seat - front | Seat cover - left side - Porous / cracked - Replace |

**Damage 3:** Seat - front: Seat cover - left side - Porous / cracked - Replace

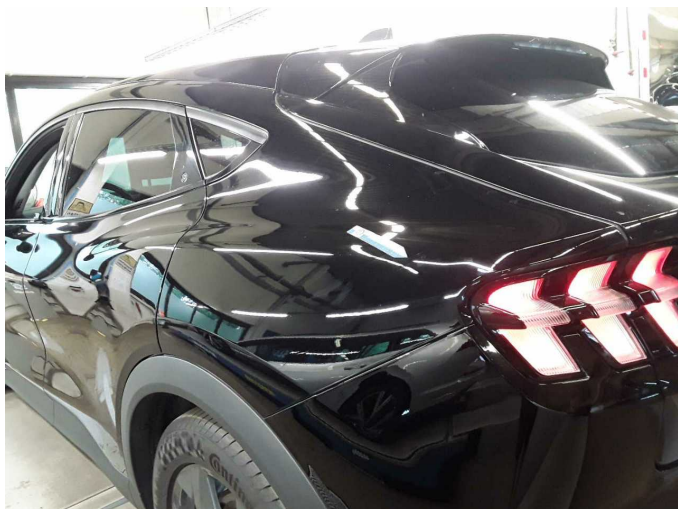
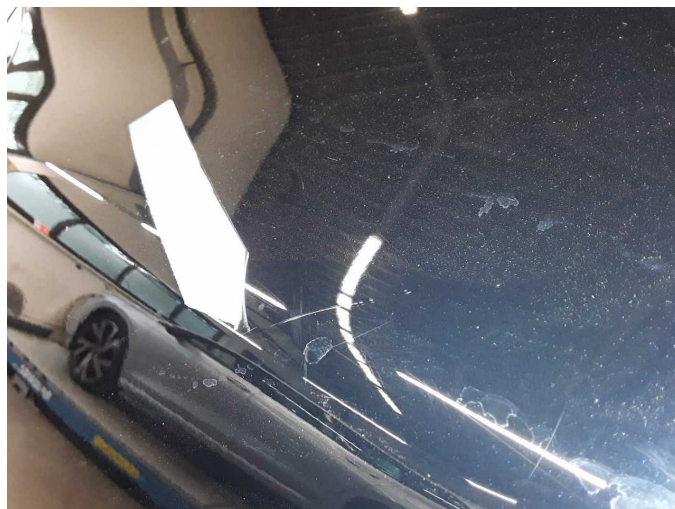
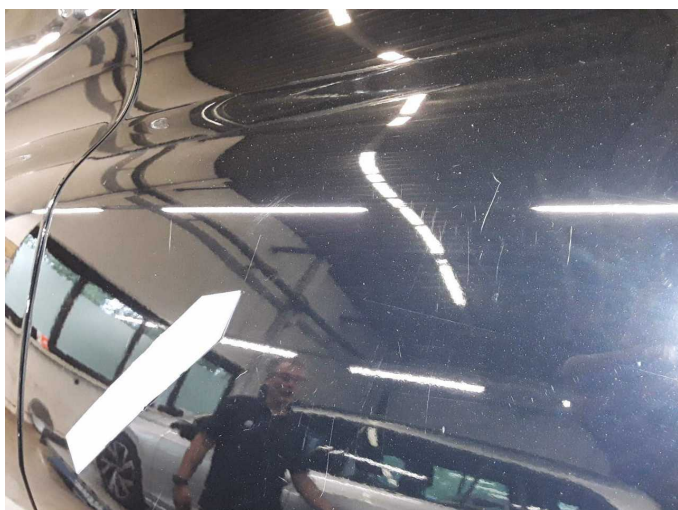
| No. | Component group | Description |
|---|---|---|
| 4 | Side panel - rear left side | Side panel - Scratch(es) - Paint |

**Damage 4:** Side panel - rear left side: Side panel - Scratch(es) - Paint

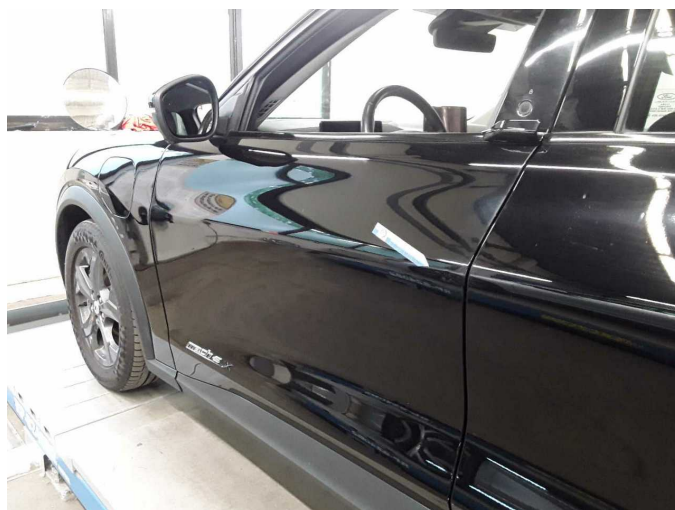
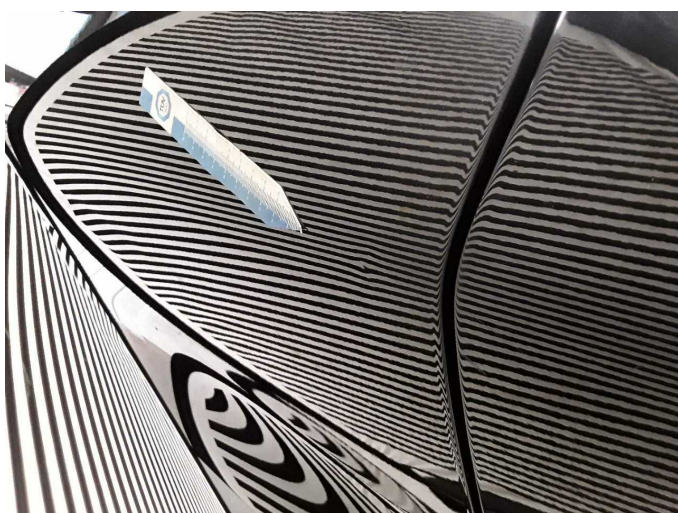
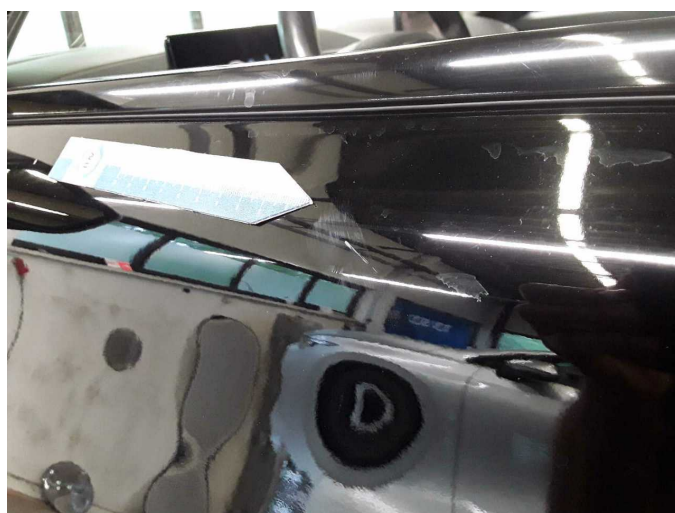
| No. | Component group | Description |
|---|---|---|
| 5 | Door - front left side | Door - Deformed - Repair and paint |

**Damage 5:** Door - front left side: Door - Deformed - Repair and paint

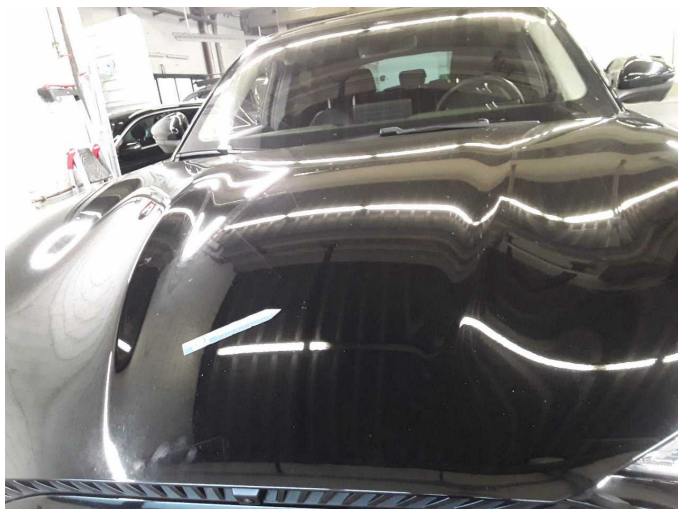
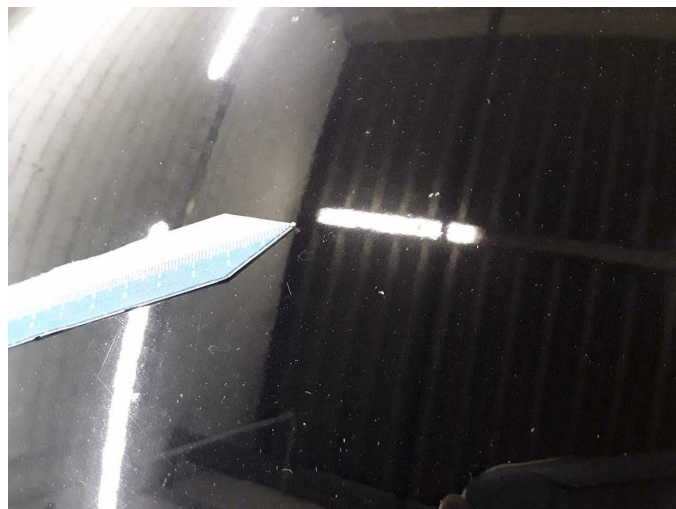
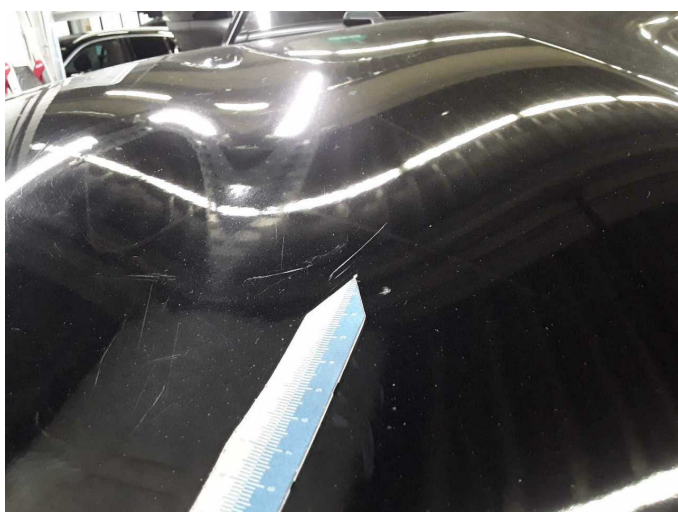
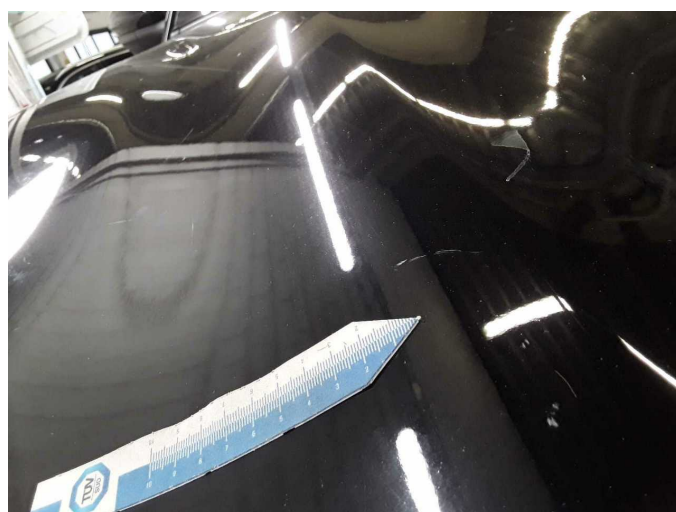
| No. | Component group | Description |
|---|---|---|
| 6 | Bonnet | Bonnet - Scratch(es) - Paint |

**Damage 6:** Bonnet: Bonnet - Scratch(es) - Paint

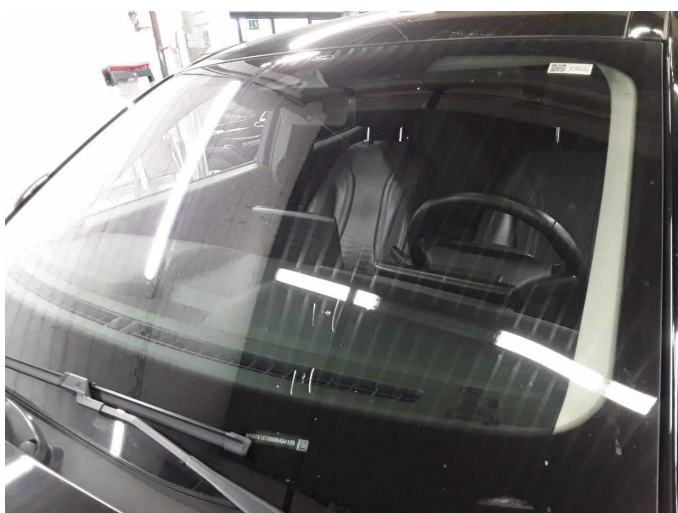
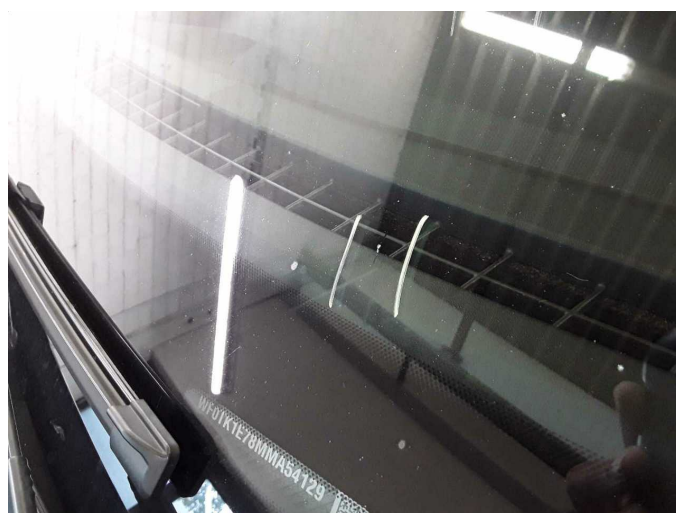
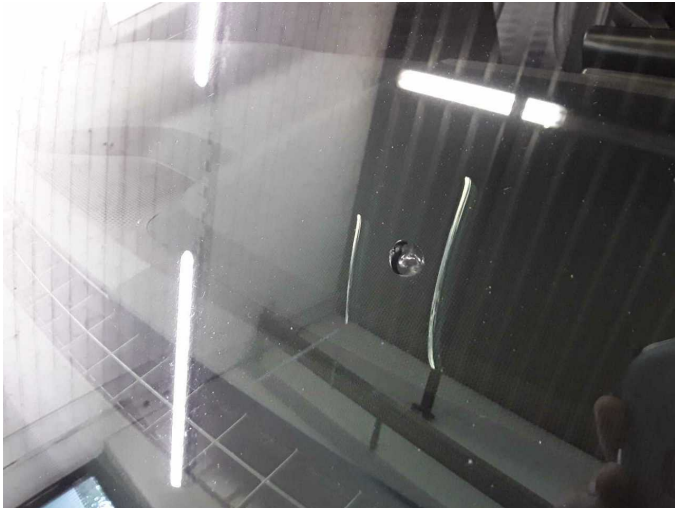
| No. | Component group | Description |
|---|---|---|
| 7 | Vehicle glazing | Windscreen (Rissbildung) - Stone chips - Replace |

**Damage 7:** Vehicle glazing: Windscreen (Rissbildung) - Stone chips - Replace

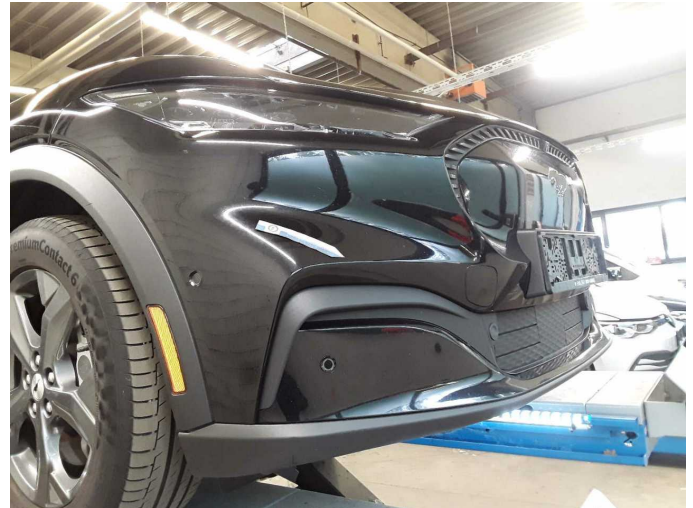
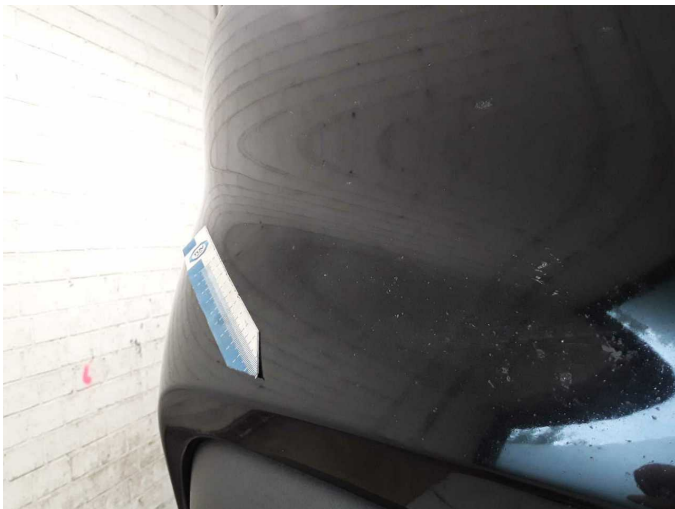
| No. | Component group | Description |
|---|---|---|
| 1 | Front bumper | Front bumper - Stone chips - No deduction |

**Wear and tear 1:** Front bumper: Front bumper - Stone chips - No deduction
