Expertise

Protocol number: 47181734  
Order No. / Reference: 26823166  
Inspection date: 11 Aug 2026

Manufacturer: Volkswagen

Model: Passat Variant 2.0 TDI SCR DSG Business

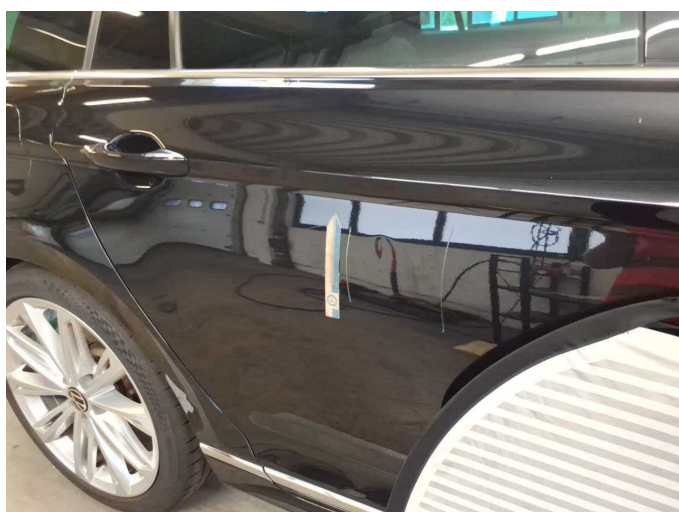
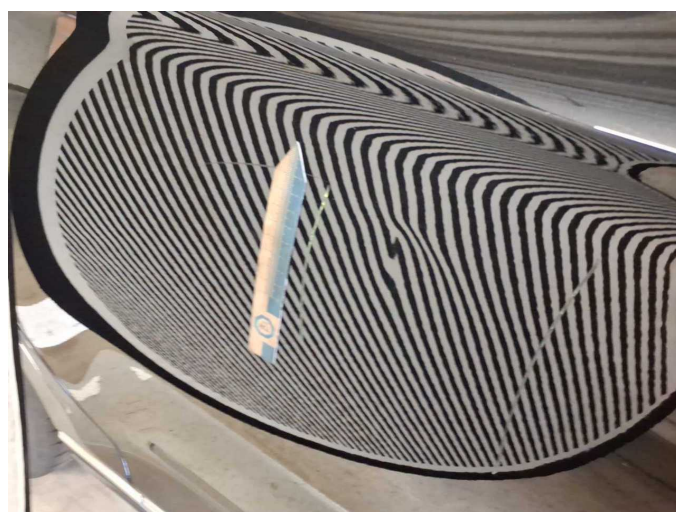
| No. | Component group | Description |
|---|---|---|
| 1 | Door - rear right side | Door - dent(s) - Smooth repair work |

**Damage 1:** Door - rear right side: Door - dent(s) - Smooth repair work

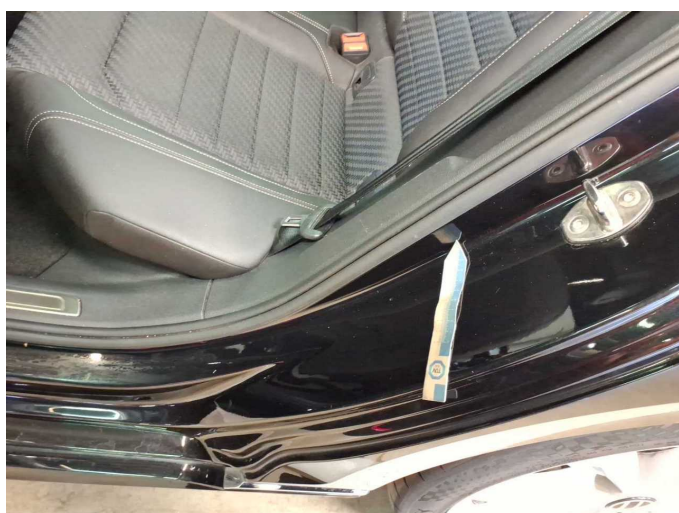
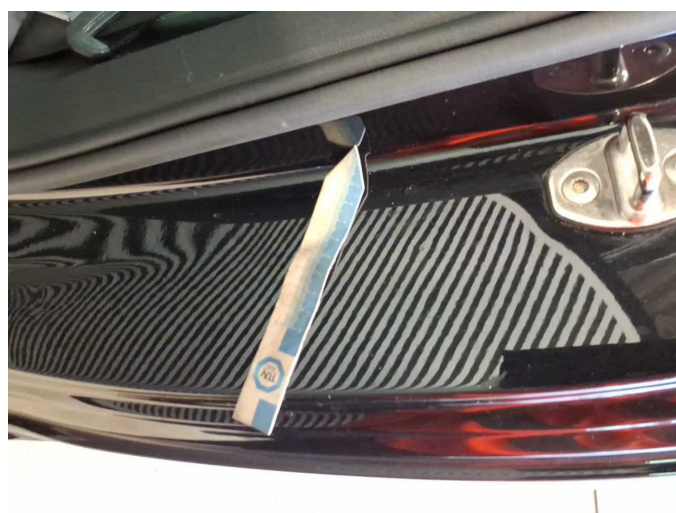
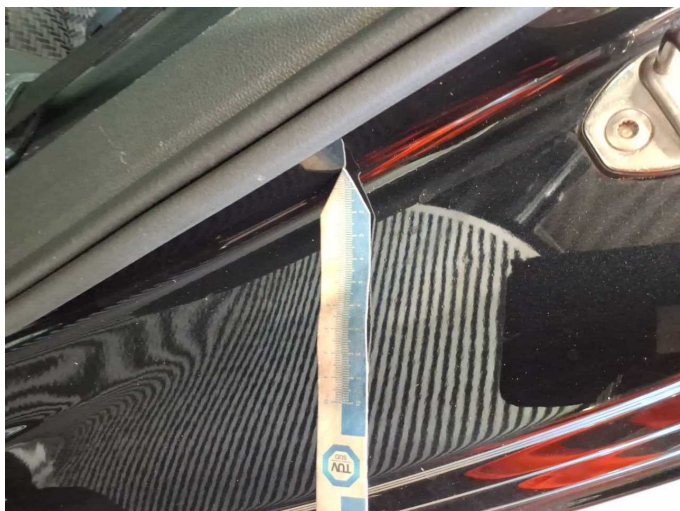
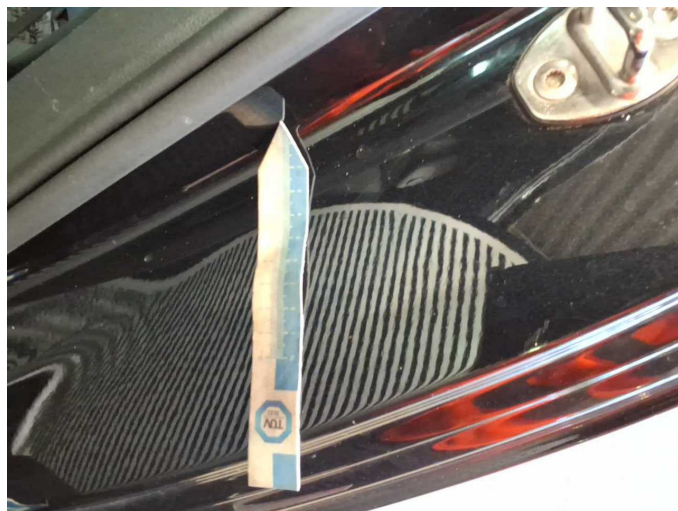
| No. | Component group | Description |
|---|---|---|
| 2 | Side panel - rear left side | Sill - dent(s) - Smooth repair work |

**Damage 2:** Side panel - rear left side: Sill - dent(s) - Smooth repair work

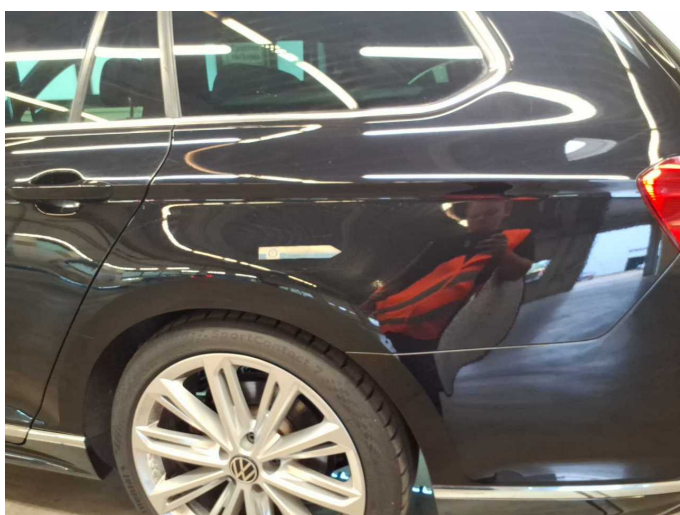
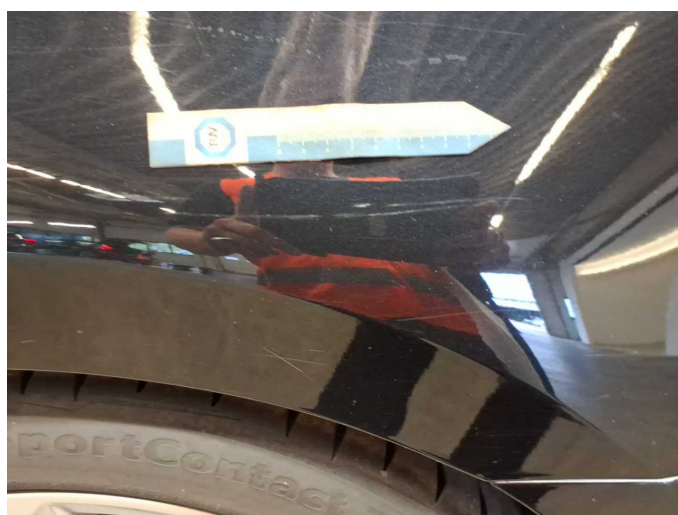
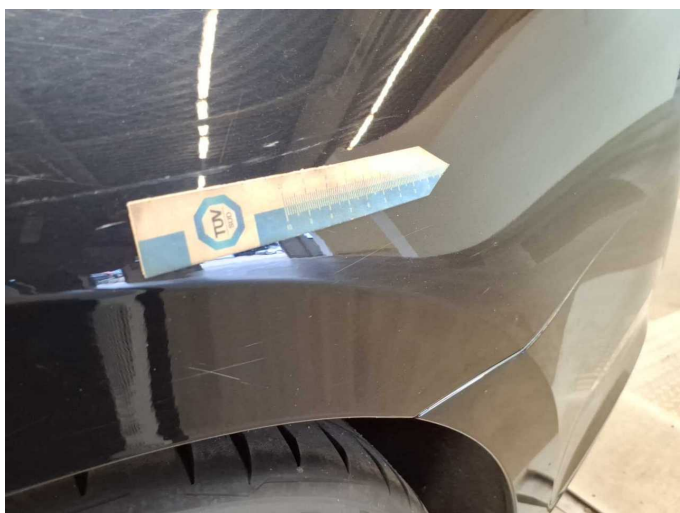
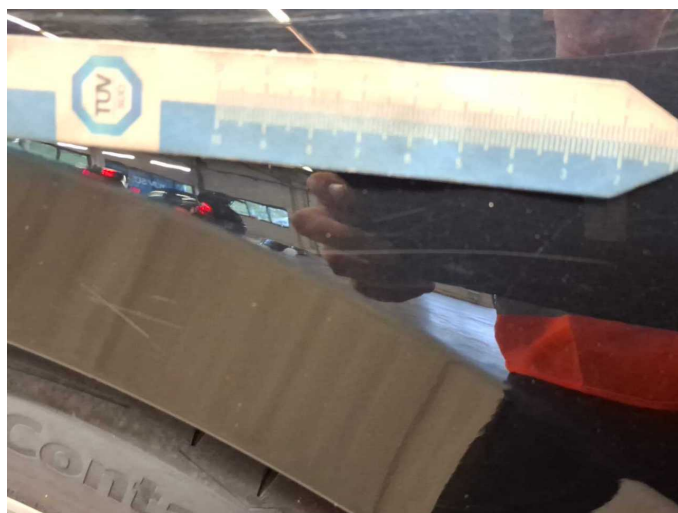
| No. | Component group | Description |
|---|---|---|
| 3 | Side panel - rear left side | Side panel - Scratched - Smart repair |

**Damage 3:** Side panel - rear left side: Side panel - Scratched - Smart repair

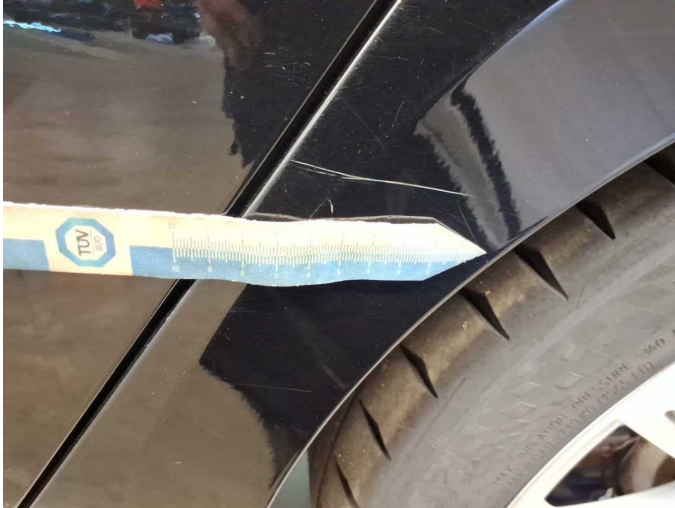
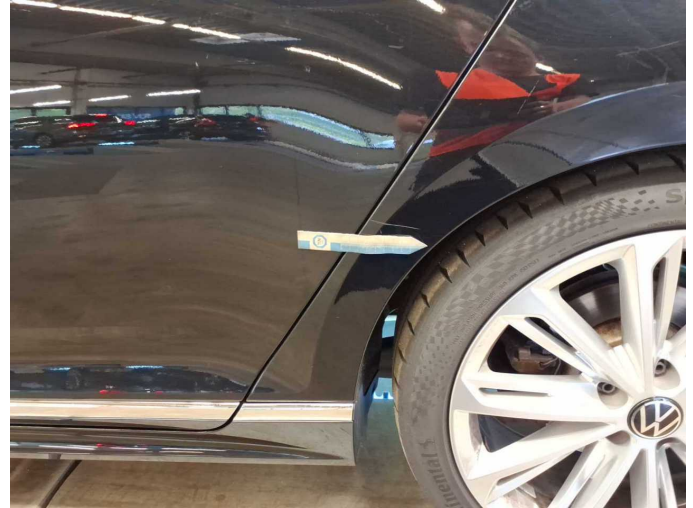
| No. | Component group | Description |
|---|---|---|
| 4 | Side panel - rear left side | Elbow - Scratched - Smart repair |

**Damage 4:** Side panel - rear left side: Elbow - Scratched - Smart repair

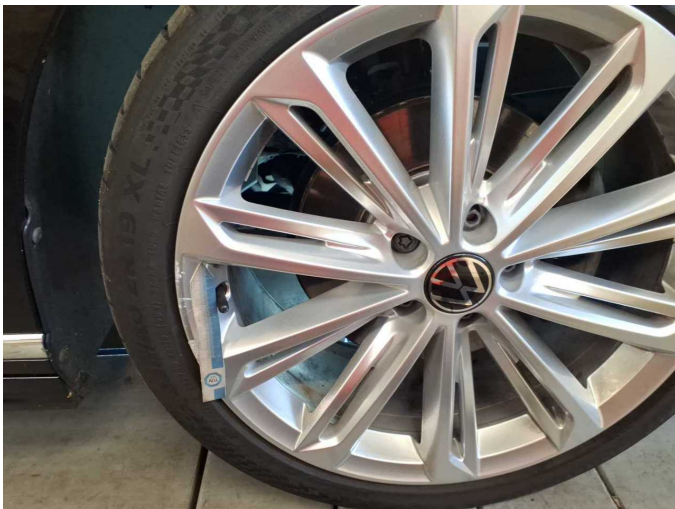
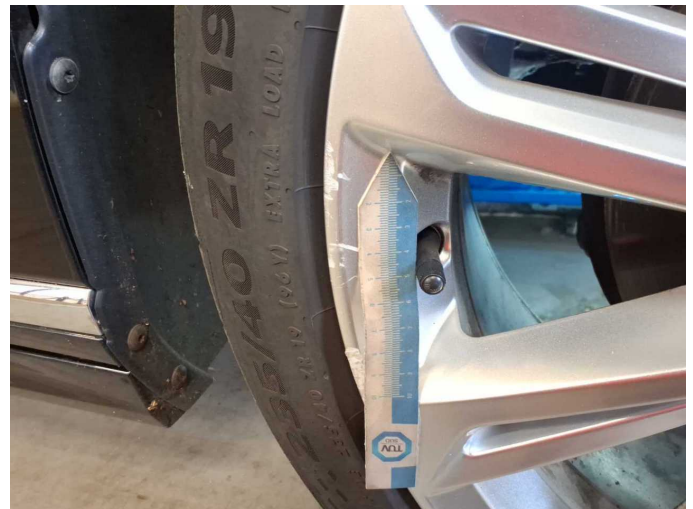
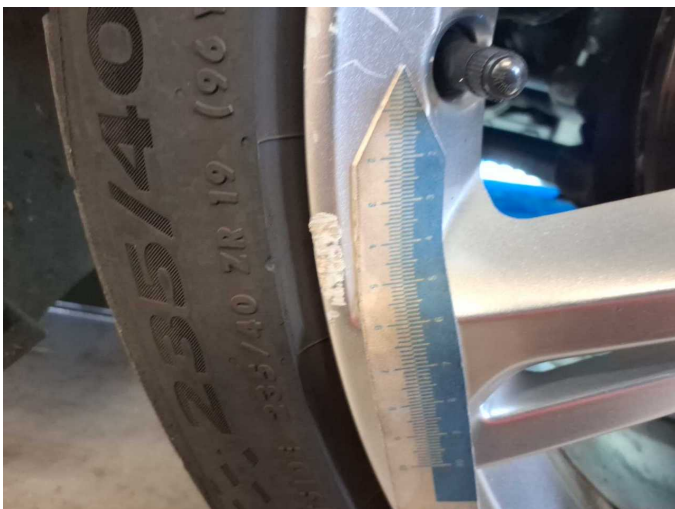
| No. | Component group | Description |
|---|---|---|
| 5 | Wheel / tyres | Alloy rim - front right side - Scratched - Smart repair |

**Damage 5:** Wheel / tyres: Alloy rim - front right side - Scratched - Smart repair

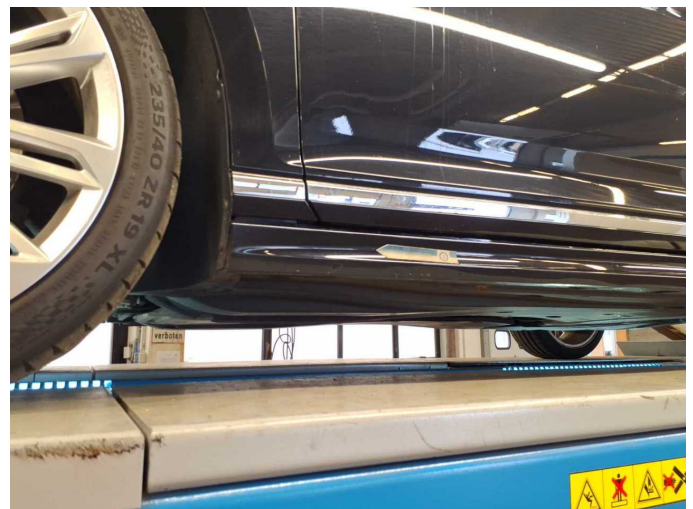
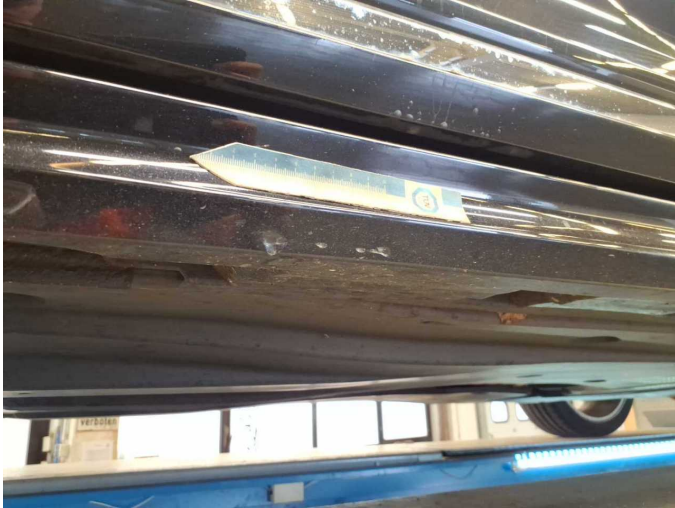
| No. | Component group | Description |
|---|---|---|
| 6 | Sill - left side | Sill - Damaged - Smart repair |

**Damage 6:** Sill - left side: Sill - Damaged - Smart repair

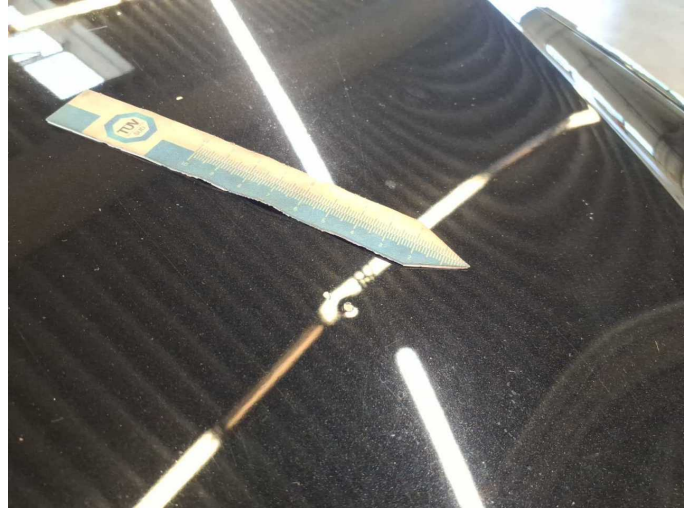
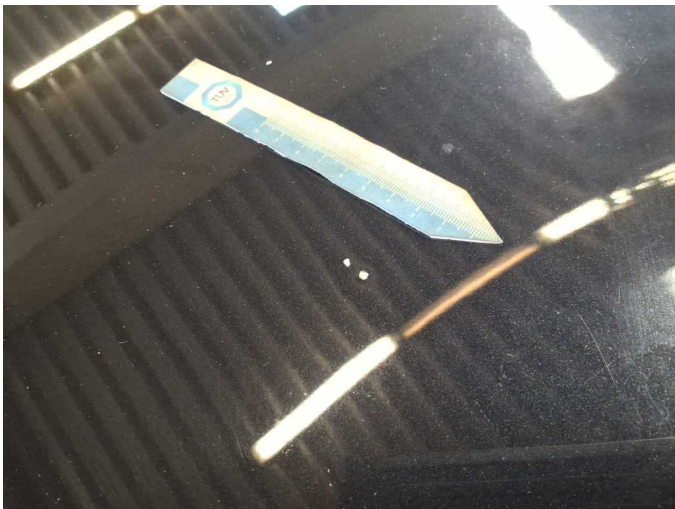
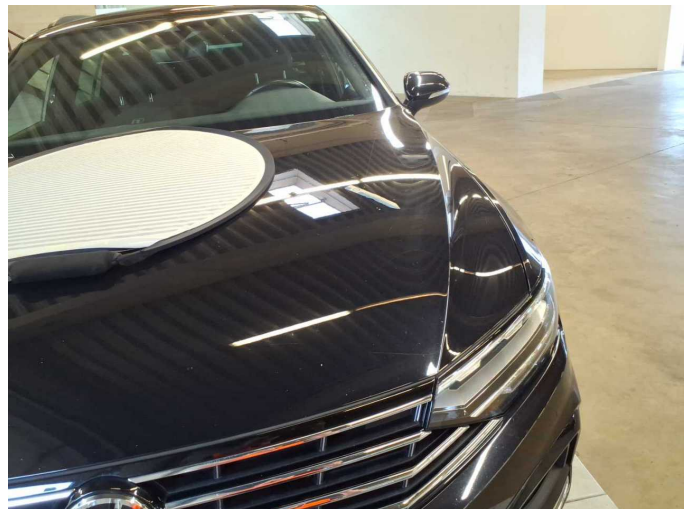
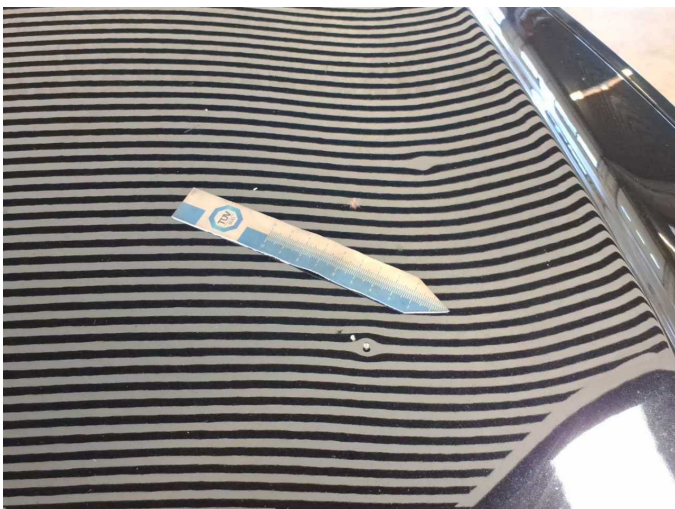
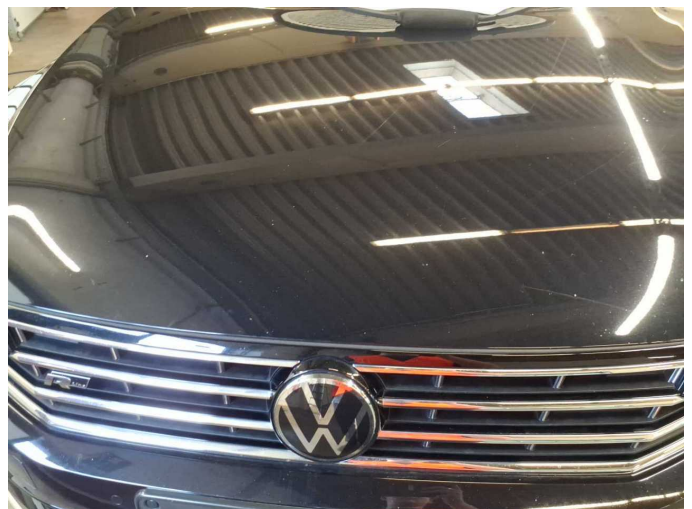
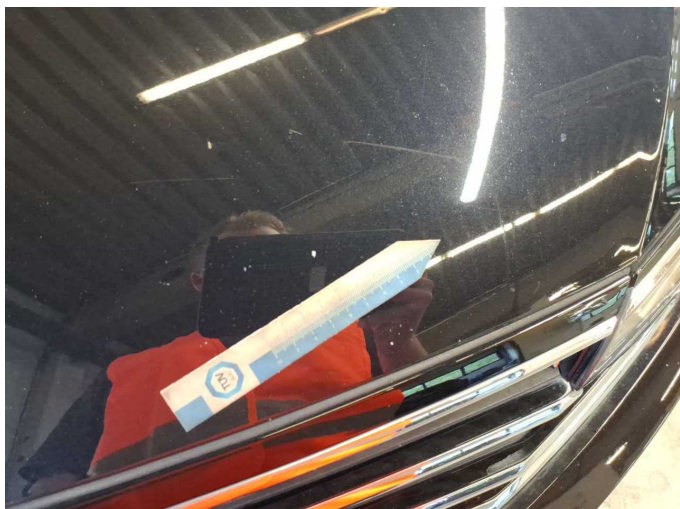
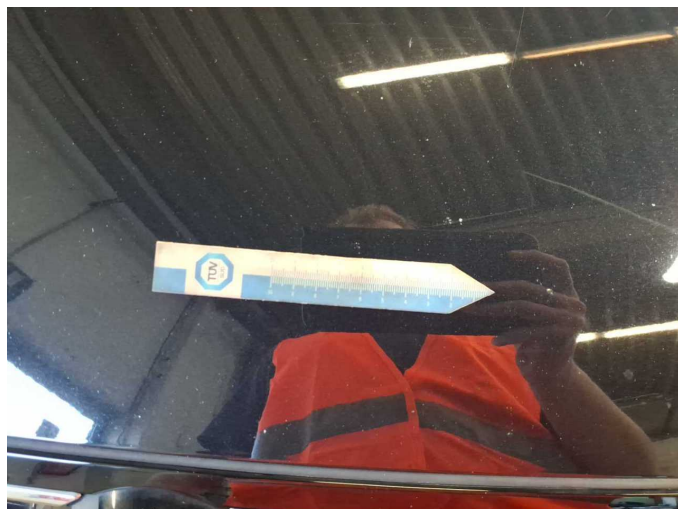
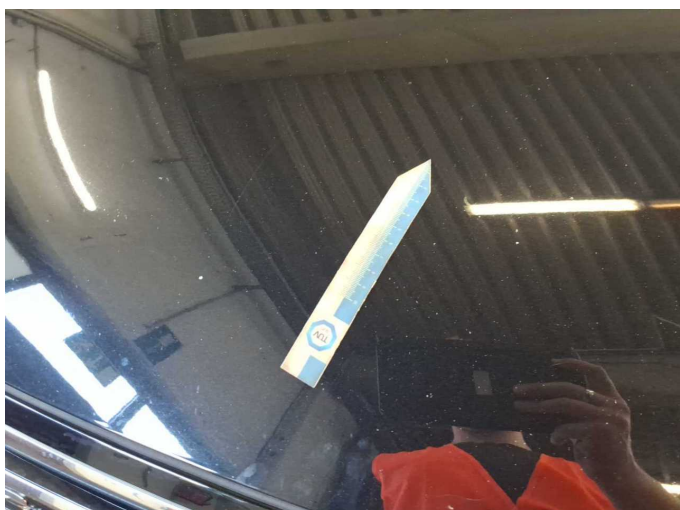
| No. | Component group | Description |
|---|---|---|
| 7 | Bonnet | Bonnet - Dent / paintcoat damage - Repair and paint |

**Damage 7:** Bonnet: Bonnet - Dent / paintcoat damage - Repair and paint

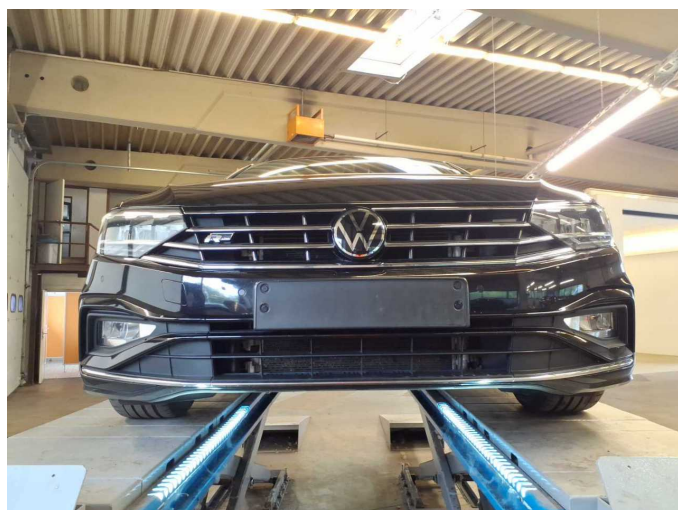
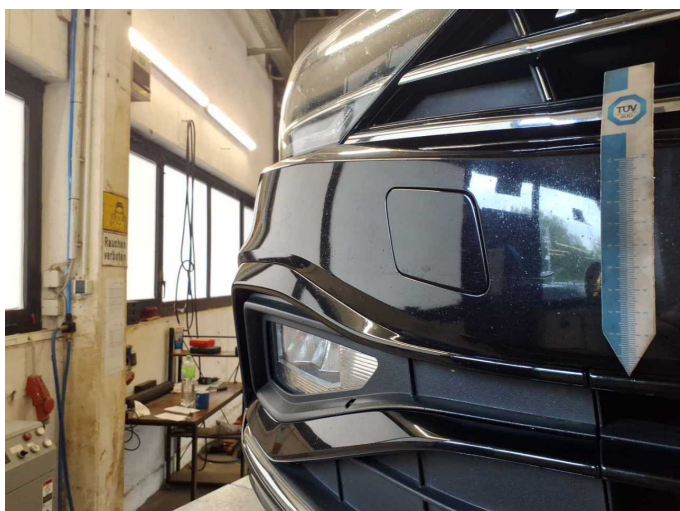
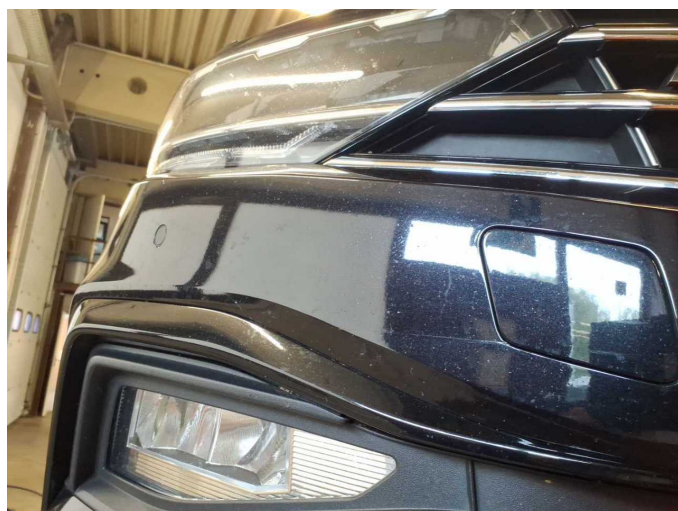
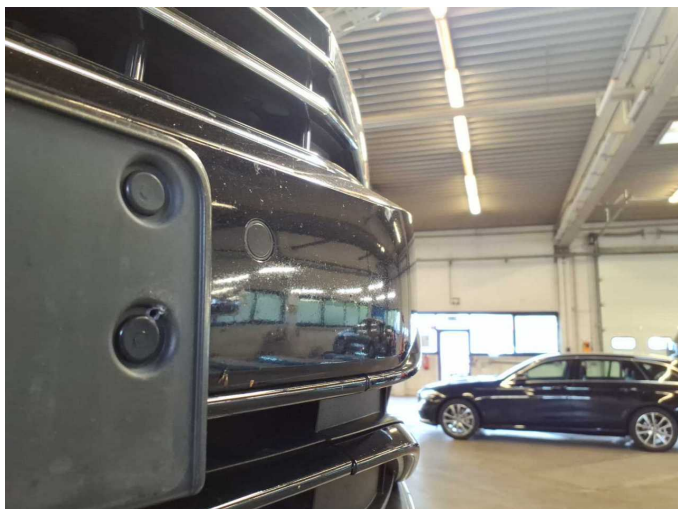
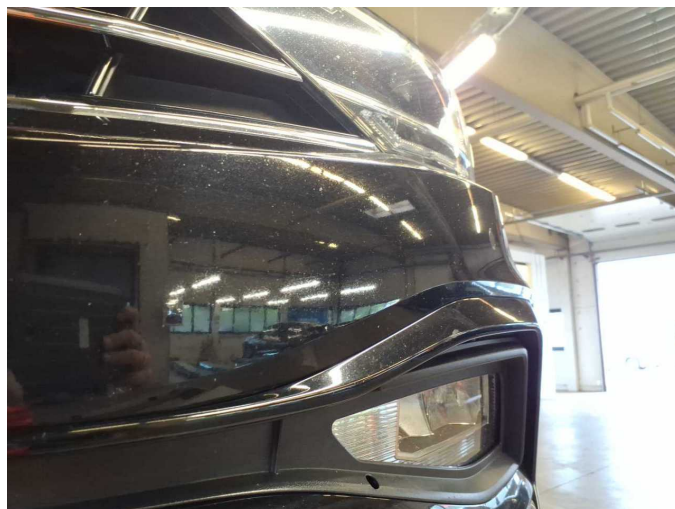
| No. | Component group | Description |
|---|---|---|
| 8 | Front bumper | Front bumper (Sandstrahleffekt) - Stone chips - Paint |

**Damage 8:** Front bumper: Front bumper (Sandstrahleffekt) - Stone chips - Paint

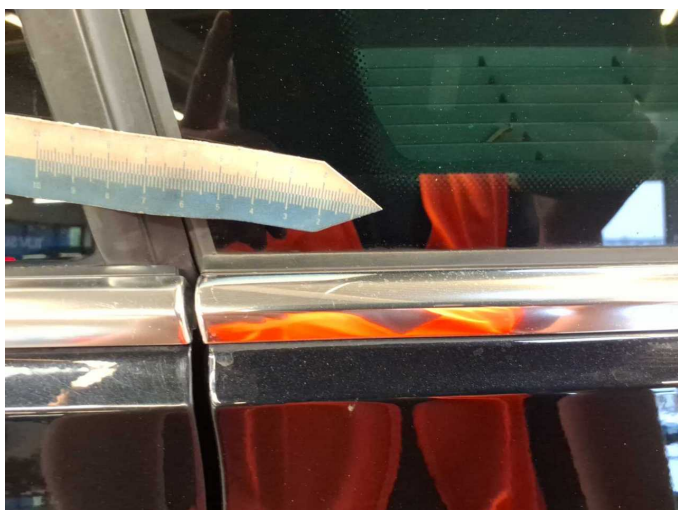
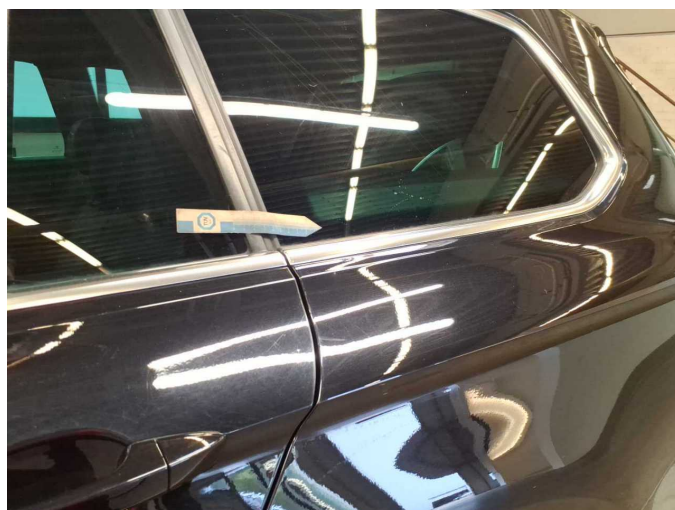
| No. | Component group | Description |
|---|---|---|
| 1 | Side panel - rear left side | Brightware - Scratched - No deduction |

**Wear and tear 1:** Side panel - rear left side: Brightware - Scratched - No deduction

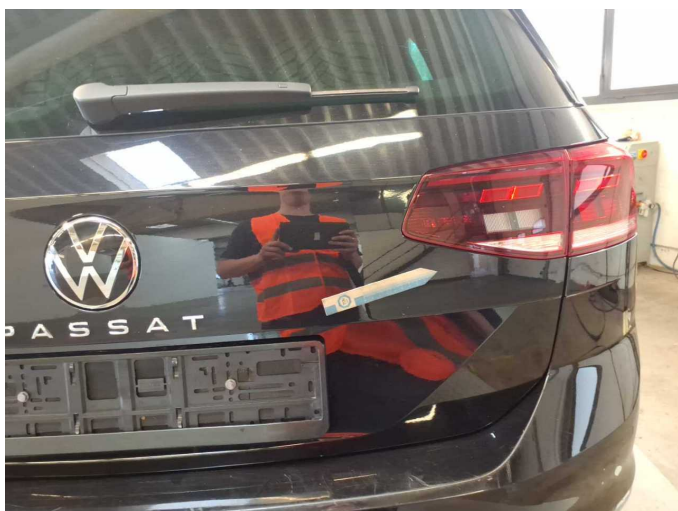
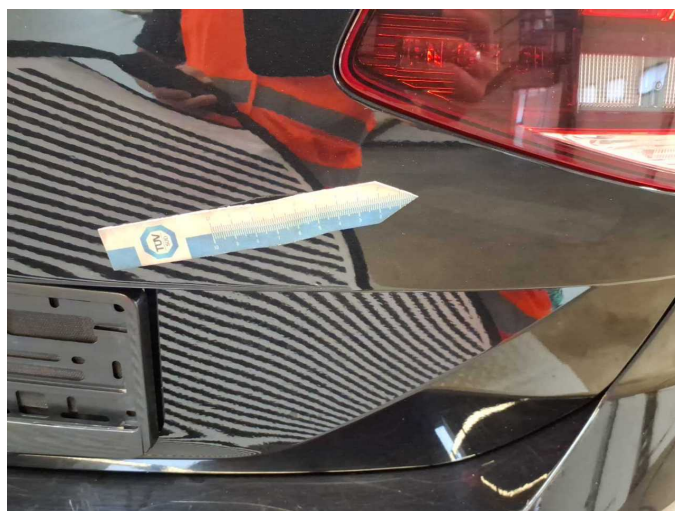
| No. | Component group | Description |
|---|---|---|
| 2 | Boot lid / rear door | Boot lid - dent(s) - Smooth repair work |

**Wear and tear 2:** Boot lid / rear door: Boot lid - dent(s) - Smooth repair work
