Expertise

Protocol number: 45988887
Order No. / Reference: 26406286
Inspection date: 16 Jun 2026

Model: A6 Avant 40 TDI S tronic

VIN: WAUZZZF24RN000896

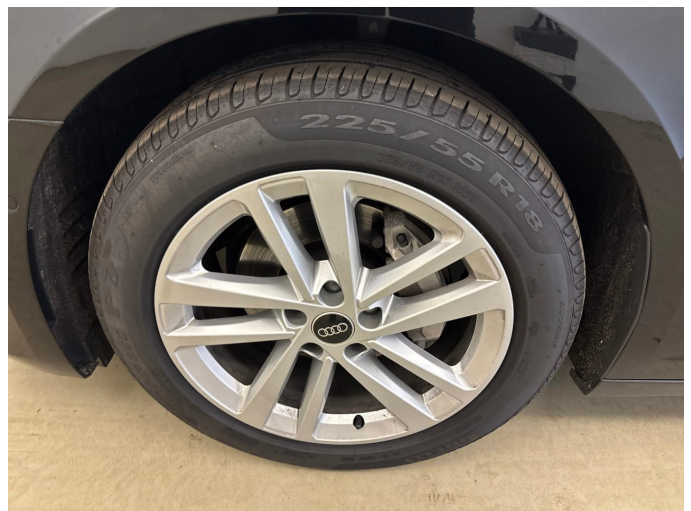
Figure 12: Mounted tyres

Mounted tyres				
#	Tyre size	Type of tyre	Manufacturer	Tread depth
1)	225/55 R18 102Y	Summer tyres on Light alloy	Pirelli	5mm / 5mm
2)	225/55 R18 102Y	Summer tyres on Light alloy	Pirelli	5mm / 5mm
Additional tyres				
#	Tyre size	Type of tyre	Manufacturer	Tread depth
1)	225/60 R17 103V	Winter tyres on Light alloy	Pirelli	5mm / 5mm
2)	225/60 R17 103V	Winter tyres on Light alloy	Pirelli	5mm / 5mm
Replacement				
Typ	Tyre size	Type of tyre	Manufacturer	Tread depth
	Tirefit	Expiration date 07/2028

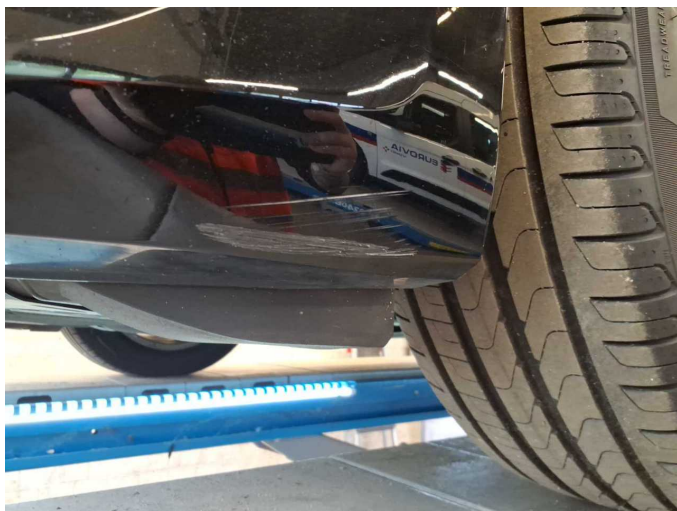
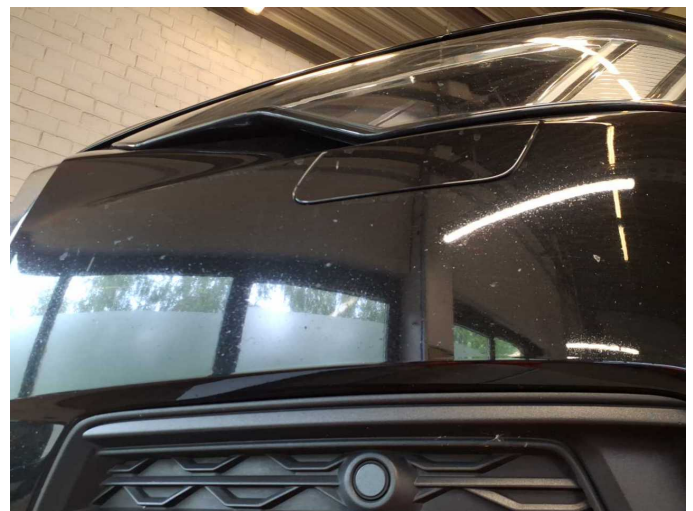
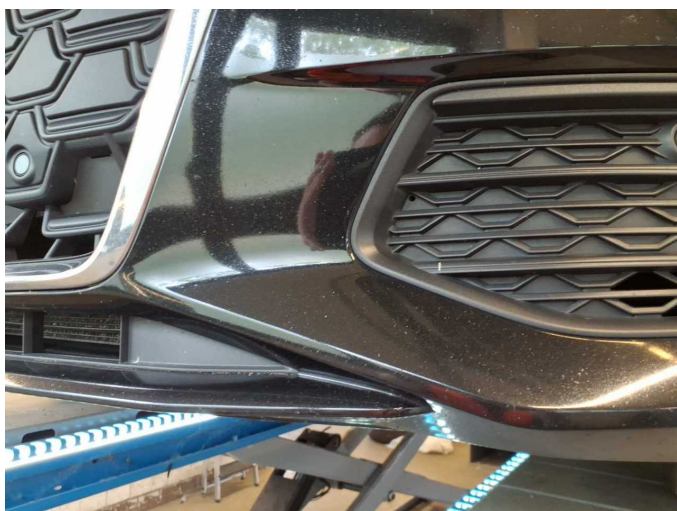
No.	Component group	Description
1	Front bumper	Front bumper - Scratch(es) - Paint

Damage 1: Front bumper: Front bumper - Scratch(es) - Paint

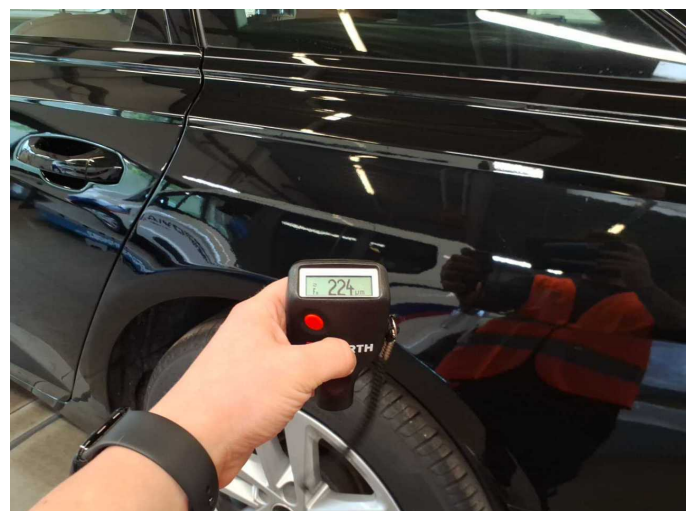
No.	Repainting
1	Side panel - rear left side, Door - front left side, Professionally carried out, Invoice of repair done Non-existent

Side panel - rear left side	224 µm	Door - front left side	174 µm
-----------------------------	--------	------------------------	--------

Repainting 1: Side panel - rear left side, Door - front left side
