Expertise

Protocol number: 46313678  
Order No. / Reference: 26325910  
Inspection date: 3 Jul 2026

Manufacturer: Audi

Model: A4 Avant 35 TDI S tronic

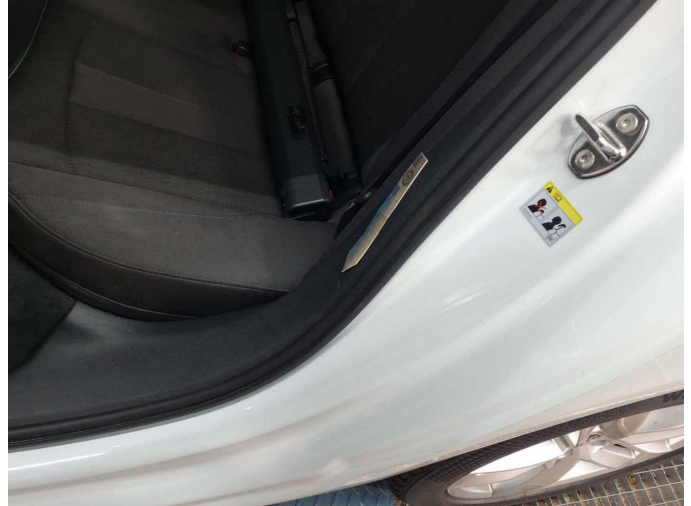
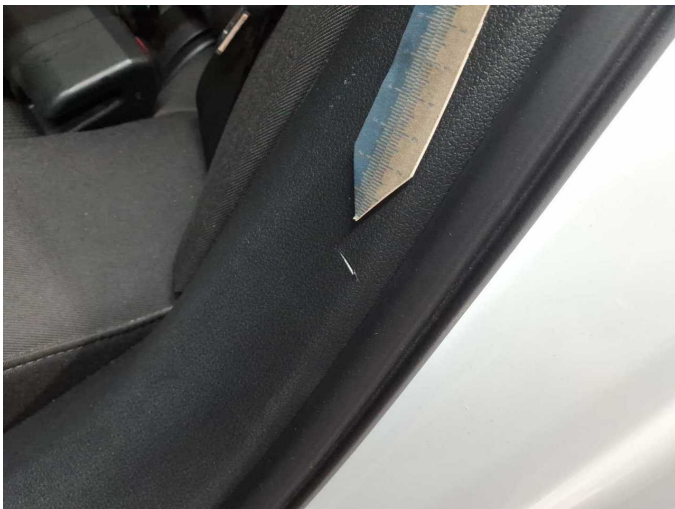
| No. | Component group | Description |
|---|---|---|
| 1 | Side panel - rear left side | Interior trim - Scratch(es) - Loss in value |

**Damage 1:** Side panel - rear left side: Interior trim - Scratch(es) - Loss in value

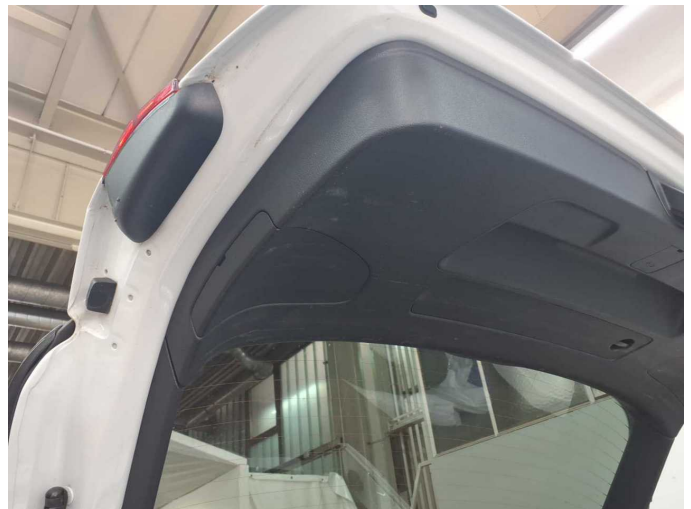
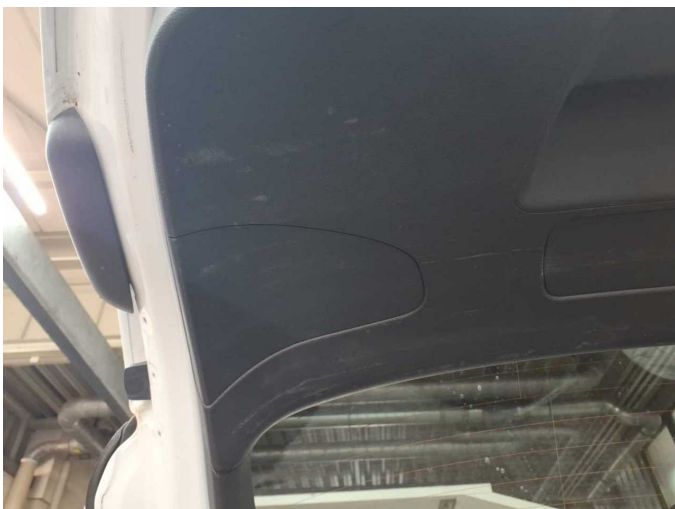
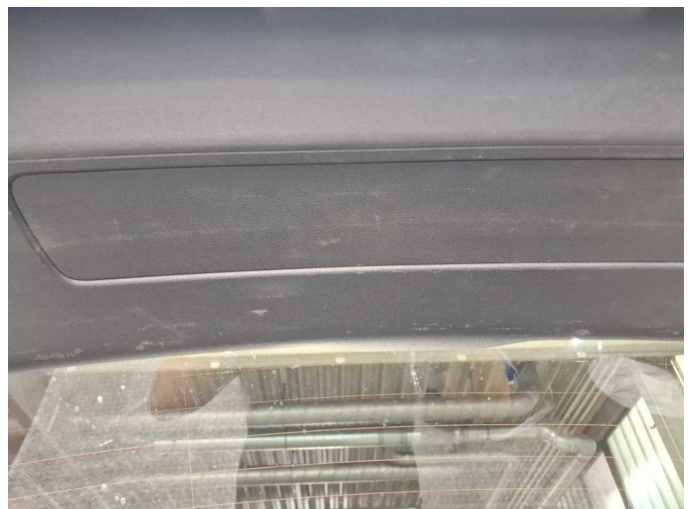
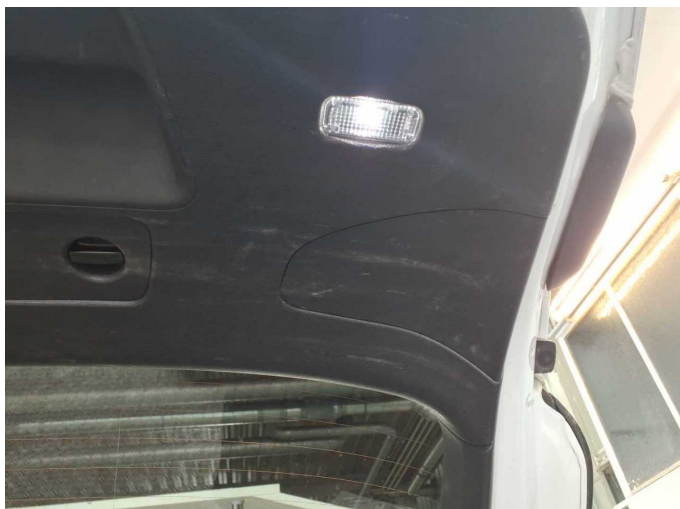
| No. | Component group | Description |
|---|---|---|
| 2 | Trim / covers | Boot lid - interior trim - Scratch(es) - Loss in value |

**Damage 2:** Trim / covers: Boot lid - interior trim - Scratch(es) - Loss in value

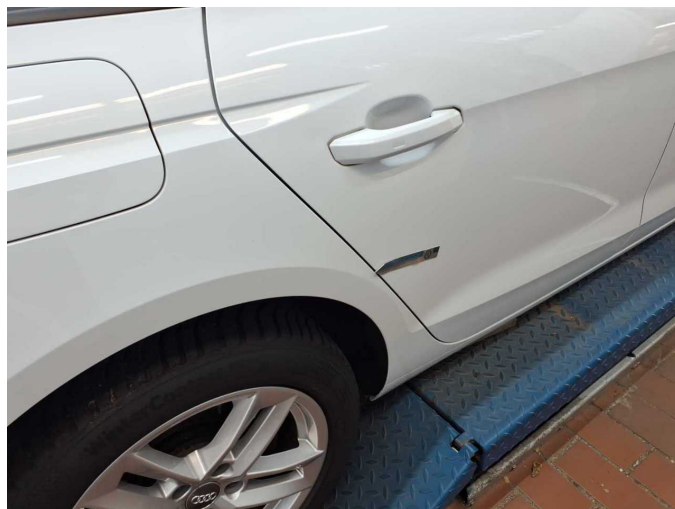
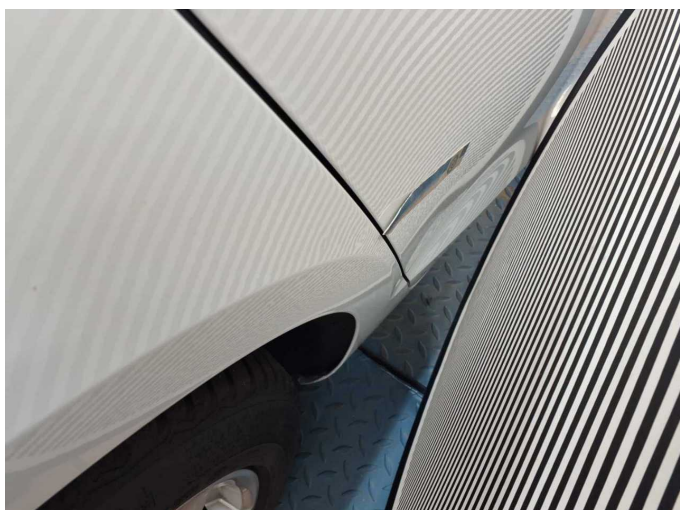
| No. | Component group | Description |
|---|---|---|
| 3 | Side panel - rear right side | Elbow - dent(s) - Smart repair |

**Damage 3:** Side panel - rear right side: Elbow - dent(s) - Smart repair

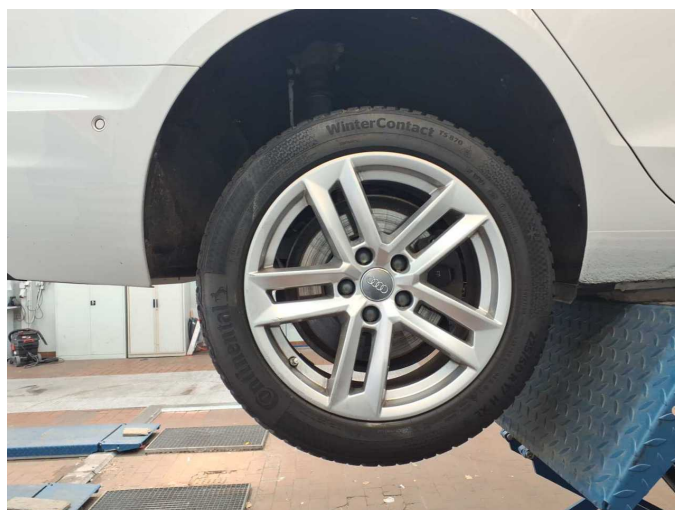
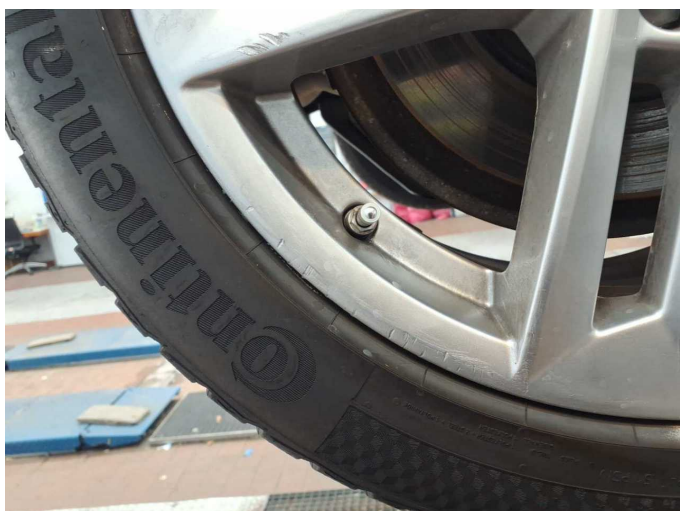
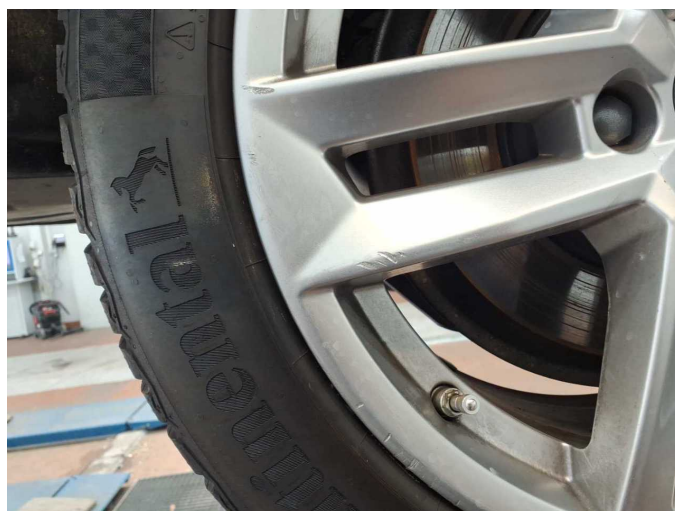
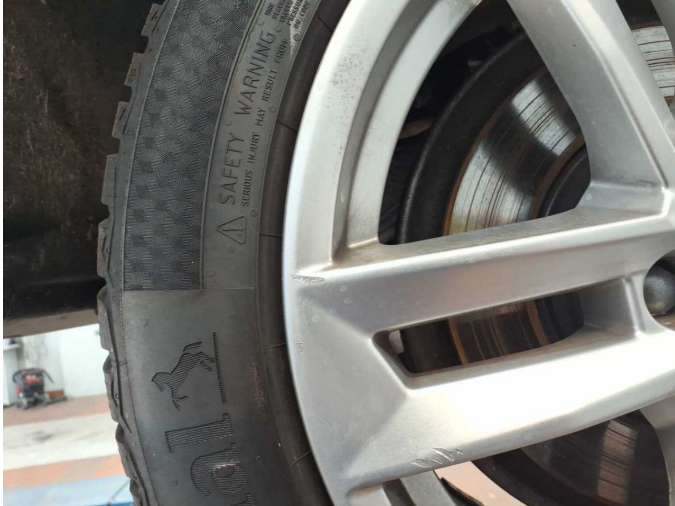
| No. | Component group | Description |
|---|---|---|
| 4 | Wheel / tyres | Alloy rim - rear left side - Scratch(es) - Loss in value |

**Damage 4:** Wheel / tyres: Alloy rim - rear left side - Scratch(es) - Loss in value

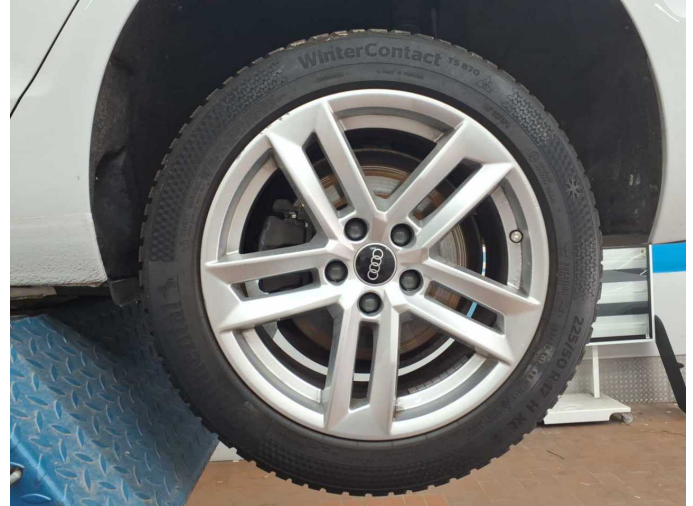
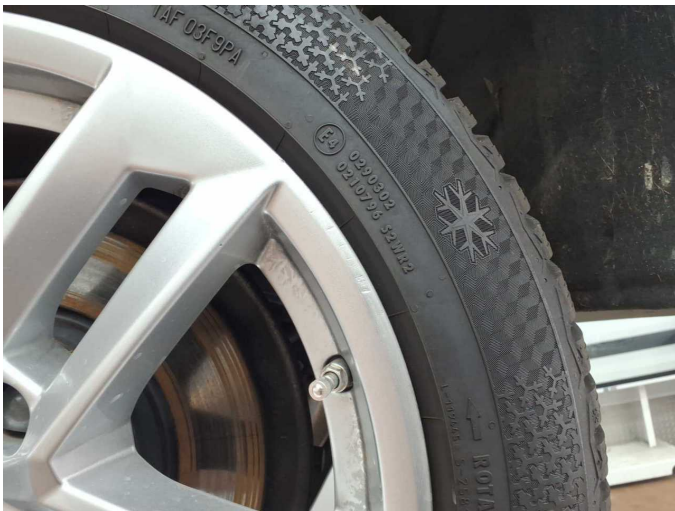
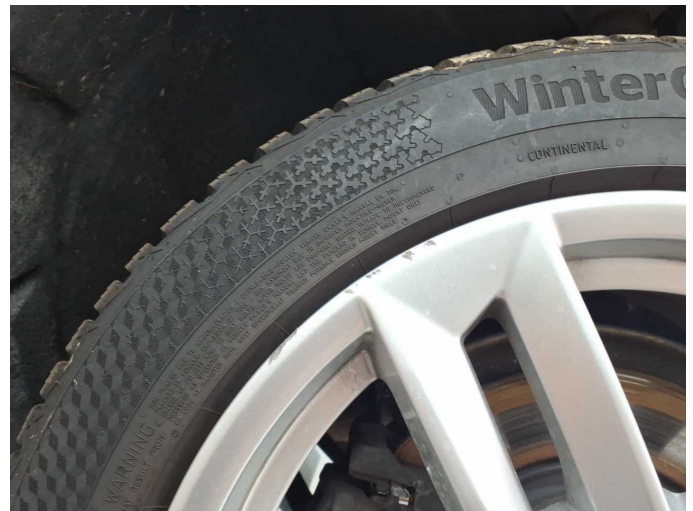
| No. | Component group | Description |
|---|---|---|
| 5 | Wheel / tyres | Alloy rim - rear left side - Scratch(es) - Loss in value |

**Damage 5:** Wheel / tyres: Alloy rim - rear left side - Scratch(es) - Loss in value

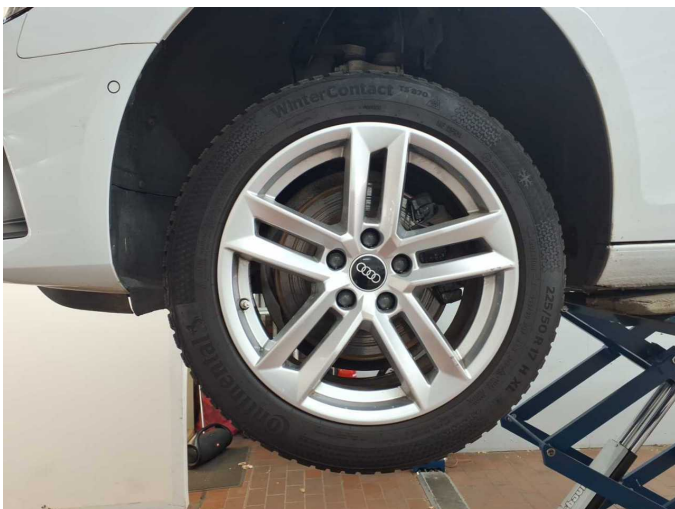
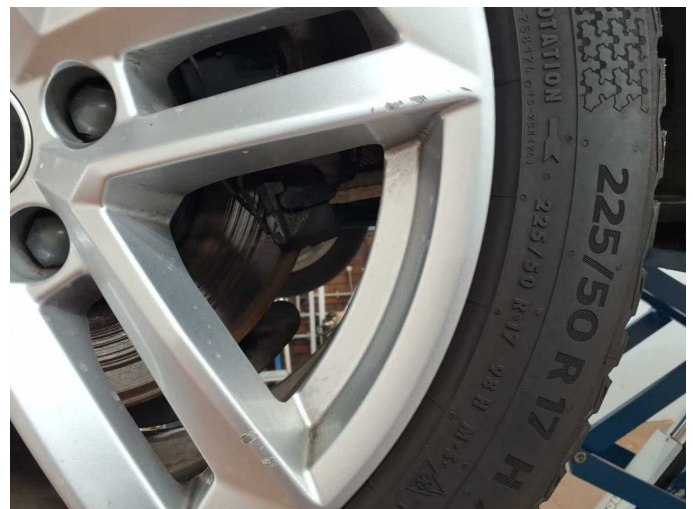
| No. | Component group | Description |
|---|---|---|
| 6 | Wheel / tyres | Alloy rim - front left side - Scratch(es) - Loss in value |

**Damage 6:** Wheel / tyres: Alloy rim - front left side - Scratch(es) - Loss in value

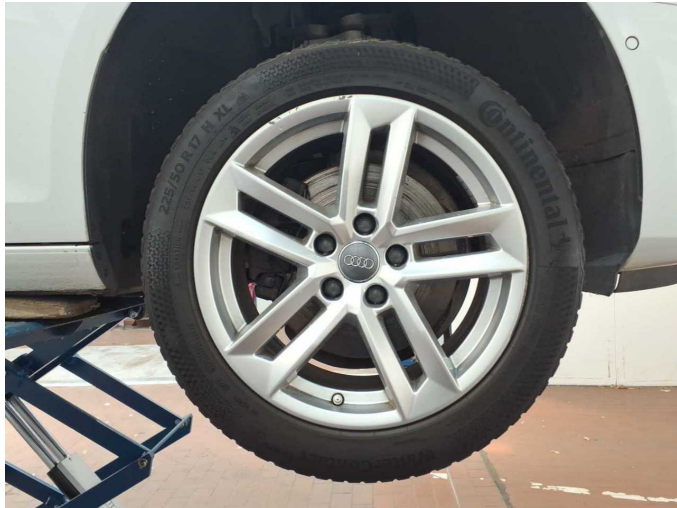
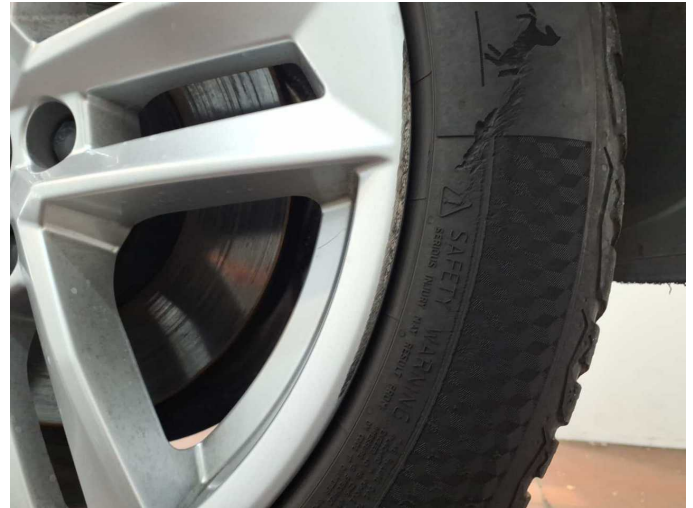
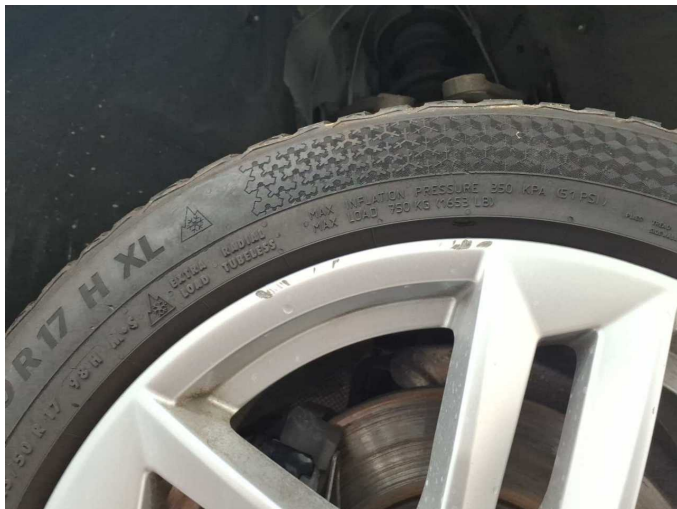
| No. | Component group | Description |
|---|---|---|
| 7 | Wheel / tyres | Alloy rim - front right side - Scratch(es) - Loss in value |

**Damage 7:** Wheel / tyres: Alloy rim - front right side - Scratch(es) - Loss in value

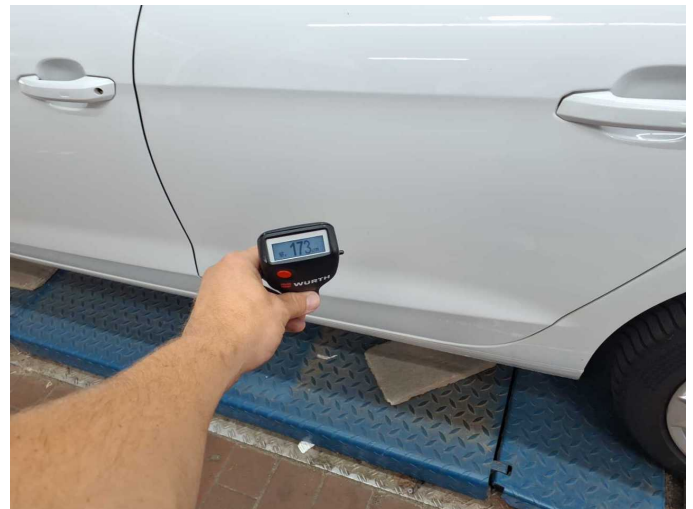
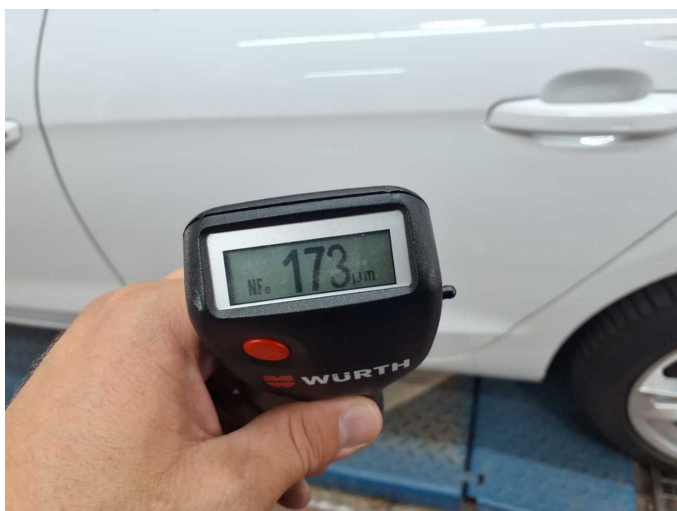
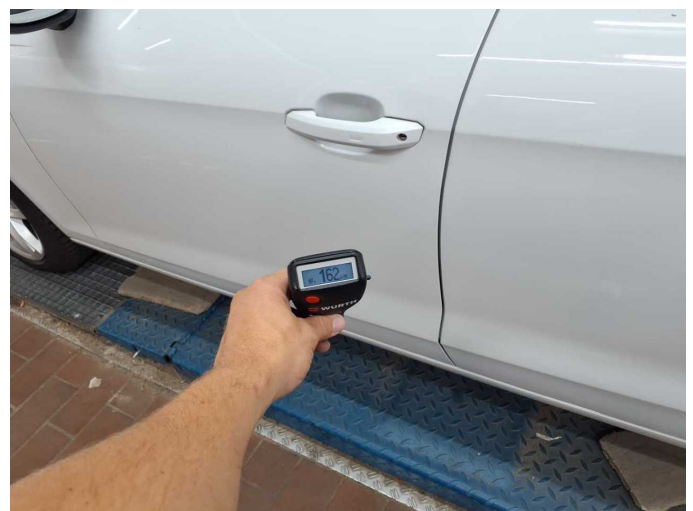
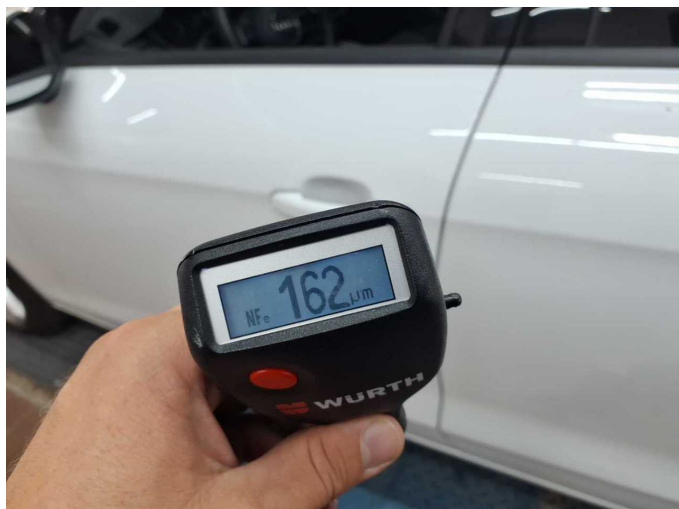
| No. | Repainting |
|---|---|
| 1 | Door - rear left side, Door - front left side, Professionally carried out, Invoice of repair done Non-existent |

**Repainting 1:** Door - rear left side, Door - front left side
