Expertise

Protocol number: 46851186  
Order No. / Reference: 26709575  
Inspection date: 3 Aug 2026

Manufacturer: Skoda  
VIN: TMBJH7NP0L7068175

Model: Superb Combi 2.0 TDI DSG Sportline

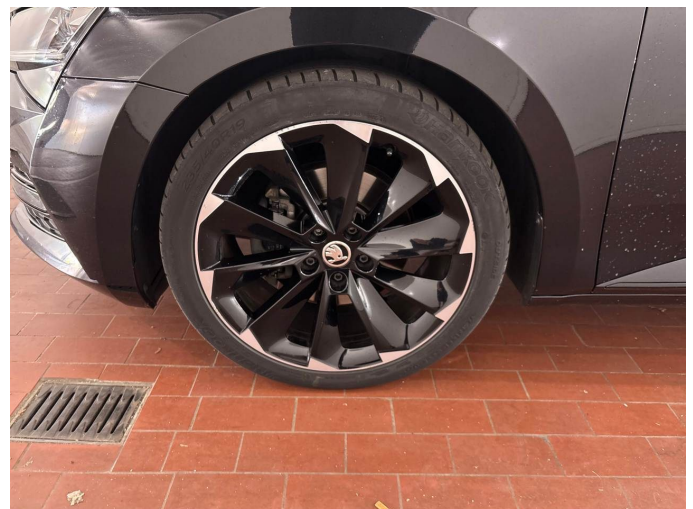
**Figure 12: Mounted tyres**

| # | Tyre size | Type of tyre | Manufacturer | Tread depth |
|---|---|---|---|---|
| 1) | 235/40 ZR19 96Y | Summer tyres on Light alloy | Continental | 4mm / 5mm |
| 2) | 235/40 ZR19 96Y | Summer tyres on Light alloy | Continental | 5 mm |
| | 235/40 R19 96W | Summer tyres on Light alloy | Hankook | 6 mm |

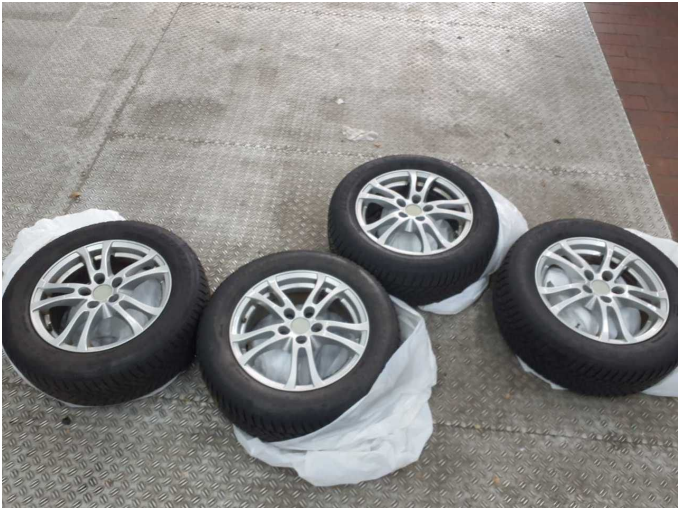
Figure 16: Additional tyres

| # | Tyre size | Type of tyre | Manufacturer | Tread depth |
|---|---|---|---|---|
| 1) | 215/60 R16 99H | Winter tyres on Light alloy | Dunlop | 5mm / 6mm |
| 2) | 215/60 R16 99H | Winter tyres on Light alloy | Dunlop | 5mm / 6mm |

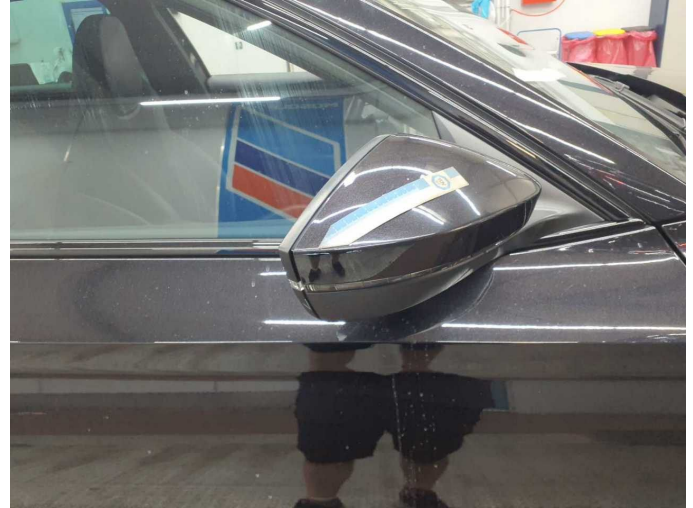
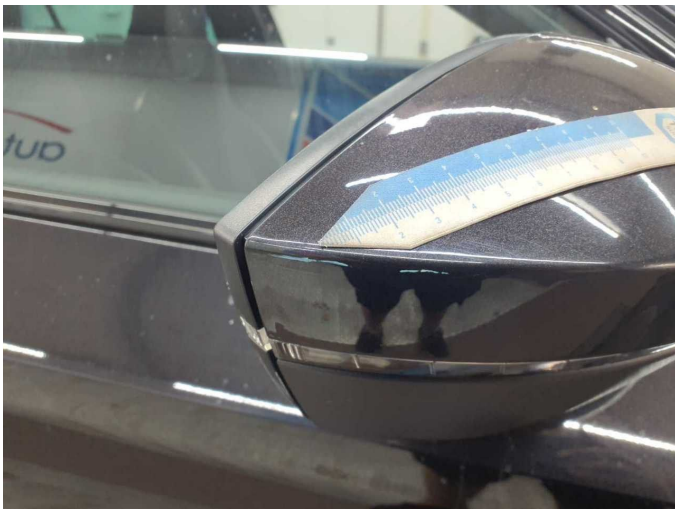
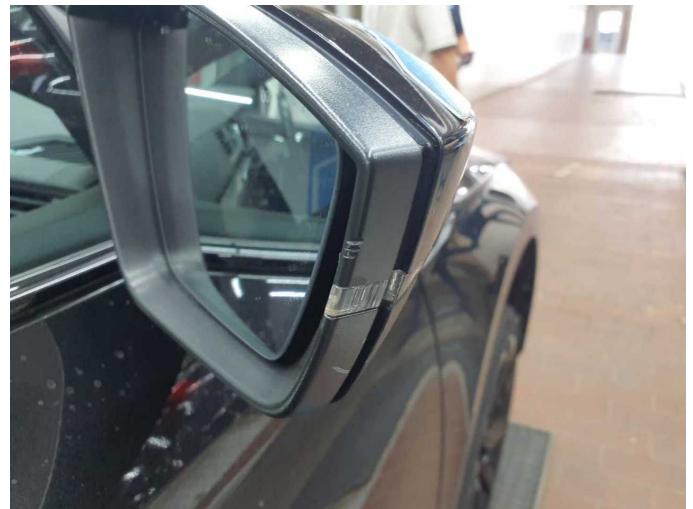
| No. | Component group | Description |
|---|---|---|
| 1 | Wing mirror - right side | Cap - Scratch(es) - Smart repair |

**Damage 1:** Wing mirror - right side: Cap - Scratch(es) - Smart repair

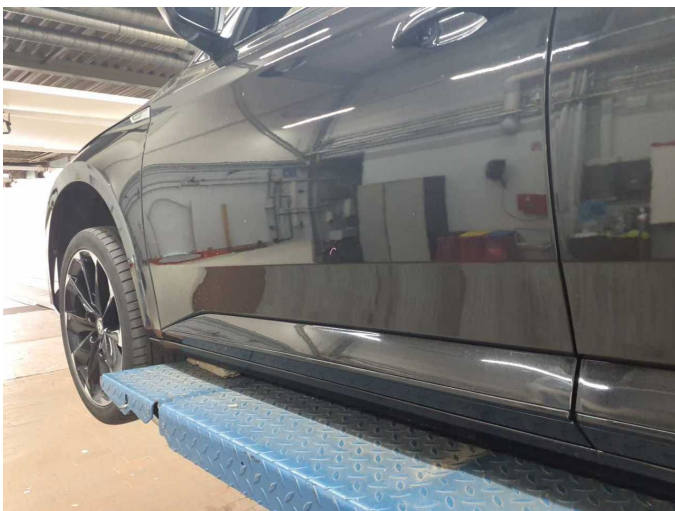
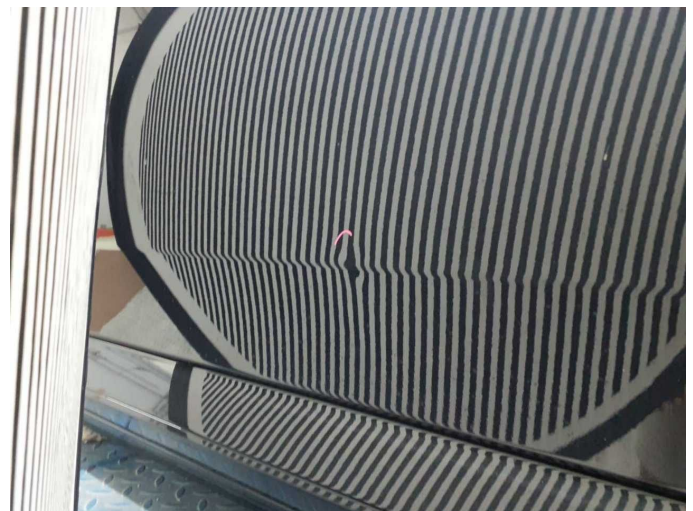
| No. | Component group | Description |
|---|---|---|
| 2 | Door - front left side | Door - Dent / paintcoat damage - Smart repair |

**Damage 2:** Door - front left side: Door - Dent / paintcoat damage - Smart repair

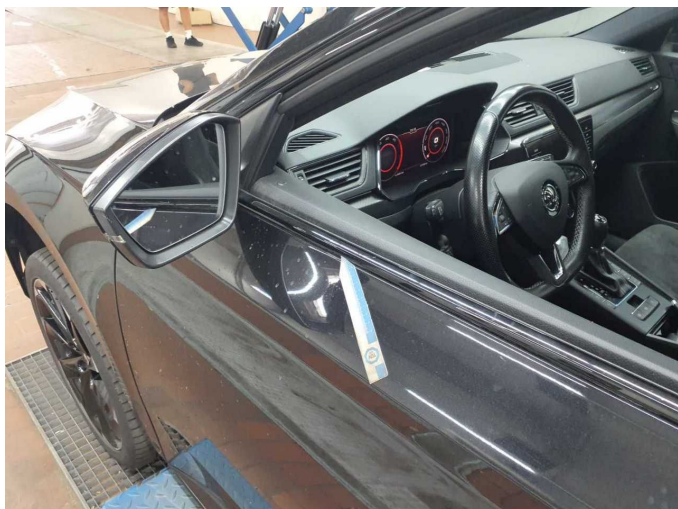
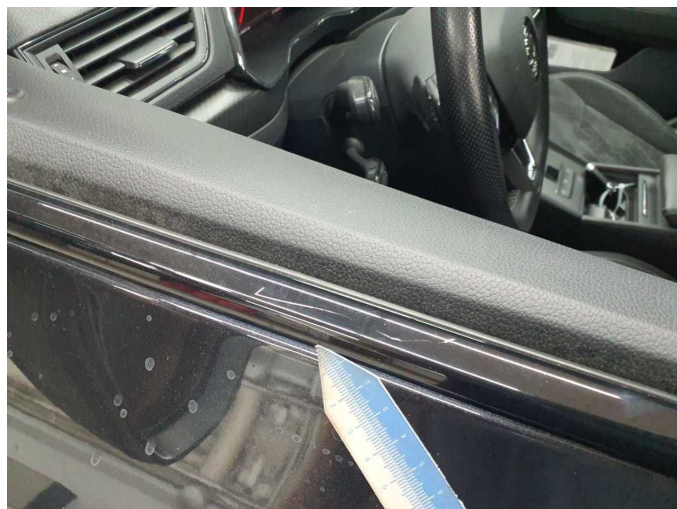
| No. | Component group | Description |
|---|---|---|
| 3 | Door - front left side | Brightware - upper - Scratched - Replace |

**Damage 3:** Door - front left side: Brightware - upper - Scratched - Replace

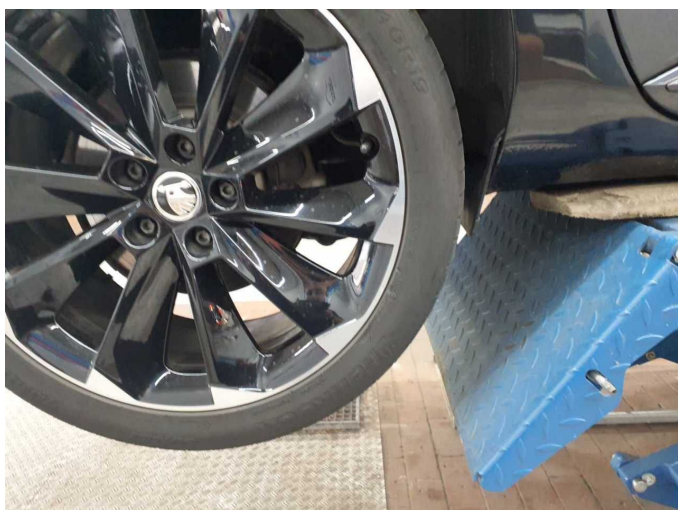
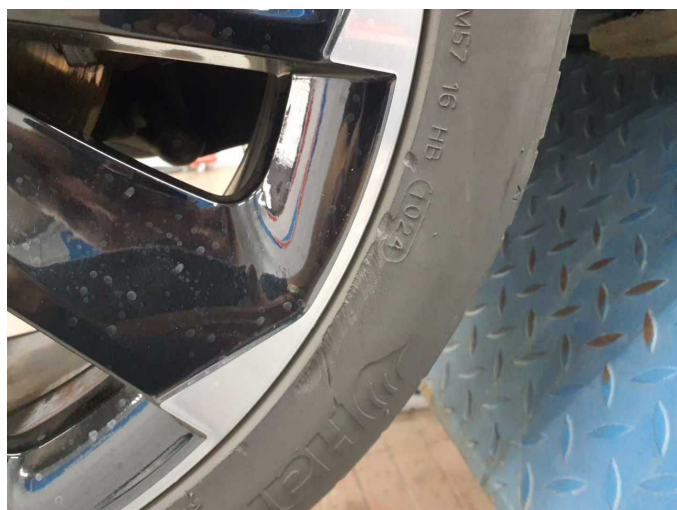
| No. | Component group | Description |
|---|---|---|
| 4 | Wheel / tyres | Tyre - rear right side (nicht fahrbereit) - Damaged - Replace |

**Damage 4:** Wheel / tyres: Tyre - rear right side (nicht fahrbereit) - Damaged - Replace

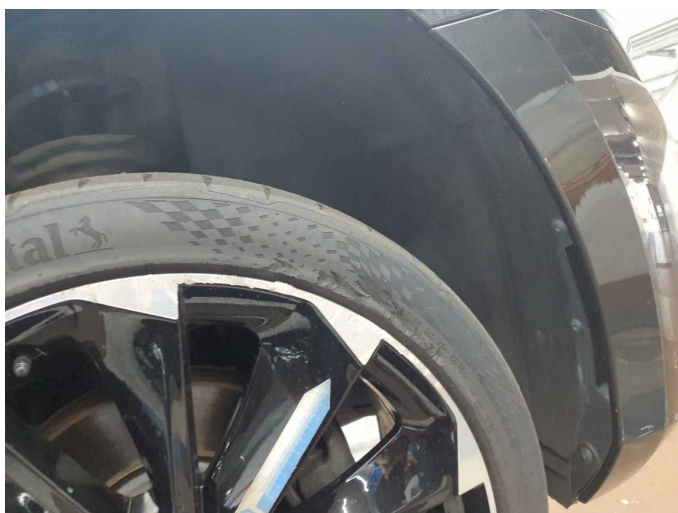
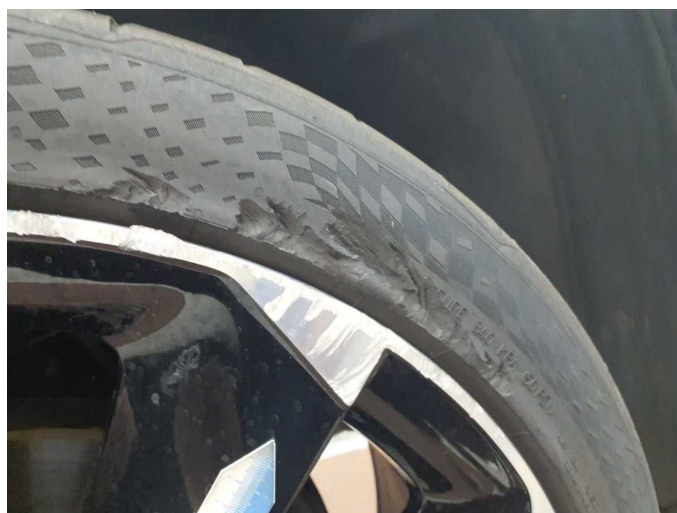
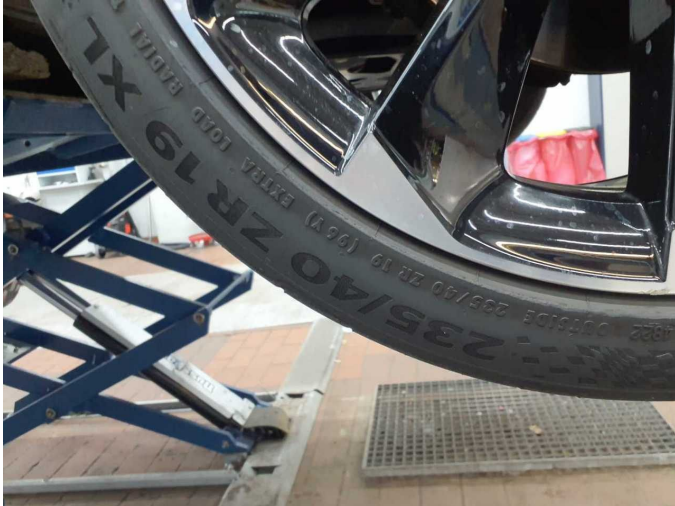
| No. | Component group | Description |
|---|---|---|
| 5 | Wheel / tyres | Tyre - front right side (nicht fahrbereit) - Damaged - Replace |

**Damage 5:** Wheel / tyres: Tyre - front right side (nicht fahrbereit) - Damaged - Replace

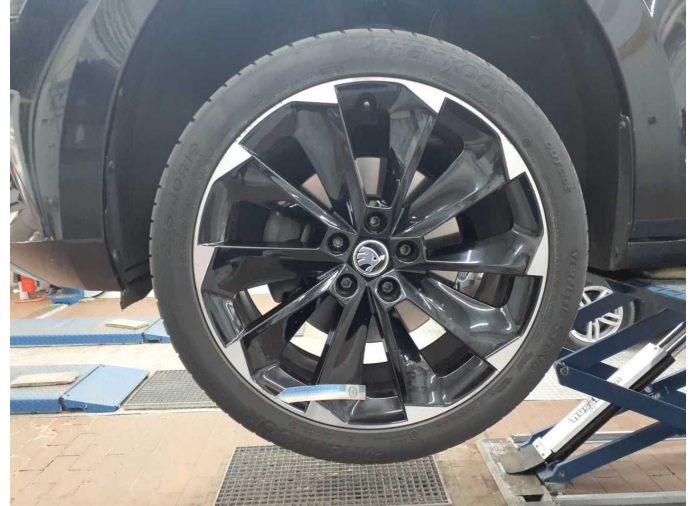
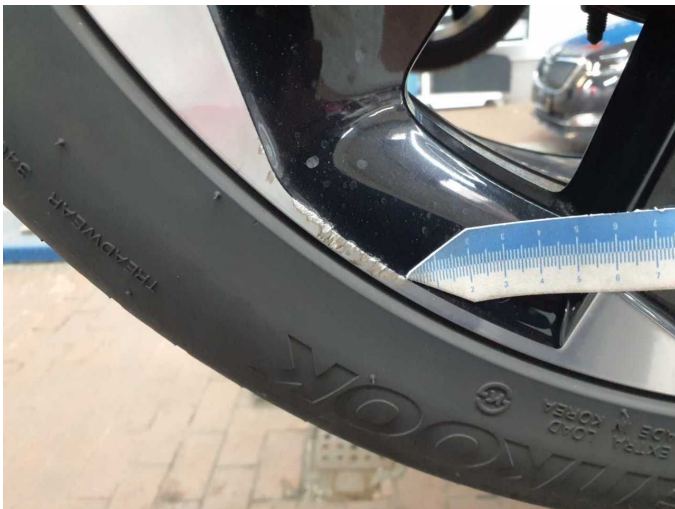
| No. | Component group | Description |
|---|---|---|
| 6 | Wheel / tyres | Alloy rim - front left side (Materialabtrag) - Scratch(es) - Replace |

**Damage 6:** Wheel / tyres: Alloy rim - front left side (Materialabtrag) - Scratch(es) - Replace

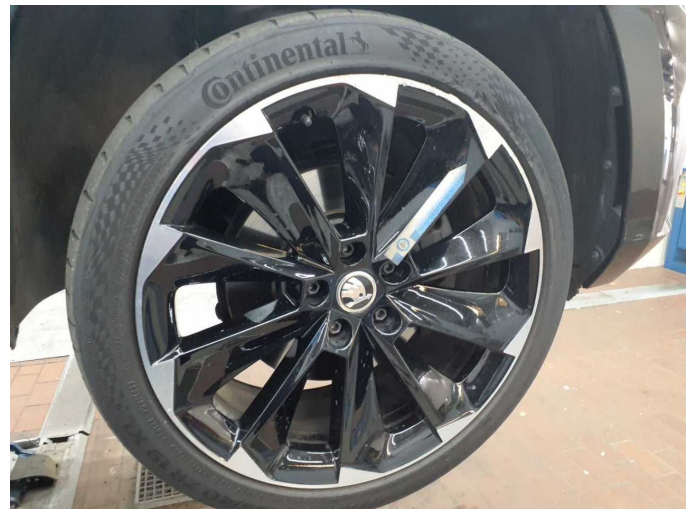
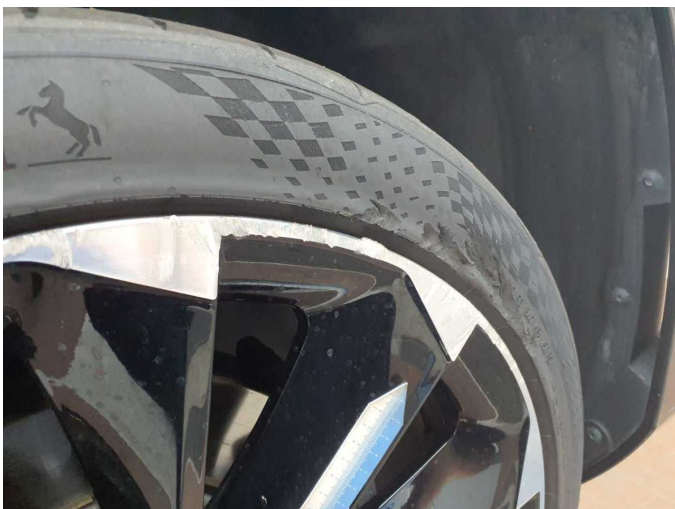
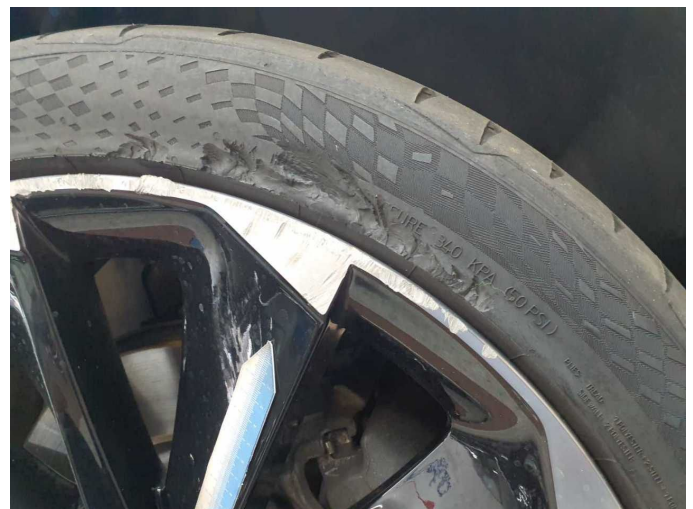
| No. | Component group | Description |
|---|---|---|
| 7 | Wheel / tyres | Alloy rim - front right side (Materialabtrag) - Scratch(es) - Replace |

**Damage 7:** Wheel / tyres: Alloy rim - front right side (Materialabtrag) - Scratch(es) - Replace

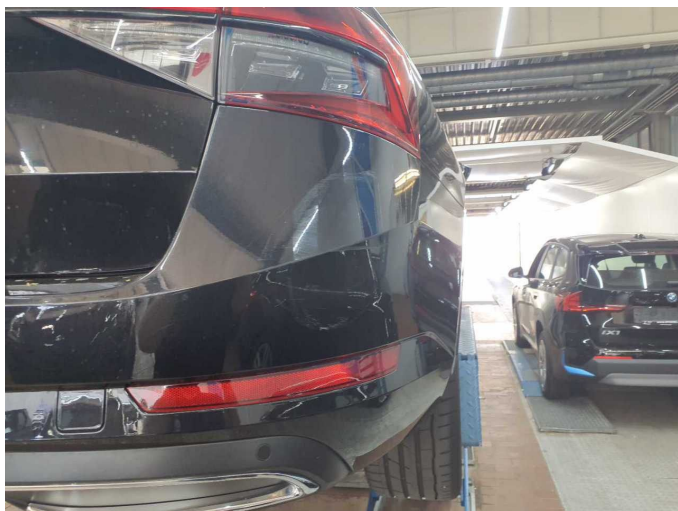
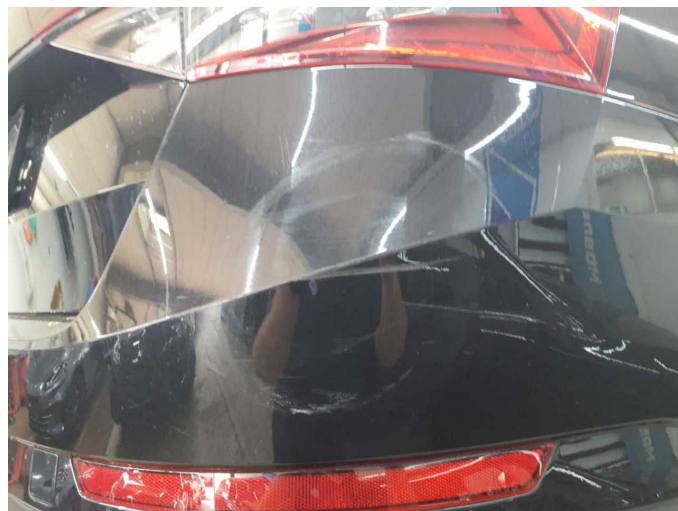
| No. | Component group | Description |
|---|---|---|
| 8 | Rear bumper | Rear bumper - Scratch(es) - Paint |

**Damage 8:** Rear bumper: Rear bumper - Scratch(es) - Paint

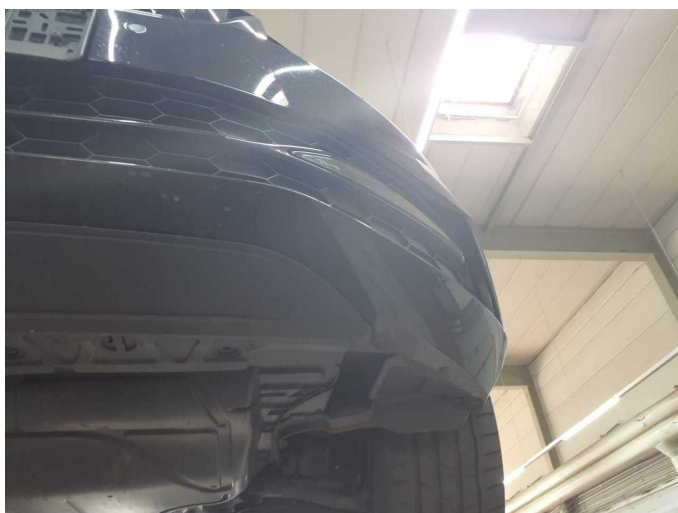
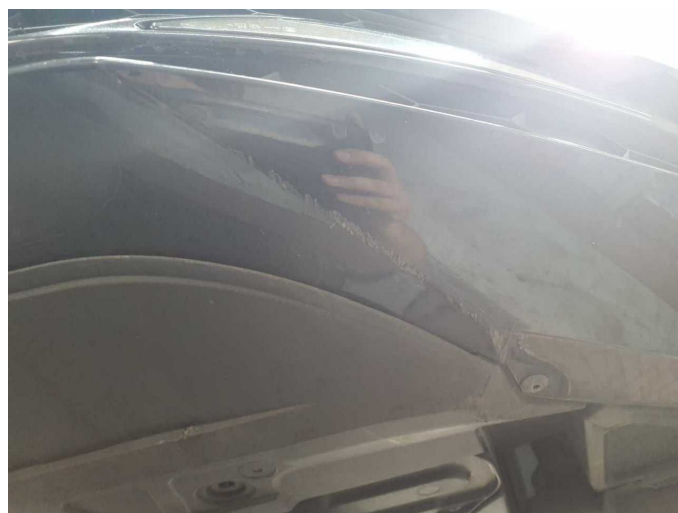
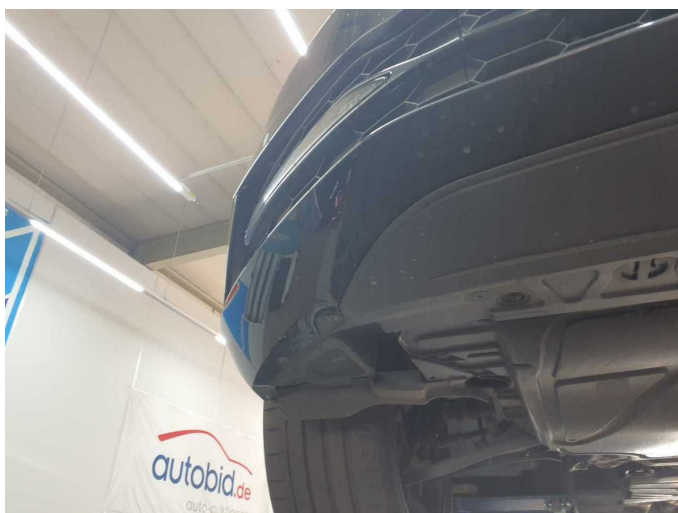
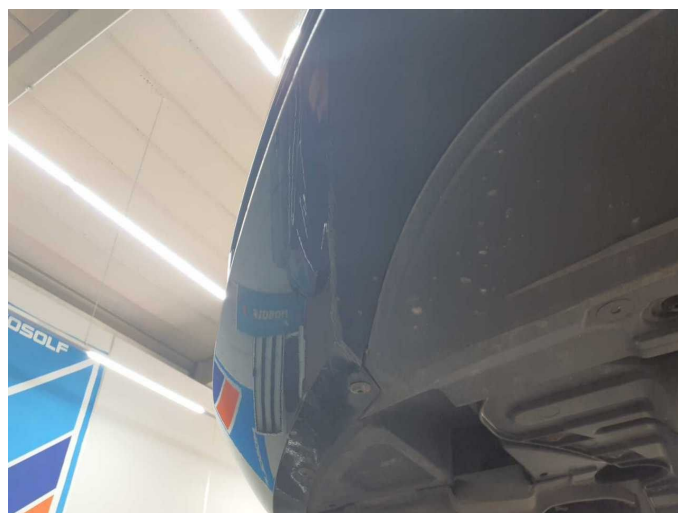
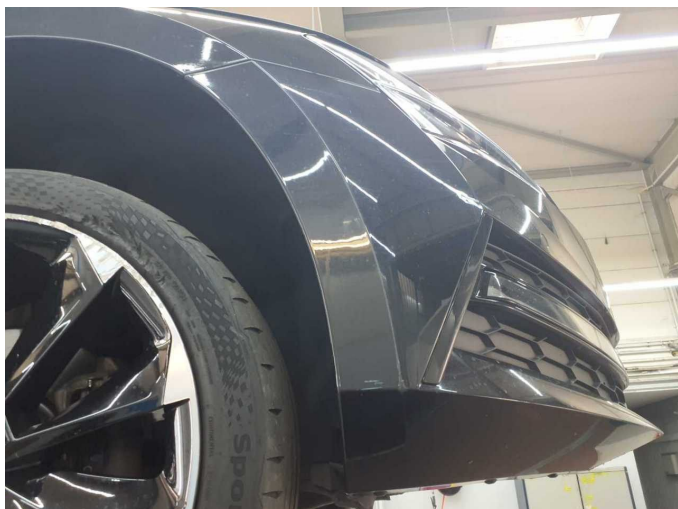
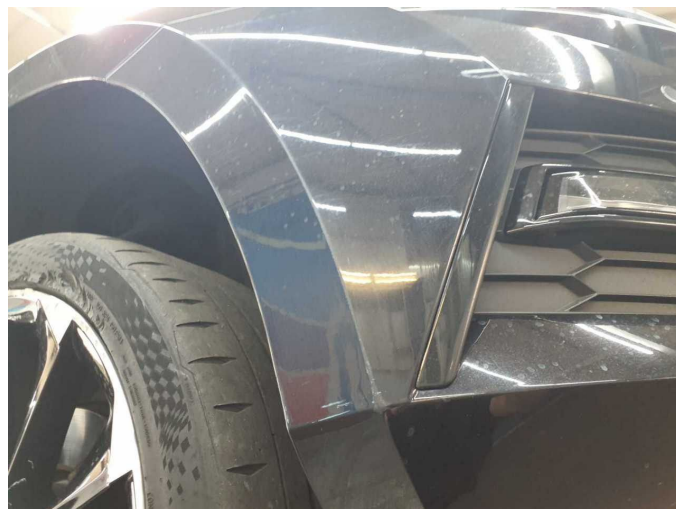
| No. | Component group | Description |
|---|---|---|
| 9 | Front bumper | Front bumper - Scratch(es) - Paint |

**Damage 9:** Front bumper: Front bumper - Scratch(es) - Paint

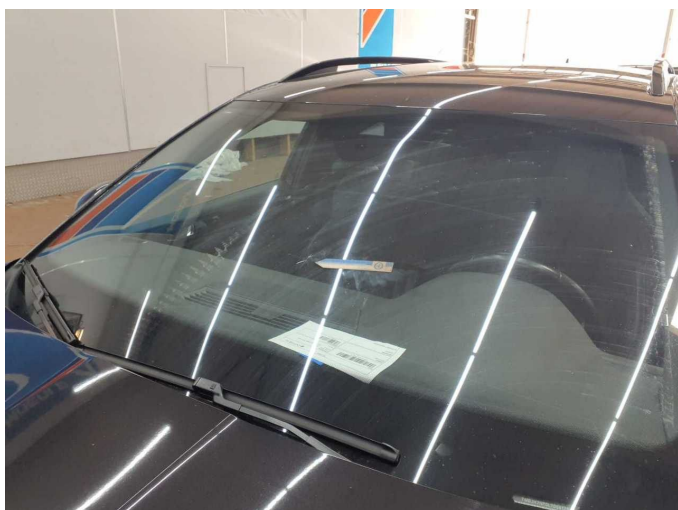
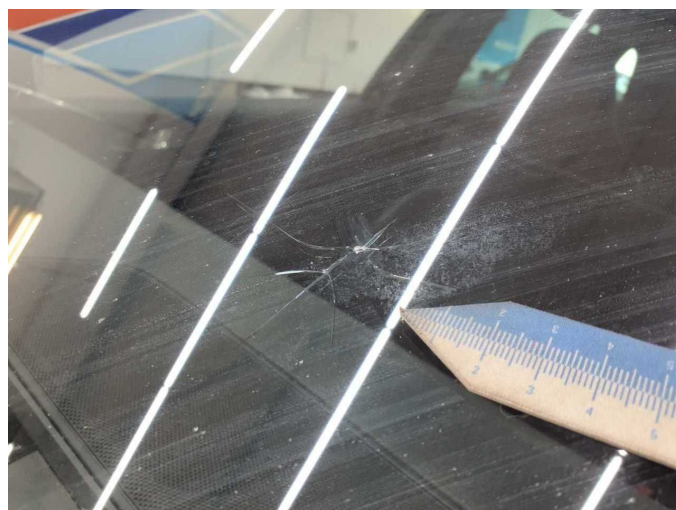
| No. | Component group | Description |
|---|---|---|
| 10 | Vehicle glazing | Windscreen - Stone chips - repair according to calculation |

**Damage 10:** Vehicle glazing: Windscreen - Stone chips - repair according to calculation

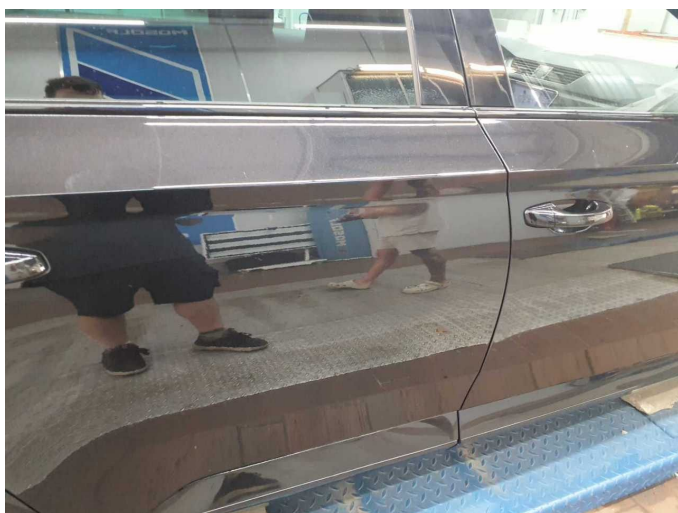
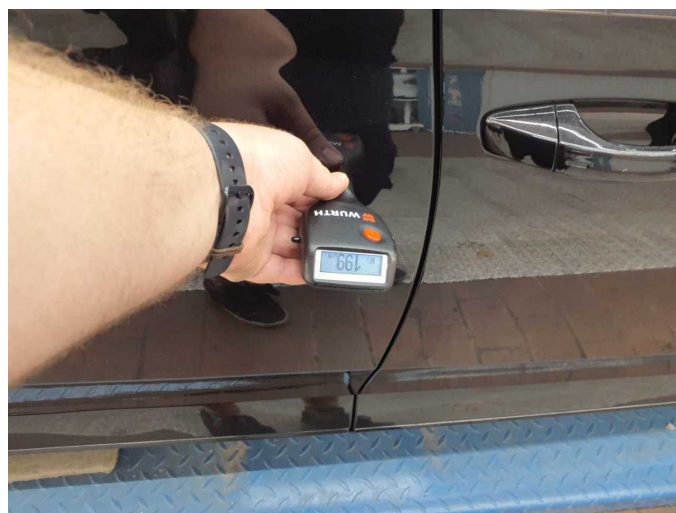
| No. | Previous damage | Extent of damage (Net) |
|---|---|---|
| 1 | Side right, Provided by user / customer, from 13 Dec 2021 | 1.848,27 € |

**Previous damage 1:** Side right

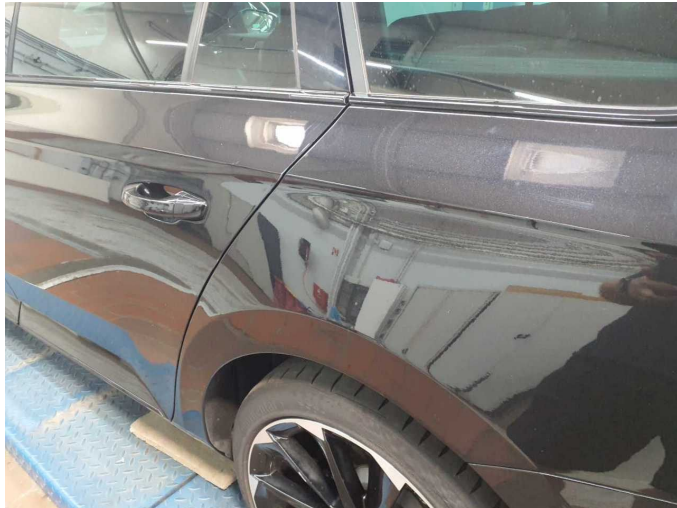
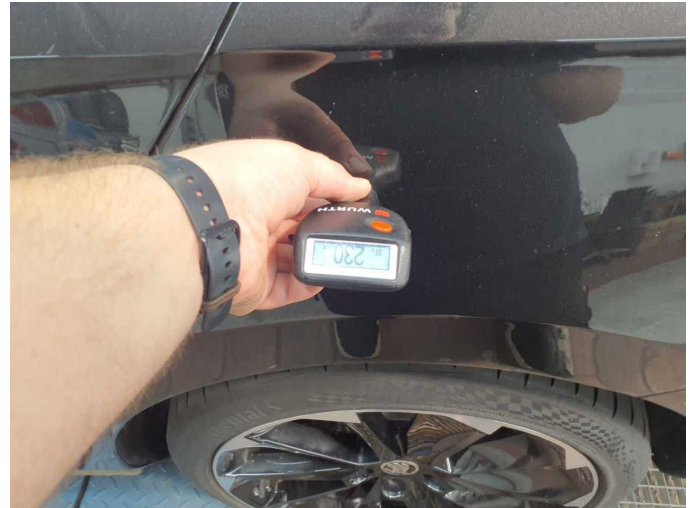
| No. | Repainting |
|---|---|
| 1 | Side panel - rear left side, Professionally carried out |

**Repainting 1:** Side panel - rear left side

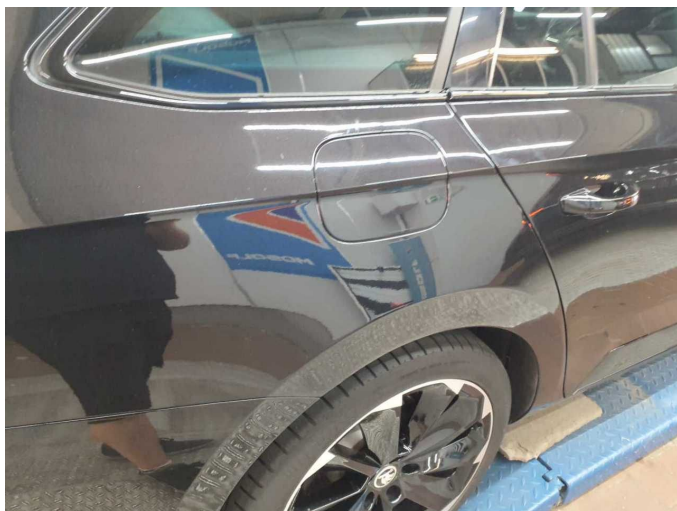
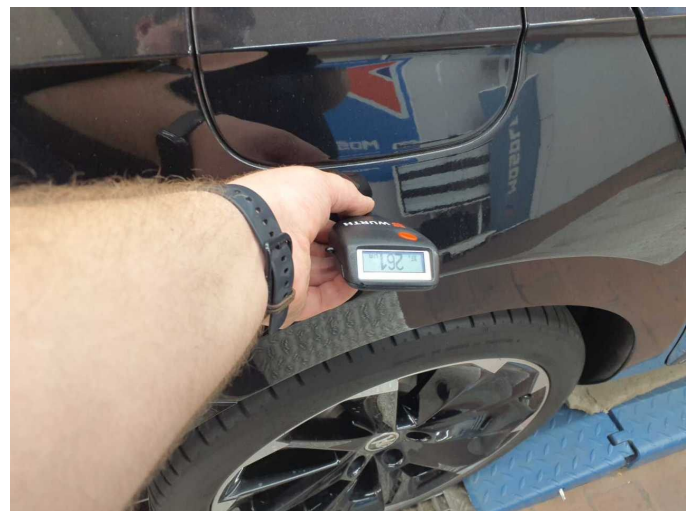
| No. | Repainting |
|---|---|
| 2 | Side panel - rear right side |

**Repainting 2:** Side panel - rear right side
