Expertise

Protocol number: 46307265
Order No. / Reference: 26472638
Inspection date: 23 Jun 2026

Model: XC60 T6 AWD Recharge Geartronic Inscription Expression

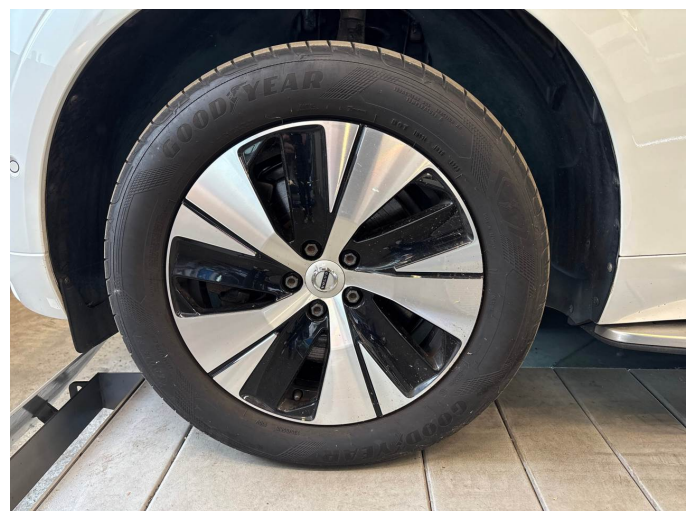
Figure 12: Mounted tyres

Mounted tyres				
#	Tyre size	Type of tyre	Manufacturer	Tread depth
1)	235/55 R18 100V	Summer tyres on Light alloy	Goodyear	4mm / 4mm
2)	235/55 R18 100V	Summer tyres on Light alloy	Goodyear	4mm / 4mm
Additional tyres				
#	Tyre size	Type of tyre	Manufacturer	Tread depth
1)	235/60 R18 107H	Winter tyres on Light alloy	Pirelli	5mm / 5mm
2)	235/60 R18 107H	Winter tyres on Light alloy	Pirelli	6mm / 6mm
Replacement				
Typ	Tyre size	Type of tyre	Manufacturer	Tread depth
	Tirefit	Expiration date 06/2029

Der montierte Radsatz ist nicht Bestandteil der Ausstattung.

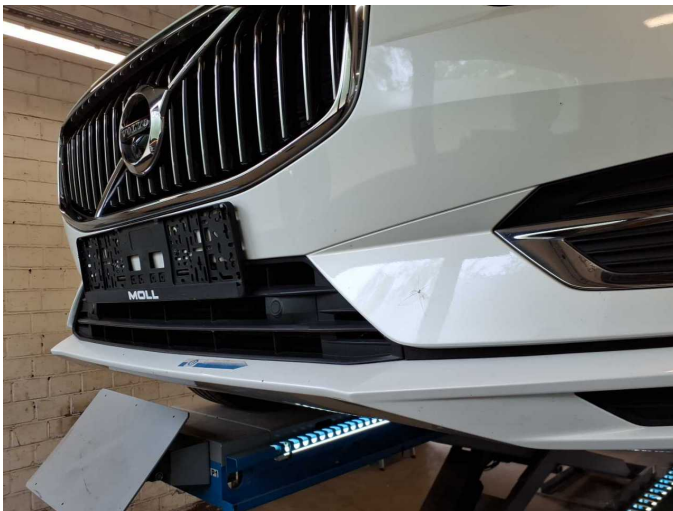
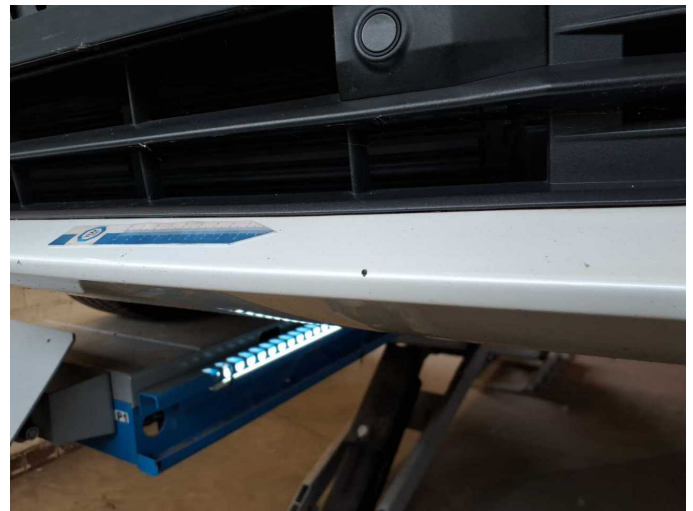
Damage 1: Front bumper: Front bumper - Scratch(es) - Smart repair

No.	Component group	Description
1	Front bumper	Front bumper - Scratch(es) - Smart repair
2	Rear bumper	Rear bumper - Scratch(es) - Smart repair
3	Wheel / tyres	Wheelset - complete (19 Zoll Radsatz fehlt) - Differs from the original configuration - repair according to calculation

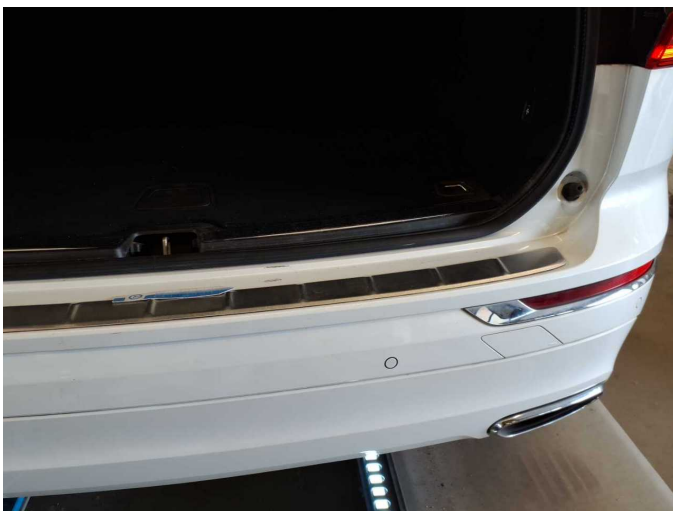
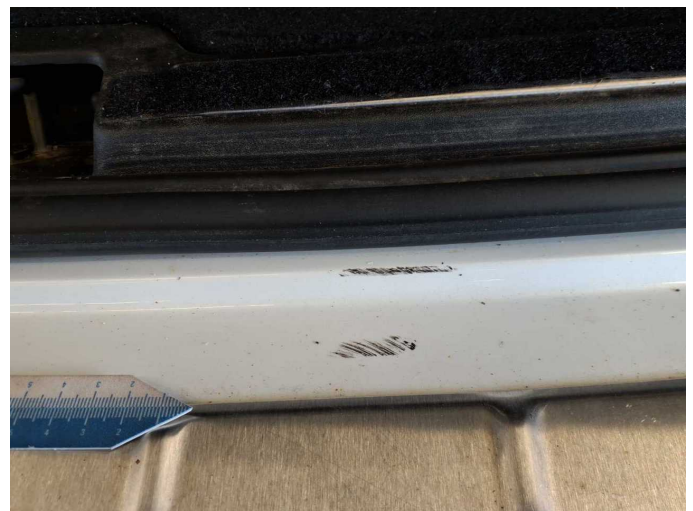
Damage 2: Rear bumper: Rear bumper - Scratch(es) - Smart repair

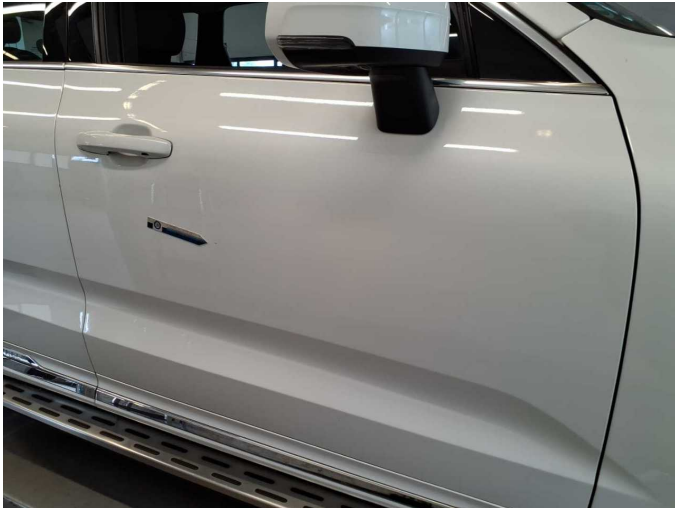
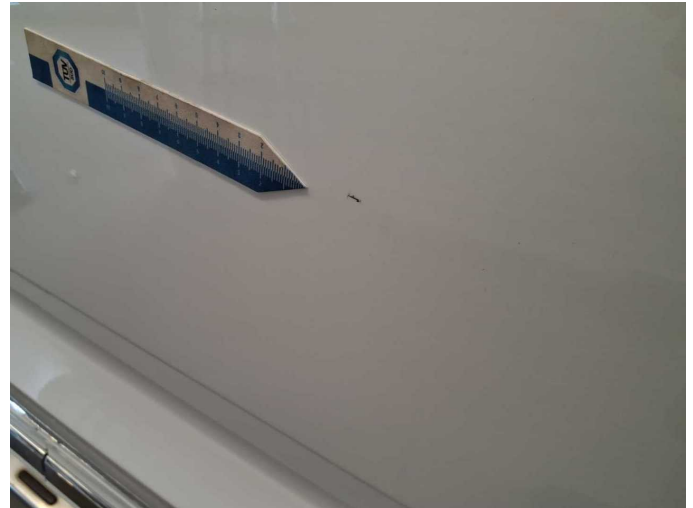
Wear and tear 1: Door - front right side: Door - Scratch(es) - No deduction

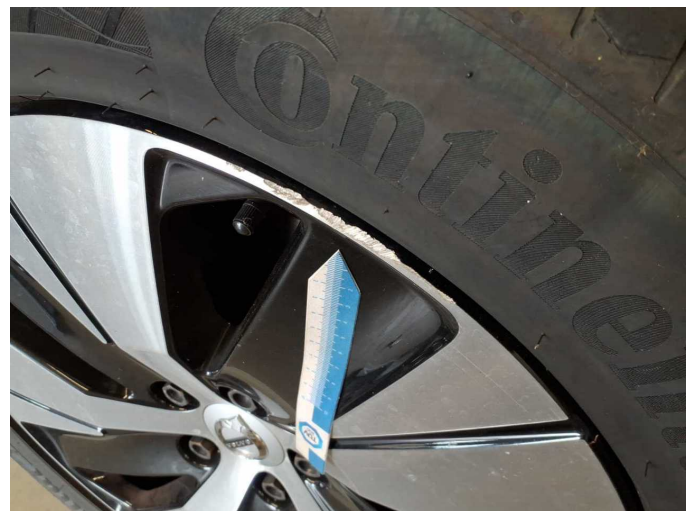
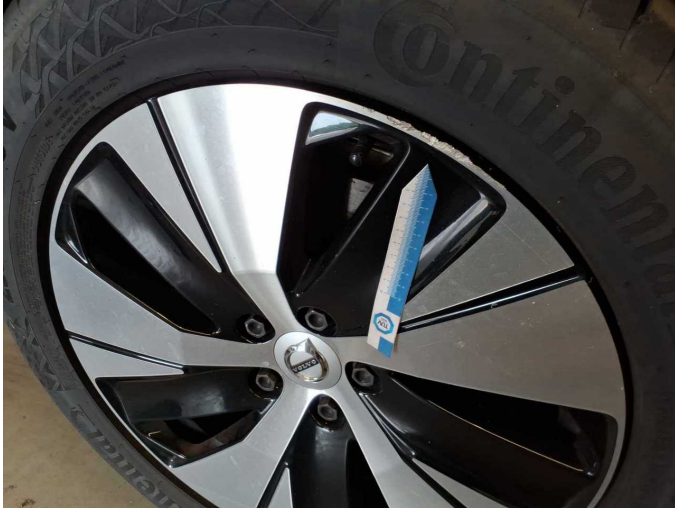
Wear and tear 3: Wheel / tyres: Alloy rim - rear right side (Materiaabtrag) - Scratched - No deduction

Wear and tear 3: Wheel / tyres: Alloy rim - rear right side (Materiaabtrag)
 - Scratched - No deduction

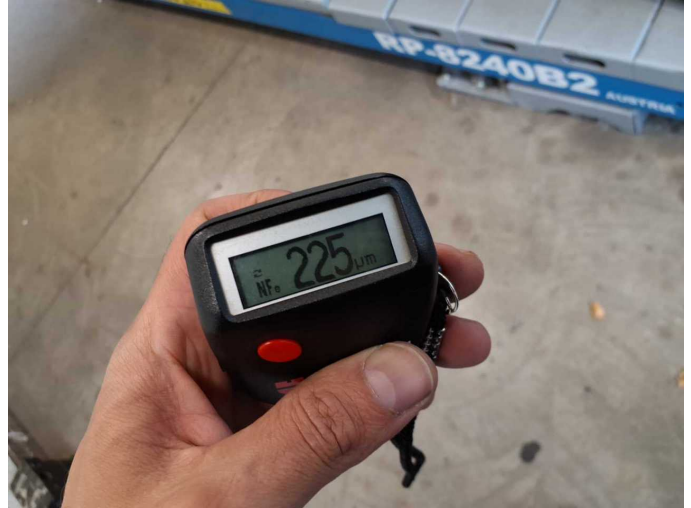
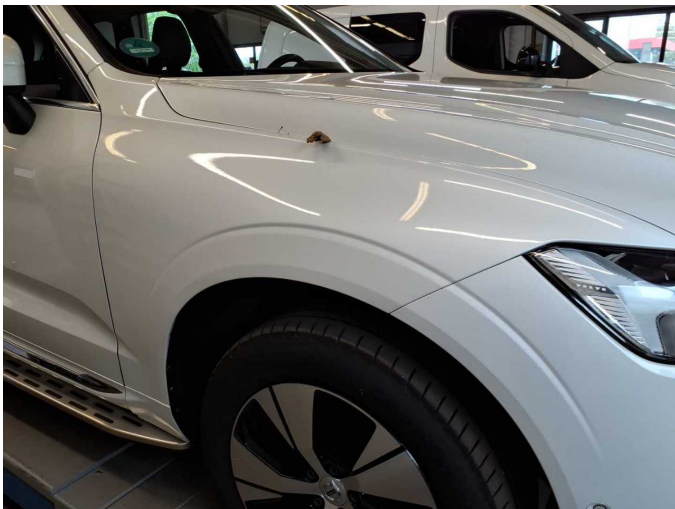
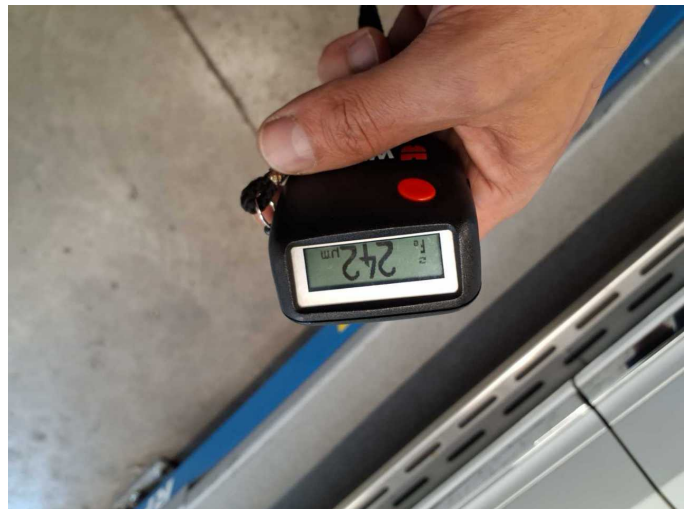
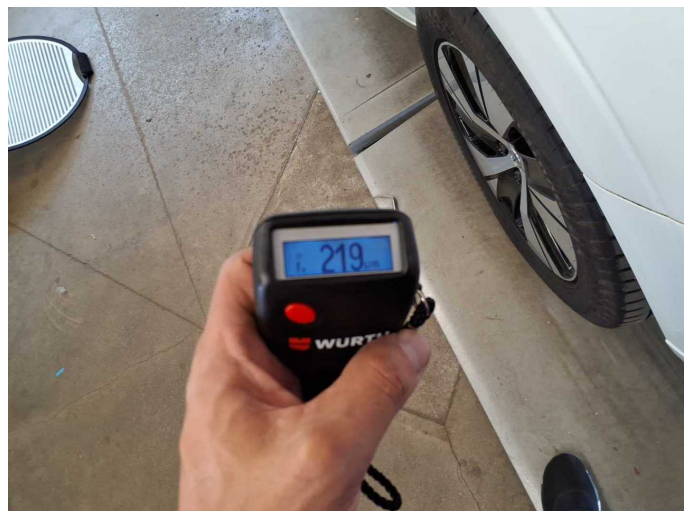
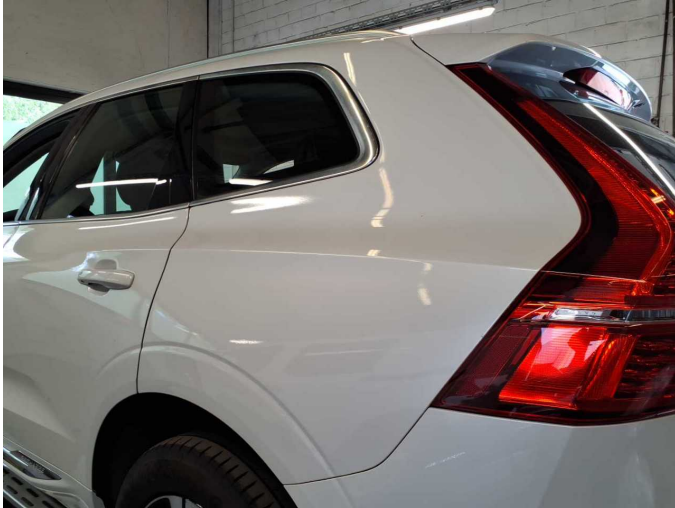
- 1 Mudguard - left side, Mudguard - right side, Side panel - rear left side, Door - rear left side, Door - front left side, Door - front right side, Professionally carried out, Invoice of repair done Non-existent

Mudguard - left side	188 µm	Mudguard - right side	225 µm
Side panel - rear left side	219 µm	Door - rear left side	306 µm
Door - front left side	167 µm	Door - front right side	242 µm

Repainting 1: Mudguard - left side, Mudguard - right side, Side panel - rear left side, Door - rear left side, Door - front left side, Door - front right side

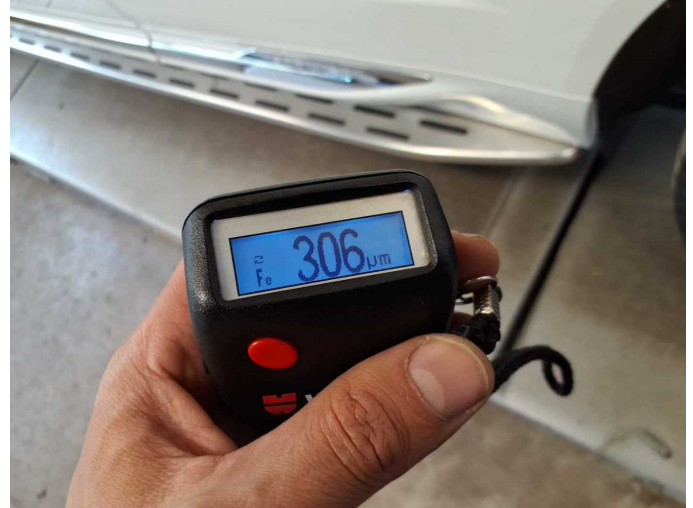
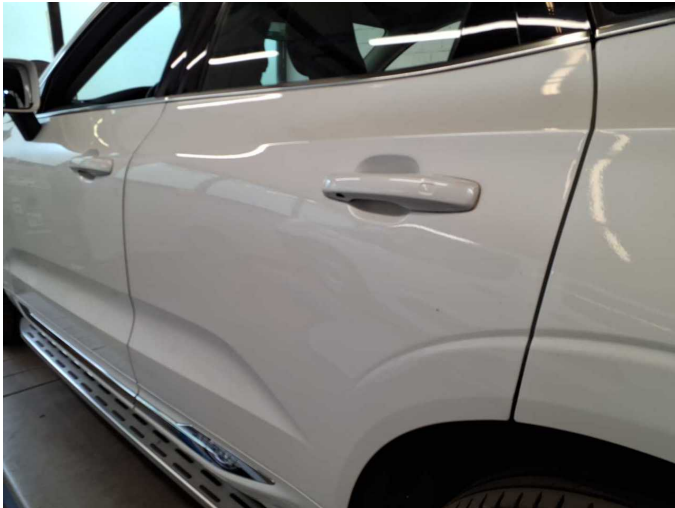
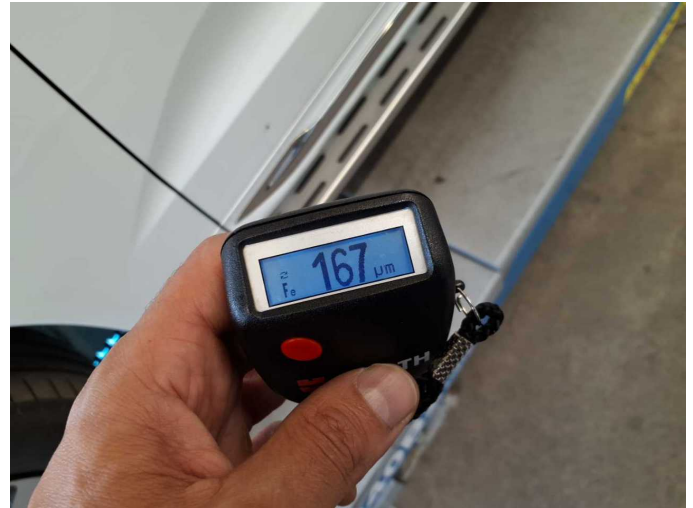
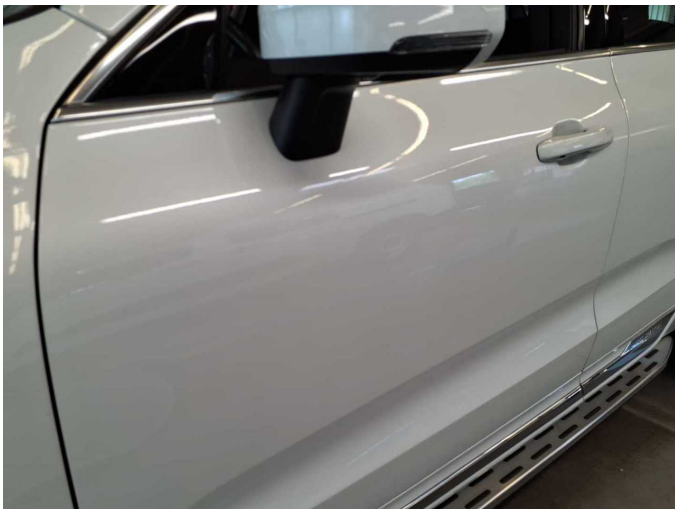
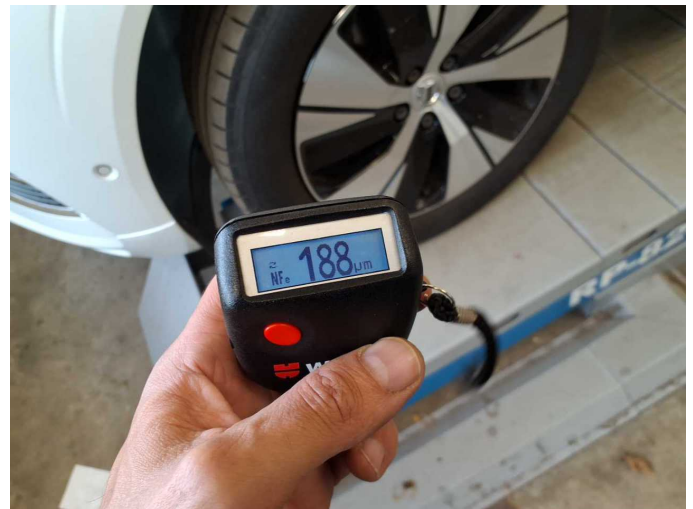
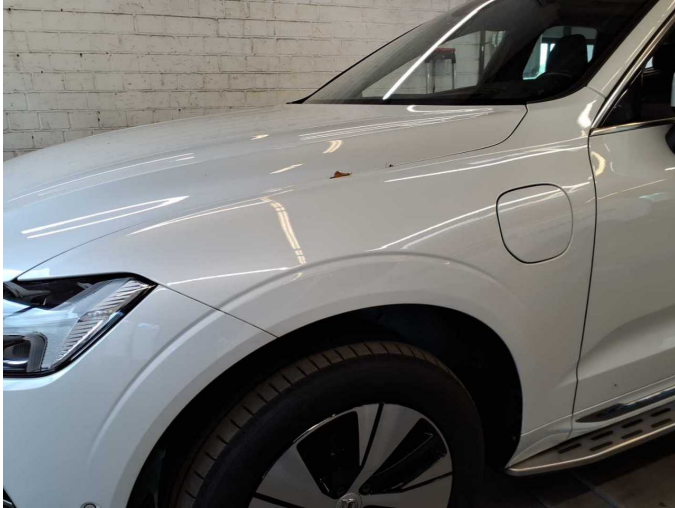
Repainting 1: Mudguard - left side, Mudguard - right side, Side panel - rear left side, Door - rear left side, Door - front left side, Door - front right side
