Expertise

Protocol number: 46606511  
Order No. / Reference: 26703169  
Inspection date: 20 Jul 2026

Manufacturer: Mercedes-Benz

Model: GLC 300 de 4Matic 9G-TRONIC AMG Line

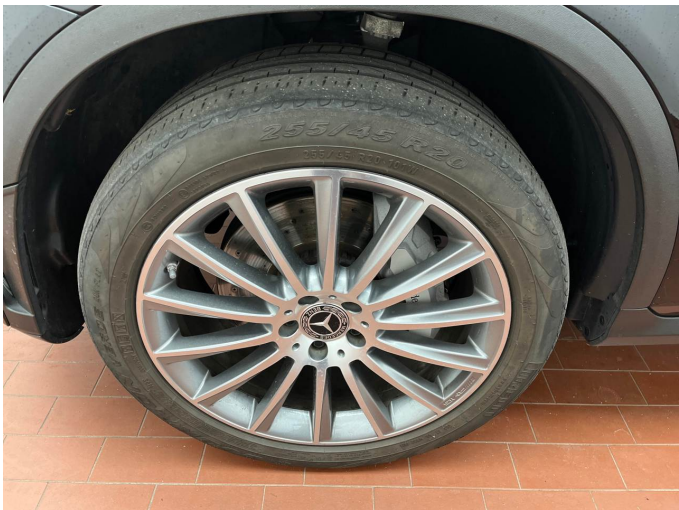
| # | Tyre size | Type of tyre | Manufacturer | Tread depth |
|---|---|---|---|---|
| 1) | 255/45 R20 101W | Summer tires (with run-flat tires) on Light alloy | Pirelli | 0mm / 0mm |
| 2) | 255/45 R20 101W | Summer tires (with run-flat tires) on Light alloy | Pirelli | 4mm / 4mm |

Figure 12: Mounted tyres

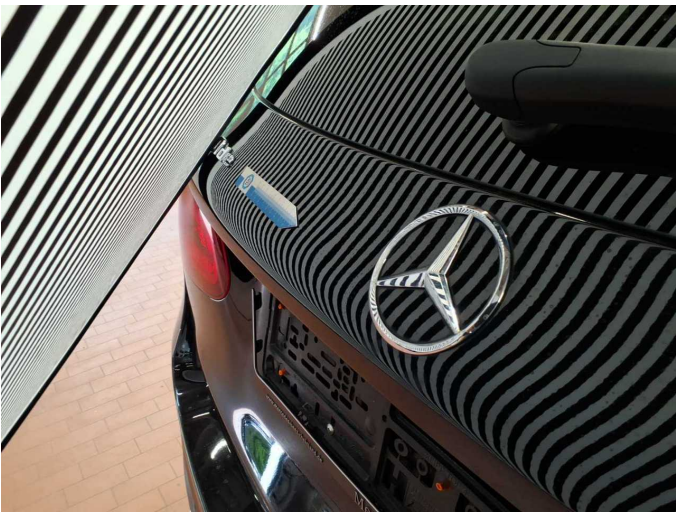
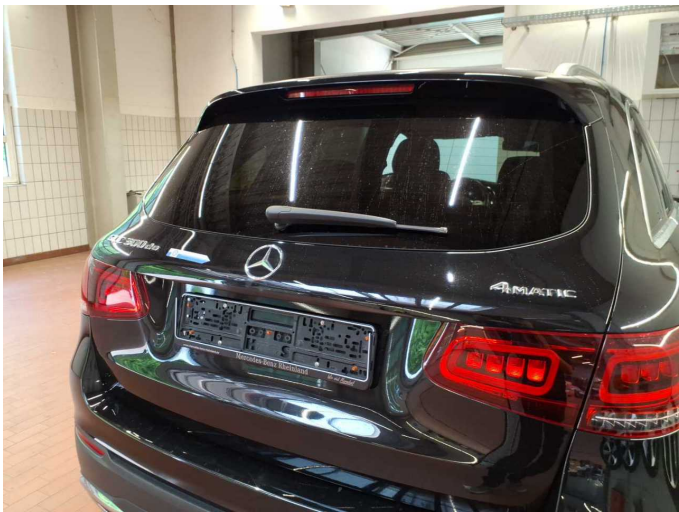
| No. | Component group | Description |
|---|---|---|
| 1 | Boot lid / rear door | Boot lid - dent(s) - Smooth repair work |

Damage 1: Boot lid / rear door: Boot lid - dent(s) - Smooth repair work

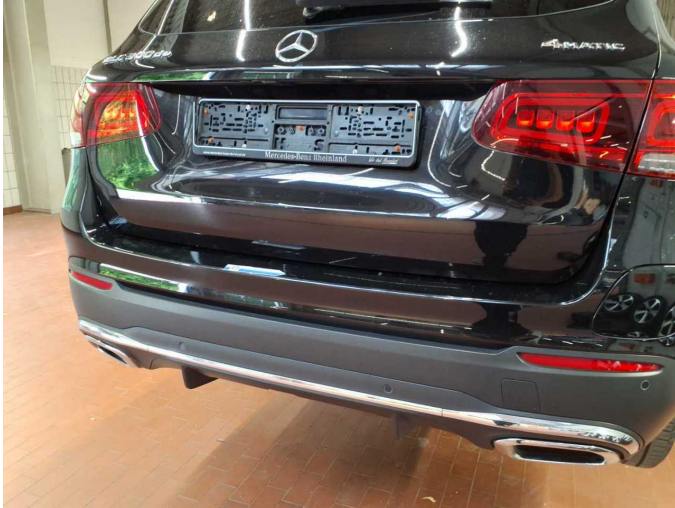
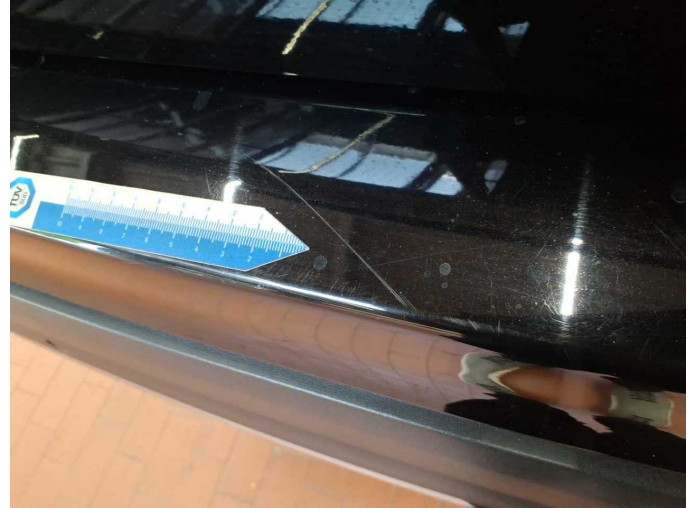
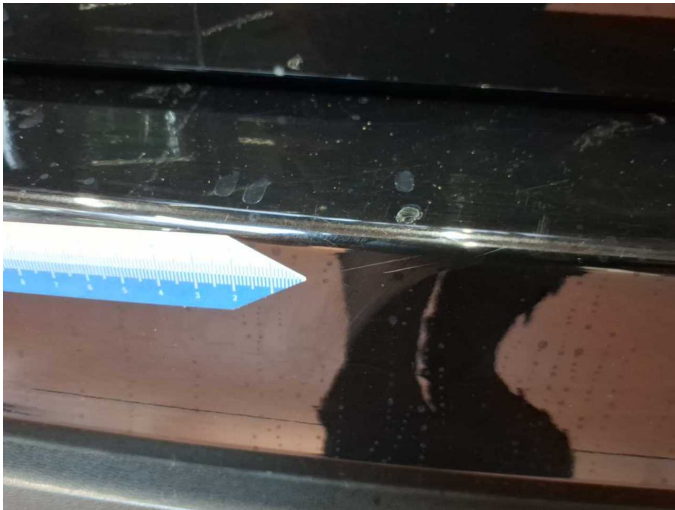
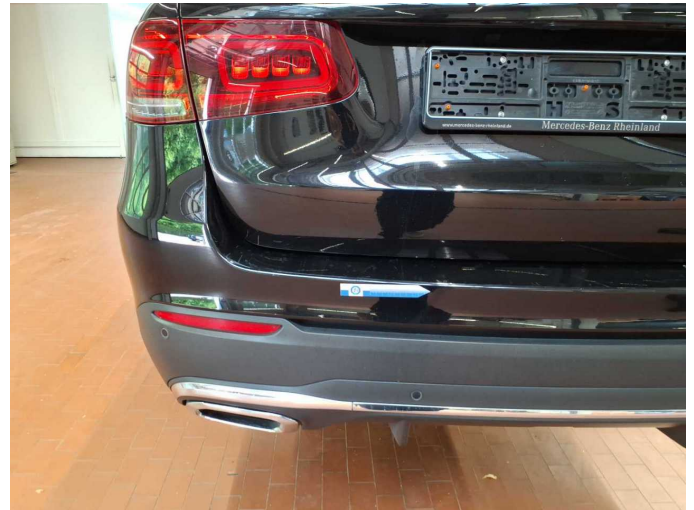
| No. | Component group | Description |
|---|---|---|
| 2 | Rear bumper | Rear bumper - Scratch(es) - Smart repair |

**Damage 2:** Rear bumper: Rear bumper - Scratch(es) - Smart repair

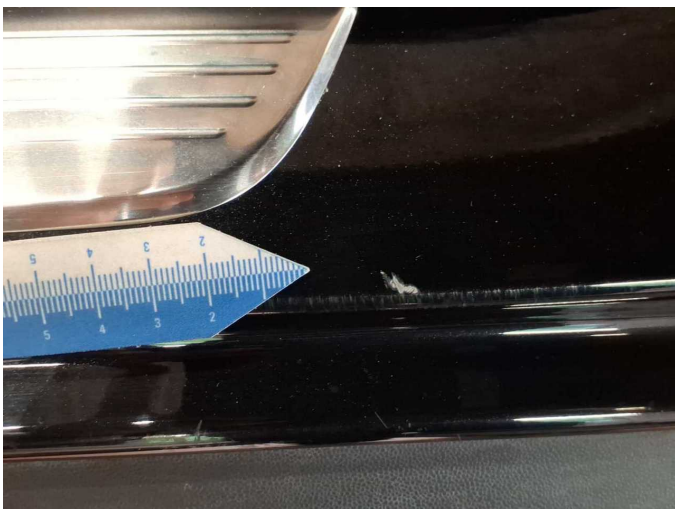
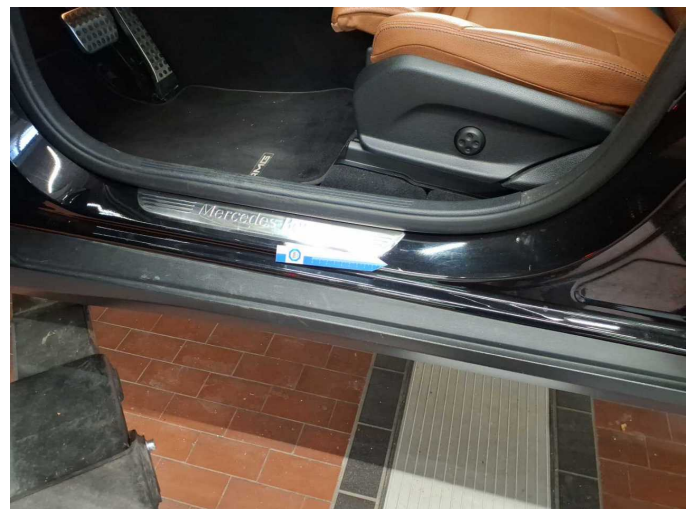
| No. | Component group | Description |
|---|---|---|
| 3 | Sill - left side | Sill - Scratch(es) - Smart repair |

**Damage 3:** Sill - left side: Sill - Scratch(es) - Smart repair

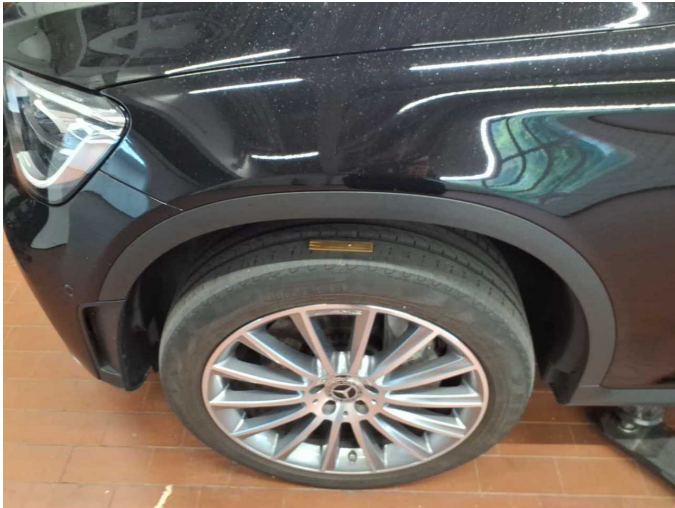
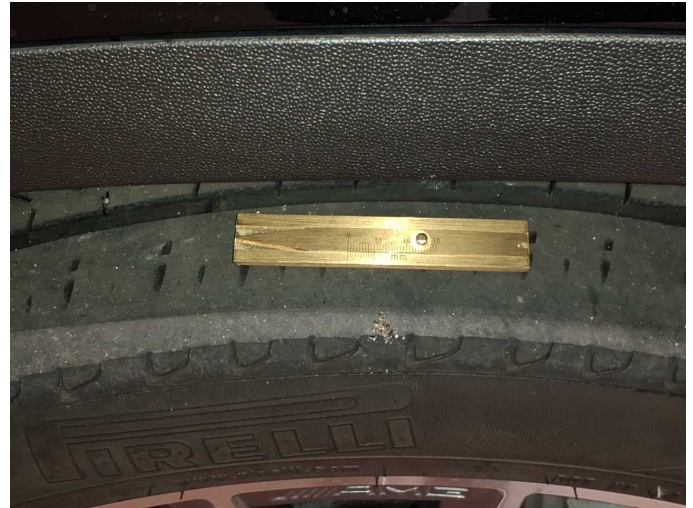
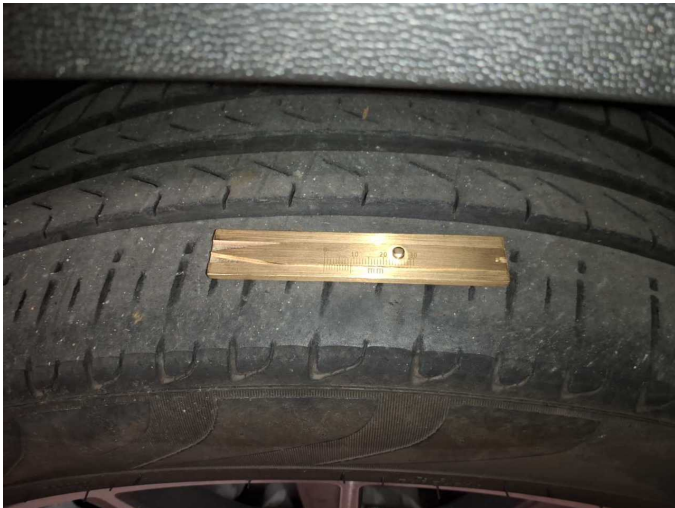
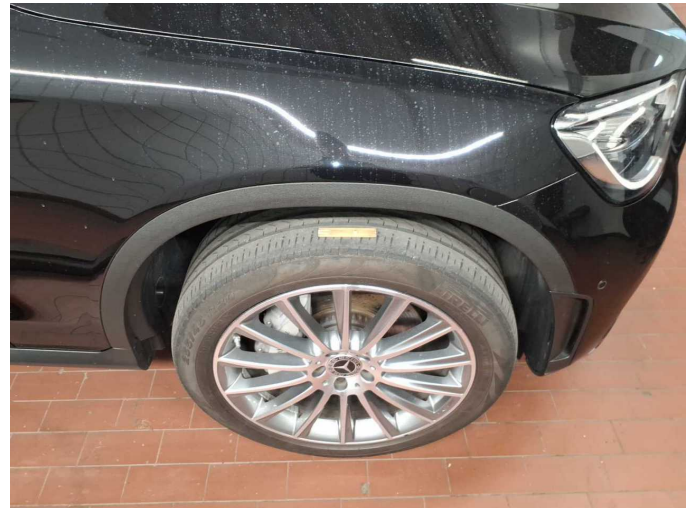
| No. | Component group | Description |
|---|---|---|
| 5 | Wheel / tyres | Tyre - front (Einseitig abgefahren) - Worn - Replace |

**Damage 5:** Wheel / tyres: Tyre - front (Einseitig abgefahren) - Worn - Replace

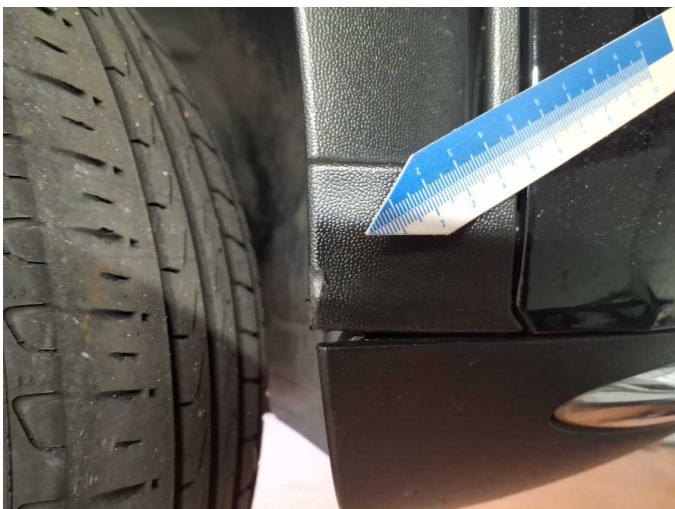
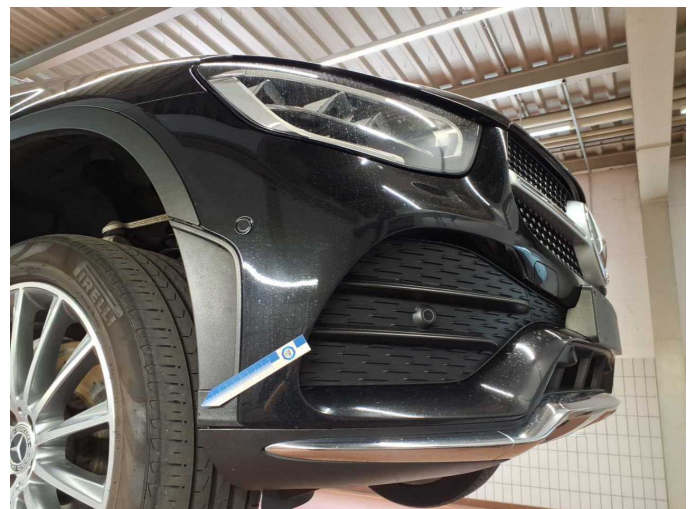
| No. | Component group | Description |
|---|---|---|
| 1 | Front bumper | Cover bumper - front - Scratch(es) - No deduction |

**Wear and tear 1:** Front bumper: Cover bumper - front - Scratch(es) - No deduction

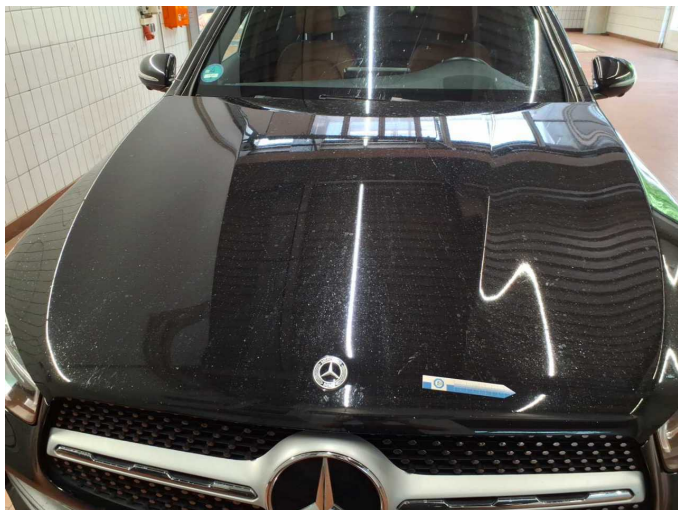
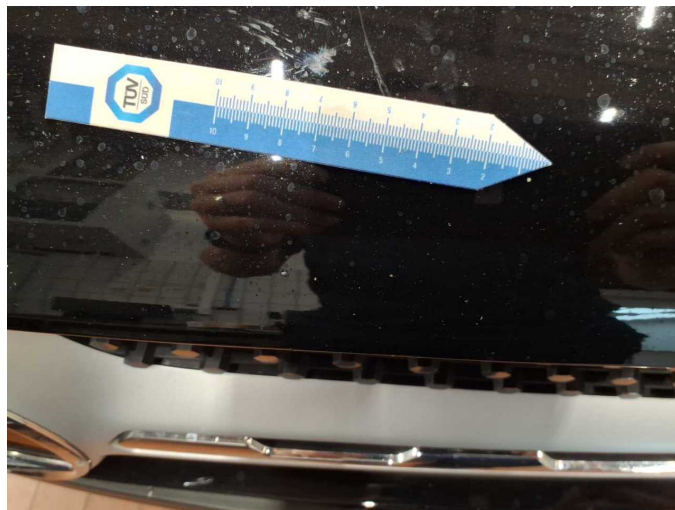
| No. | Component group | Description |
|---|---|---|
| 2 | Bonnet | Bonnet - Stone chips - No deduction |

**Wear and tear 2:** Bonnet: Bonnet - Stone chips - No deduction

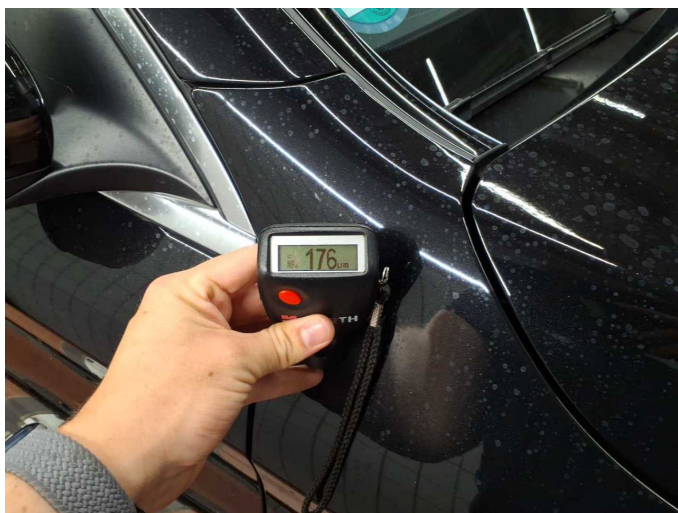
| No. | Repainting |
|---|---|
| 1 | Mudguard - right side, Professionally carried out, Invoice of repair done Non-existent |

| Mudguard - right side | 176 µm |

**Repainting 1:** Mudguard - right side
