Protocol number: 45574175
Order No. / Reference: 26364355
Inspection date: 15 May 2026

Manufacturer: Volvo

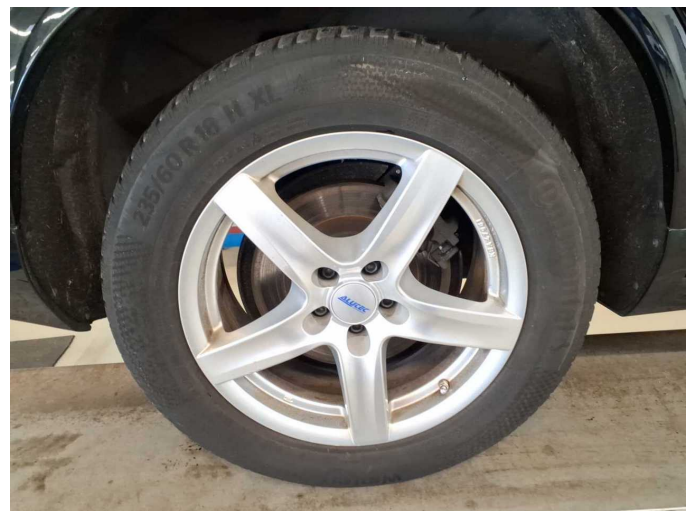
Damage 1: Wheel / tyres: Tyre - rear right side - Damaged - No deduction

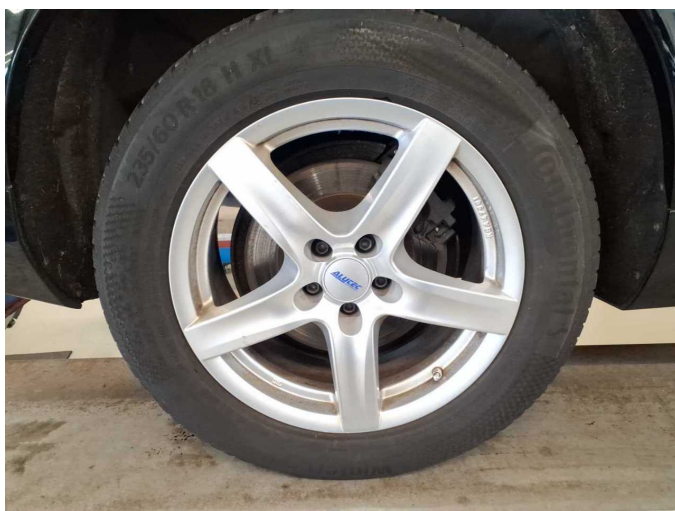
Damage 2: Wheel / tyres: Alloy rim - rear right side - Scratch(es) - No deduction

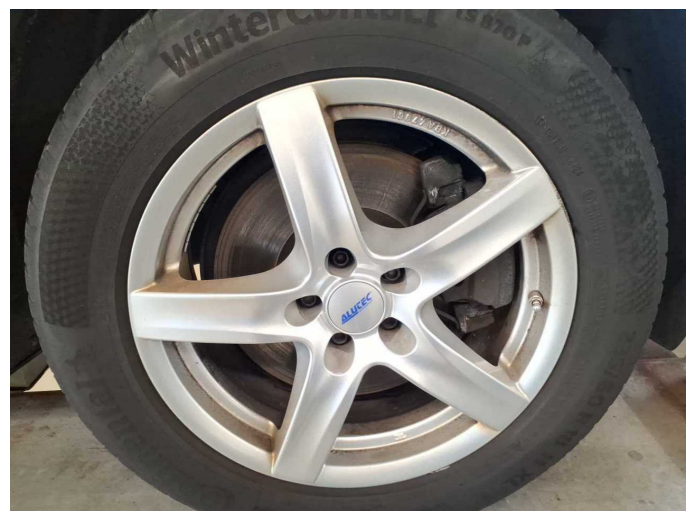
Damage 3: Wheel / tyres: Alloy rim - front right side - Scratch(es) - No deduction

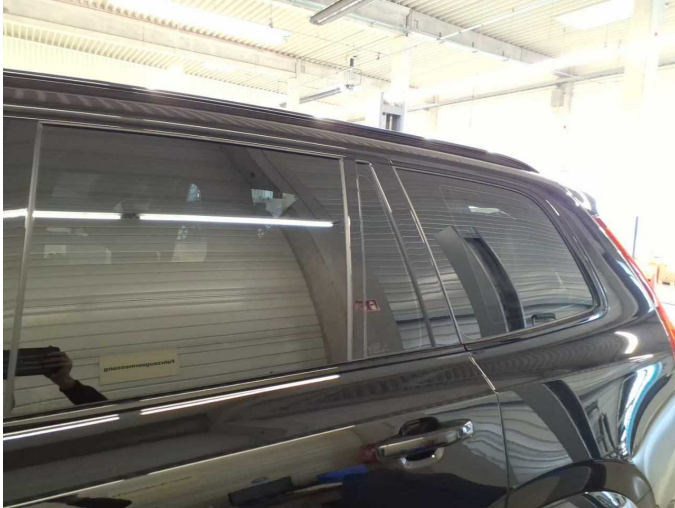
Damage 4: Misc.: Misc. (hintere Seitenscheiben foliert) - Differs from the original configuration - No deduction

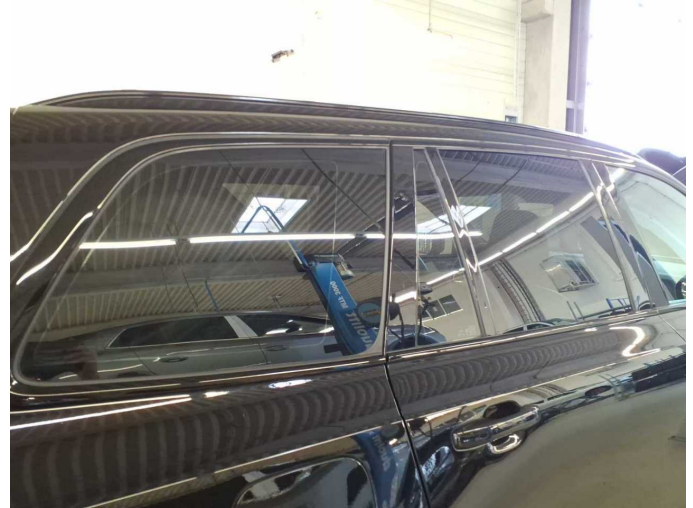
Damage 4: Misc.: Misc. (hintere Seitenscheiben foliert) - Differs from the original configuration - No deduction

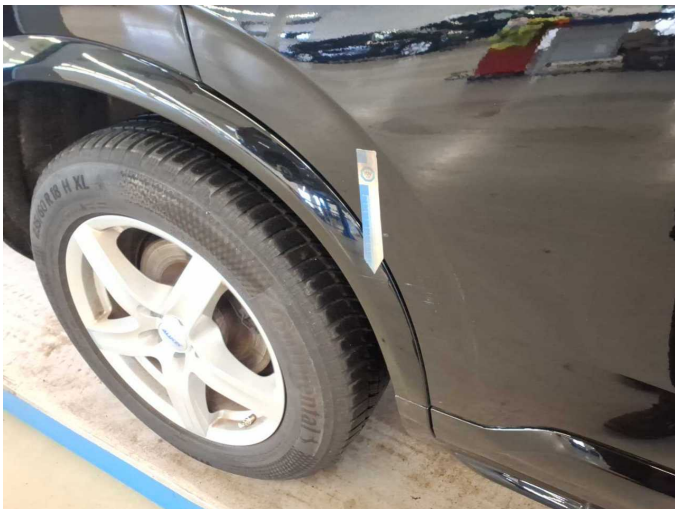
Damage 5: Side panel - rear right side: Wheel arch (Verkleidung) - Abrasion - Cover / polish

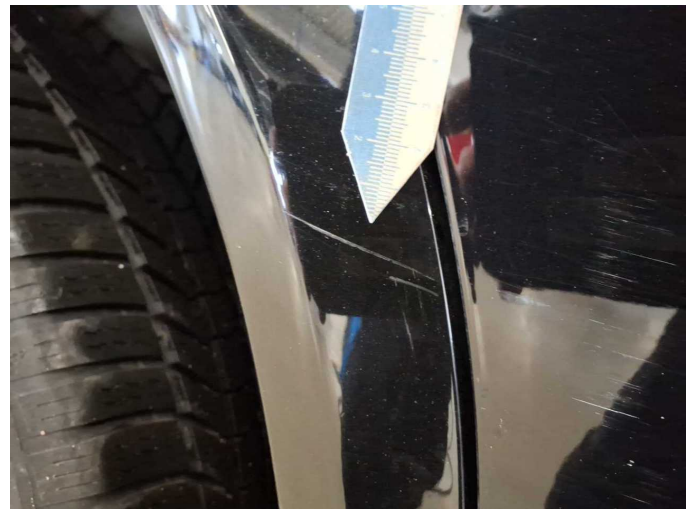
Damage 5: Side panel - rear right side: Wheel arch (Verkleidung) - Abrasion - Cover / polish

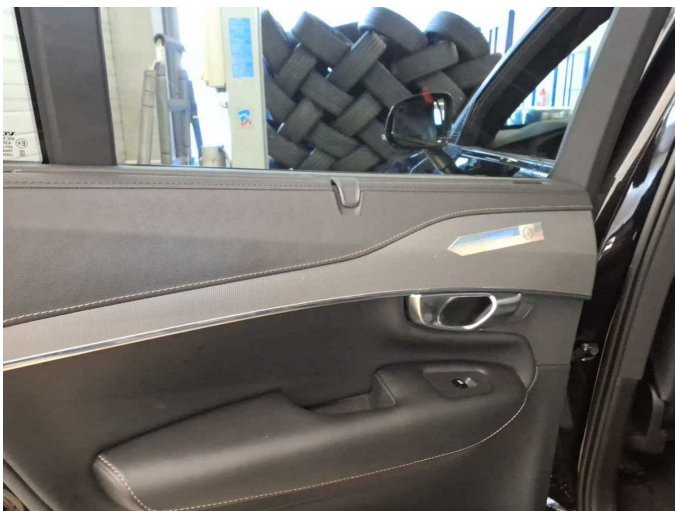
Damage 6: Trim / covers: Door trim - rear left side - Scratch(es) - Loss in value

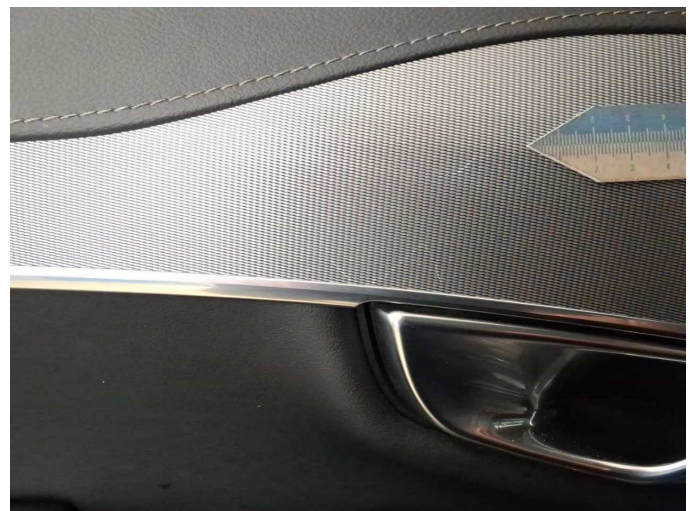
Damage 6: Trim / covers: Door trim - rear left side - Scratch(es) - Loss in value

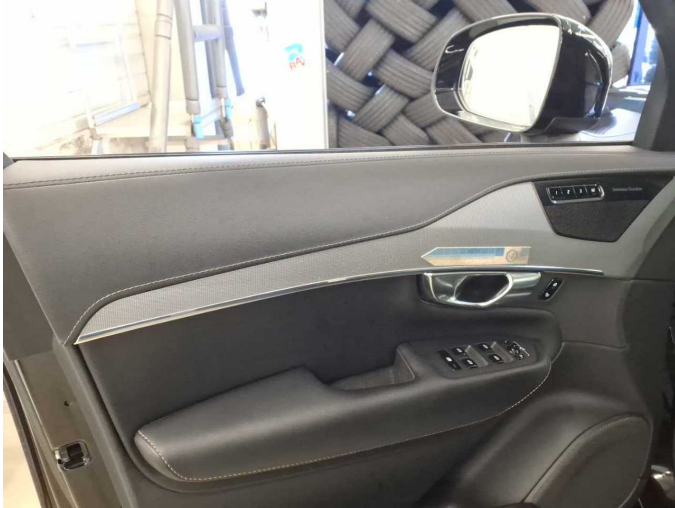
Damage 7: Trim / covers: Door trim - front left side - Scratch(es) - Loss in value

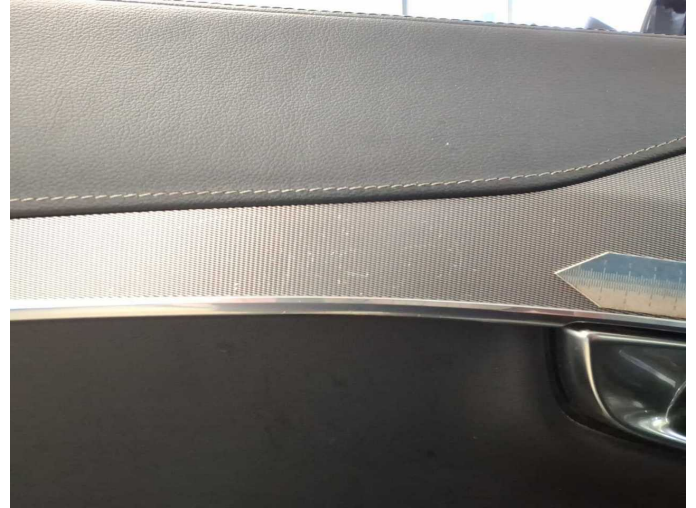
Damage 7: Trim / covers: Door trim - front left side - Scratch(es) - Loss in value

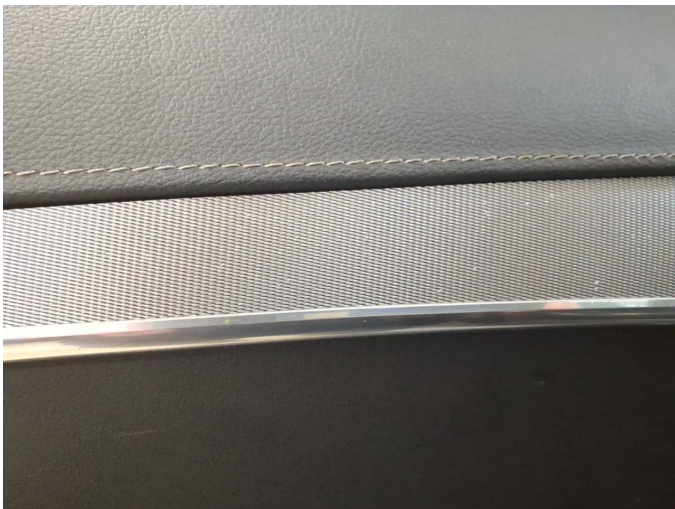
Damage 7: Trim / covers: Door trim - front left side - Scratch(es) - Loss in value

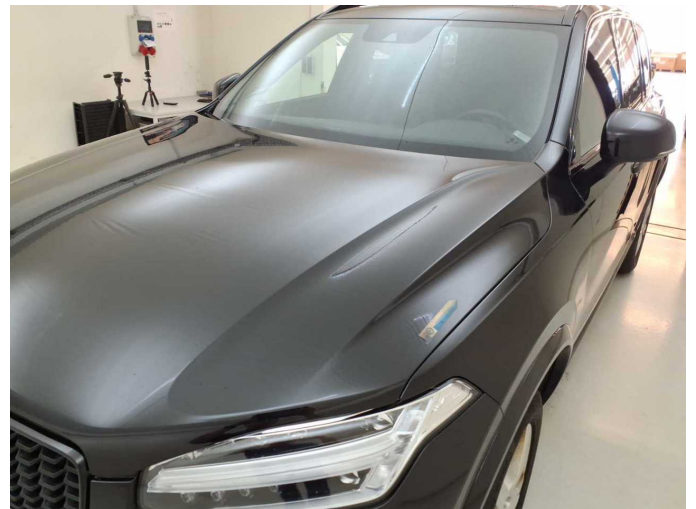
Damage 8: Bonnet: Bonnet - dent(s) - Smart repair

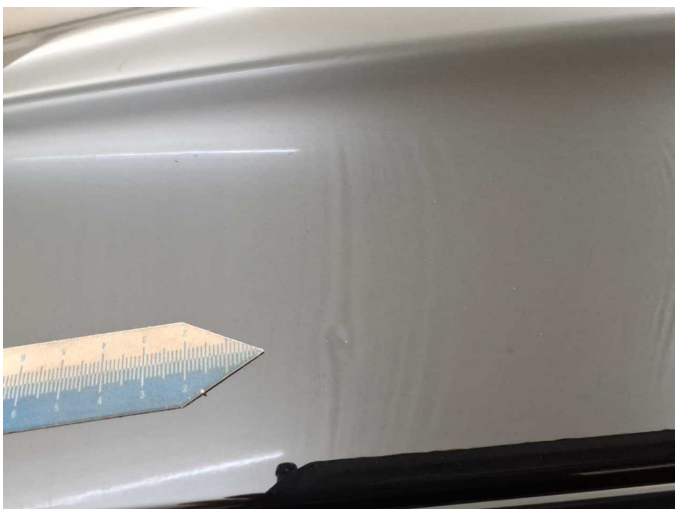
Damage 8: Bonnet: Bonnet - dent(s) - Smart repair

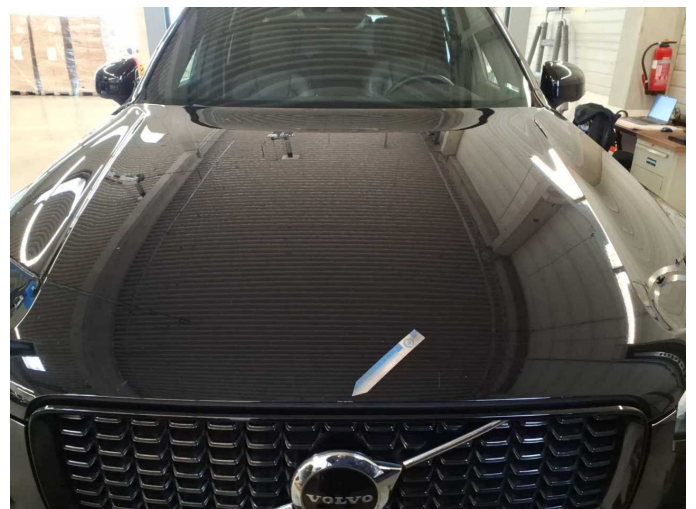
Damage 9: Bonnet: Bonnet - Scratch(es) - Smart repair

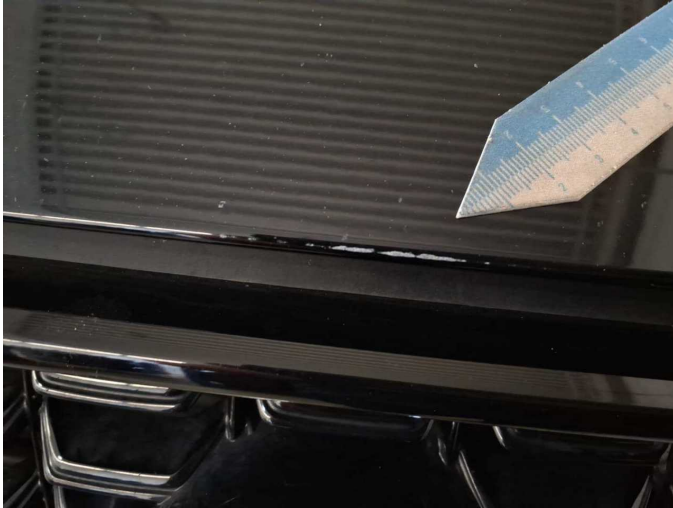
Damage 9: Bonnet: Bonnet - Scratch(es) - Smart repair

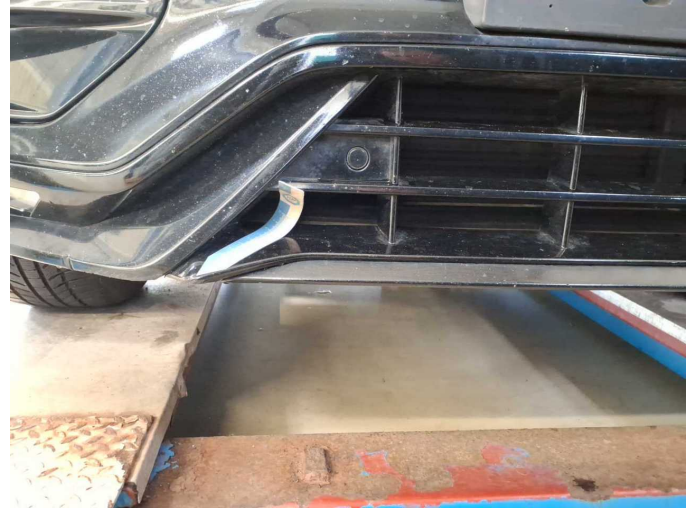
Damage 10: Trim / covers: Trim / covers (Stossfänger vorn mitte unten) - Scratched - Smart repair

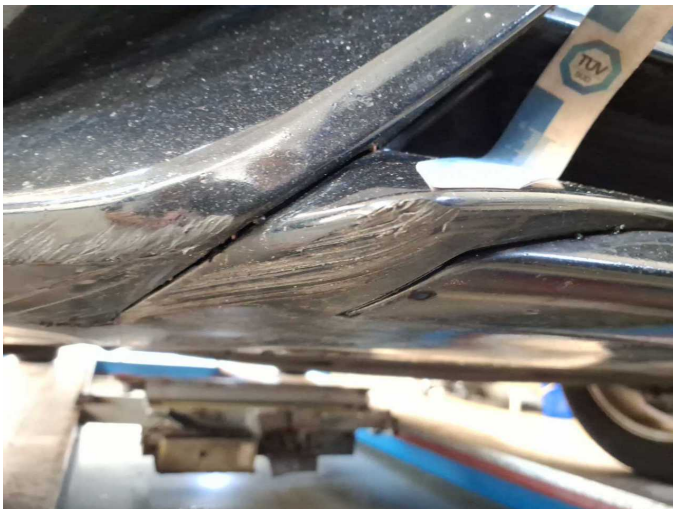
Damage 10: Trim / covers: Trim / covers (Stossfänger vorn mitte unten) - Scratched - Smart repair

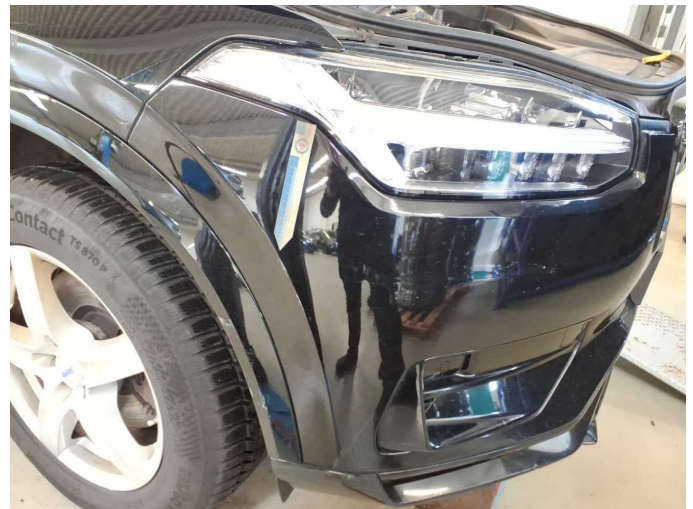
Damage 11: Front bumper: Bumper with Parktronic - Scratch(es) - Smart repair

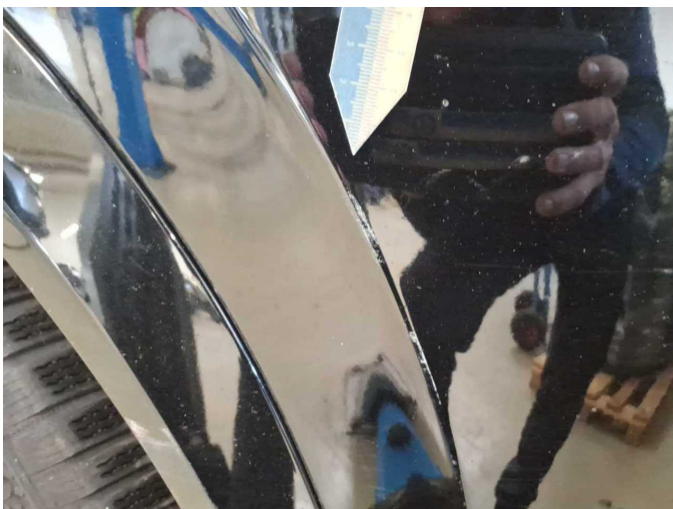
Damage 11: Front bumper: Bumper with Parktronic - Scratch(es) - Smart repair

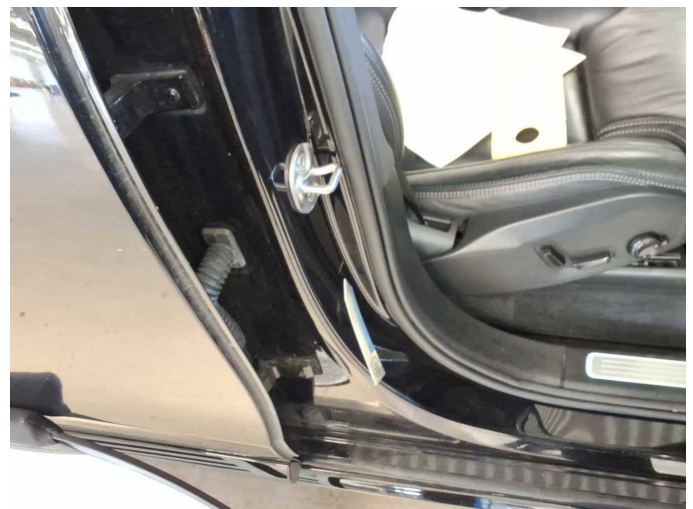
Damage 12: Body: B-pillar - right side - Scratch(es) - Smart repair

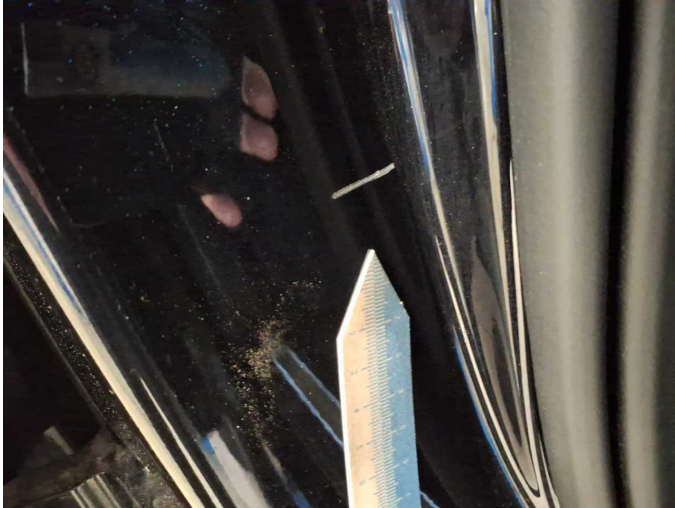
Damage 12: Body: B-pillar - right side - Scratch(es) - Smart repair

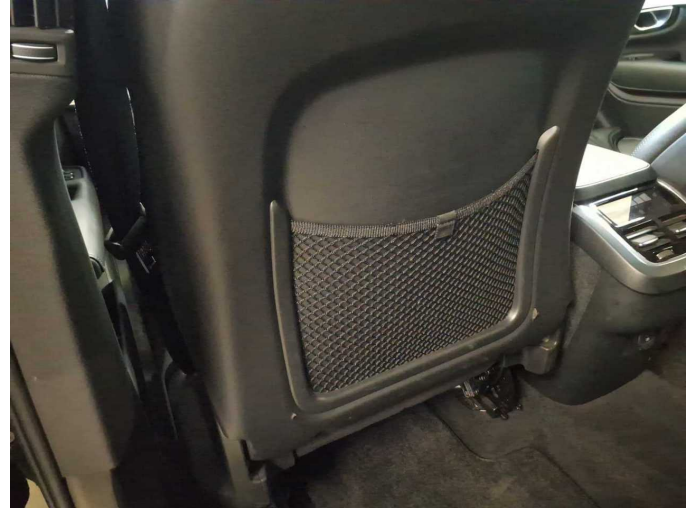
Damage 13: Seat - front: Seat - left side (Lehnenverkleidung) - Broken / torn - Replace

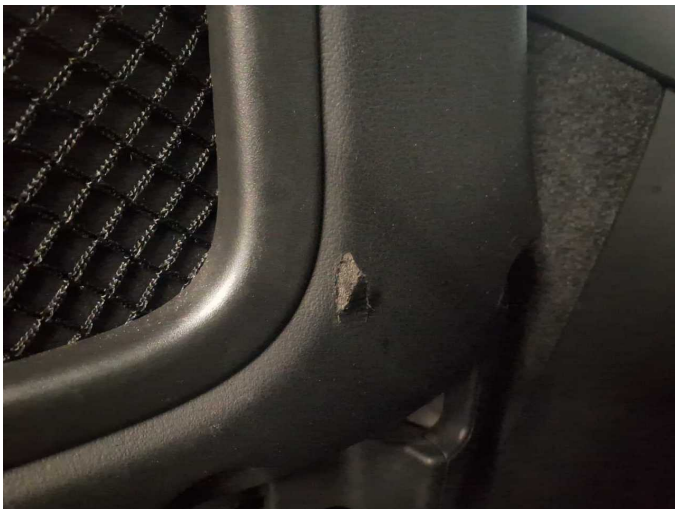
Damage 13: Seat - front: Seat - left side (Lehnenverkleidung) - Broken / torn - Replace

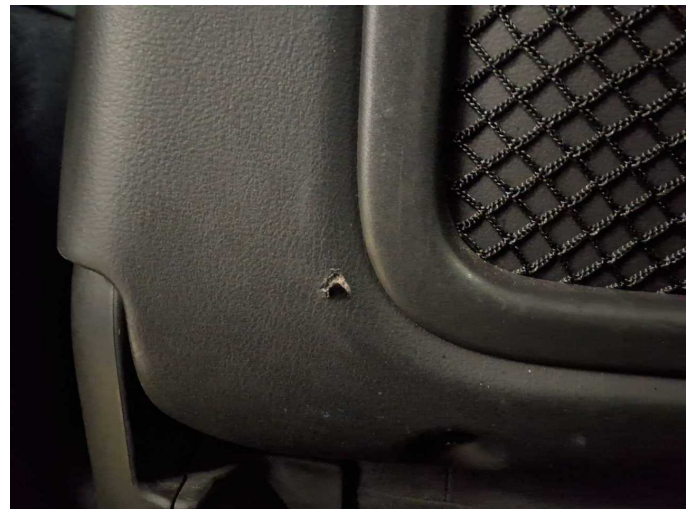
Damage 13: Seat - front: Seat - left side (Lehnenverkleidung) - Broken / torn - Replace

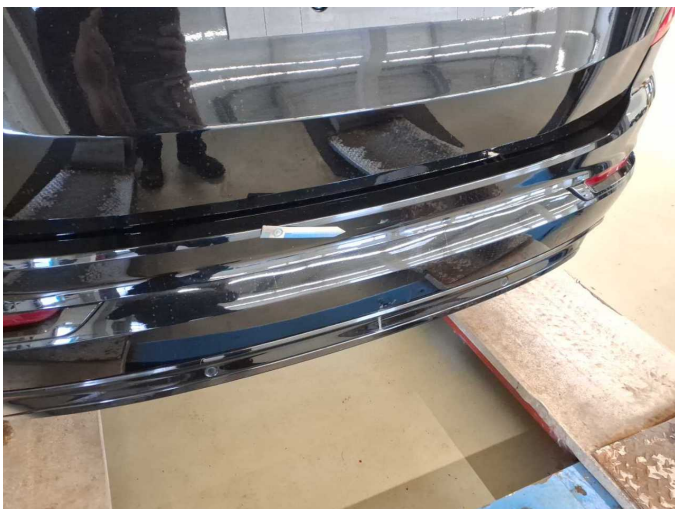
Damage 14: Rear bumper: Bumper with Parktronic - Abrasion - Cover / polish

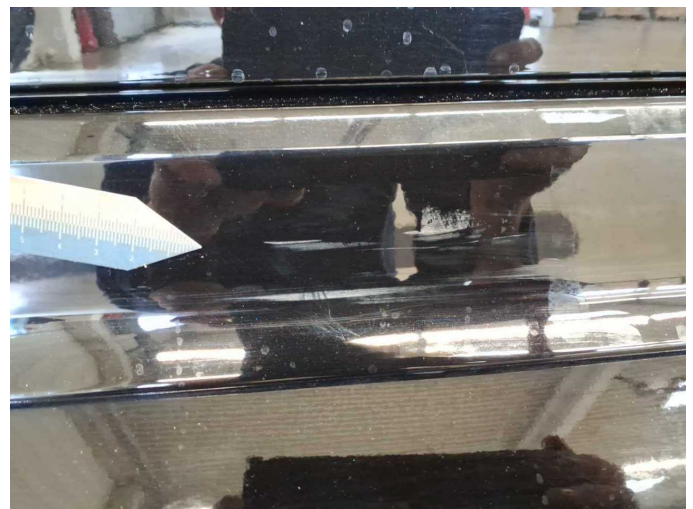
Damage 14: Rear bumper: Bumper with Parktronic - Abrasion - Cover / polish

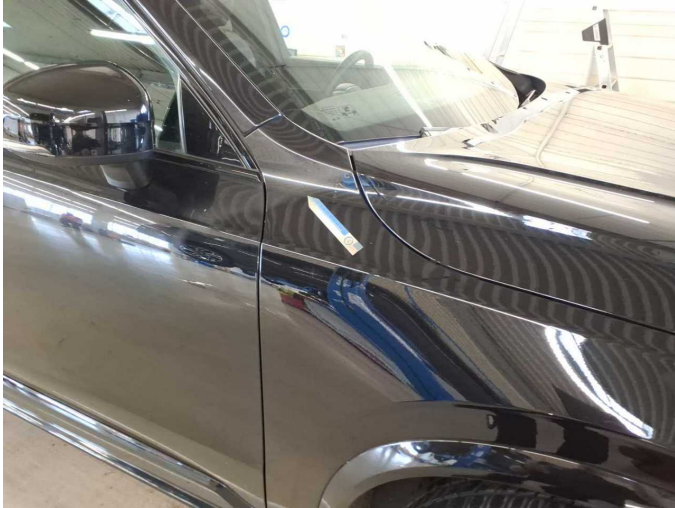
Damage 15: Mudguard - right side: Mudguard - right side (Farbnebel) - Paint defect - Cover / polish

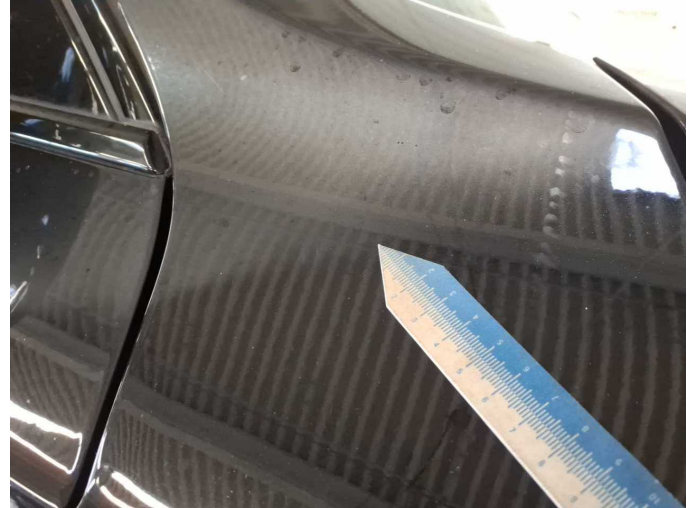
Damage 15: Mudguard - right side: Mudguard - right side (Farbnebel) - Paint defect - Cover / polish

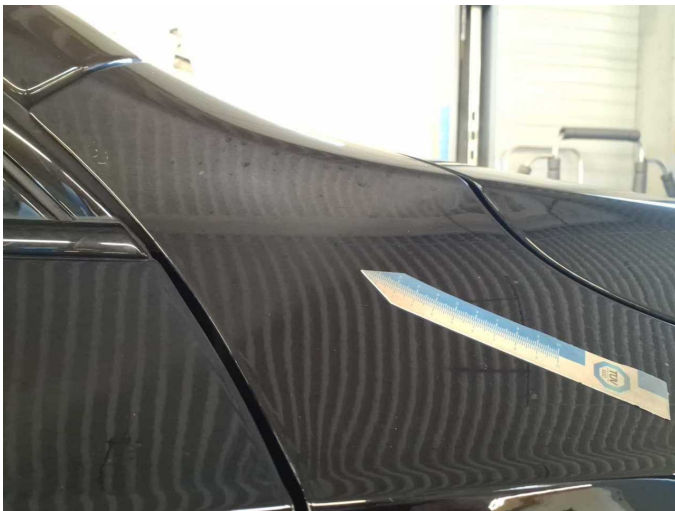
Damage 15: Mudguard - right side: Mudguard - right side (Farbnebel) - Paint defect - Cover / polish

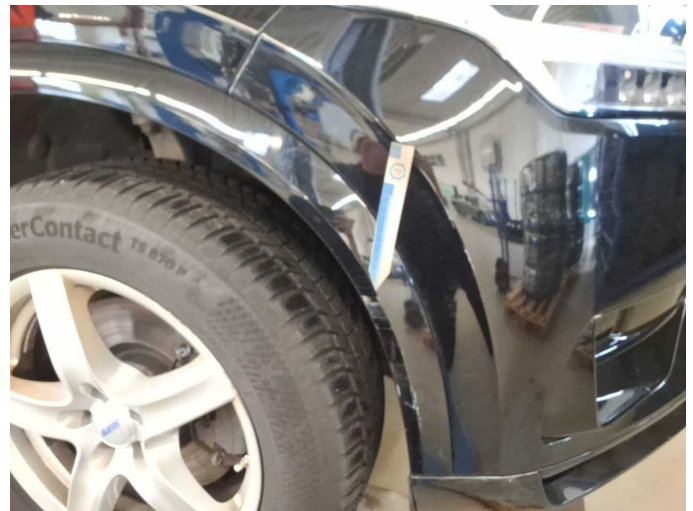
Damage 16: Mudguard - right side: Wheel arch (Verkleidung) - Scratch(es) - Paint

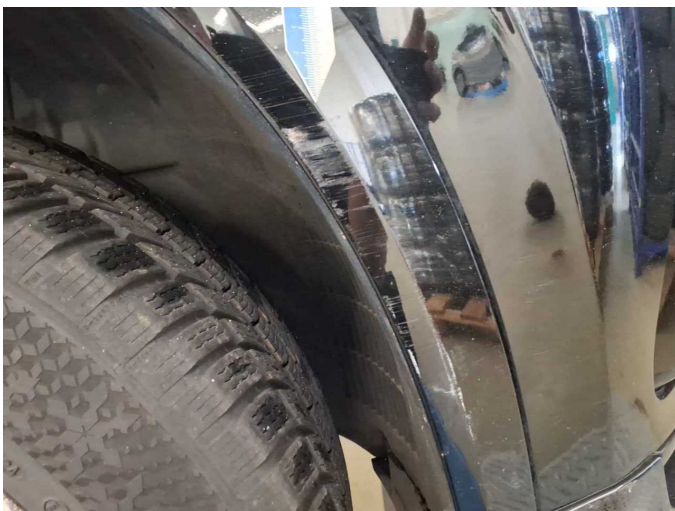
Damage 16: Mudguard - right side: Wheel arch (Verkleidung) - Scratch(es) - Paint

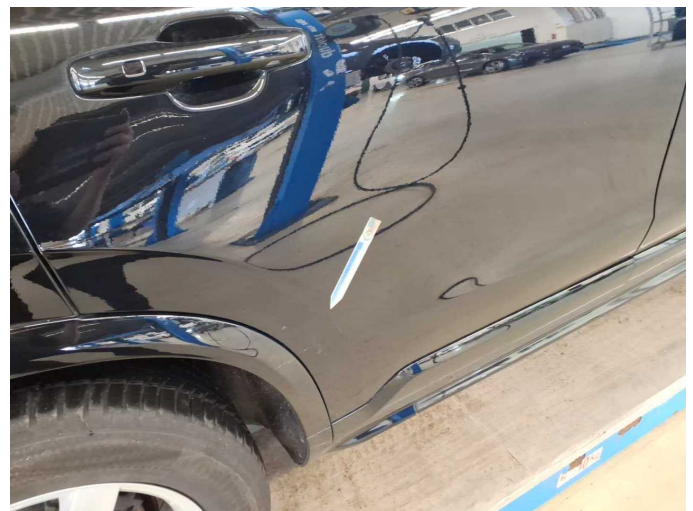
Damage 17: Door - rear right side: Door - Scratch(es) - Paint

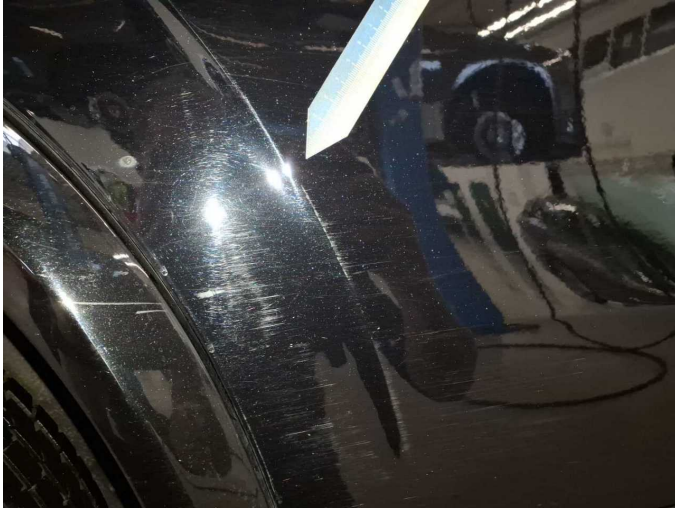
Damage 17: Door - rear right side: Door - Scratch(es) - Paint

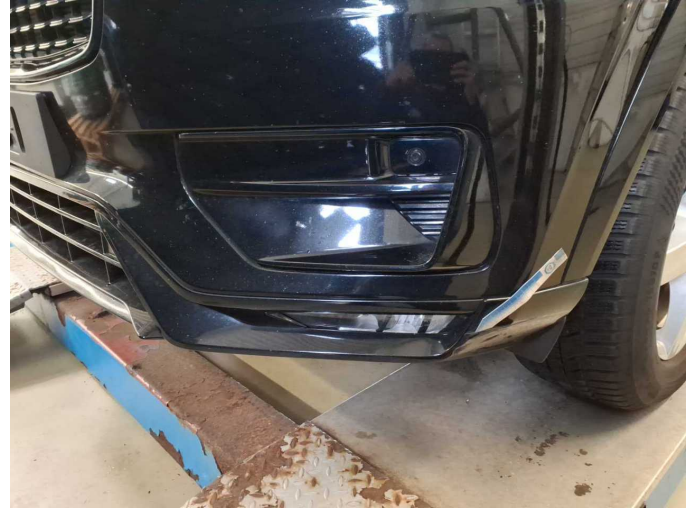
Damage 18: Front bumper: Spoiler (links + rechts) - Deformed - Replace

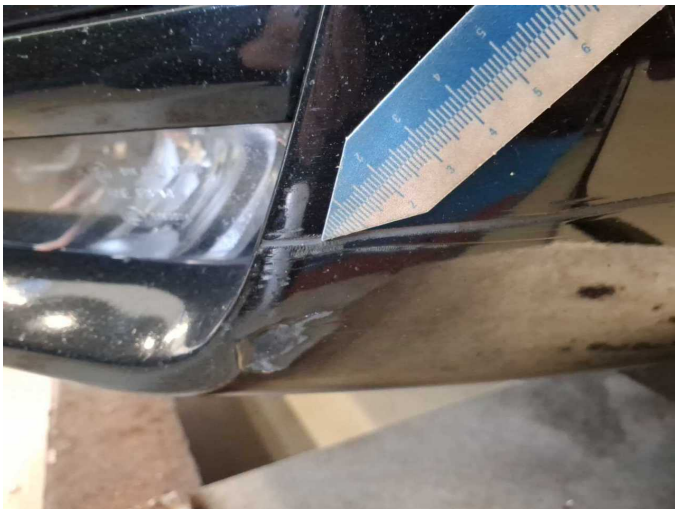
Damage 18: Front bumper: Spoiler (links + rechts) - Deformed - Replace

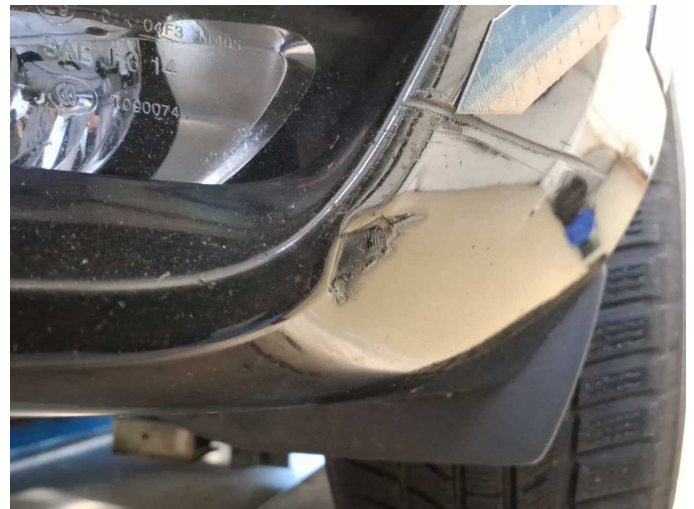
Damage 18: Front bumper: Spoiler (links + rechts) - Deformed - Replace

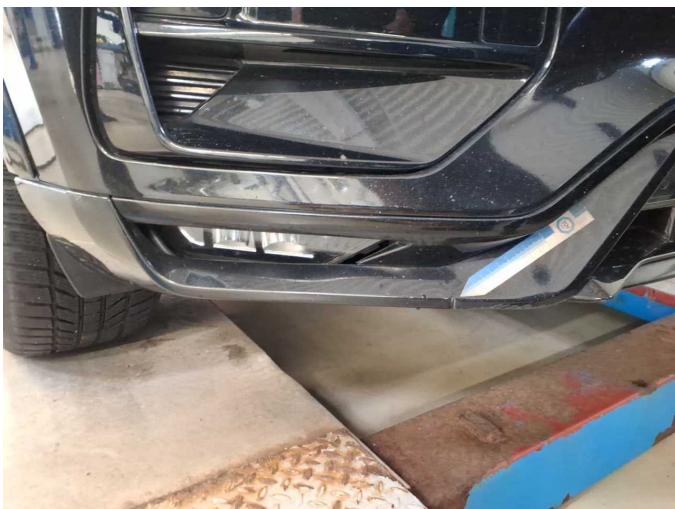
Damage 18: Front bumper: Spoiler (links + rechts) - Deformed - Replace

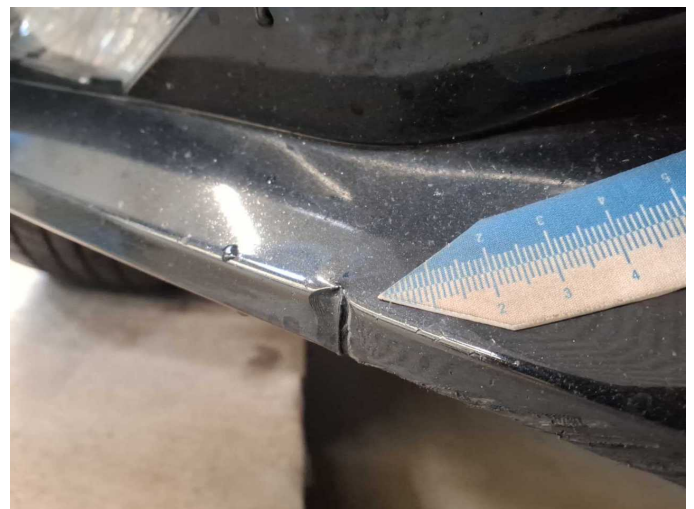
Damage 18: Front bumper: Spoiler (links + rechts) - Deformed - Replace

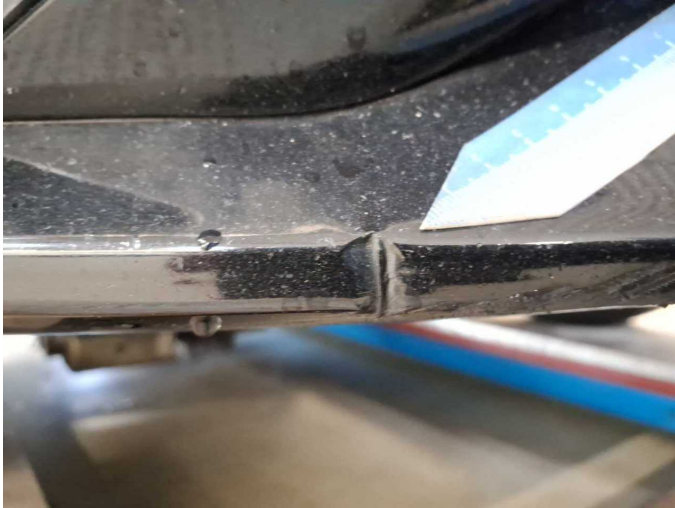
Damage 18: Front bumper: Spoiler (links + rechts) - Deformed - Replace

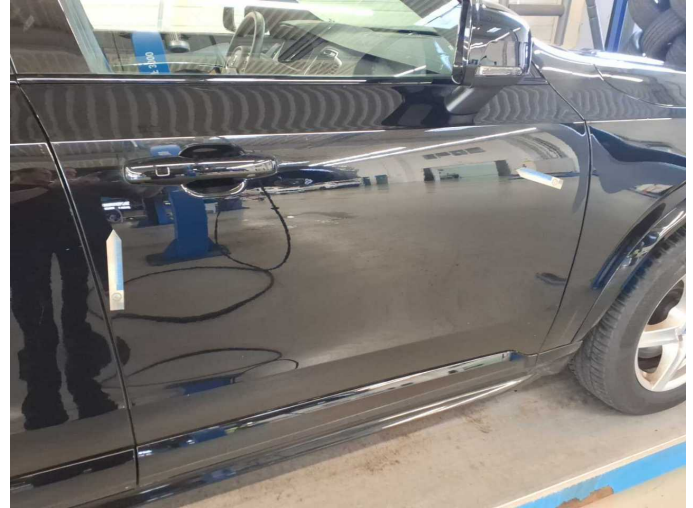
Damage 19: Door - front right side: Door (Lackmängel + Folgeschaden) - Unprofessionally repaired - Repair and paint

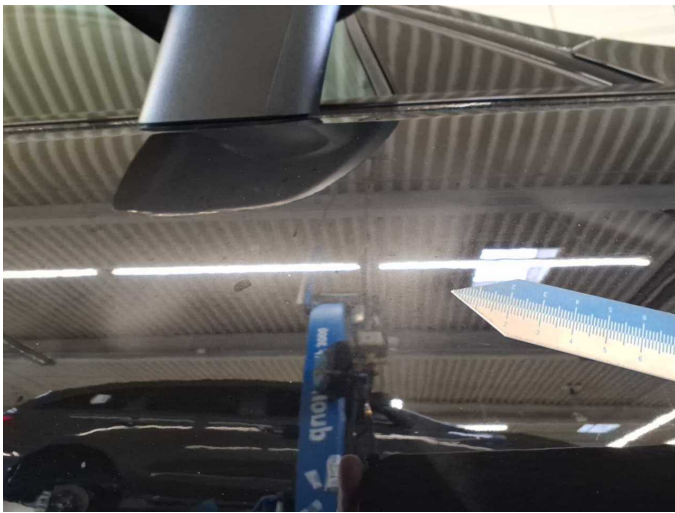
Damage 19: Door - front right side: Door (Lackmängel + Folgeschaden) - Unprofessionally repaired - Repair and paint

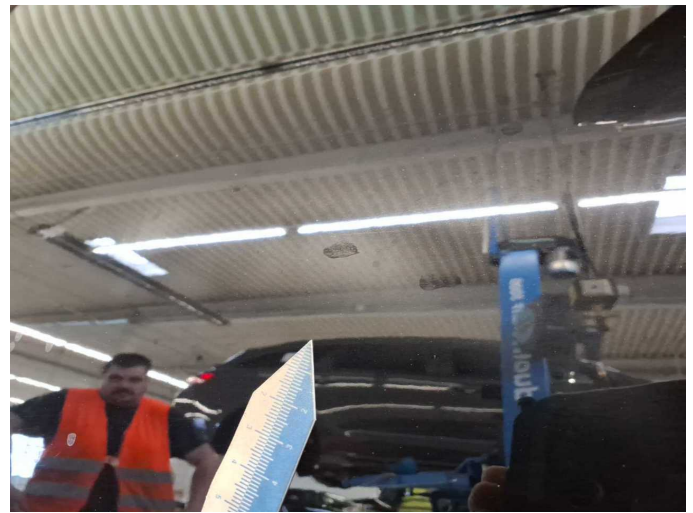
Damage 19: Door - front right side: Door (Lackmängel + Folgeschaden) - Unprofessionally repaired - Repair and paint

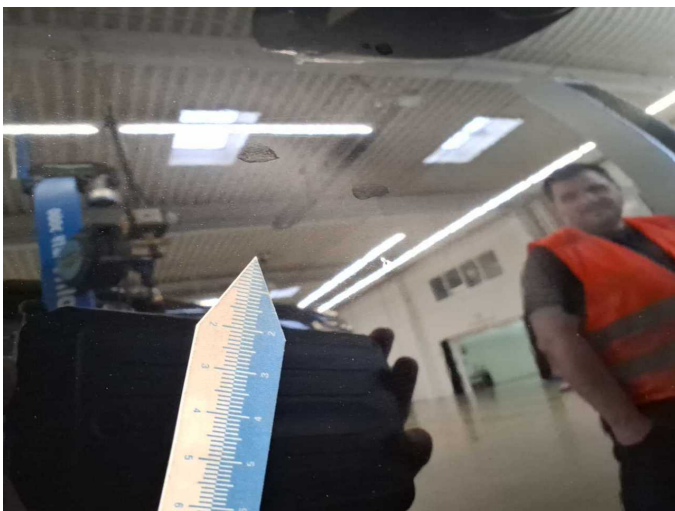
Damage 19: Door - front right side: Door (Lackmängel + Folgeschaden) - Unprofessionally repaired - Repair and paint

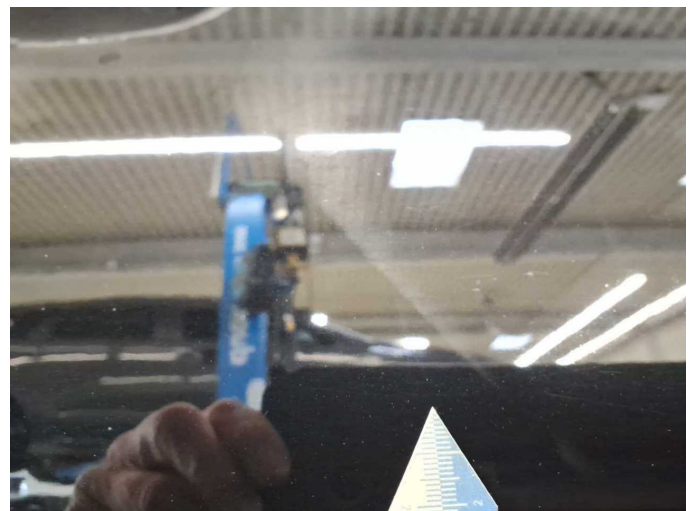
Damage 19: Door - front right side: Door (Lackmängel + Folgeschaden) - Unprofessionally repaired - Repair and paint

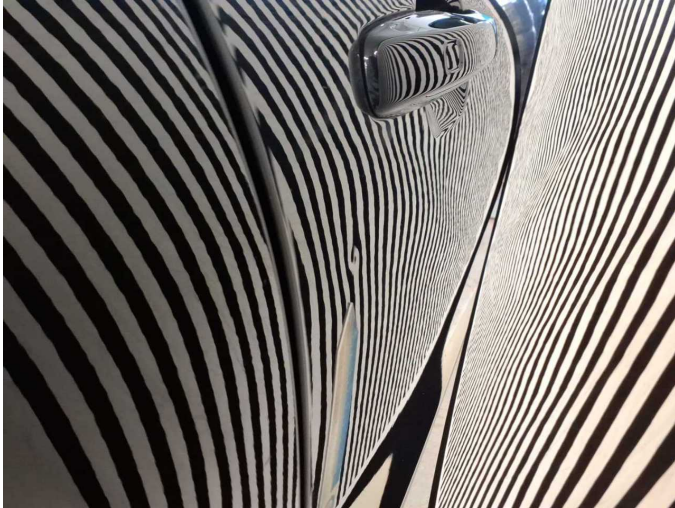
Damage 19: Door - front right side: Door (Lackmängel + Folgeschaden) - Unprofessionally repaired - Repair and paint

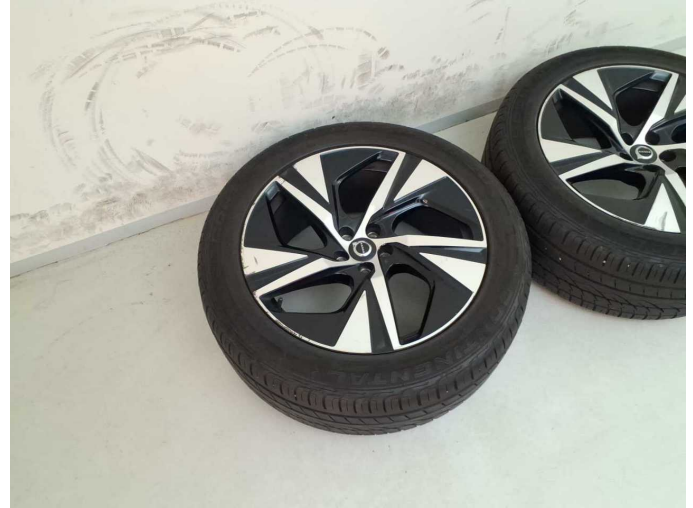
Damage 20: 2nd wheel set: 1 alloy rim (Materialabtrag) - Scratched - Replace

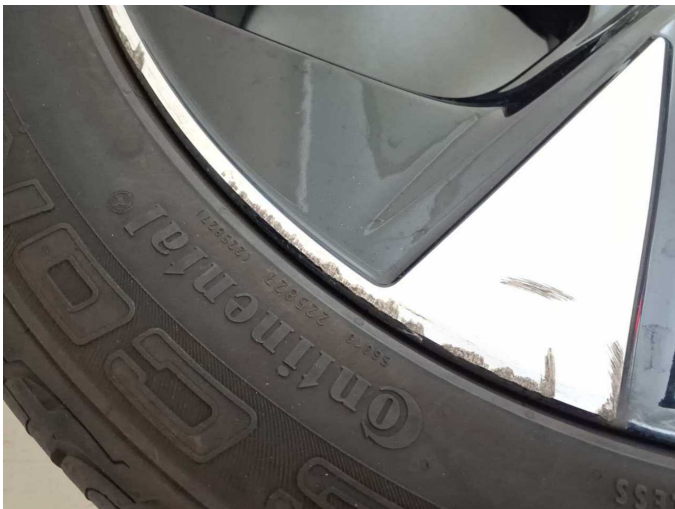
Damage 20: 2nd wheel set: 1 alloy rim (Materialabtrag) - Scratched - Replace

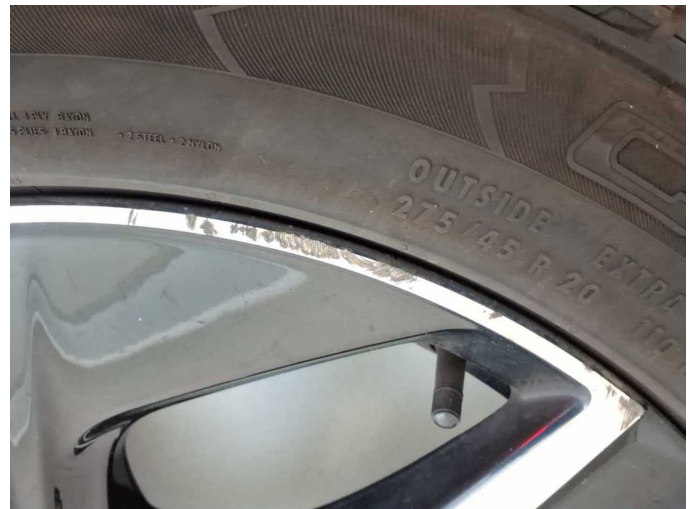
Damage 20: 2nd wheel set: 1 alloy rim (Materialabtrag) - Scratched - Replace

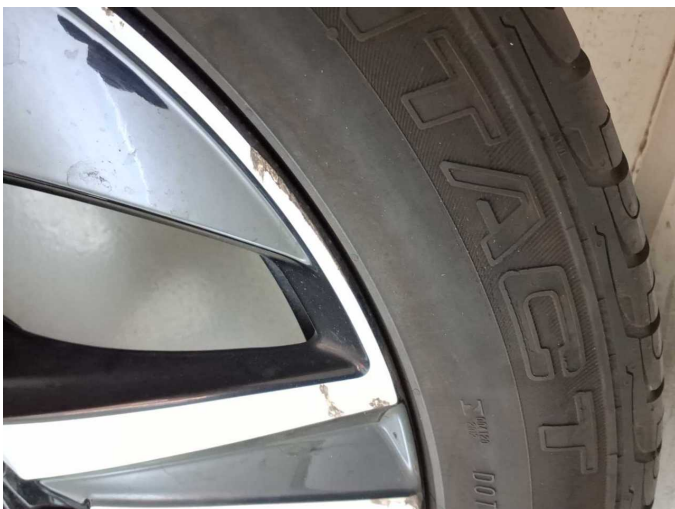
Damage 20: 2nd wheel set: 1 alloy rim (Materialabtrag) - Scratched - Replace

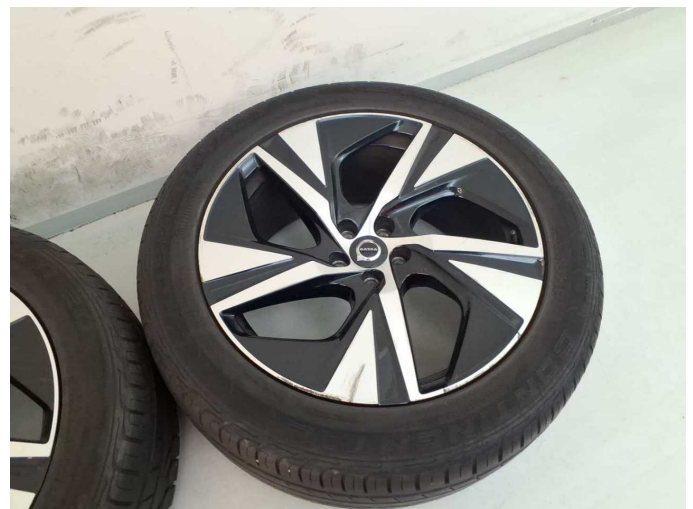
Damage 21: 2nd wheel set: 1 alloy rim (Materialabtrag) - Scratched - Replace

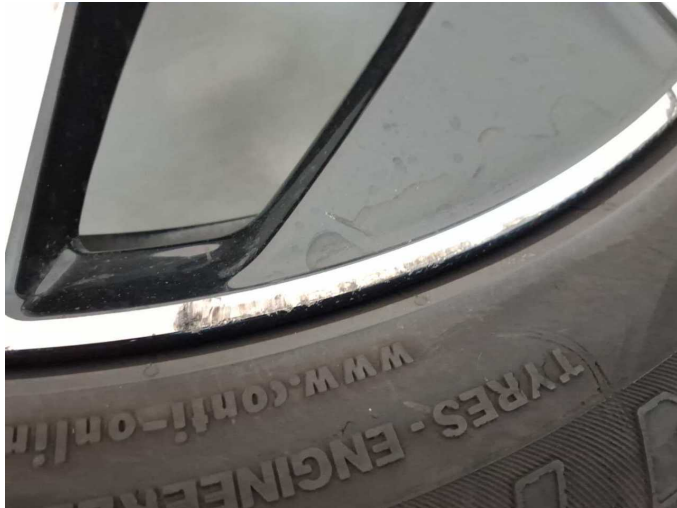
Damage 21: 2nd wheel set: 1 alloy rim (Materialabtrag) - Scratched - Replace

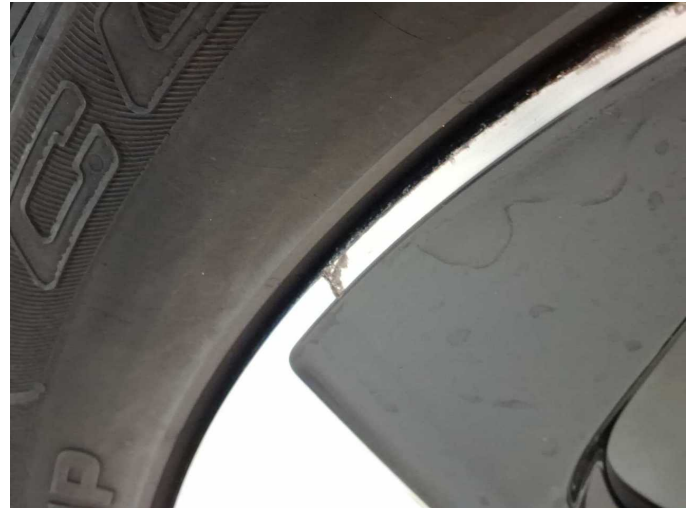
Damage 21: 2nd wheel set: 1 alloy rim (Materialabtrag) - Scratched - Replace

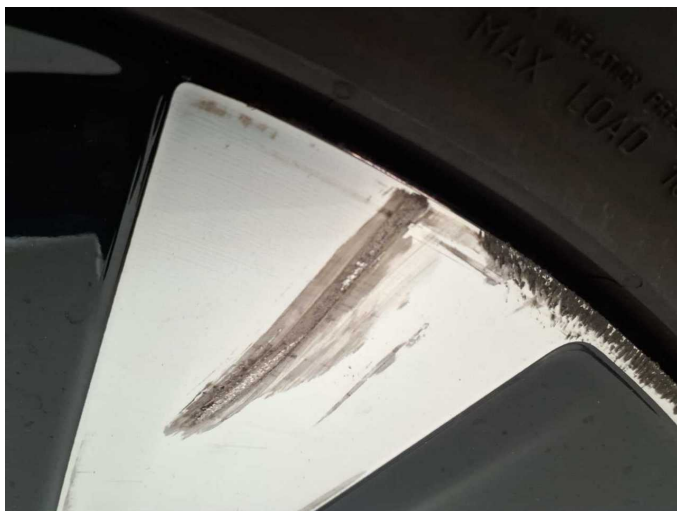
Damage 21: 2nd wheel set: 1 alloy rim (Materialabtrag) - Scratched - Replace

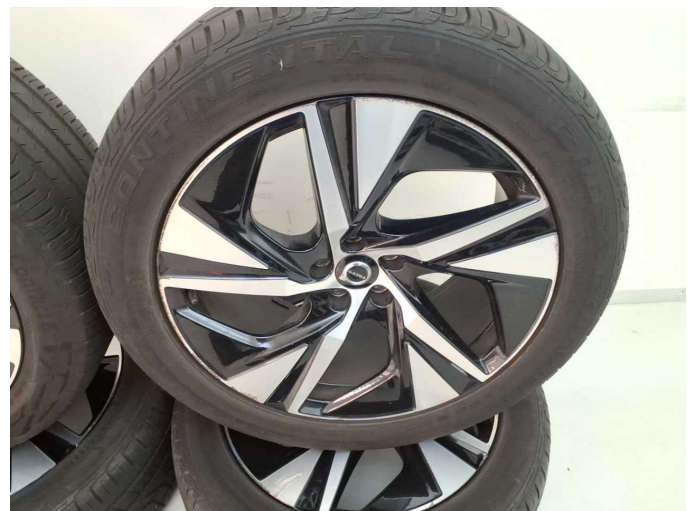
Damage 22: 2nd wheel set: 1 alloy rim (Materialabtrag) - Scratched - Replace

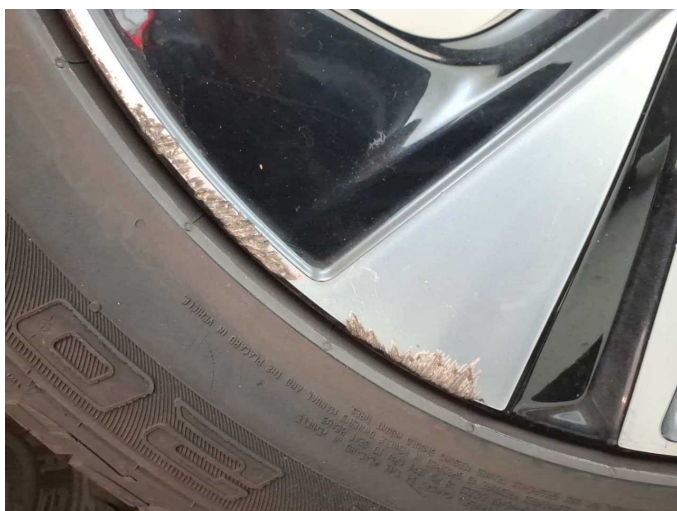
Damage 22: 2nd wheel set: 1 alloy rim (Materialabtrag) - Scratched - Replace

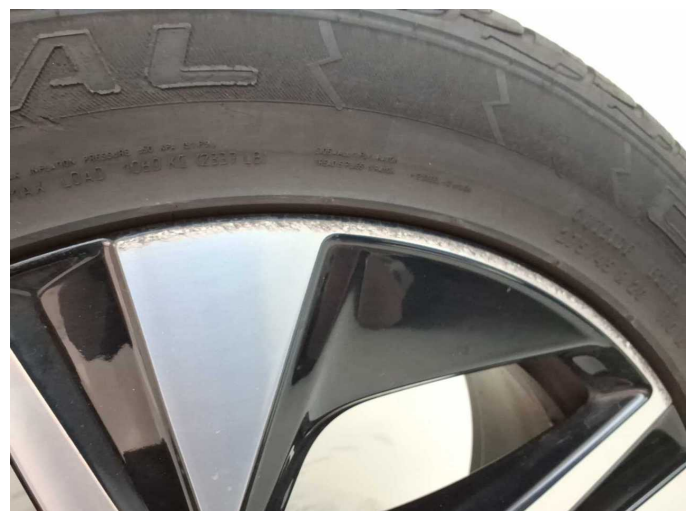
Damage 22: 2nd wheel set: 1 alloy rim (Materialabtrag) - Scratched - Replace

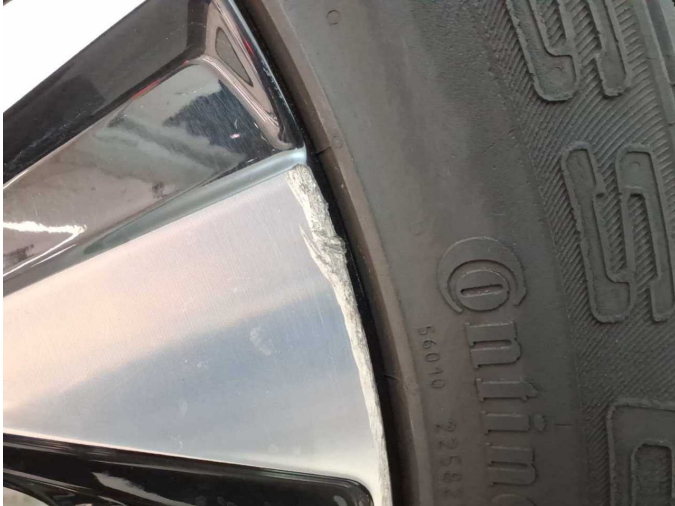
Damage 22: 2nd wheel set: 1 alloy rim (Materialabtrag) - Scratched - Replace

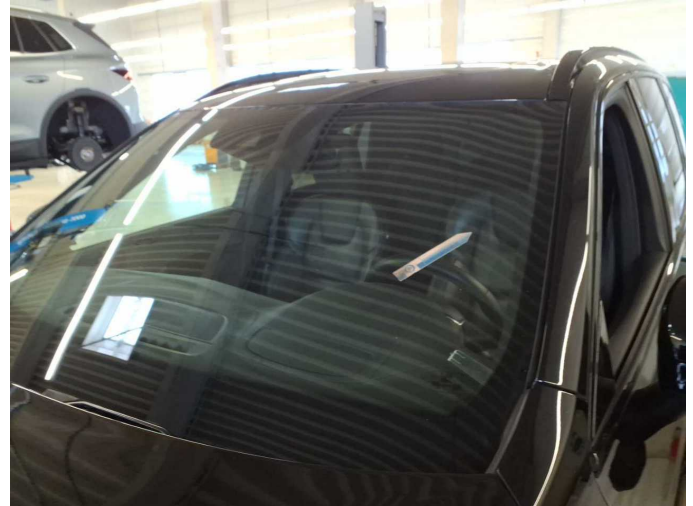
Damage 23: Vehicle glazing: Windscreen with lane departure assistant (Steinschlag) - Unprofessionally repaired - Replace

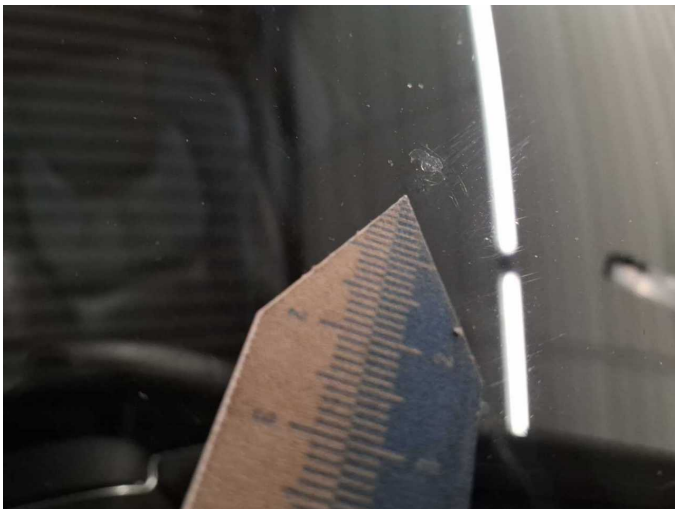
Damage 23: Vehicle glazing: Windscreen with lane departure assistant (Steinschlag) - Unprofessionally repaired - Replace

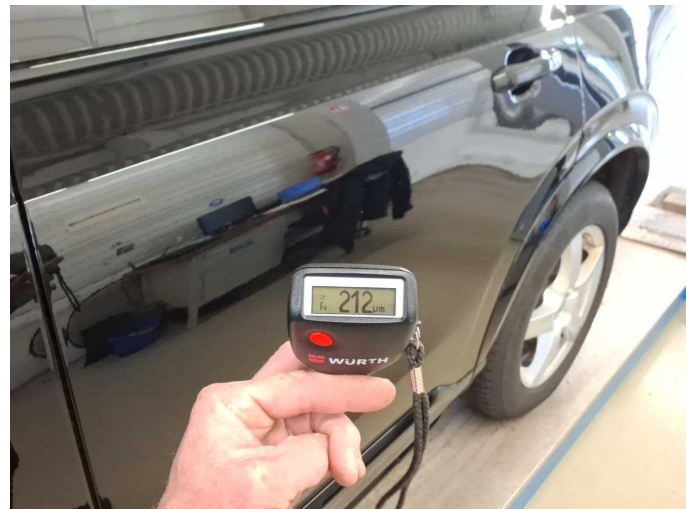
Door - rear left side: 212 µm
