Expertise

Protocol number: 46294389
Order No. / Reference: 26460481
Inspection date: 1 Jul 2026

Model: Tiguan Allspace 2.0 TDI SCR DSG Life

VIN: WVGZZZ5N2PM038785

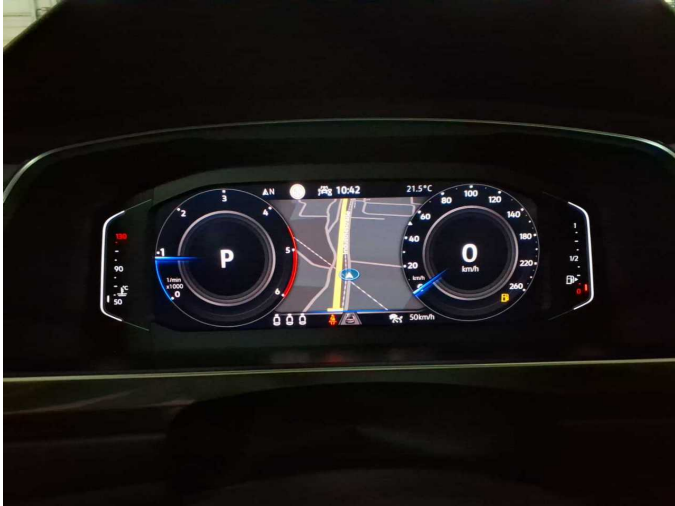
Figure 7: Instrument cluster

Mileage (Read) 112,993 km

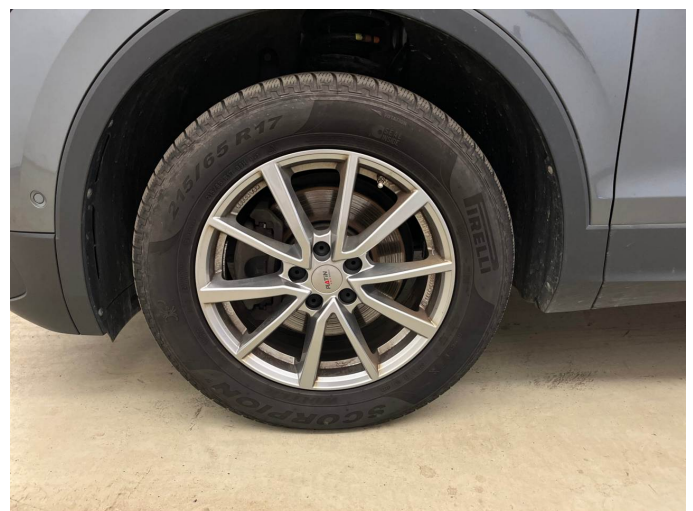
Figure 12: Mounted tyres

#	Tyre size	Type of tyre	Manufacturer	Tread depth
1)	215/65 R17 99H	Winter tyres on Light alloy	Pirelli	4mm / 4mm
2)	215/65 R17 99H	Winter tyres on Light alloy	Pirelli	5mm / 5mm

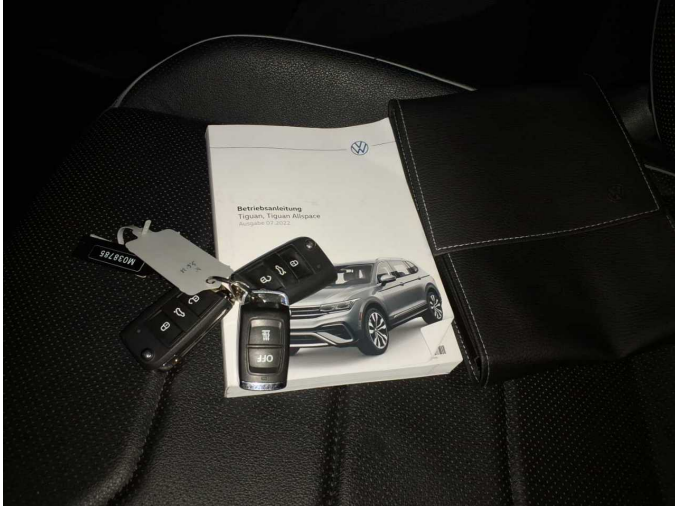
Figure 13: Documents

Documents submitted	At the time of the inspection, the vehicle registration certificate Part 2 (title) was available, but the vehicle registration certificate Part 1 (document) was not. (Copy)
VIN comparison	The vehicle identification number (VIN) was read from the vehicle and its conformity with the submitted documents was confirmed by the undersigned during the inspection.
Inspection	The inspection conditions were sufficient for the assessment of the vehicle. Lifting equipment and/or a pit were available for examining the vehicle.
Test drive	No test drive/shunting maneuver was carried out during the inspection of the vehicle.
Engine function test	An engine test run was performed.

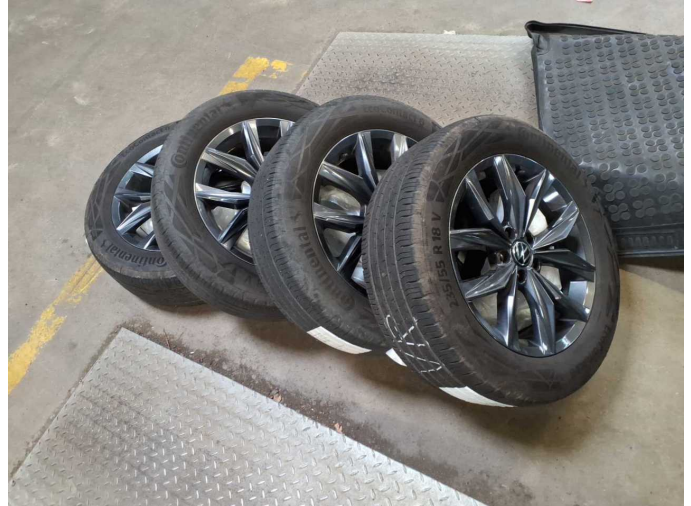
Figure 14: Additional tyres

#	Tyre size	Type of tyre	Manufacturer	Tread depth
1)	235/55 R18 100V	Summer tyres on Light alloy	Continental	4mm / 4mm
2)	235/55 R18 100V	Summer tyres on Light alloy	Continental	5mm / 5mm

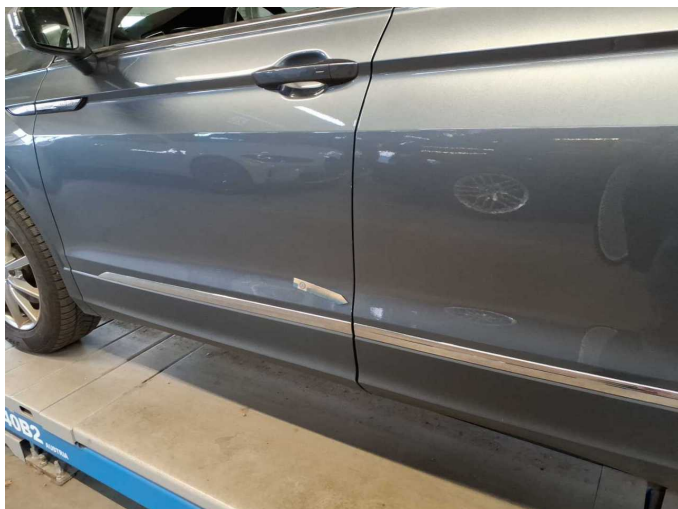
No.	Component group	Description
1	Equipment	Vehicle key (Batterie) - Empty - Replace
2	Bonnet	Bonnet - dent(s) - Smooth repair work
3	Door - front left side	Door edge - Scratch(es) - Smart repair

Damage 3: Door - front left side: Door edge - Scratch(es) - Smart repair

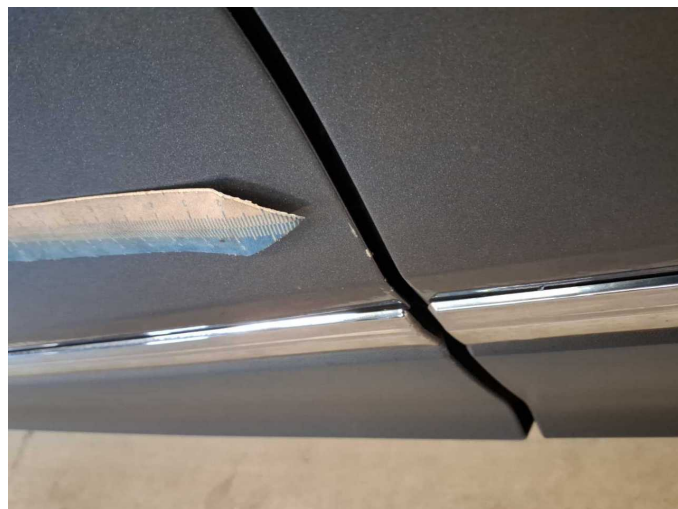
Damage 3: Door - front left side: Door edge - Scratch(es) - Smart repair

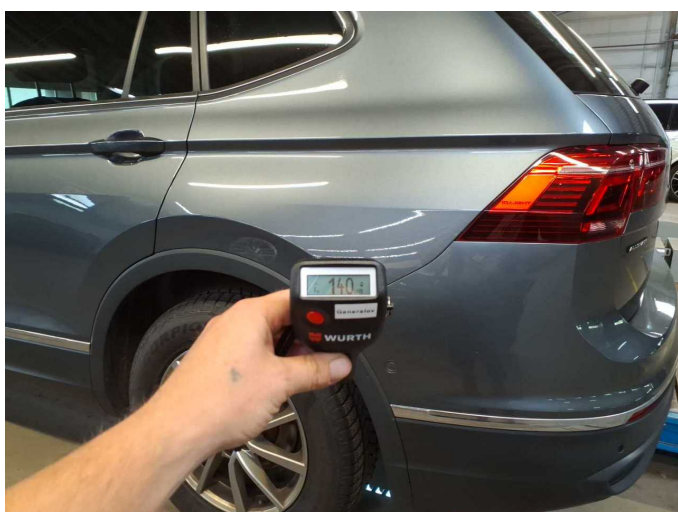
No.	Repainting
1	Side panel - rear left side, Professionally carried out, Invoice of repair done Non-existent

Side panel - rear left side 140 µm |

Repainting 1: Side panel - rear left side
