Expertise

Protocol number: 47203481  
Order No. / Reference: 26766169  
Inspection date: 24 Aug 2026

Manufacturer: Volkswagen  
VIN: WVGZZZ5NZNW526895

Model: Tiguan 2.0 TDI SCR R-Line

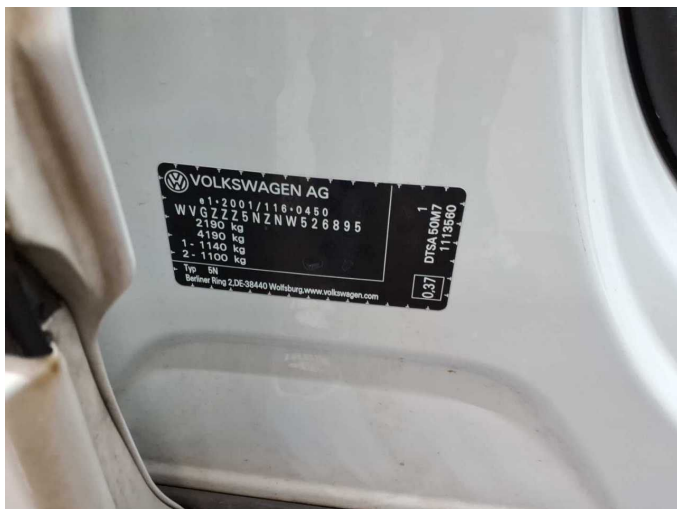
Figure 11: VIN

| VIN comparison | The vehicle identification number (VIN) was read from the vehicle and its conformity with the submitted documents was confirmed by the undersigned during the inspection. |

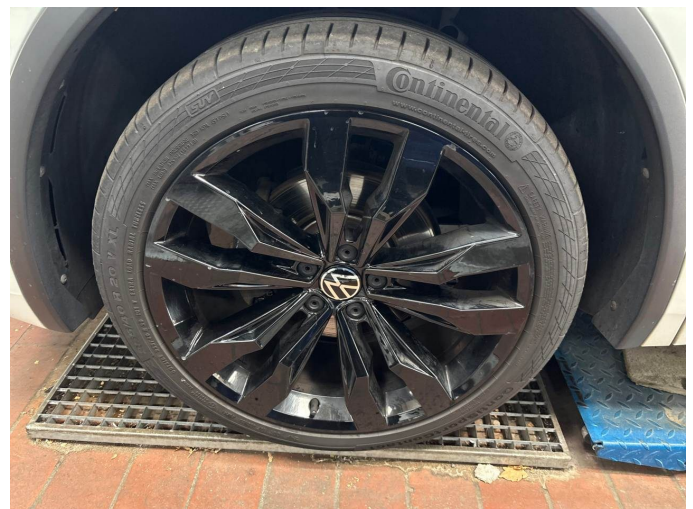
| # | Tyre size | Type of tyre | Manufacturer | Tread depth |
|---|---|---|---|---|
| 1) | 255/40 R20 101V | Summer tyres on Light alloy | Continental | 4mm / 4mm |
| 2) | 255/40 R20 101V | Summer tyres on Light alloy | Continental | 4mm / 4mm |

Figure 12: Mounted tyres

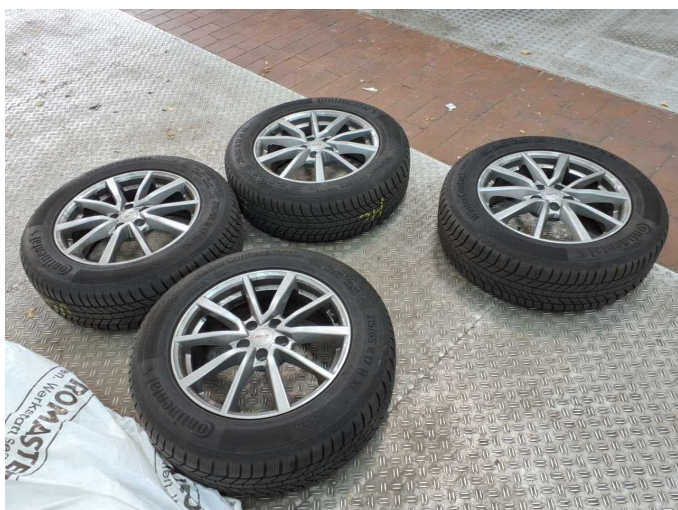
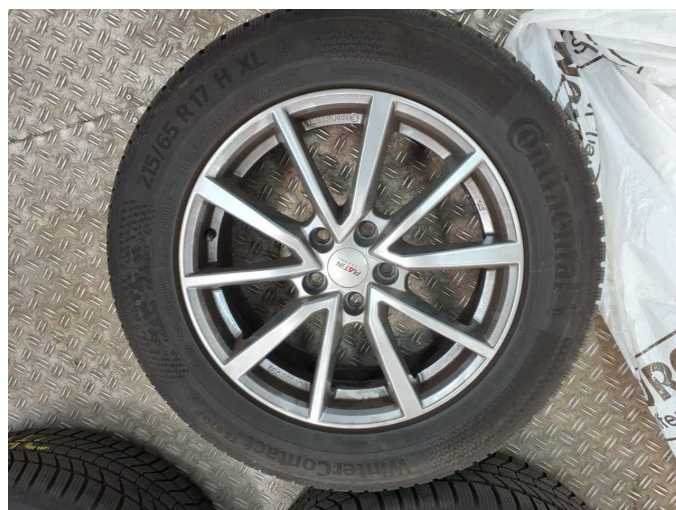
| # | Tyre size | Type of tyre | Manufacturer | Tread depth |
|---|---|---|---|---|
| 1) | 215/65 R17 103H | Winter tyres on Light alloy | Continental | 5mm / 5mm |
| 2) | 215/65 R17 103H | Winter tyres on Light alloy | Continental | 5mm / 5mm |

Figure 15: Additional tyres

Figure 16: Additional tyres

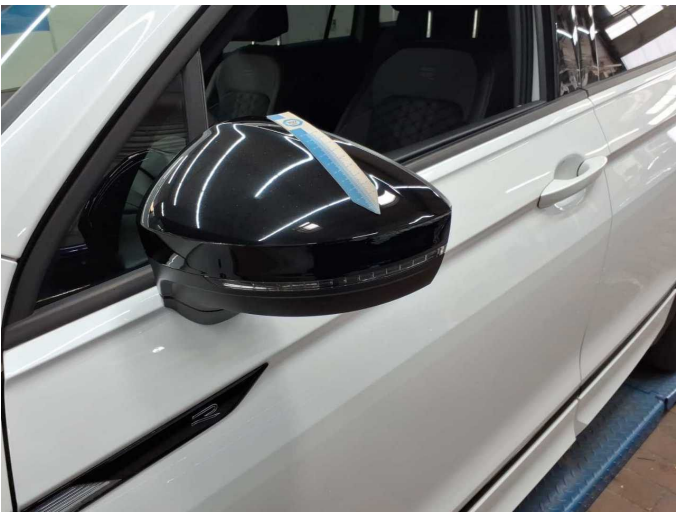
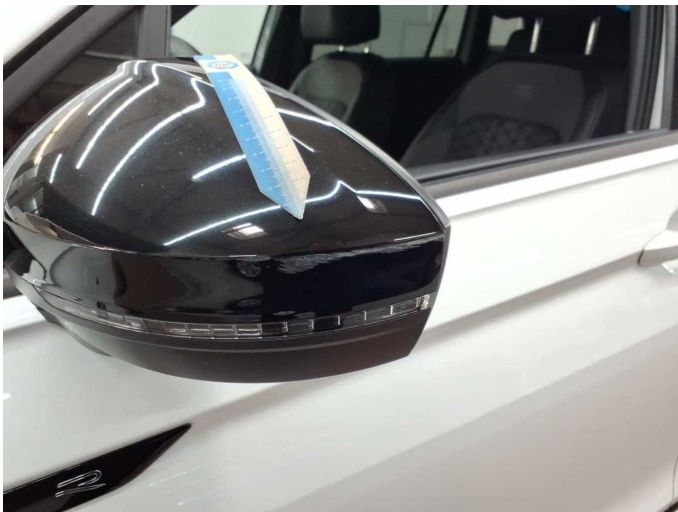
Damage 1: Wing mirror - left side: Cap - Scratch(es) - Smart repair

| No. | Component group | Description |
|---|---|---|
| 1 | Wing mirror - left side | Cap - Scratch(es) - Smart repair |

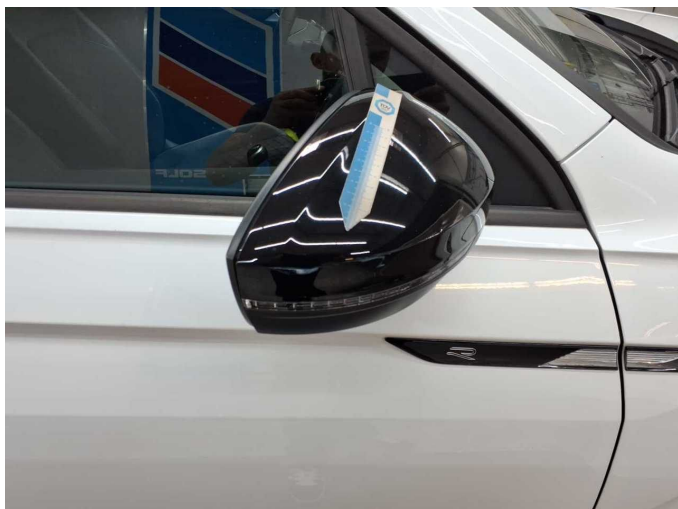
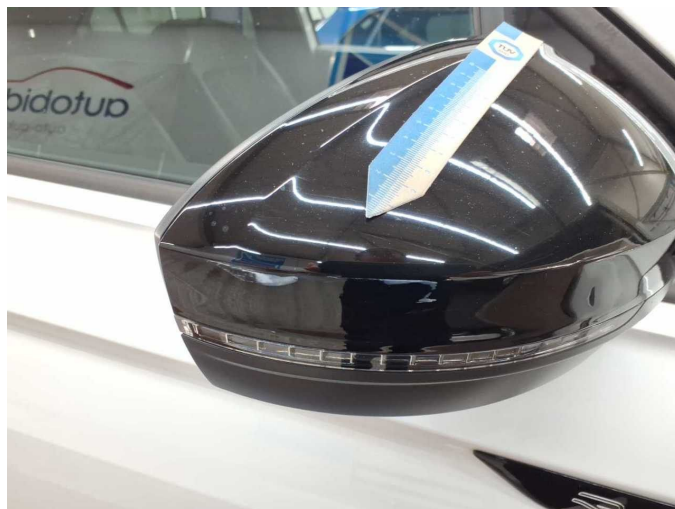
**Damage 2:** Wing mirror - right side: Cap - Scratch(es) - Smart repair

| No. | Component group | Description |
|---|---|---|
| 2 | Wing mirror - right side | Cap - Scratch(es) - Smart repair |

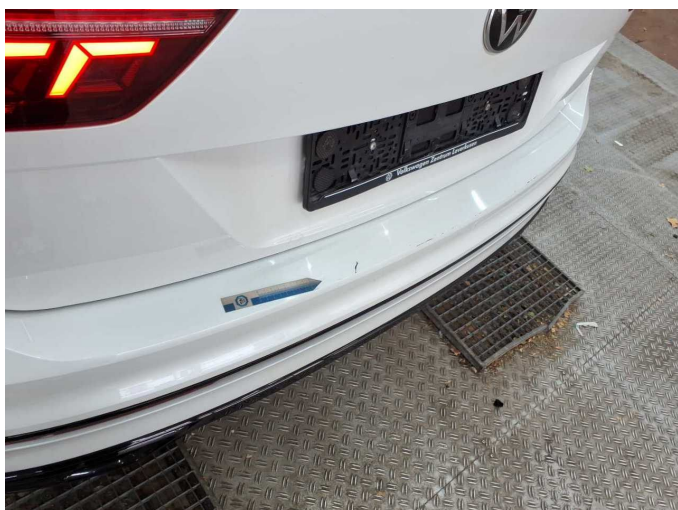
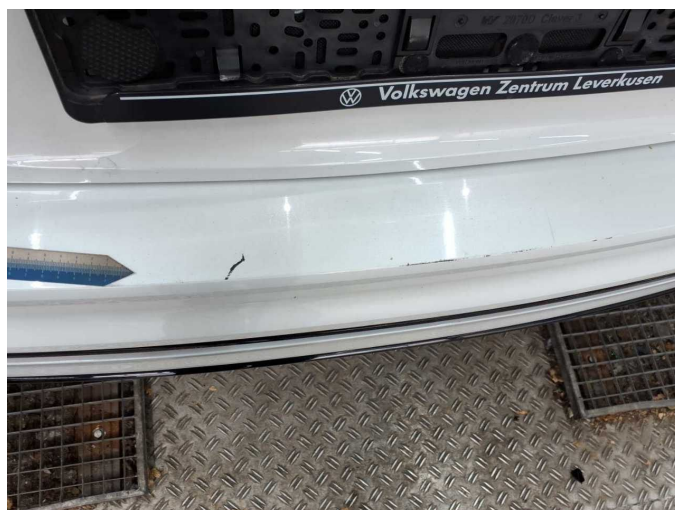
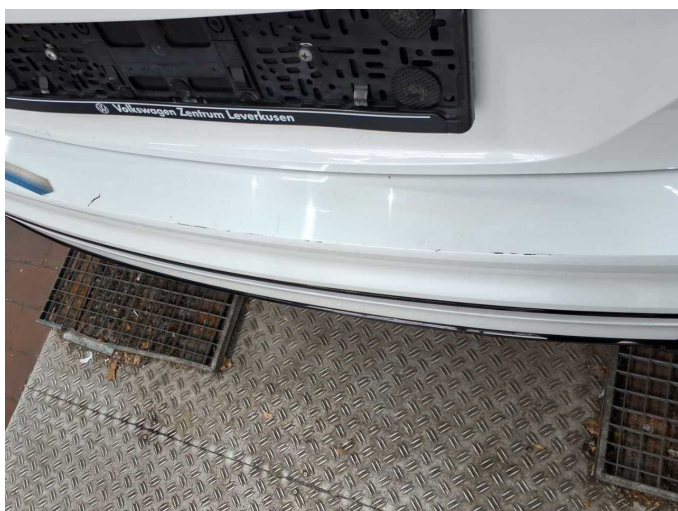
**Damage 3:** Rear bumper: Rear bumper - Scratch(es) - Paint

| No. | Component group | Description |
|---|---|---|
| 3 | Rear bumper | Rear bumper - Scratch(es) - Paint |
