## Expertise

Protocol number: 46352732  
Order No. / Reference: 26482530  
Inspection date: 7 Jul 2026

Model: Superb Combi 2.0 TDI DSG 4x4 L&K

VIN: TMBLR0NZXTC007177

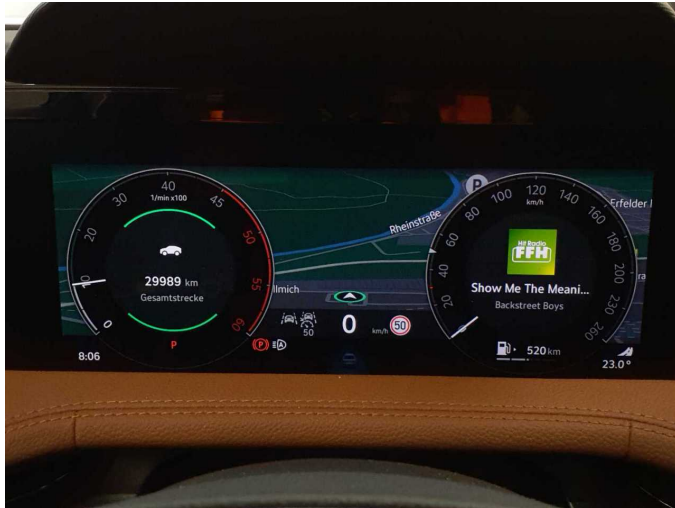
**Mileage (Read)** 29,989 km

Figure 7: Instrument cluster

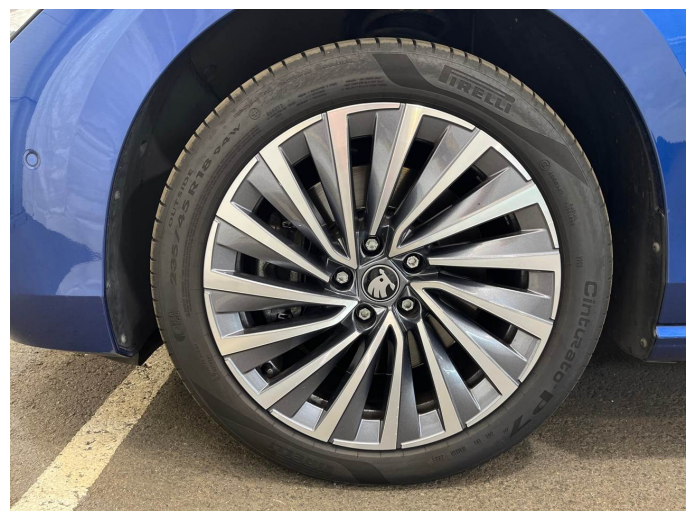
#	Tyre size	Type of tyre	Manufacturer	Tread depth
1)	235/45 R18 94W	Summer tyres (with run-flat tyres) on Light alloy	Pirelli	5mm / 5mm
2)	235/45 R18 94W	Summer tyres (with run-flat tyres) on Light alloy	Pirelli	5mm / 5mm

Figure 12: Mounted tyres

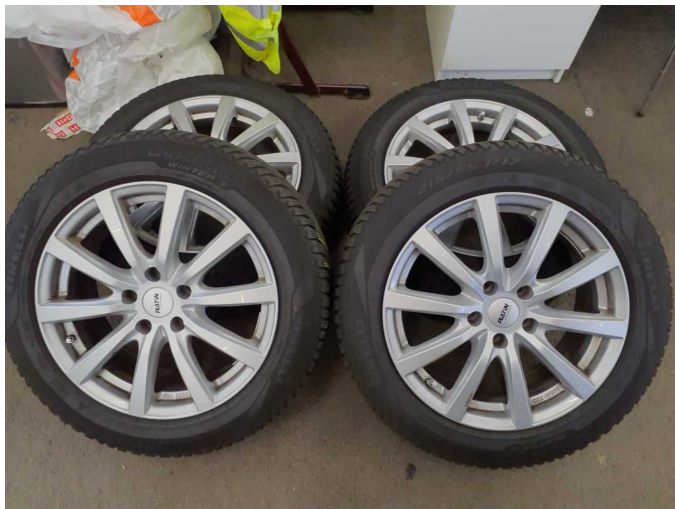
#	Tyre size	Type of tyre	Manufacturer	Tread depth
1)	215/55 R17 98V	Winter tyres on Light alloy	Pirelli	7mm / 7mm
2)	215/55 R17 98V	Winter tyres on Light alloy	Pirelli	8mm / 8mm

Figure 15: Additional tyres

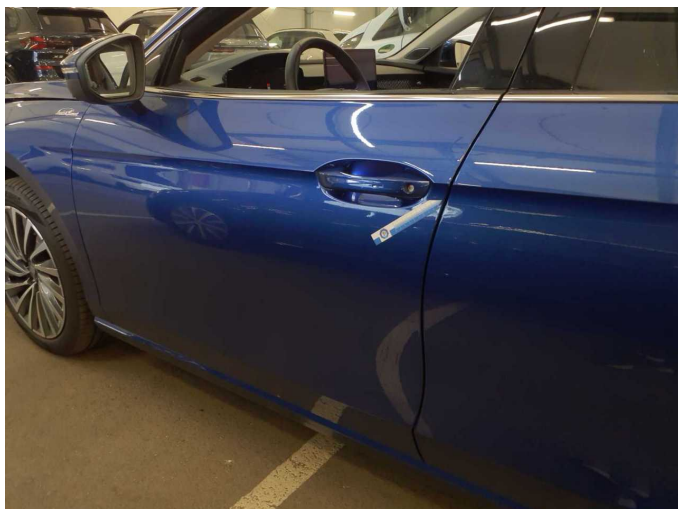
No.	Component group	Description
1	Door - front left side	Door edge - Scratch(es) - Smart repair

**Damage 1:** Door - front left side: Door edge - Scratch(es) - Smart repair
