Expertise

Protocol number: 46591614  
Order No. / Reference: 26607774  
Inspection date: 20 Jul 2026

Manufacturer: Ford

Model: Focus Turnier 1.0 EcoBoost Hybrid Aut. TITANIUM

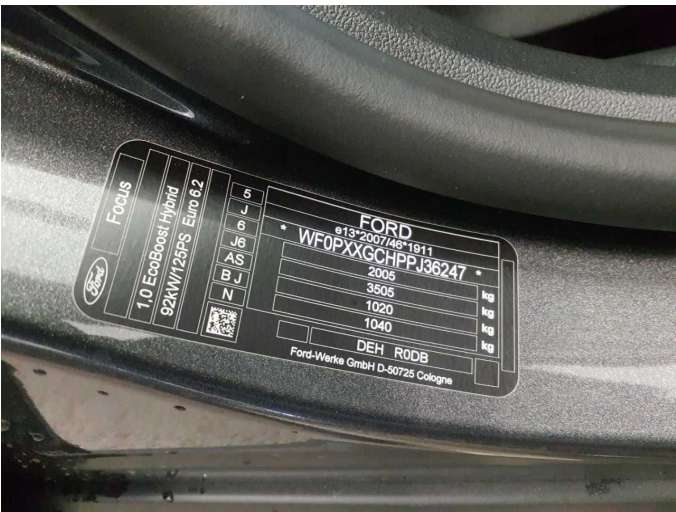
| VIN comparison | The vehicle identification number (VIN) was read from the vehicle and its conformity with the submitted documents was confirmed by the undersigned during the inspection. |

Figure 11: VIN

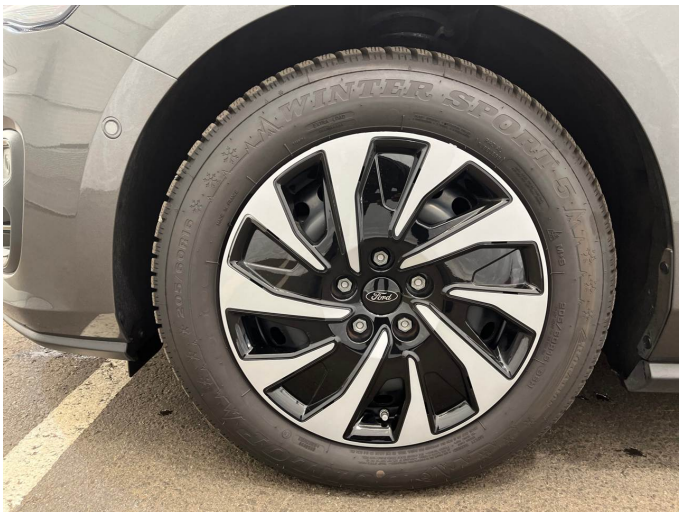
| # | Tyre size | Type of tyre | Manufacturer | Tread depth |
|---|---|---|---|---|
| 1) | 205/60 R16 96H | Winter tyres on Steel rim with wheel cover | Dunlop | 7mm / 7mm |
| 2) | 205/60 R16 96H | Winter tyres on Steel rim with wheel cover | Dunlop | 7mm / 7mm |

Figure 12: Mounted tyres

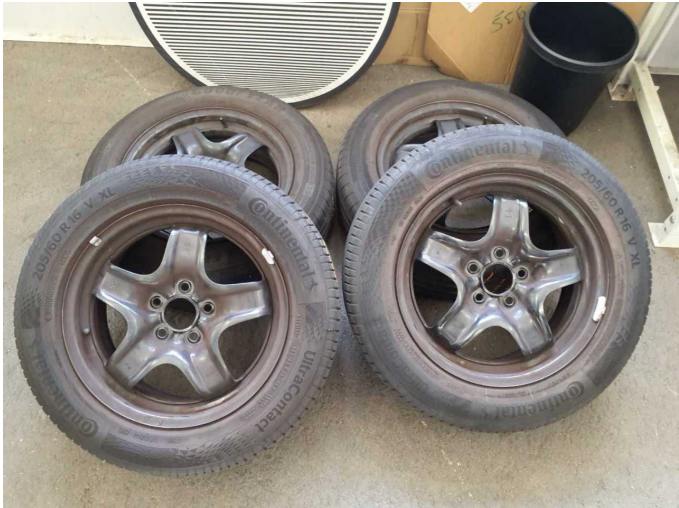
| # | Tyre size | Type of tyre | Manufacturer | Tread depth |
|---|---|---|---|---|
| 1) | 205/60 R16 96V | Summer tyres on Steel | Continental | 6mm / 6mm |
| 2) | 205/60 R16 96V | Summer tyres on Steel | Goodyear | 6mm / 6mm |

Figure 16: Additional tyres

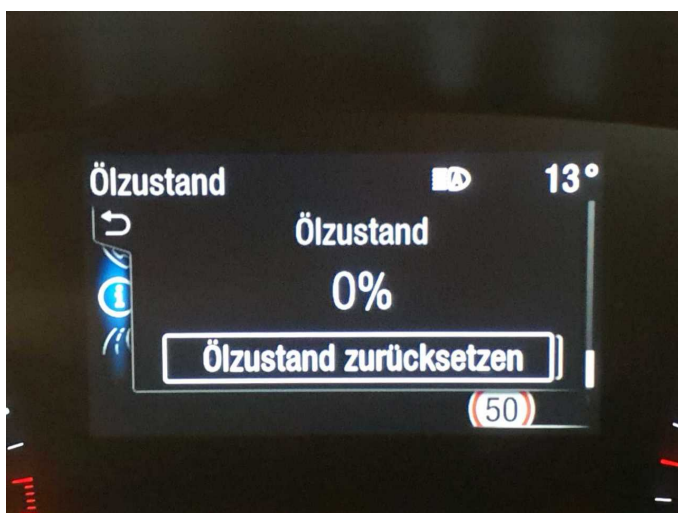
| No. | Component group | Description |
|---|---|---|
| 1 | Misc. | Inspection / maintenance - Due - Replace |

Damage 1: Misc.: Inspection / maintenance - Due - Replace

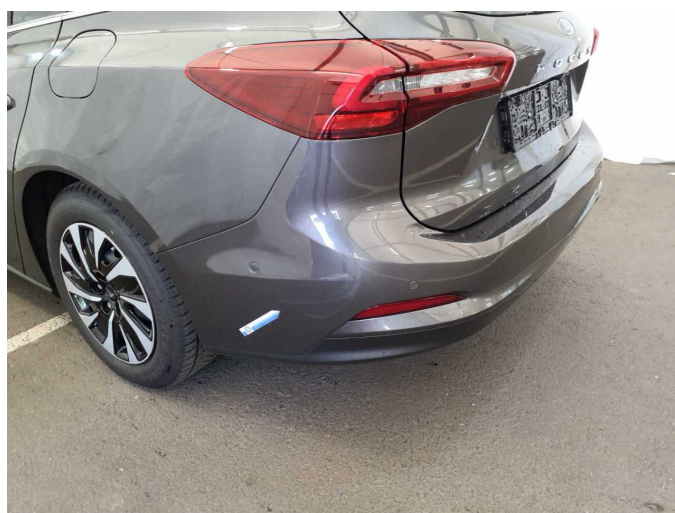
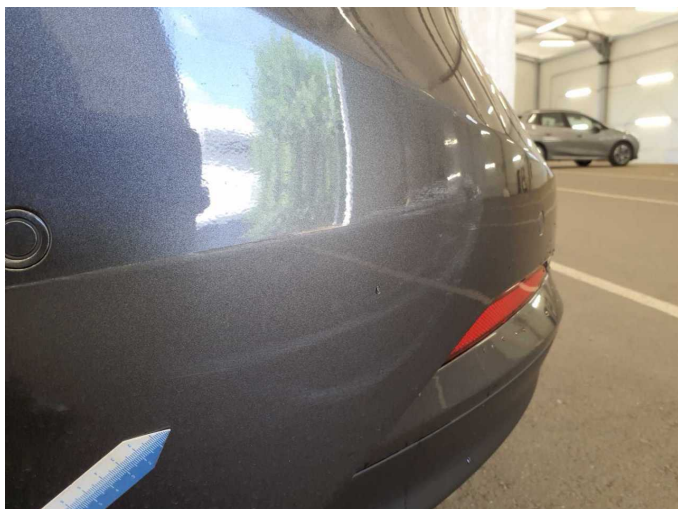
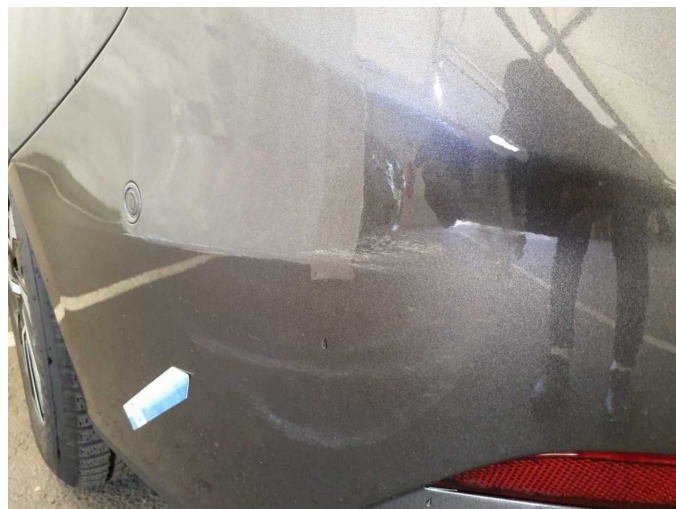
| No. | Component group | Description |
|---|---|---|
| 2 | Rear bumper | Rear bumper - Scratch(es) - Paint |

Damage 2: Rear bumper: Rear bumper - Scratch(es) - Paint

**Damage 2:** Rear bumper: Rear bumper - Scratch(es) - Paint
