Expertise

Protocol number: 46408002  
Order No. / Reference: 26628655  
Inspection date: 8 Jul 2026

Manufacturer: Ford

Model: Mondeo Turnier 2.0 EcoBlue Aut. Trend

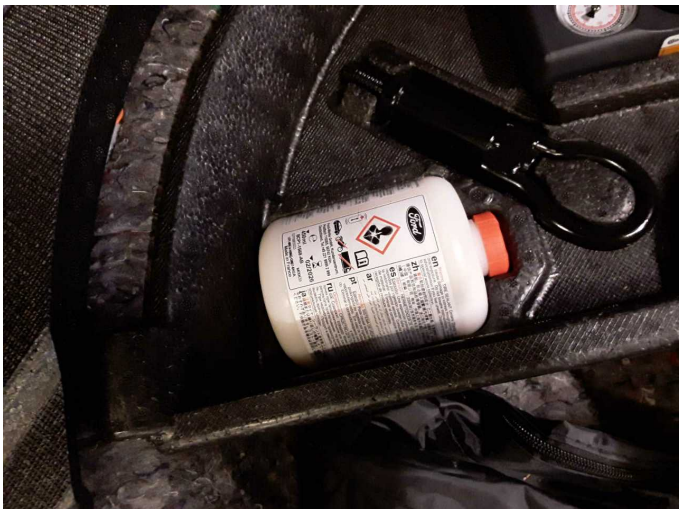
Damage 1: Equipment: Tirefit filler - Expired - Replace

| No. | Component group | Description |
|---|---|---|
| 1 | Equipment | Tirefit filler - Expired - Replace |

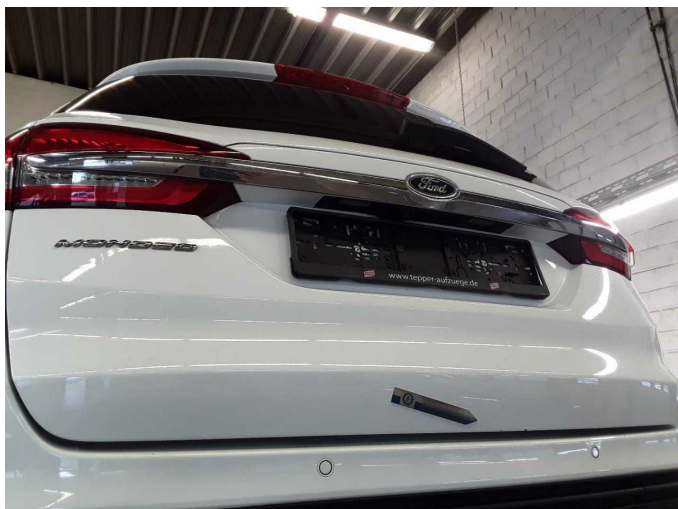
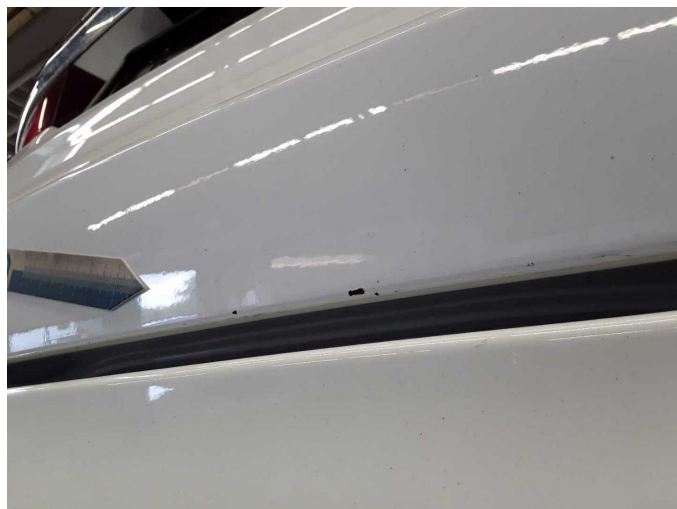
**Damage 2:** Boot lid / rear door: Boot lid - Scratch(es) - Smart repair

| No. | Component group | Description |
|---|---|---|
| 2 | Boot lid / rear door | Boot lid - Scratch(es) - Smart repair |

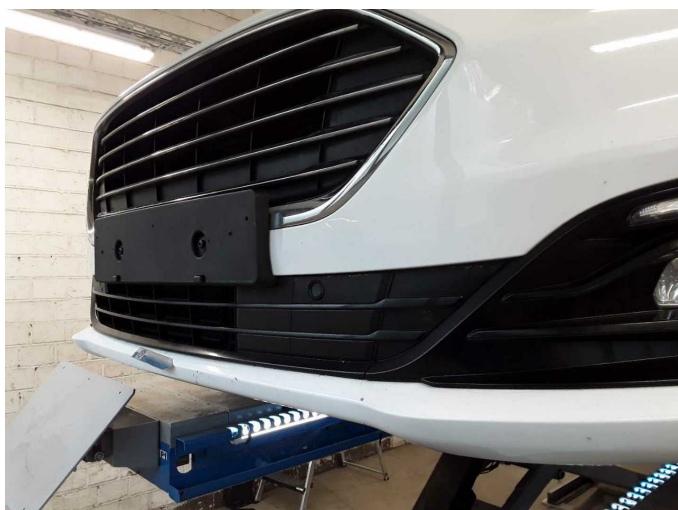
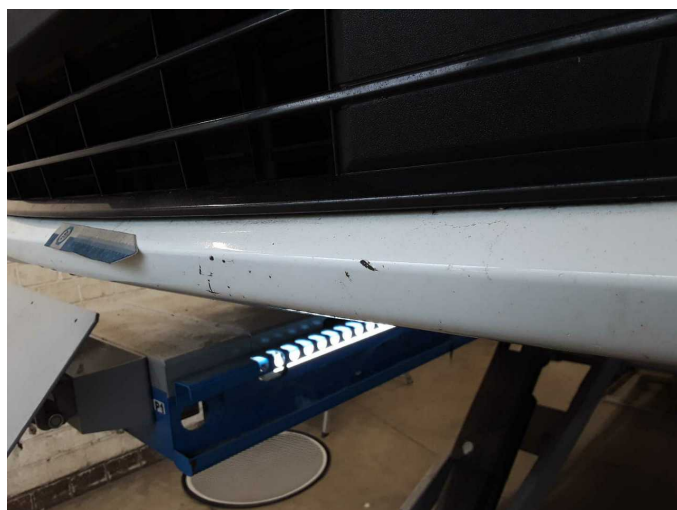
**Damage 3:** Front bumper: Front bumper - Scratch(es) - Smart repair

| No. | Component group | Description |
|---|---|---|
| 3 | Front bumper | Front bumper - Scratch(es) - Smart repair |

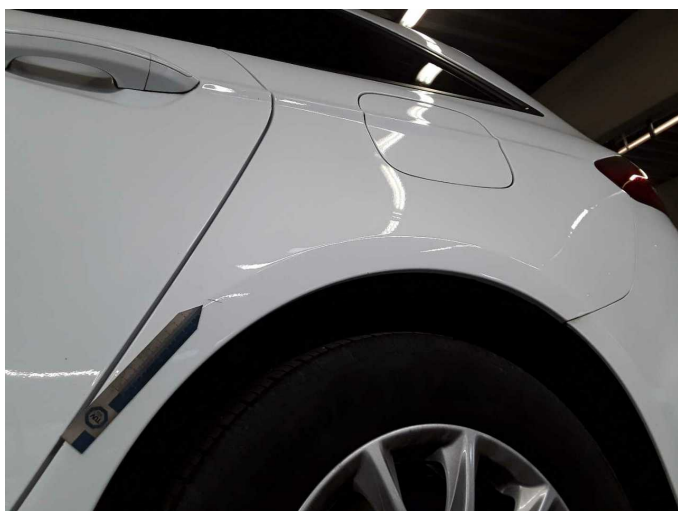
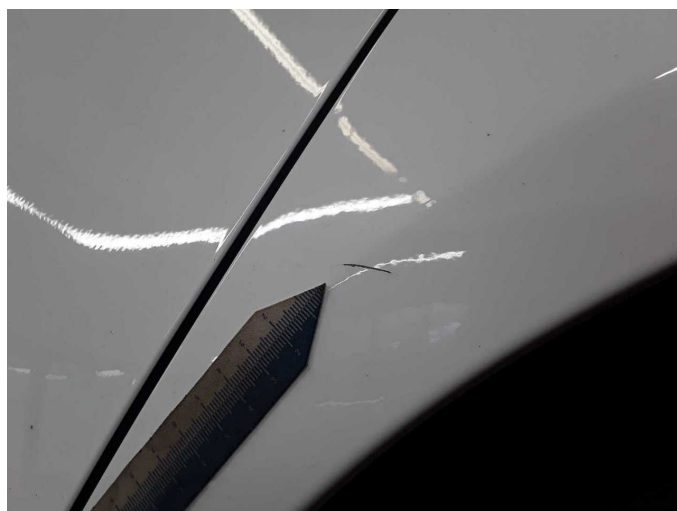
**Damage 4:** Side panel - rear left side: Side panel - Scratch(es) - Smart repair

| No. | Component group | Description |
|---|---|---|
| 4 | Side panel - rear left side | Side panel - Scratch(es) - Smart repair |

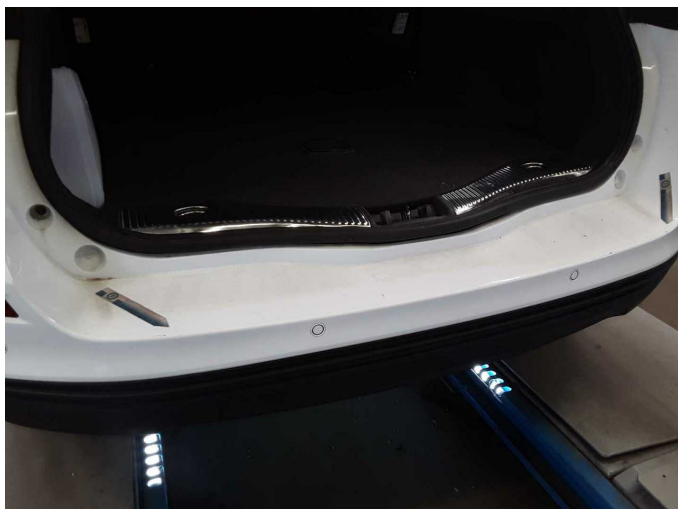
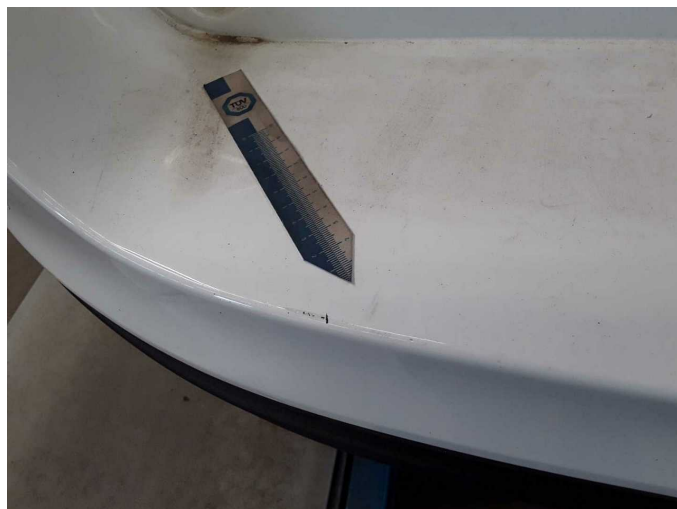
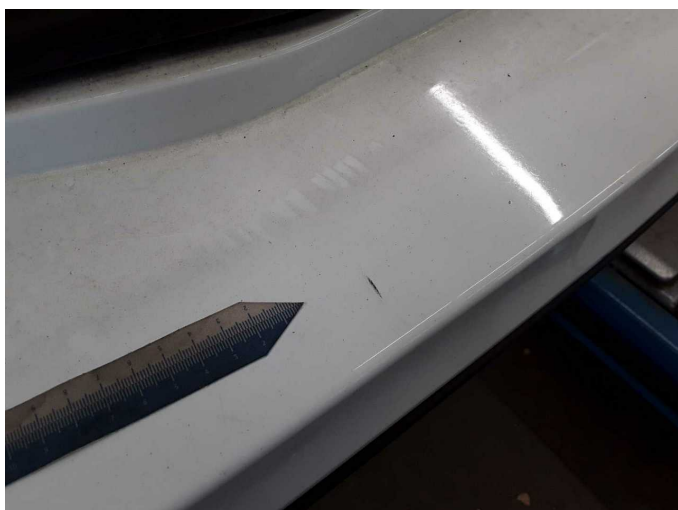
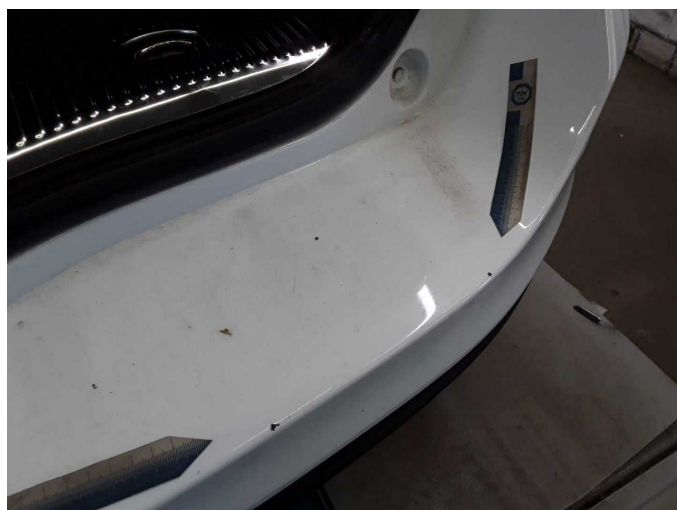
**Damage 5:** Rear bumper: Rear bumper - Scratch(es) - Smart repair

| No. | Component group | Description |
|---|---|---|
| 5 | Rear bumper | Rear bumper - Scratch(es) - Smart repair |

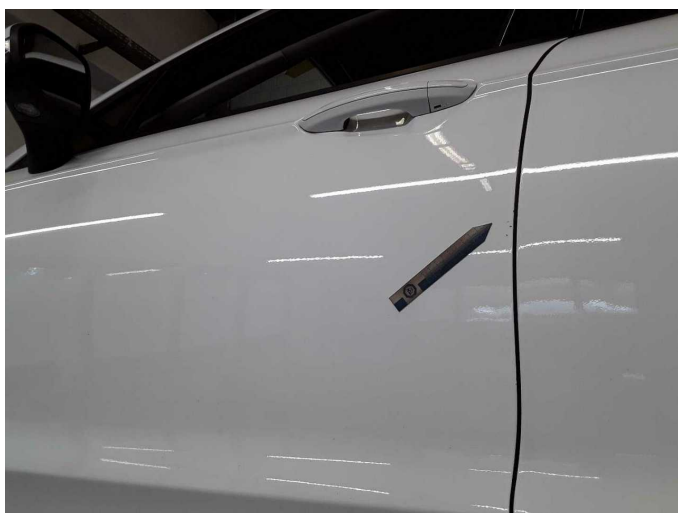
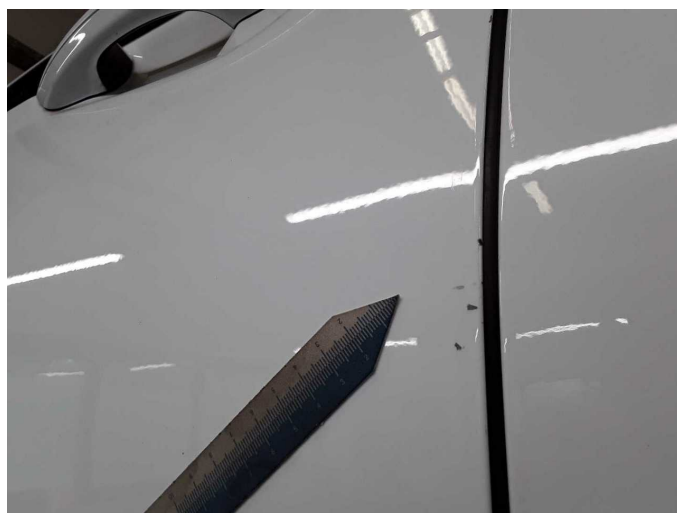
**Damage 7:** Door - front left side: Door - Scratch(es) - Paint

| No. | Component group | Description |
|---|---|---|
| 7 | Door - front left side | Door - Scratch(es) - Paint |

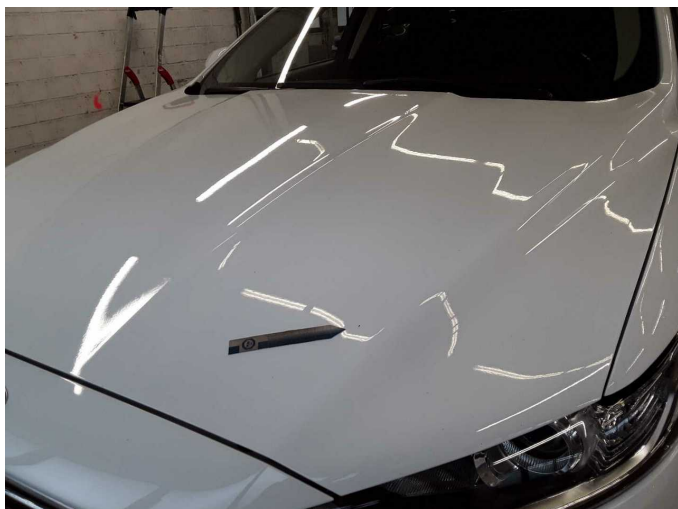
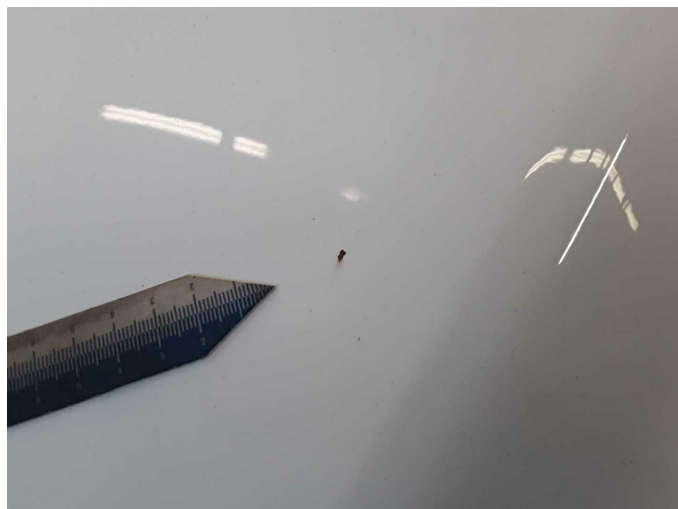
**Damage 8:** Bonnet: Bonnet - Corrosion - Repair and paint

| No. | Component group | Description |
|---|---|---|
| 8 | Bonnet | Bonnet - Corrosion - Repair and paint |
