Expertise

Protocol number: 46800753  
Order No. / Reference: 26754738  
Inspection date: 30 Jul 2026

Manufacturer: Audi  
VIN: WAUZZZGE1MB029551

Model: e-tron 55 quattro S line

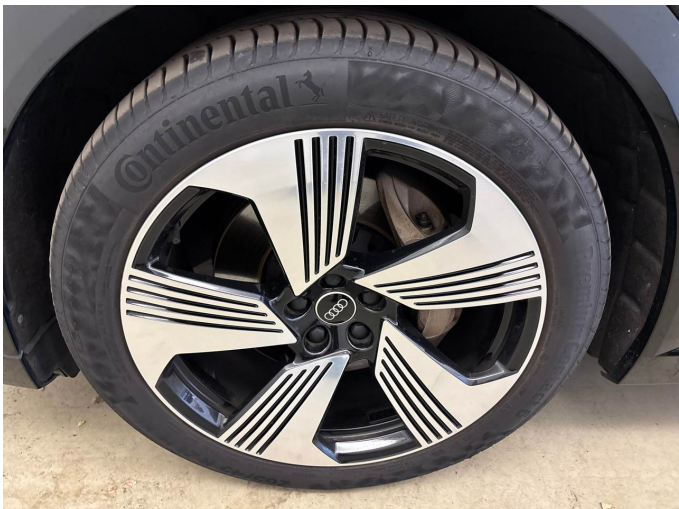
Figure 12: Mounted tyres

| # | Tyre size | Type of tyre | Manufacturer | Tread depth |
|---|---|---|---|---|
| 1) | 265/45 R21 108H | Summer tyres on Light alloy | Continental | 5mm / 5mm |
| 2) | 265/45 R21 108H | Summer tyres on Light alloy | Continental | 6mm / 6mm |

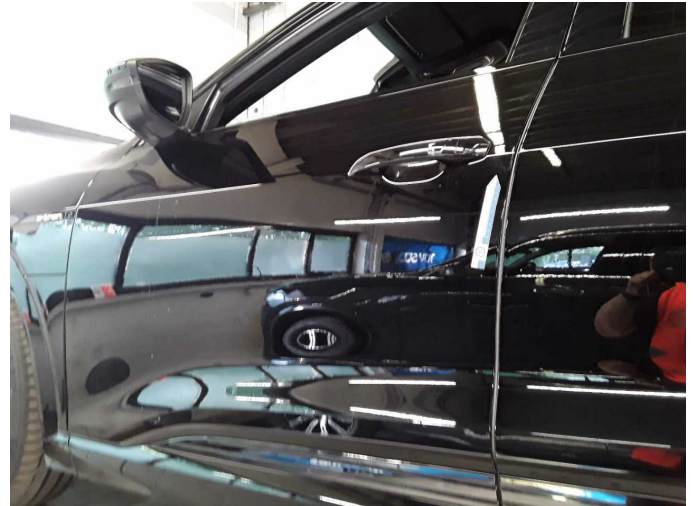
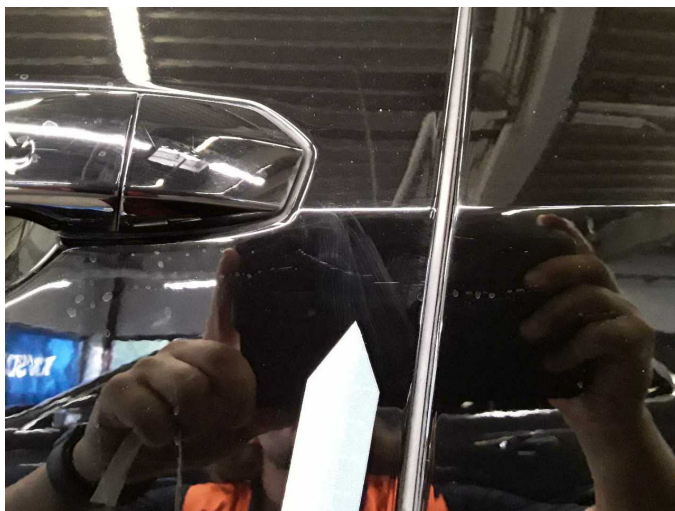
**Damage 1:** Door - front left side: Door - Scratch(es) - Cover / polish

| No. | Component group | Description |
|---|---|---|
| 1 | Door - front left side | Door - Scratch(es) - Cover / polish |

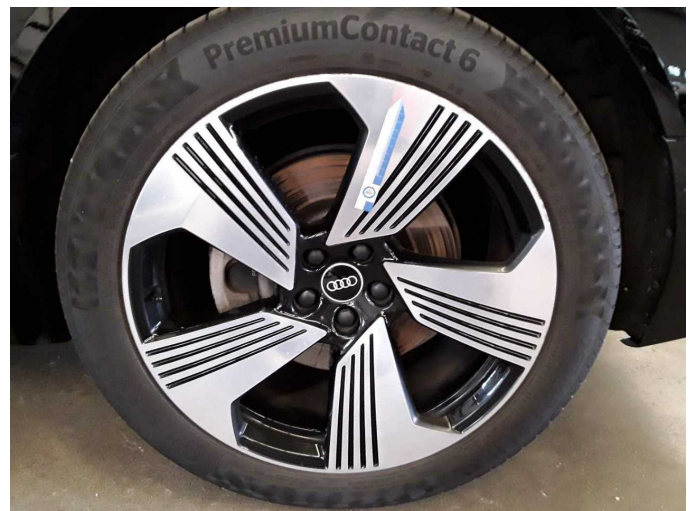
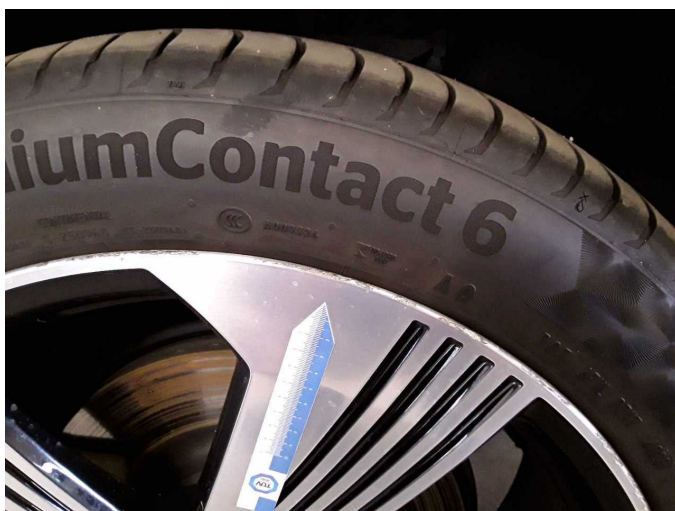
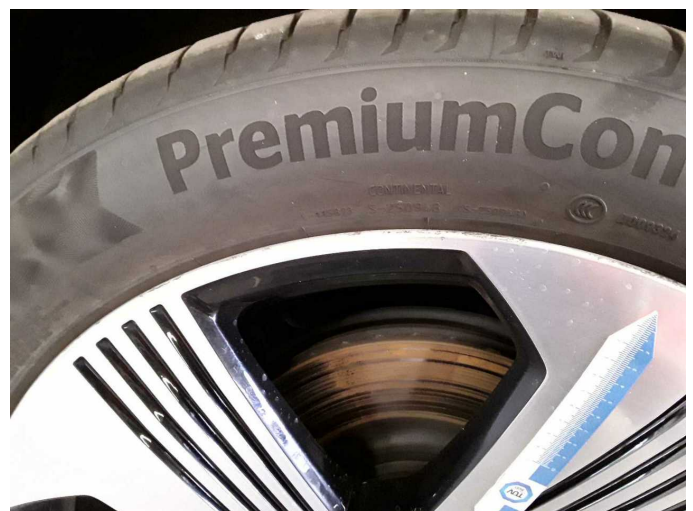
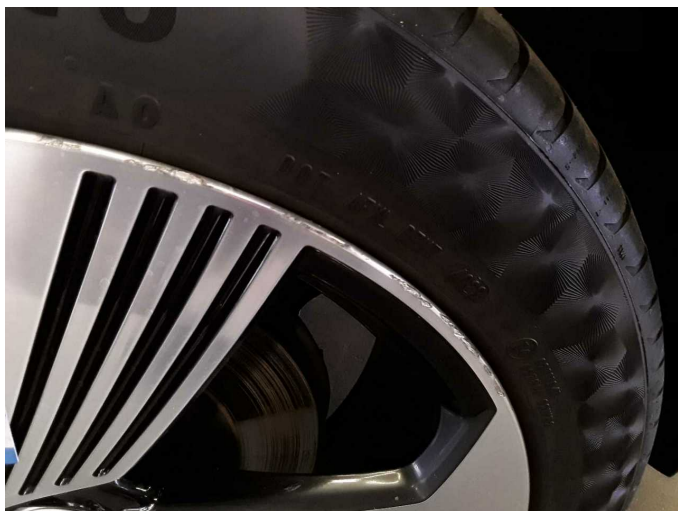
**Damage 2:** Wheel / tyres: Alloy rim - rear left side - Scratch(es) - Loss in value

| No. | Component group | Description |
|---|---|---|
| 2 | Wheel / tyres | Alloy rim - rear left side - Scratch(es) - Loss in value |

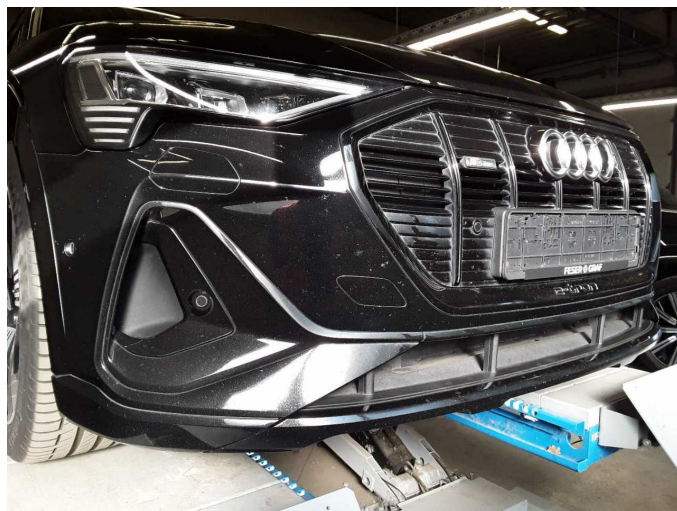
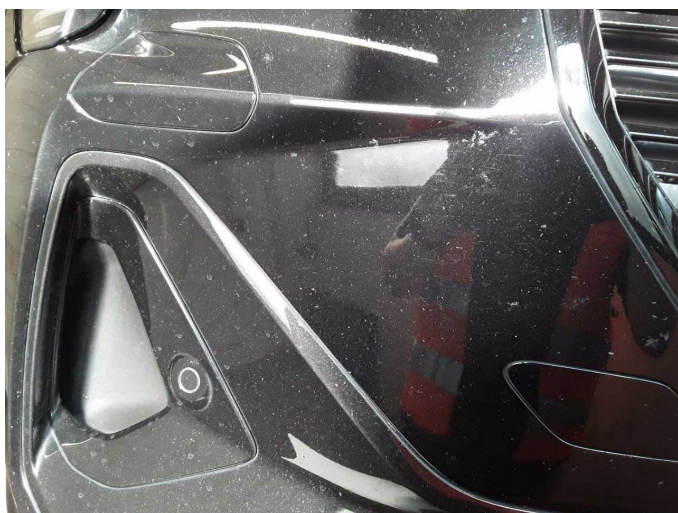
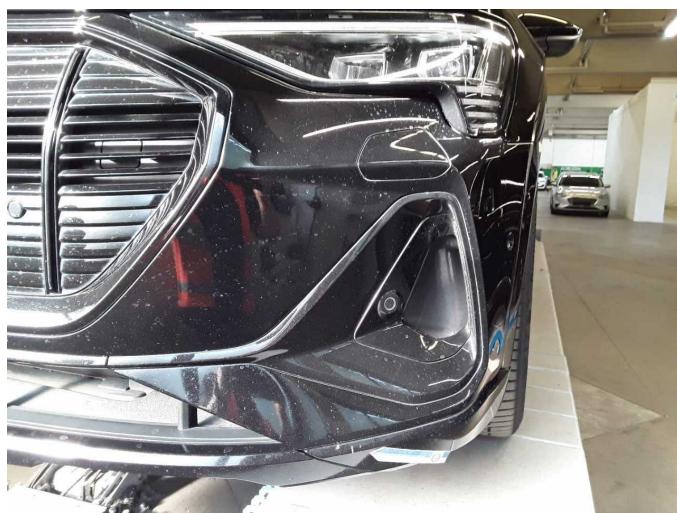
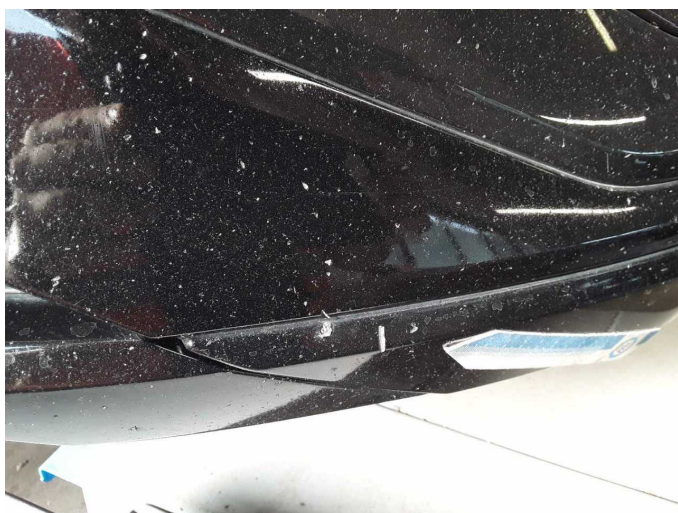
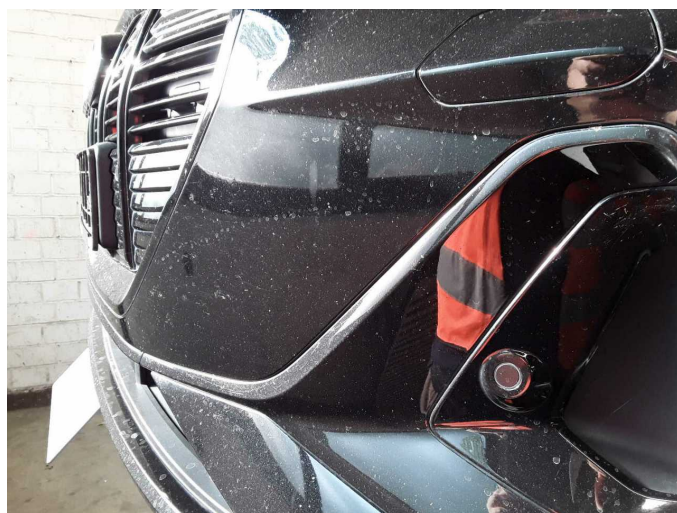
**Damage 3:** Front bumper: Front bumper - Stone chips - Paint

| No. | Component group | Description |
|---|---|---|
| 3 | Front bumper | Front bumper - Stone chips - Paint |

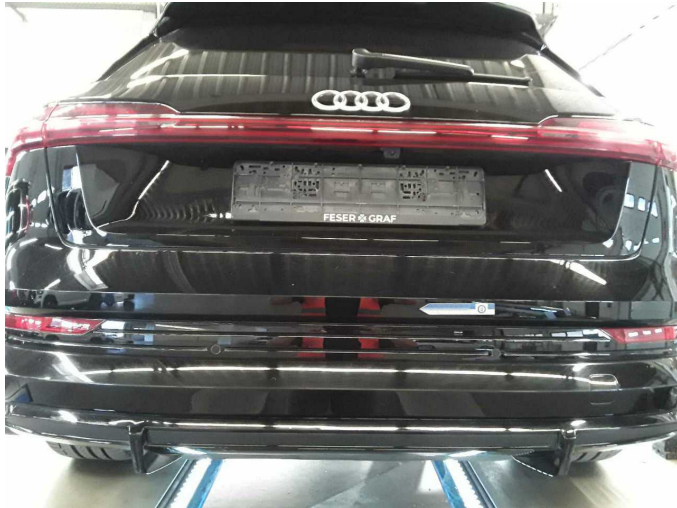
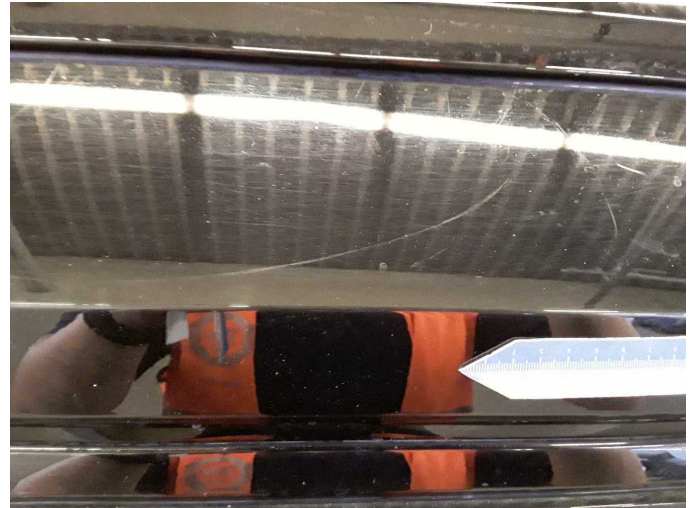
**Wear and tear 1:** Rear bumper: Rear bumper - Scratch(es) - No deduction

| No. | Component group | Description |
|---|---|---|
| 1 | Rear bumper | Rear bumper - Scratch(es) - No deduction |

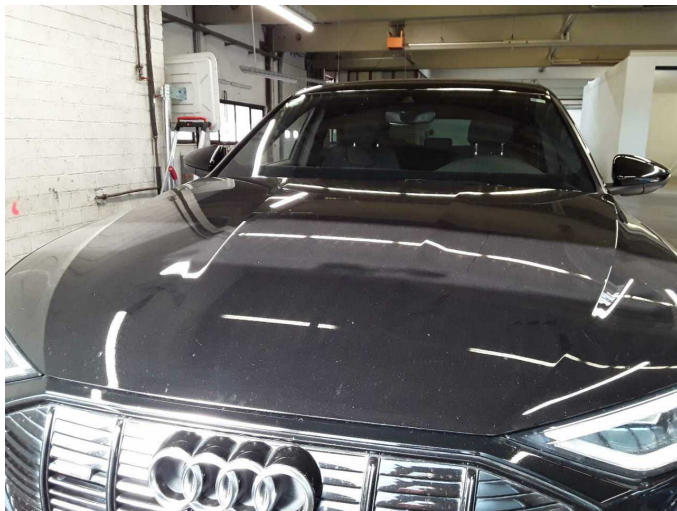
**Wear and tear 2:** Bonnet: Bonnet - Stone chips - No deduction

| No. | Component group | Description |
|---|---|---|
| 2 | Bonnet | Bonnet - Stone chips - No deduction |
