Expertise

Protocol number: 46275039  
Order No. / Reference: 26565741  
Inspection date: 25 Jun 2026

Manufacturer: Volvo

Model: V90 T6 Recharge AWD Plus Bright

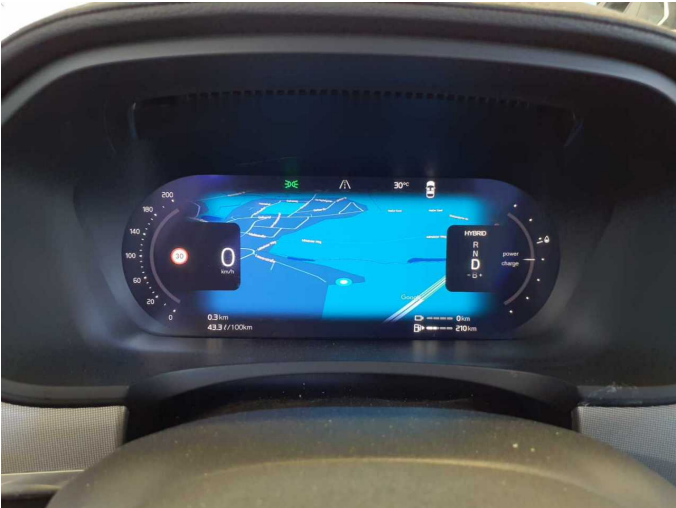
| Vehicle details | |
|---|---|
| Mileage (Read) | 100,796 km |

Figure 7: Instrument cluster

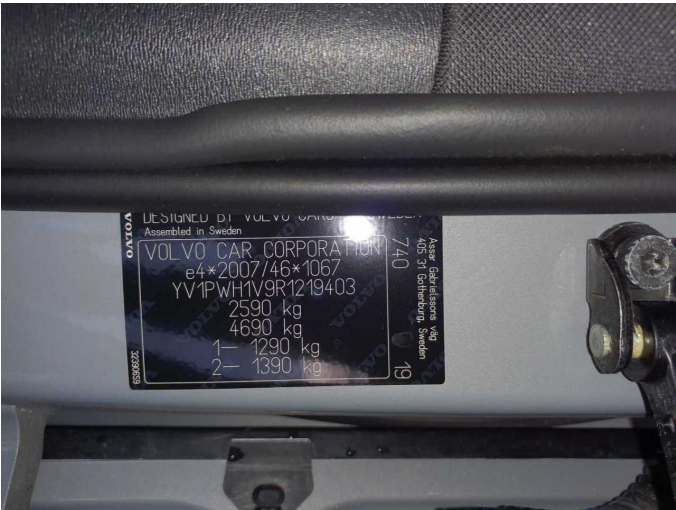
| VIN comparison | The vehicle identification number (VIN) was read from the vehicle and its conformity with the submitted documents was confirmed by the undersigned during the inspection. |

Figure 11: VIN

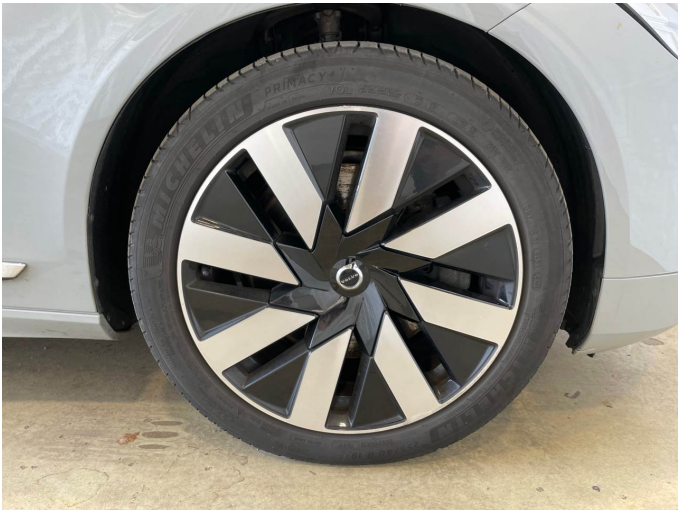
| # | Tyre size | Type of tyre | Manufacturer | Tread depth |
|---|---|---|---|---|
| 1) | 255/40 R19 100W | Summer tyres on Light alloy | Michelin | 5mm / 5mm |
| 2) | 255/40 R19 100W | Summer tyres on Light alloy | Michelin | 5mm / 5mm |

Figure 12: Mounted tyres

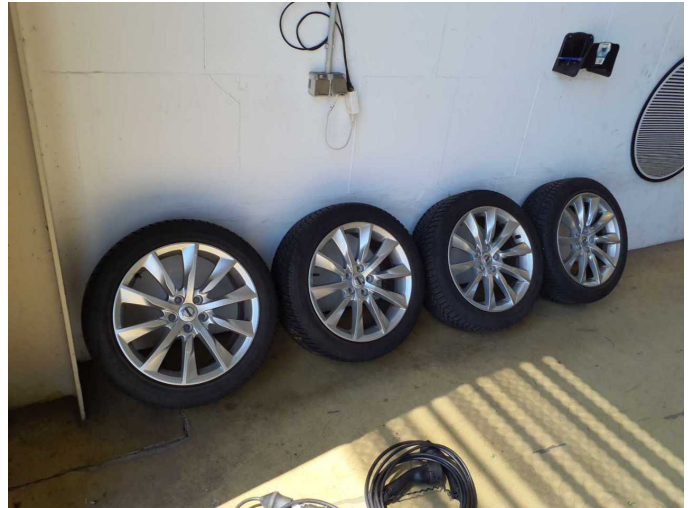
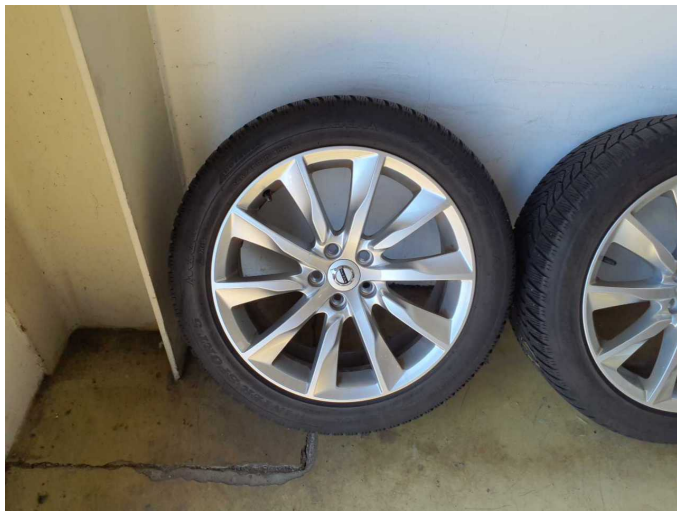
| # | Tyre size | Type of tyre | Manufacturer | Tread depth |
|---|---|---|---|---|
| 1) | 245/45 R18 100V | Winter tyres on Light alloy | Dunlop | 5mm / 5mm |
| 2) | 245/45 R18 100V | Winter tyres on Light alloy | Dunlop | 6mm / 6mm |

Figure 14: Additional tyres

Figure 15: Additional tyres

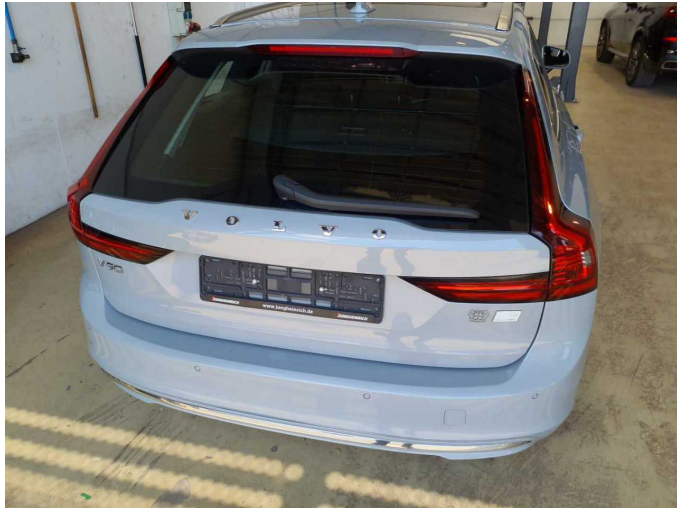
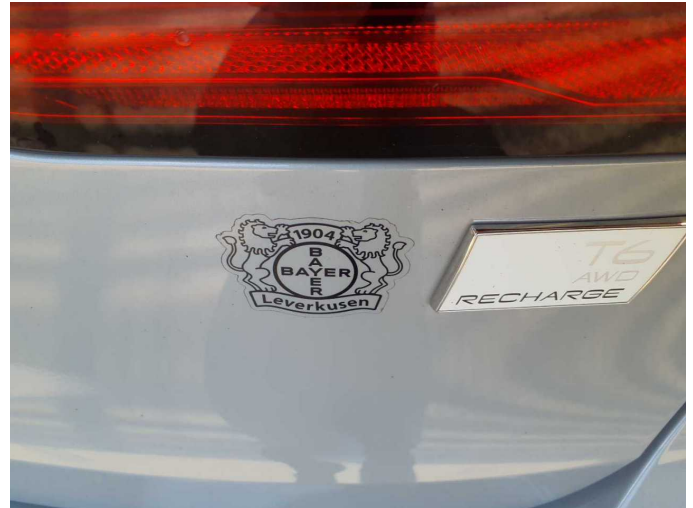
| No. | Component group | Description |
|---|---|---|
| 1 | Boot lid / rear door | Boot lid - Glued / labelled - De-glue / neutralise |

**Damage 1:** Boot lid / rear door: Boot lid - Glued / labelled - De-glue / neutralise

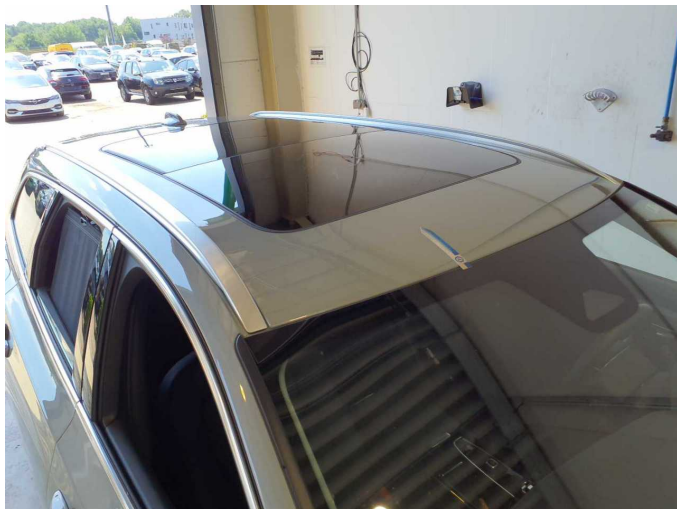
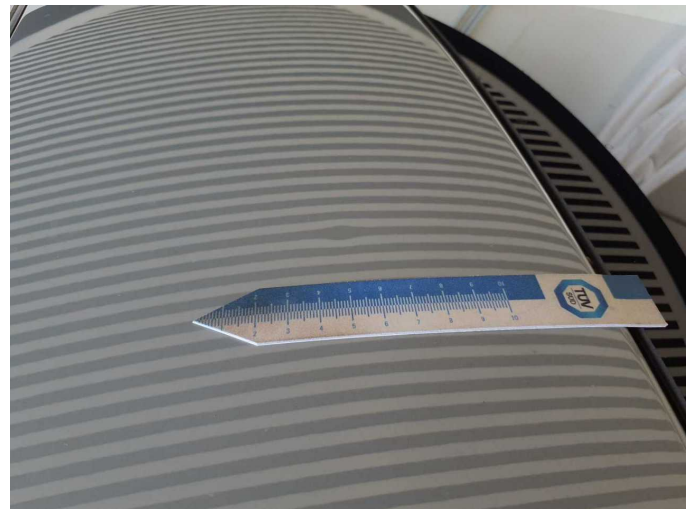
| No. | Component group | Description |
|---|---|---|
| 2 | Roof | Roof - dent(s) - Smooth repair work |

**Damage 2:** Roof: Roof - dent(s) - Smooth repair work

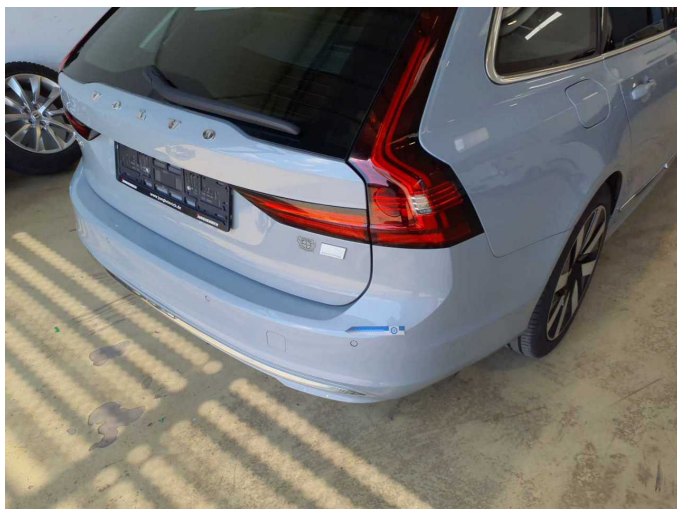
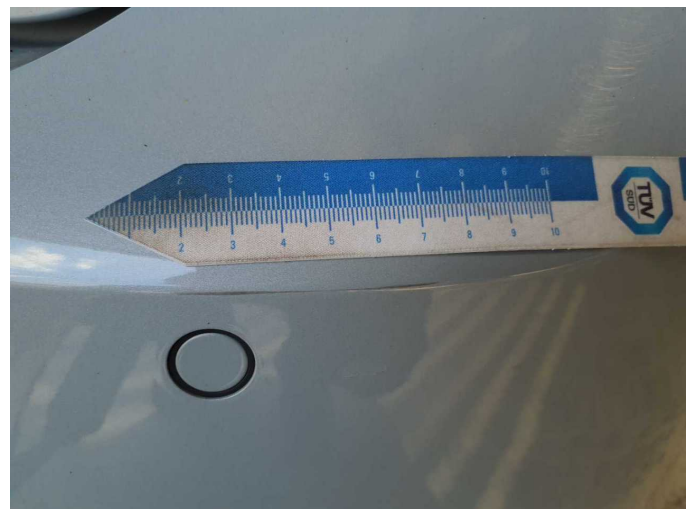
| No. | Component group | Description |
|---|---|---|
| 3 | Rear bumper | Rear bumper - Scratch(es) - Smart repair |

**Damage 3:** Rear bumper: Rear bumper - Scratch(es) - Smart repair

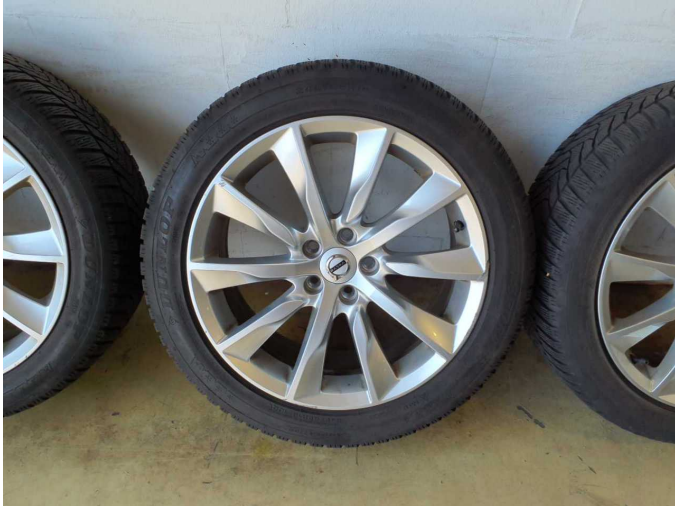
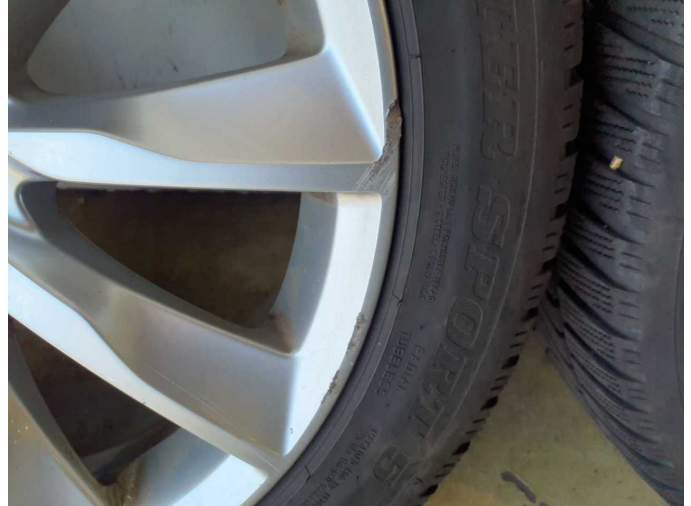
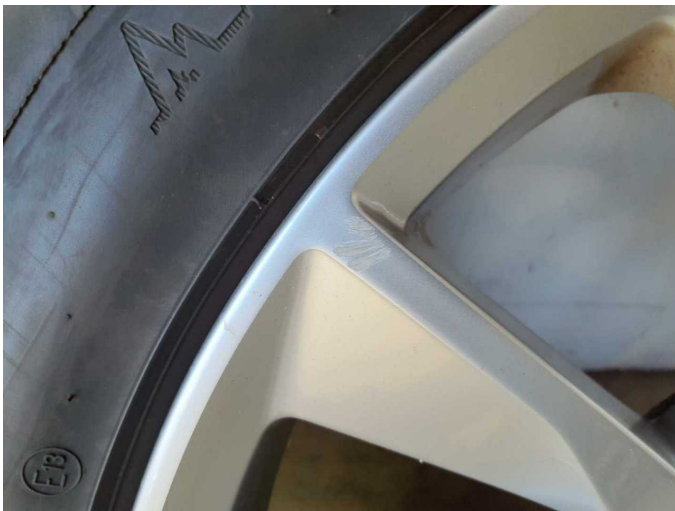
| No. | Component group | Description |
|---|---|---|
| 4 | 2nd wheel set | 1 alloy rim - Scratched - Loss in value |

**Damage 4:** 2nd wheel set: 1 alloy rim - Scratched - Loss in value

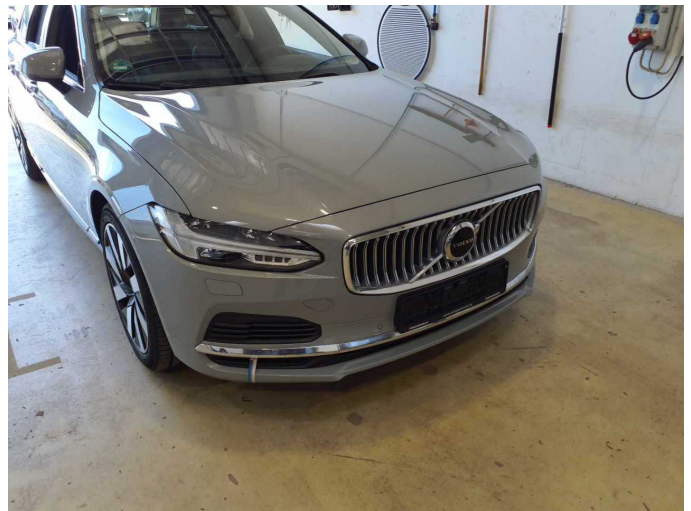
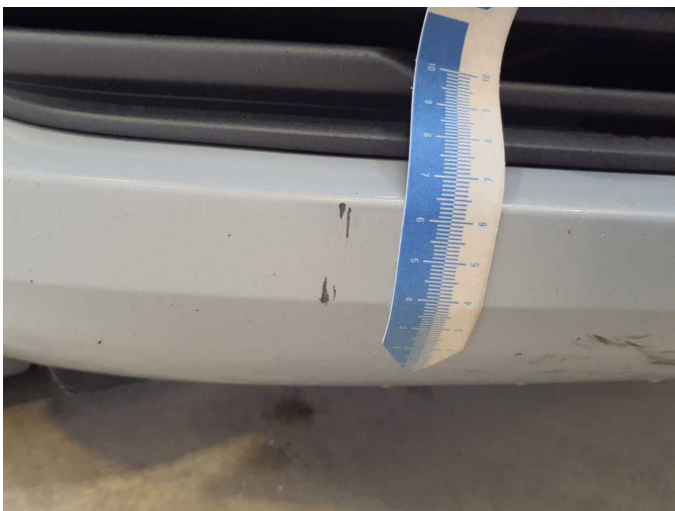
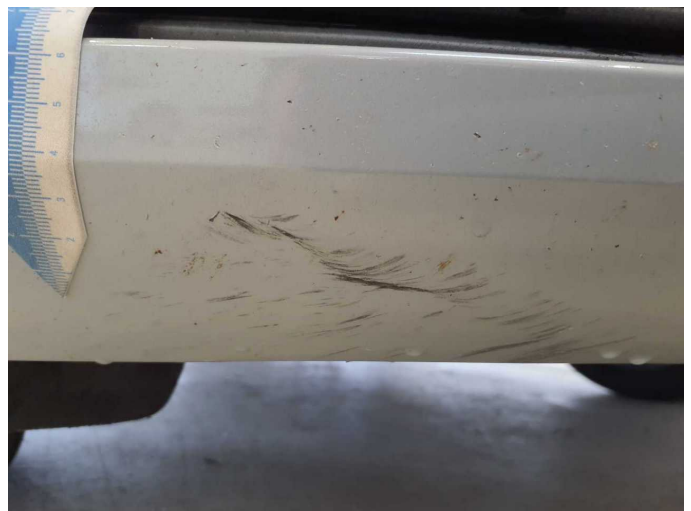
| No. | Component group | Description |
|---|---|---|
| 5 | Front bumper | Front bumper - Scratched - Paint |

**Damage 5:** Front bumper: Front bumper - Scratched - Paint

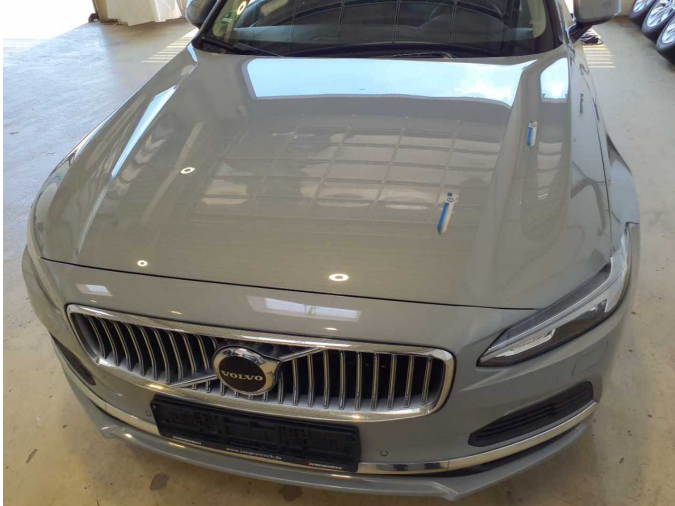
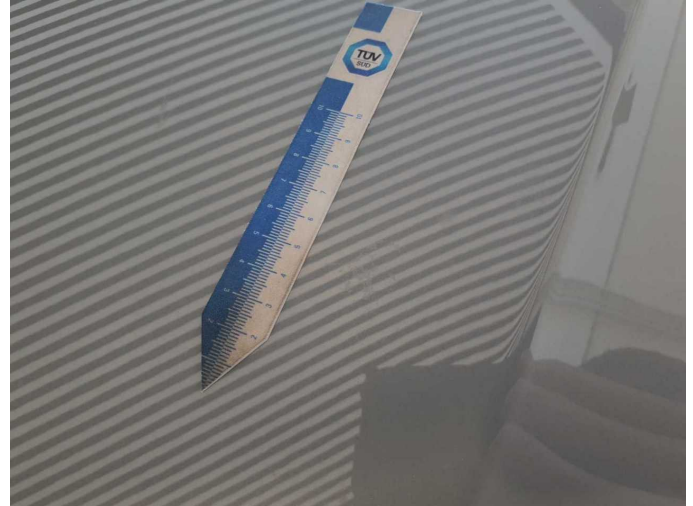
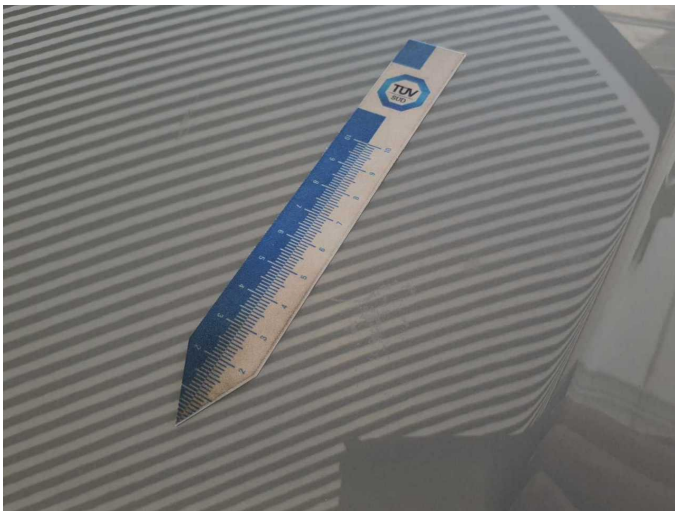
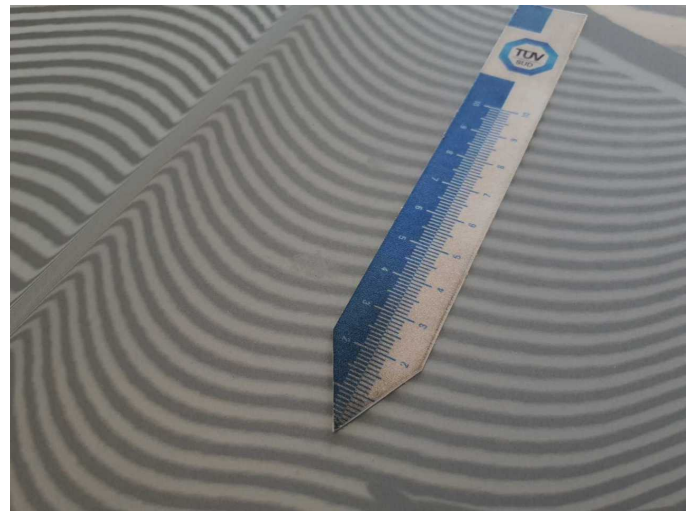
| No. | Component group | Description |
|---|---|---|
| 6 | Bonnet | Bonnet (Anätzung) - Paint defect - Paint |

**Damage 6:** Bonnet: Bonnet (Anätzung) - Paint defect - Paint

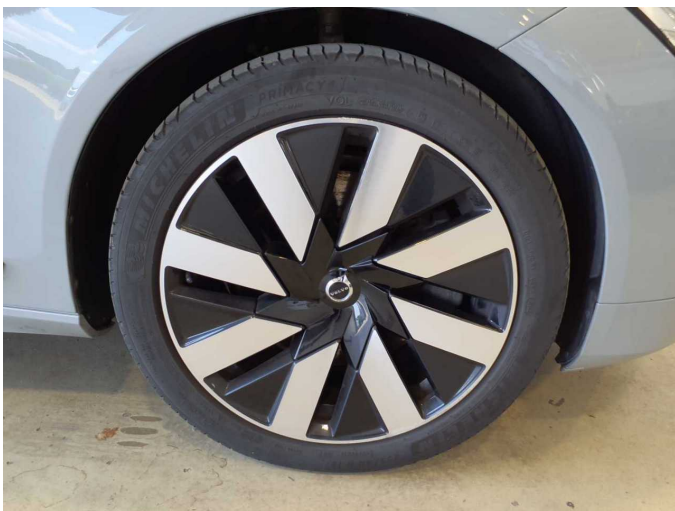
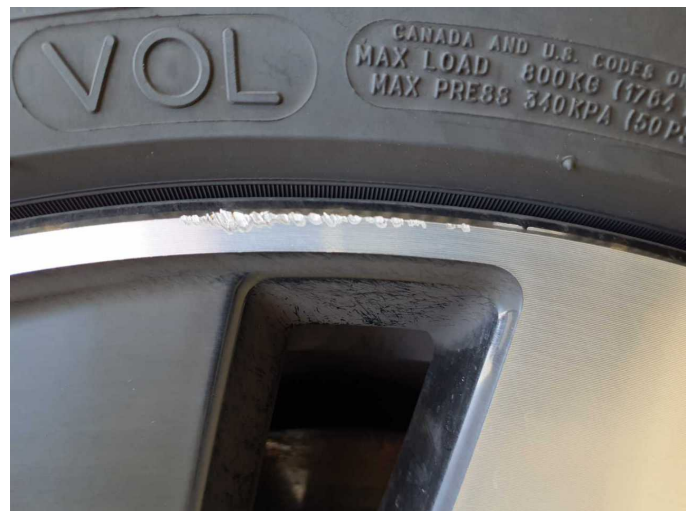
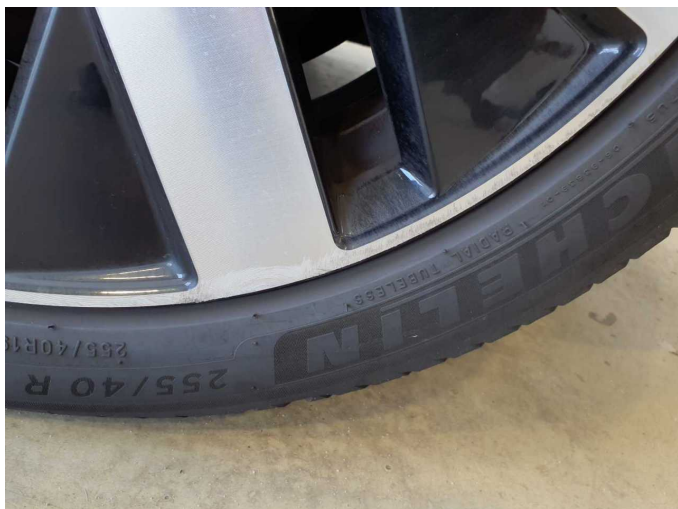
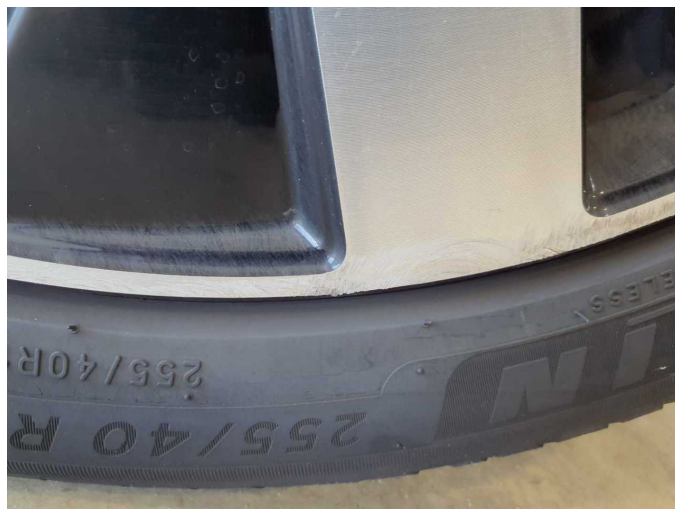
| No. | Component group | Description |
|---|---|---|
| 7 | Wheel / tyres | Alloy rim - front right side - Scratch(es) - Replace |

**Damage 7:** Wheel / tyres: Alloy rim - front right side - Scratch(es) - Replace
