Expertise

Protocol number: 46537350  
Order No. / Reference: 26630191  
Inspection date: 15 Jul 2026

Manufacturer: Skoda  
VIN: TMBJC7NY0PF037219

Model: Enyaq iV 80

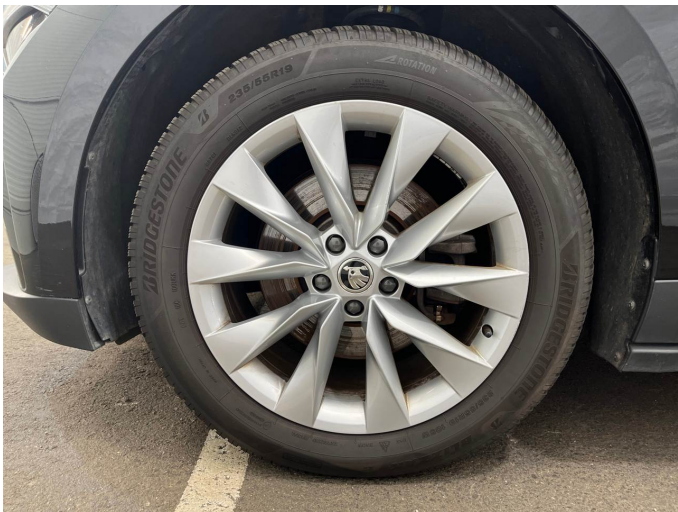
| # | Tyre size | Type of tyre | Manufacturer | Tread depth |
|---|---|---|---|---|
| 1) | 235/55 R19 105W | Winter tyres on Light alloy | Bridgestone | 7mm / 7mm |
| 2) | 255/50 R19 107W | Winter tyres on Light alloy | Bridgestone | 5mm / 5mm |

Figure 12: Mounted tyres

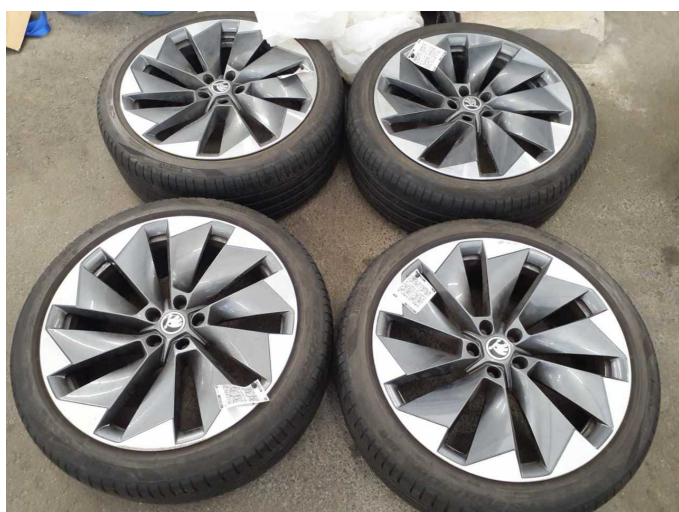
| # | Tyre size | Type of tyre | Manufacturer | Tread depth |
|---|---|---|---|---|
| 1) | 235/40 R21 102T | Summer tires (with run-flat tires) on Light alloy | Pirelli | 5mm / 5mm |
| 2) | 255/40 R21 102T | Summer tires (with run-flat tires) on Light alloy | Pirelli | 4mm / 4mm |

Figure 15: Additional tyres

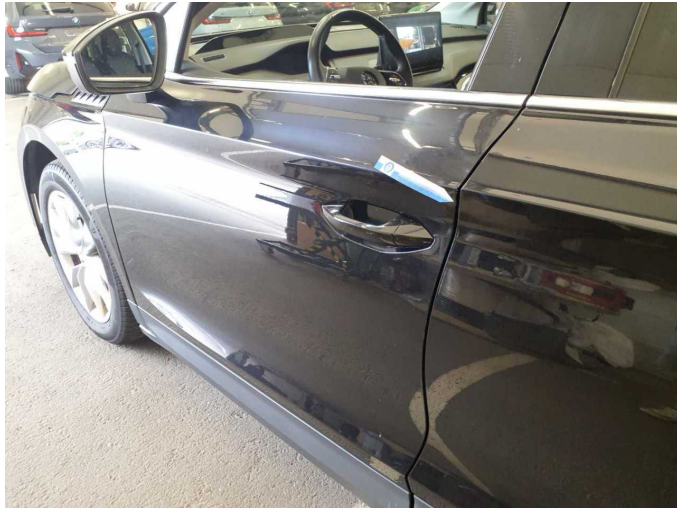
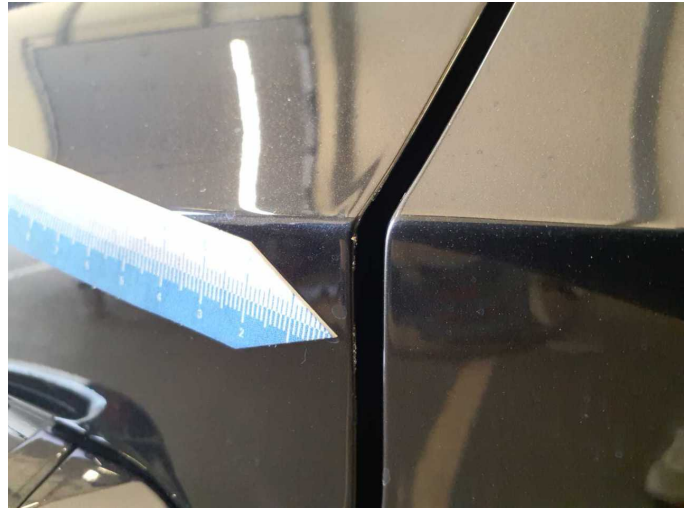
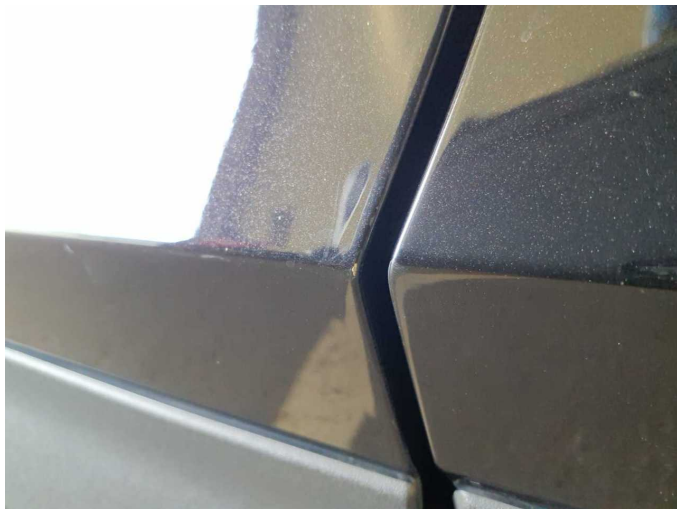
| No. | Component group | Description |
|---|---|---|
| 1 | Door - front left side | Door edge - Scratch(es) - Smart repair |

**Damage 1:** Door - front left side: Door edge - Scratch(es) - Smart repair

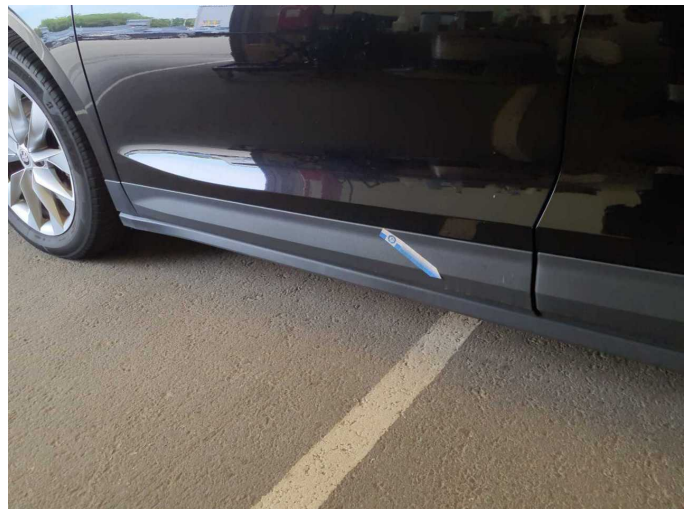
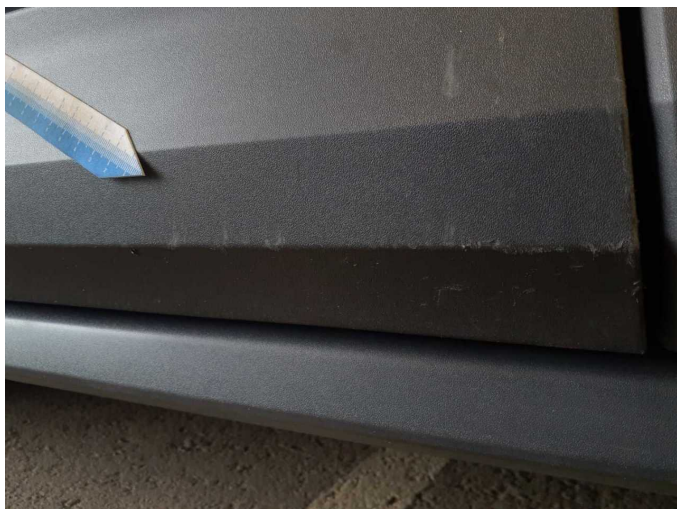
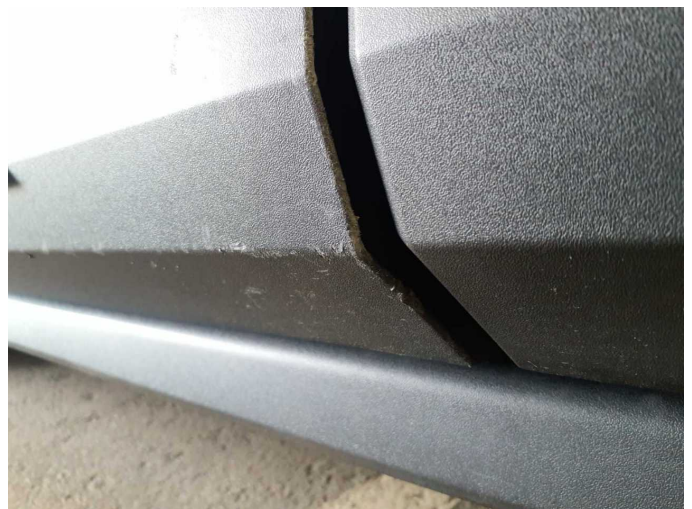
| No. | Component group | Description |
|---|---|---|
| 2 | Door - front left side | Brightware - lower - Scratch(es) - Loss in value |

**Damage 2:** Door - front left side: Brightware - lower - Scratch(es) - Loss in value

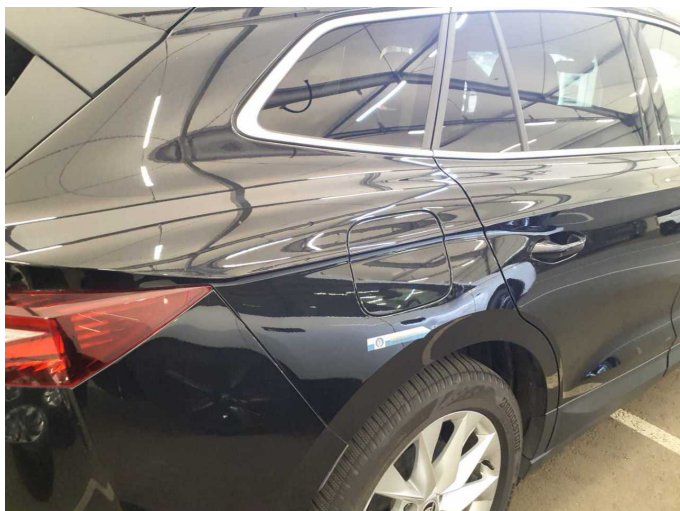
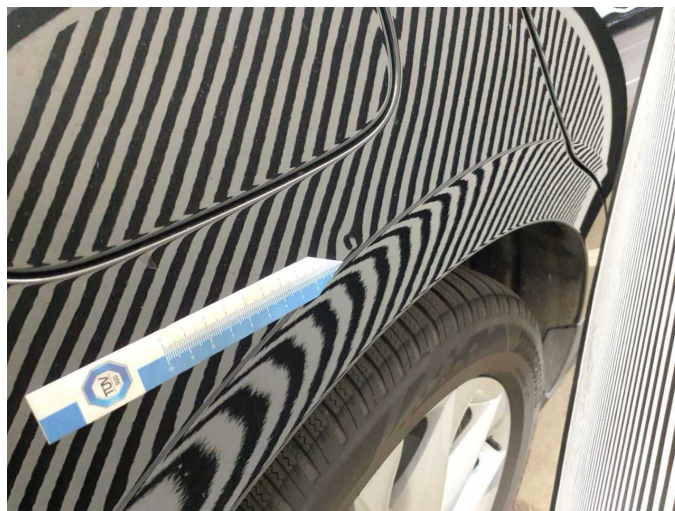
| No. | Component group | Description |
|---|---|---|
| 3 | Side panel - rear right side | Side panel - dent(s) - Smart repair |

**Damage 3:** Side panel - rear right side: Side panel - dent(s) - Smart repair

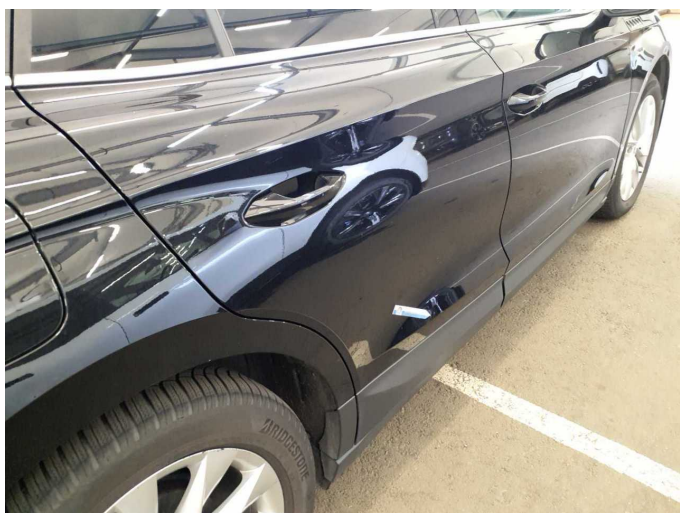
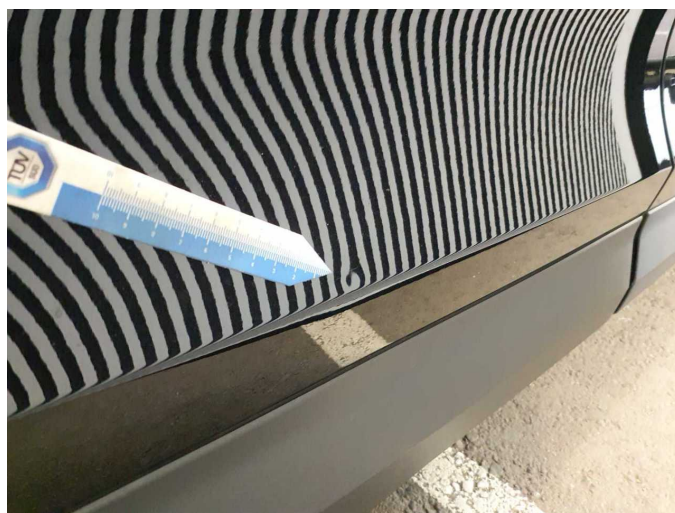
| No. | Component group | Description |
|---|---|---|
| 4 | Door - rear right side | Door - dent(s) - Smart repair |

**Damage 4:** Door - rear right side: Door - dent(s) - Smart repair

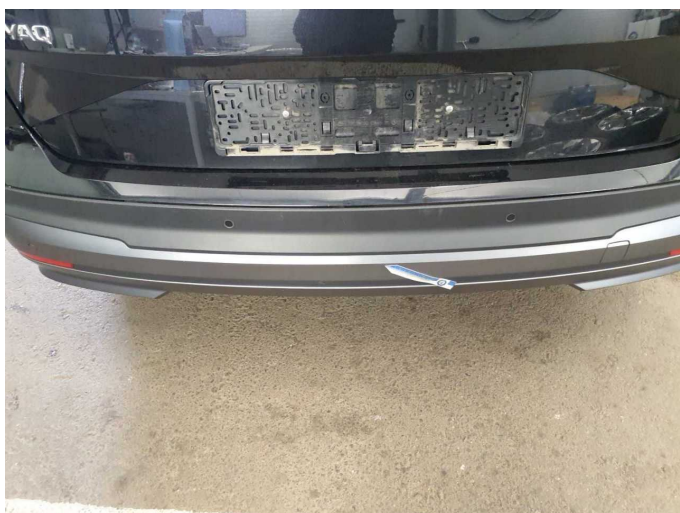
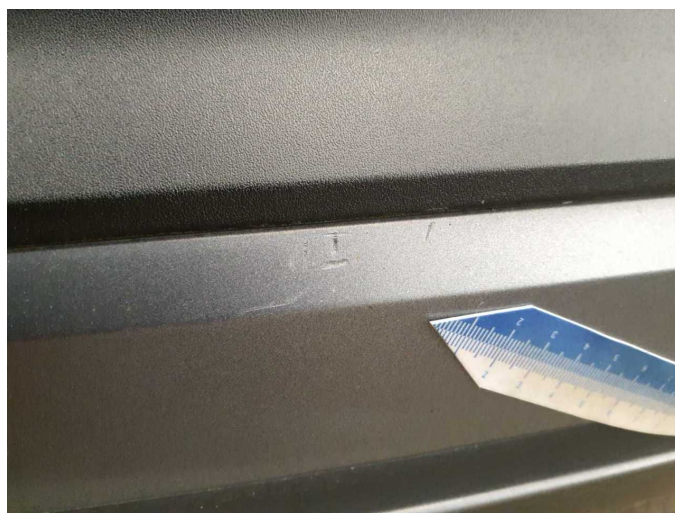
| No. | Component group | Description |
|---|---|---|
| 5 | Rear bumper | Spoiler - Scratch(es) - Loss in value |

**Damage 5:** Rear bumper: Spoiler - Scratch(es) - Loss in value

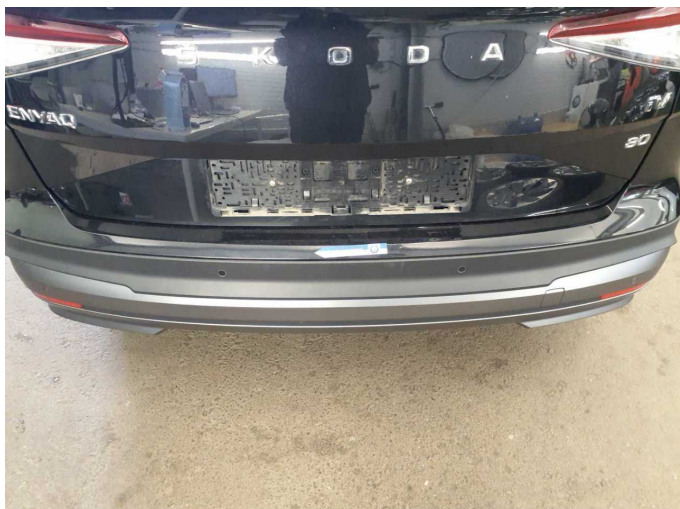
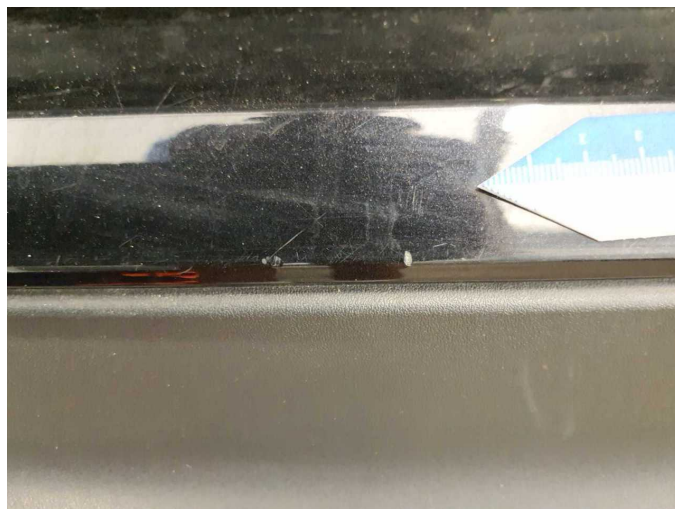
| No. | Component group | Description |
|---|---|---|
| 6 | Rear bumper | Rear bumper - Scratch(es) - Smart repair |

**Damage 6:** Rear bumper: Rear bumper - Scratch(es) - Smart repair

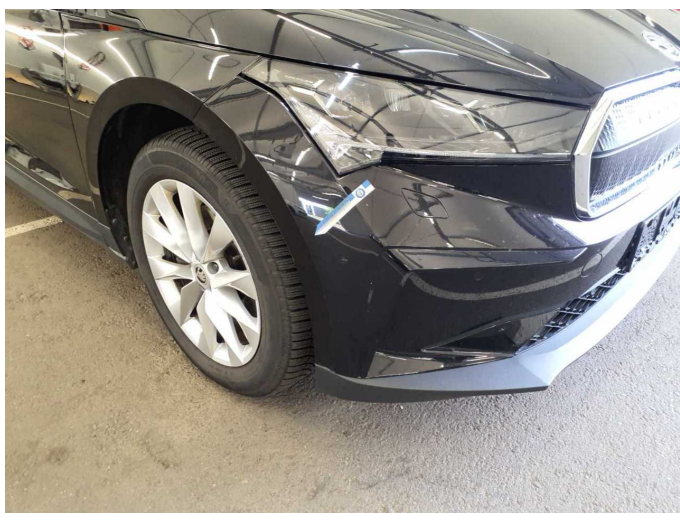
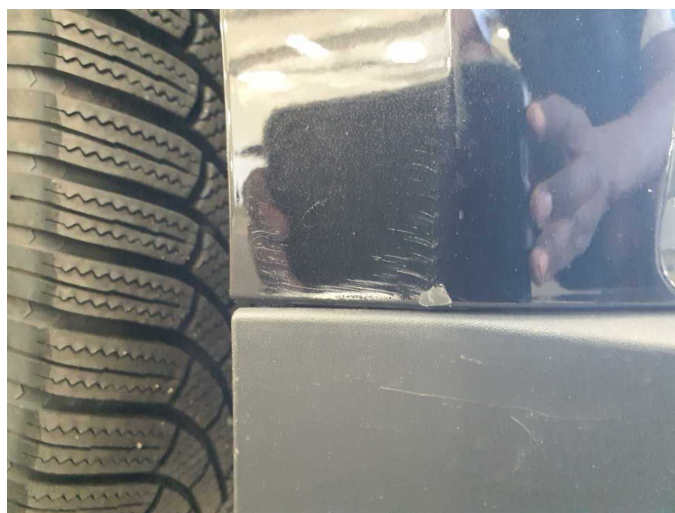
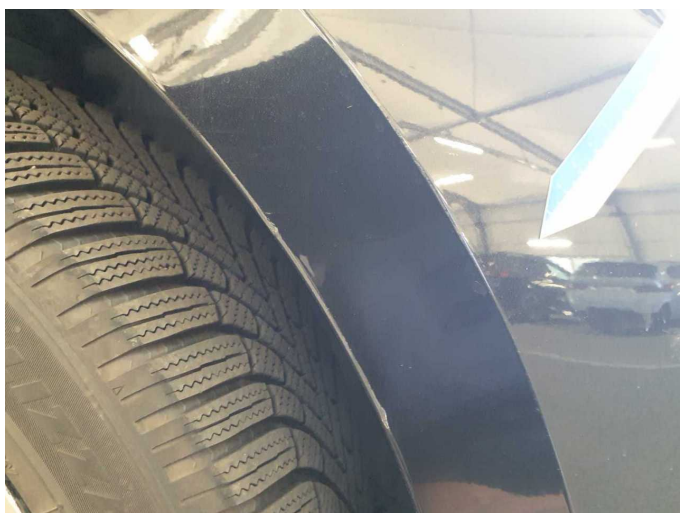
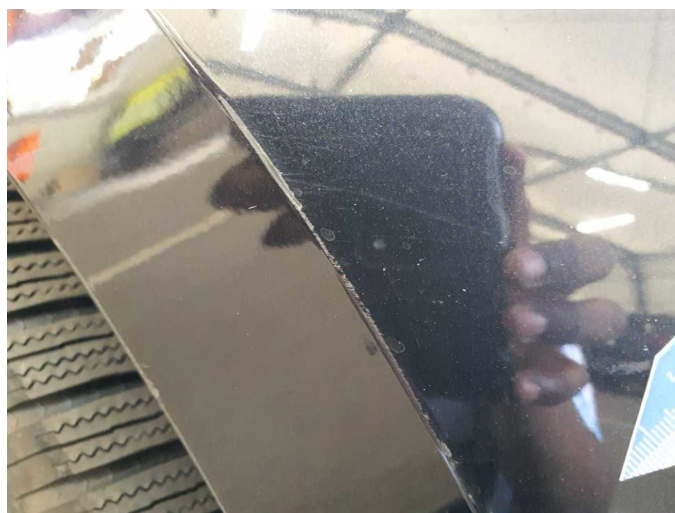
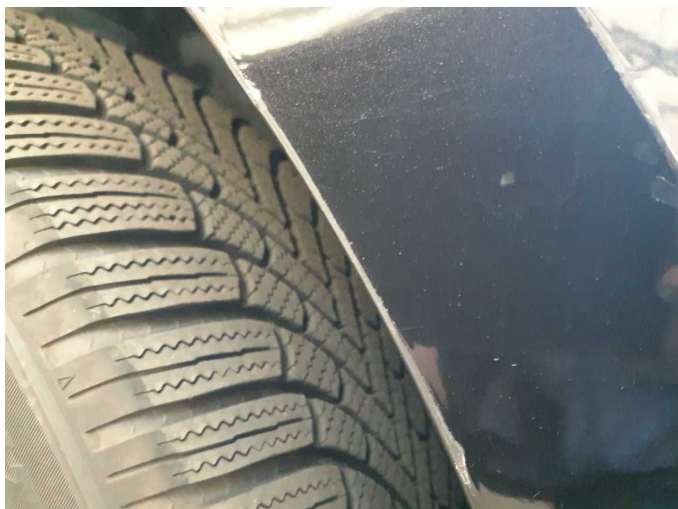
| No. | Component group | Description |
|---|---|---|
| 7 | Front bumper | Front bumper - Scratch(es) - Paint |

**Damage 7:** Front bumper: Front bumper - Scratch(es) - Paint

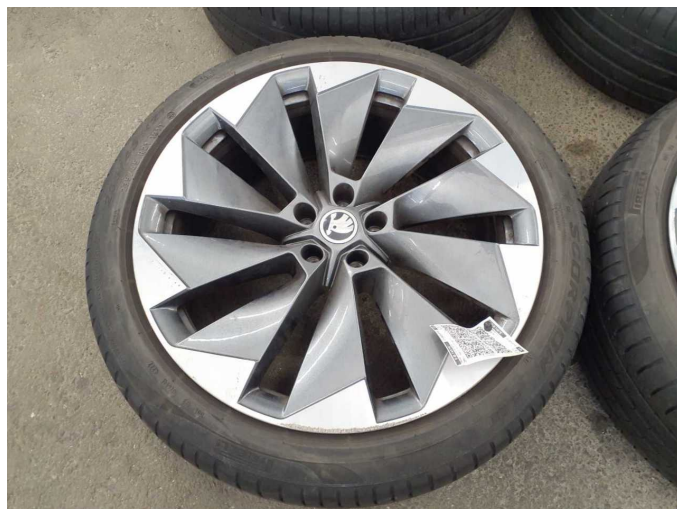
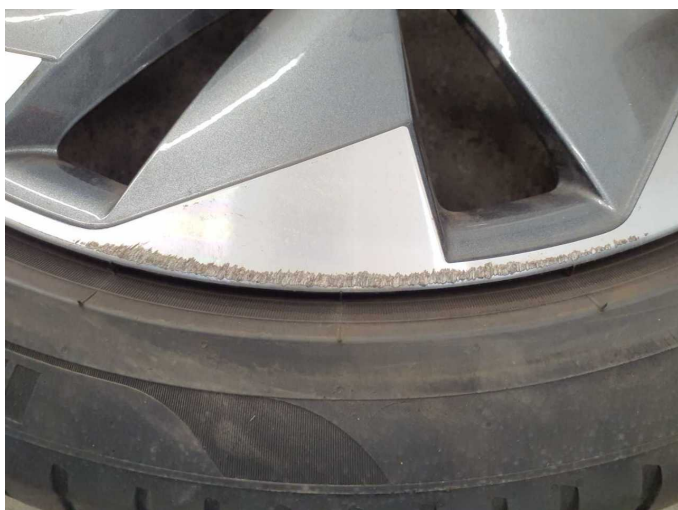
| No. | Component group | Description |
|---|---|---|
| 8 | 2nd wheel set | 1 alloy rim (Materialabtrag) - Scratched - Replace |

**Damage 8:** 2nd wheel set: 1 alloy rim (Materialabtrag) - Scratched - Replace

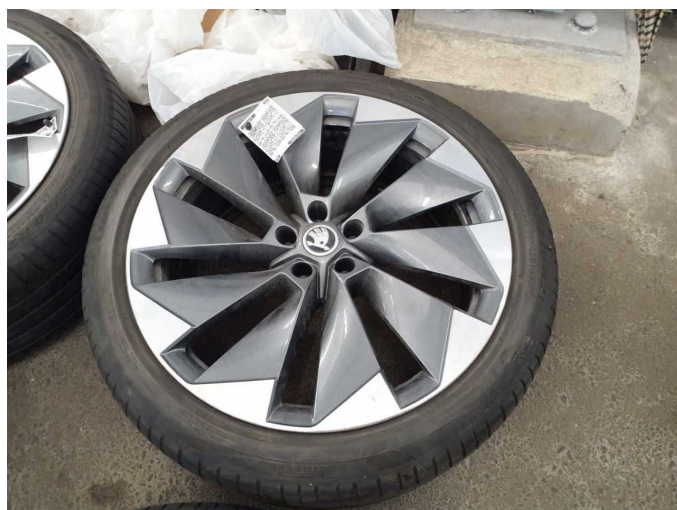
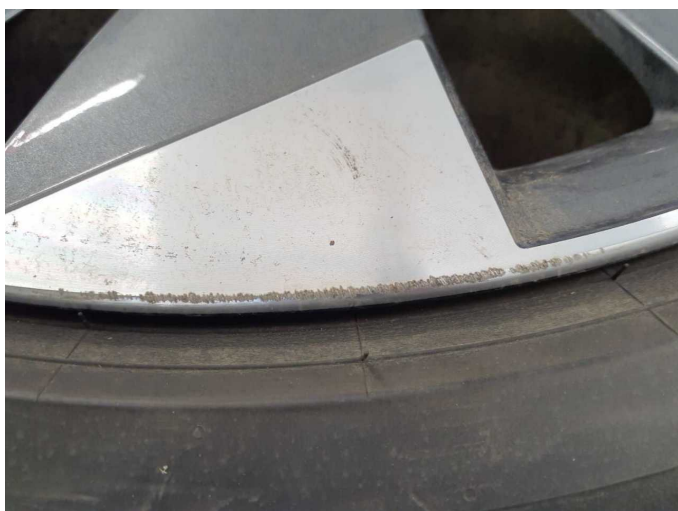
| No. | Component group | Description |
|---|---|---|
| 9 | 2nd wheel set | 1 alloy rim (Materialabtrag) - Scratched - Replace |

**Damage 9:** 2nd wheel set: 1 alloy rim (Materialabtrag) - Scratched - Replace

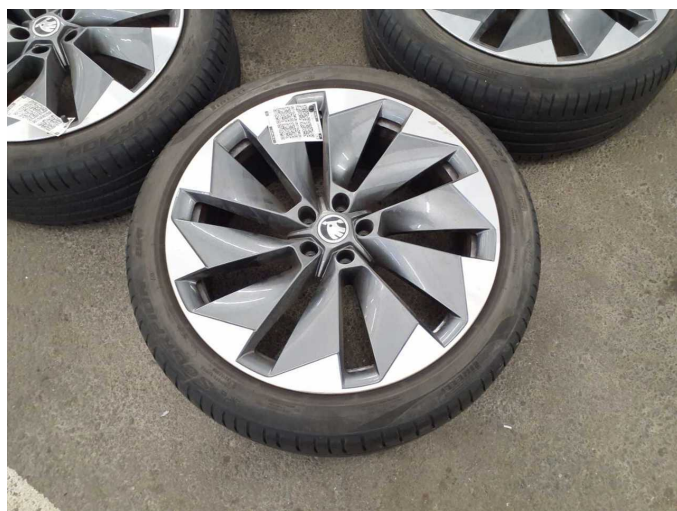
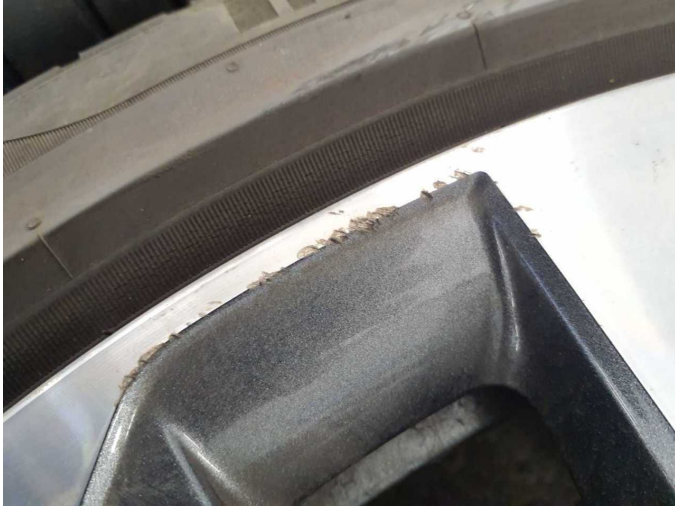
| No. | Component group | Description |
|---|---|---|
| 10 | 2nd wheel set | 1 alloy rim (Materialabtrag) - Scratched - Replace |

**Damage 10:** 2nd wheel set: 1 alloy rim (Materialabtrag) - Scratched - Replace

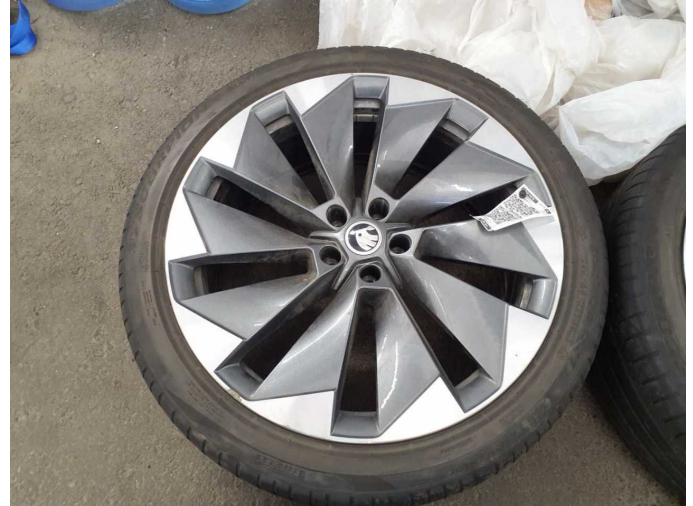
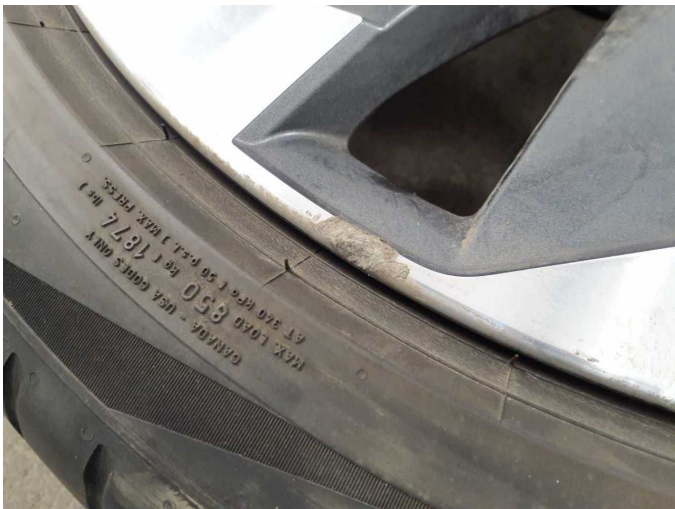
| No. | Component group | Description |
|---|---|---|
| 11 | 2nd wheel set | 1 alloy rim (Materialabtrag) - Scratched - Replace |

**Damage 11:** 2nd wheel set: 1 alloy rim (Materialabtrag) - Scratched - Replace
