Expertise

Protocol number: 46417646  
Order No. / Reference: 26622494  
Inspection date: 9 Jul 2026

Manufacturer: Skoda  
VIN: TMBAR9NP4P7025456

Model: Superb 2.0 TDI DSG Premium Edition

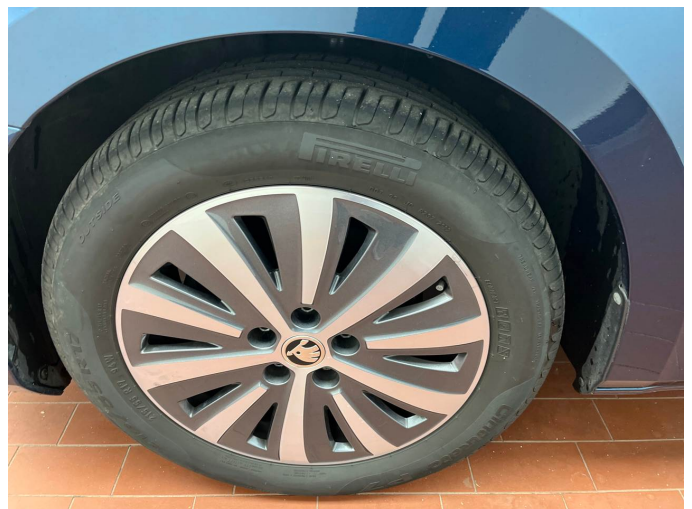
Figure 12: Mounted tyres

| # | Tyre size | Type of tyre | Manufacturer | Tread depth |
|---|---|---|---|---|
| 1) | 215/55 R17 94W | Summer tyres on Light alloy | Pirelli | 5mm / 5mm |
| 2) | 215/55 R17 94W | Summer tyres on Light alloy | Pirelli | 7mm / 7mm |

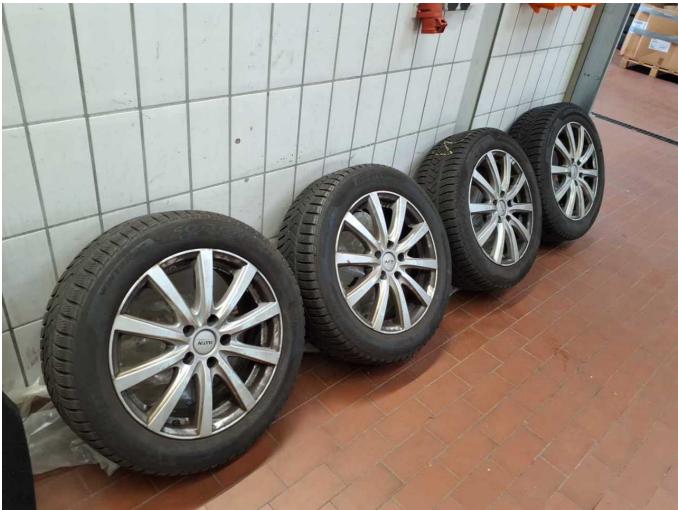
Figure 16: Additional tyres

| # | Tyre size | Type of tyre | Manufacturer | Tread depth |
|---|---|---|---|---|
| 1) | 215/55 R17 94H | Winter tyres on Light alloy | Pirelli | 5mm / 5mm |
| 2) | 215/55 R17 94H | Winter tyres on Light alloy | Pirelli | 6mm / 6mm |

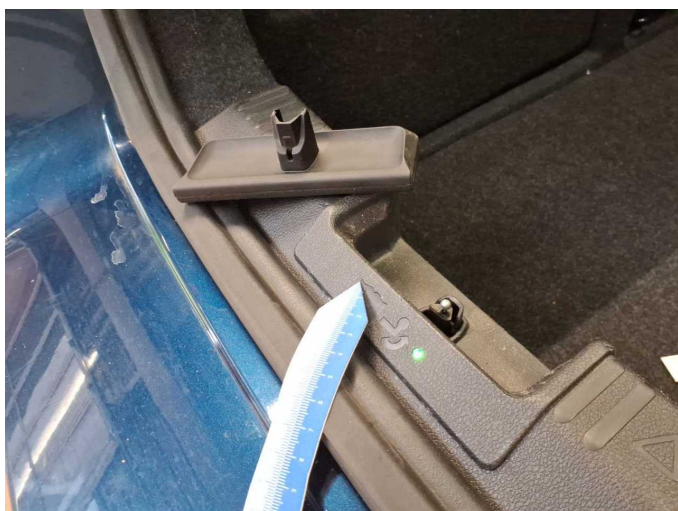
| No. | Component group | Description |
|---|---|---|
| 1 | Rear of vehicle | Trailer hitch - Malposition - Un- / install |

Damage 1: Rear of vehicle: Trailer hitch - Malposition - Un- / install

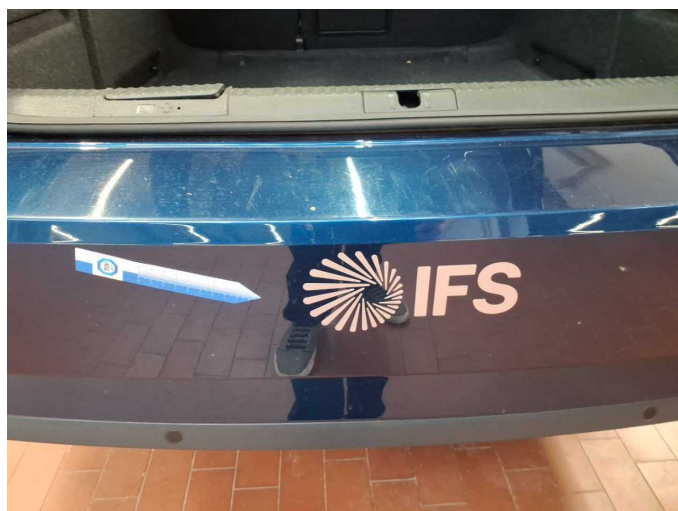
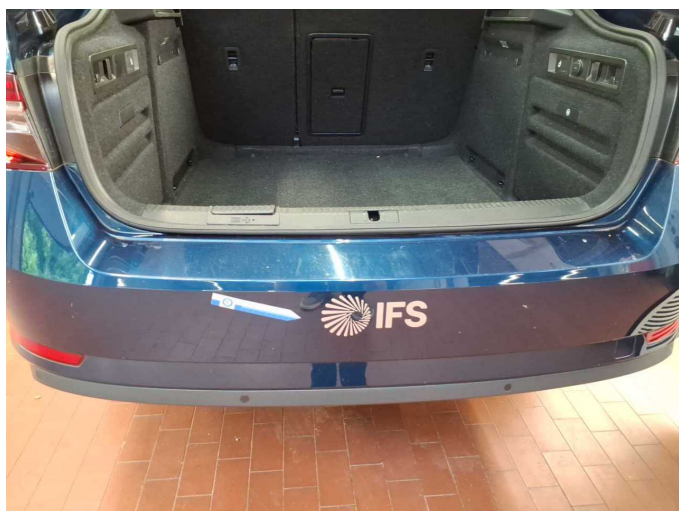
| No. | Component group | Description |
|---|---|---|
| 2 | Rear bumper | Rear bumper - Glued / labelled - De-glue / neutralise |

Damage 2: Rear bumper: Rear bumper - Glued / labelled - De-glue / neutralise

**Damage 2:** Rear bumper: Rear bumper - Glued / labelled - De-glue / neutralise

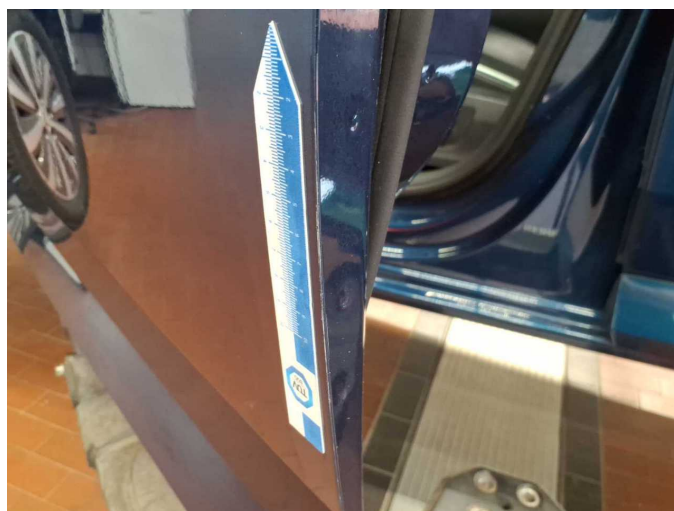
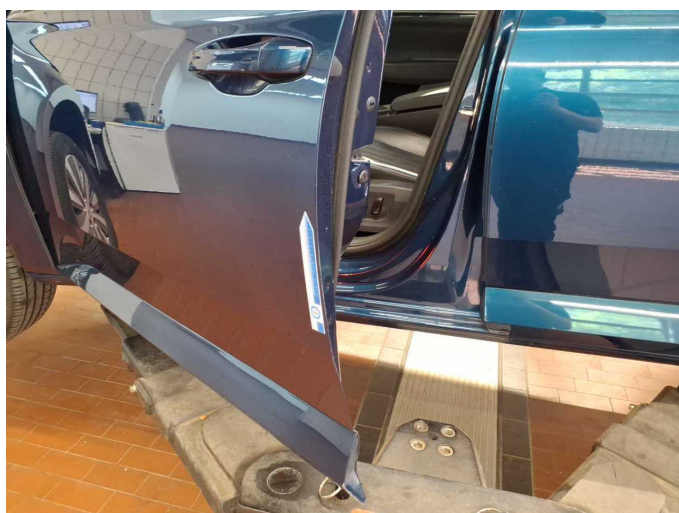
| No. | Component group | Description |
|---|---|---|
| 3 | Door - front left side | Door edge - Scratch(es) - Smart repair |

**Damage 3:** Door - front left side: Door edge - Scratch(es) - Smart repair

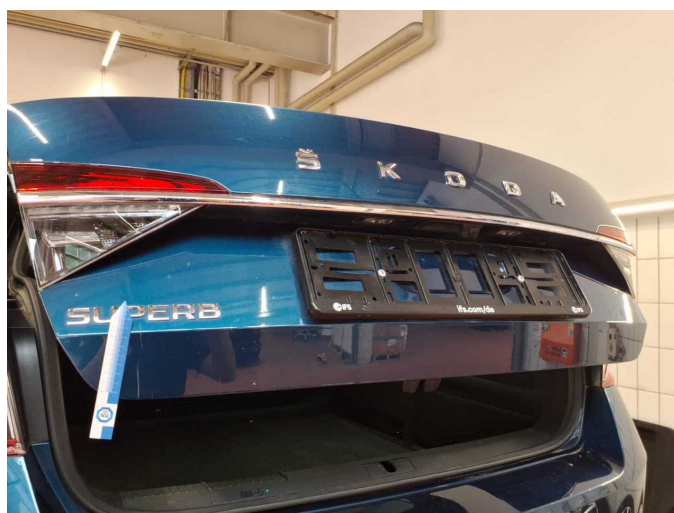
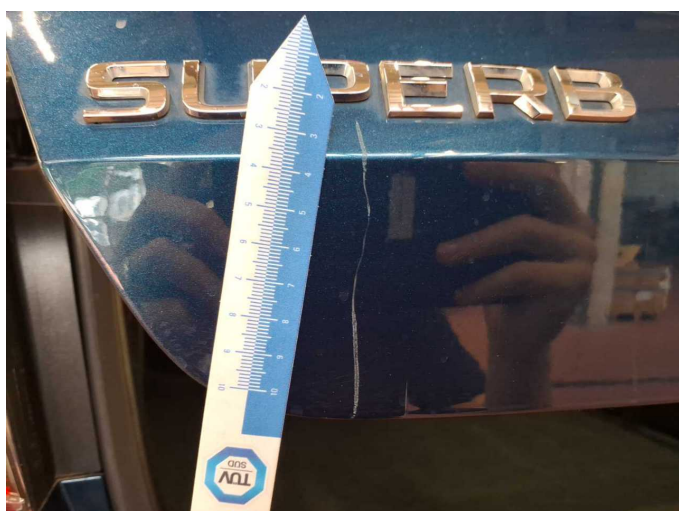
| No. | Component group | Description |
|---|---|---|
| 4 | Boot lid / rear door | Boot lid - Scratched - Repair and paint |

**Damage 4:** Boot lid / rear door: Boot lid - Scratched - Repair and paint

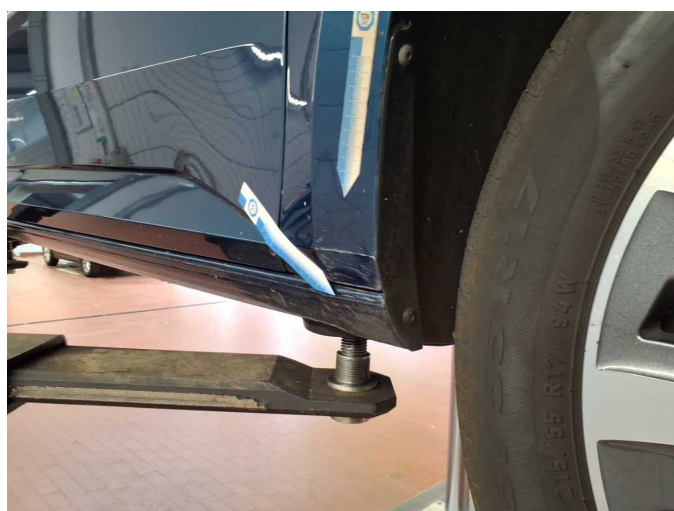
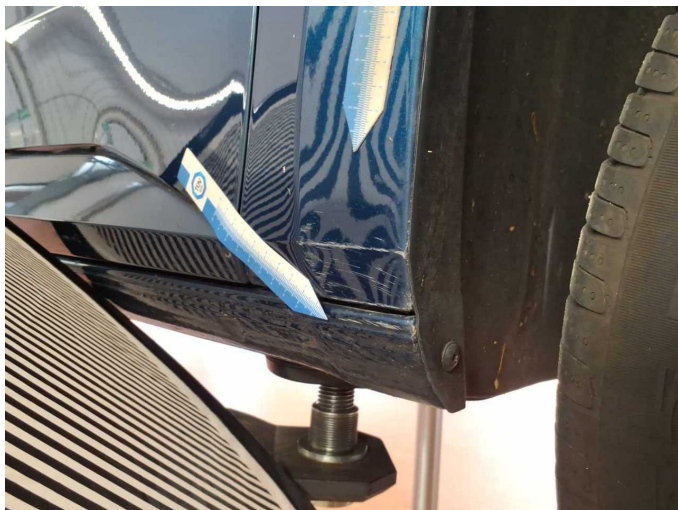
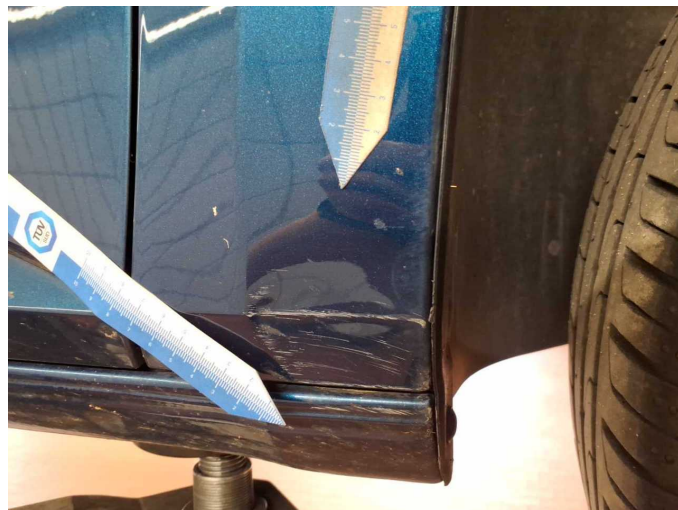
| No. | Component group | Description |
|---|---|---|
| 5 | Side panel - rear left side | Side panel (+ Unterholm) - Damaged - Repair and paint |

**Damage 5:** Side panel - rear left side: Side panel (+ Unterholm) - Damaged - Repair and paint

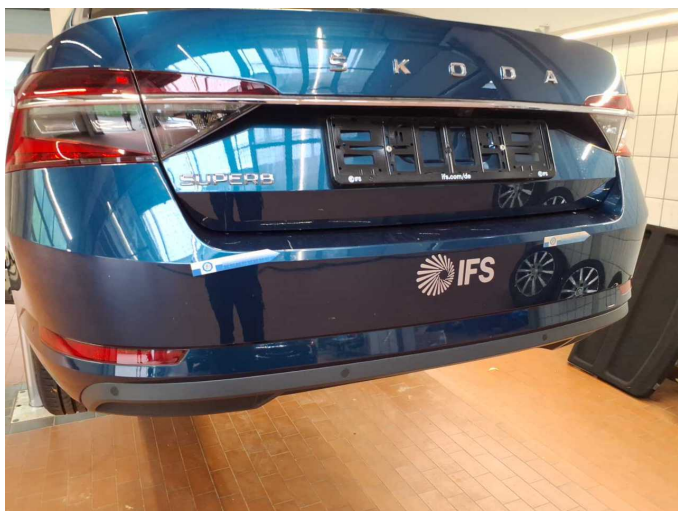
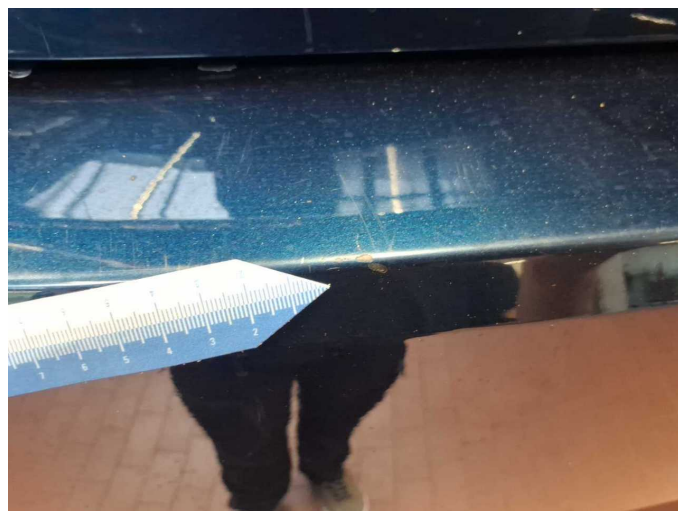
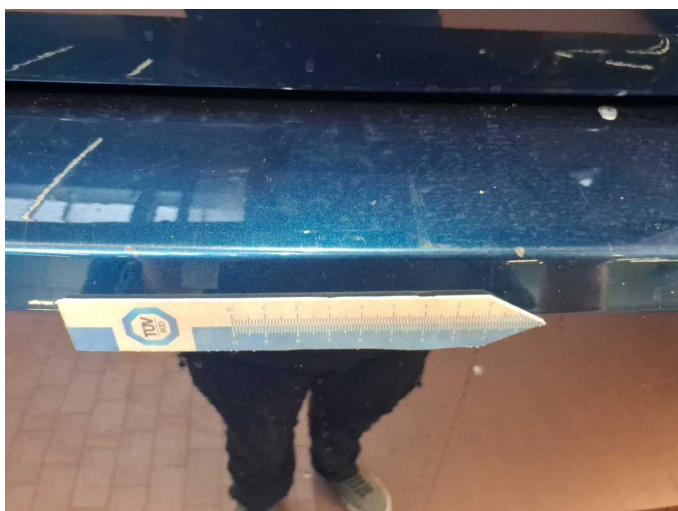
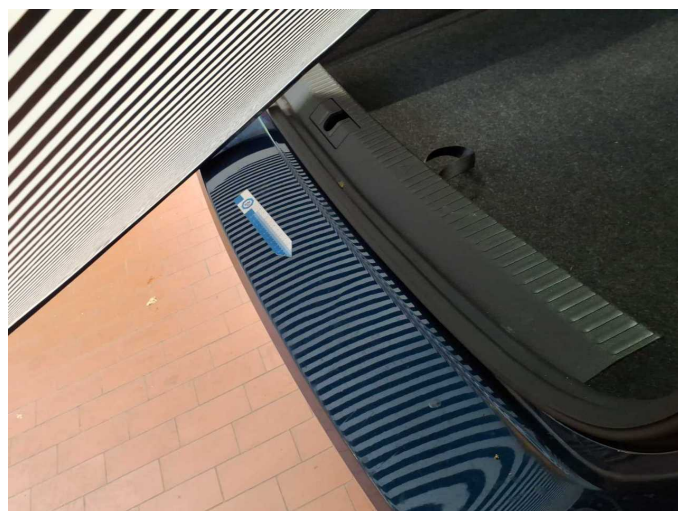
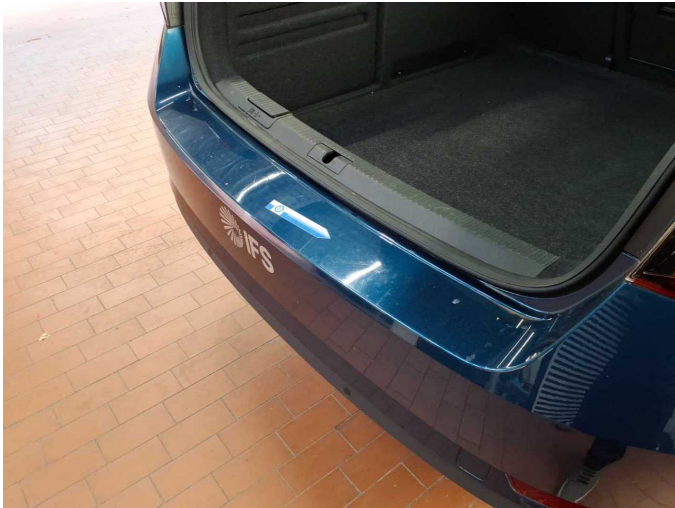
| No. | Component group | Description |
|---|---|---|
| 6 | Rear bumper | Rear bumper - Scratch(es) - Paint |

**Damage 6:** Rear bumper: Rear bumper - Scratch(es) - Paint

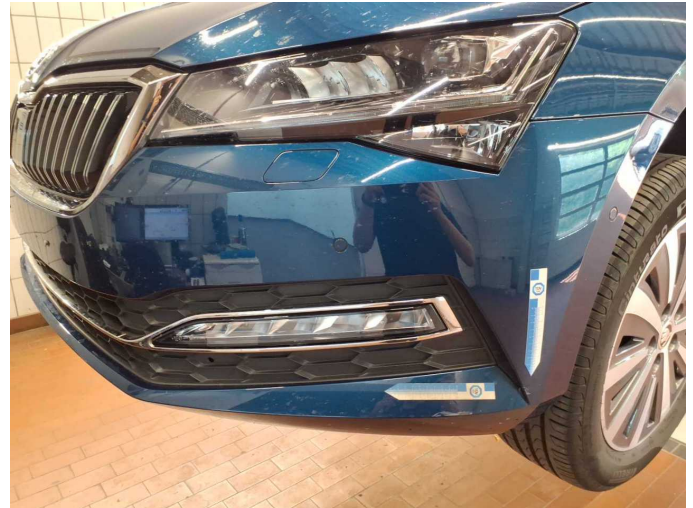
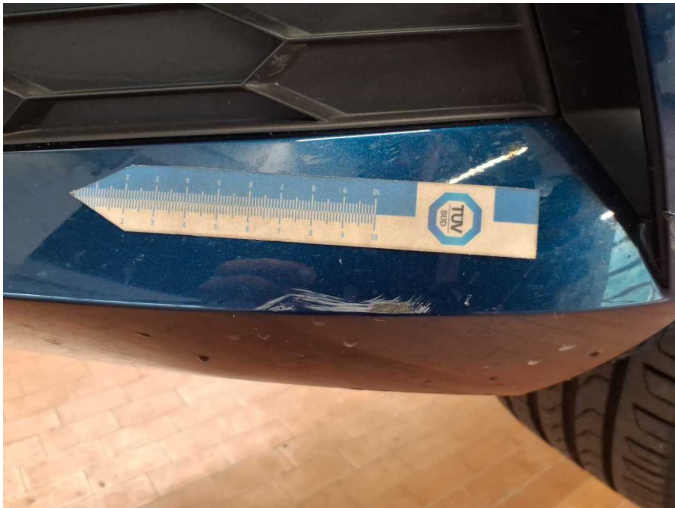
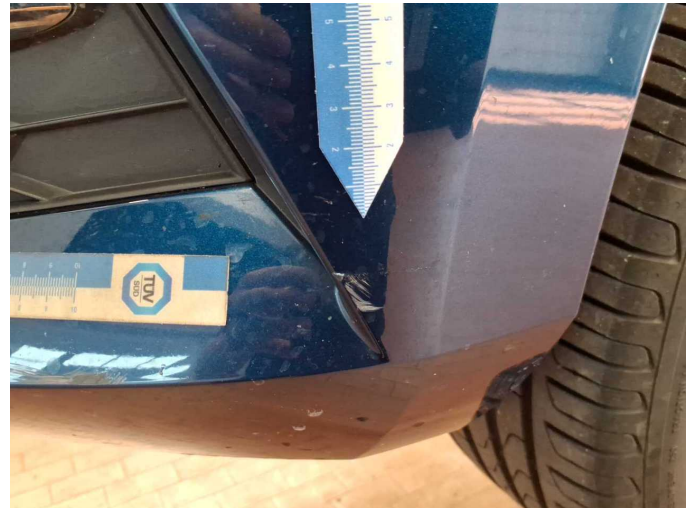
| No. | Component group | Description |
|---|---|---|
| 7 | Front bumper | Front bumper - Scratch(es) - Paint |

**Damage 7:** Front bumper: Front bumper - Scratch(es) - Paint

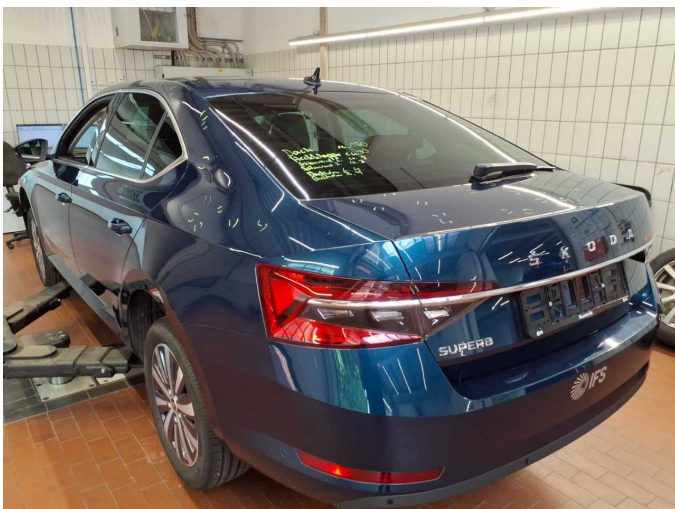
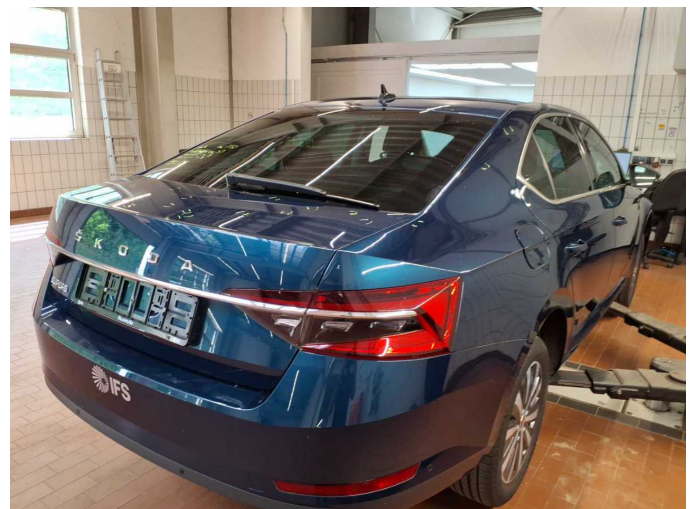
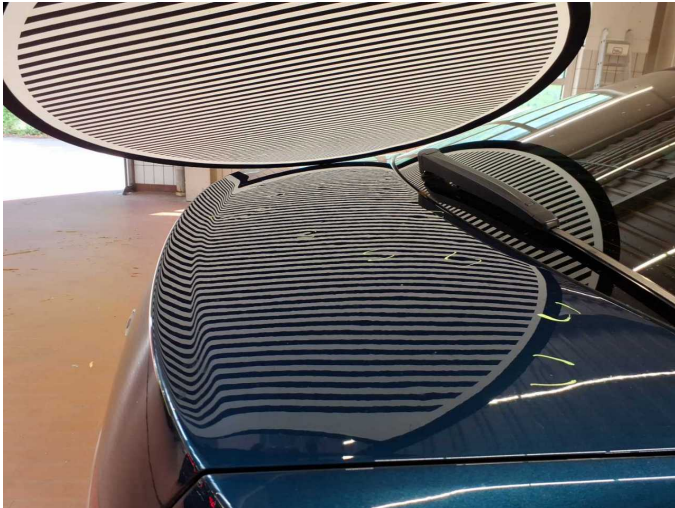
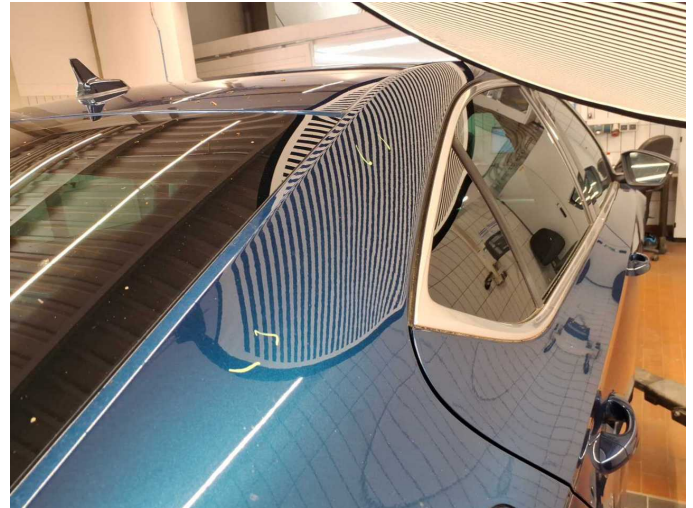
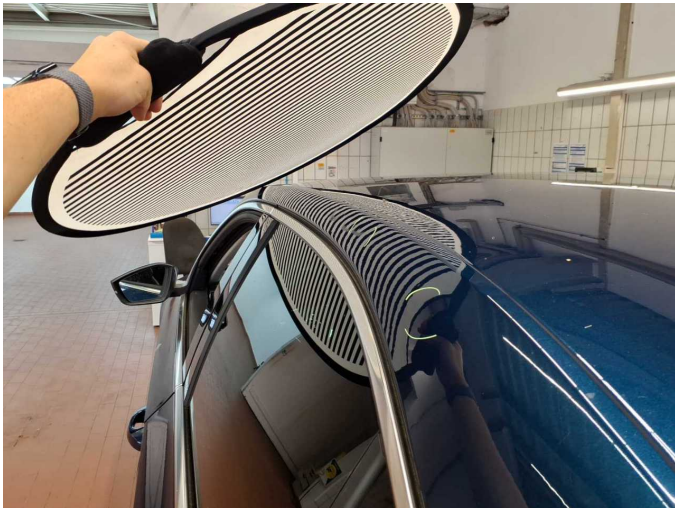
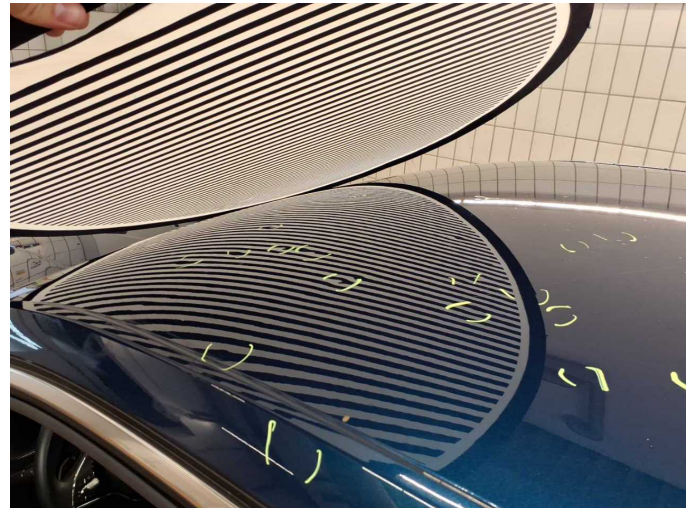
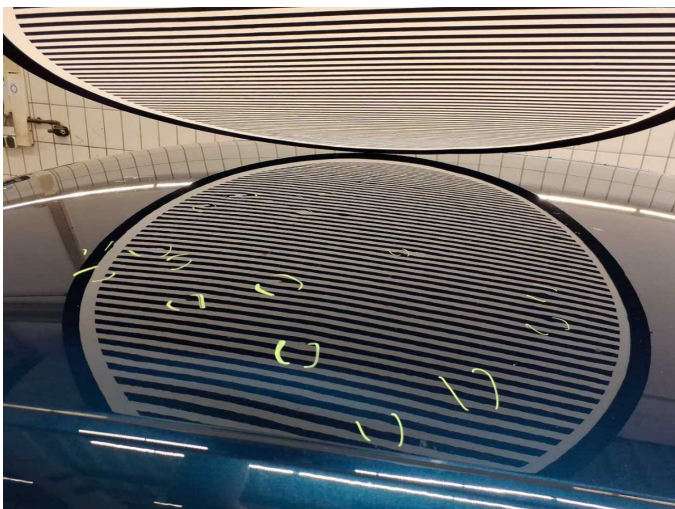
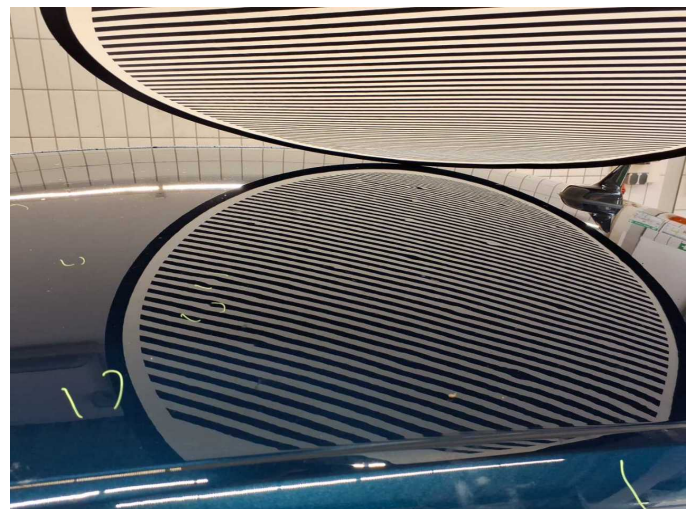
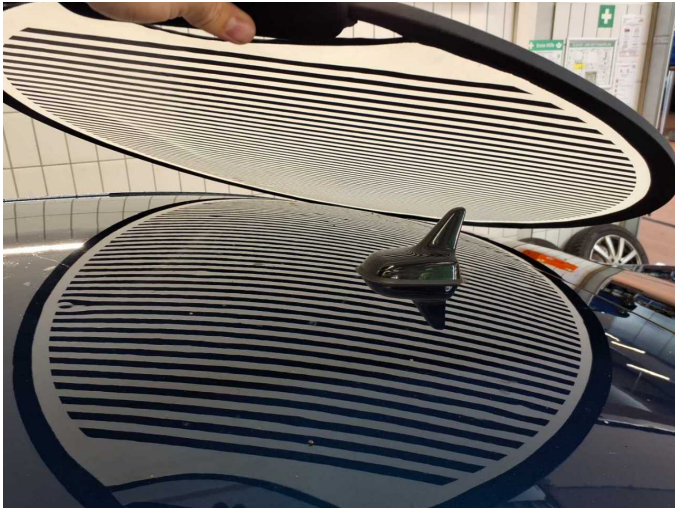
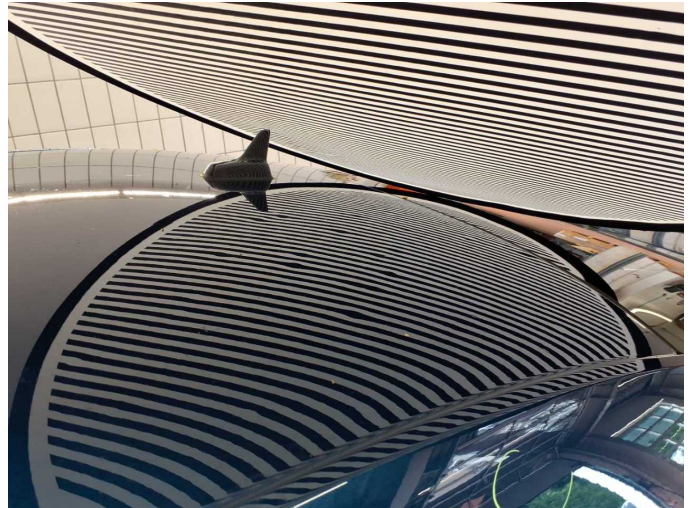
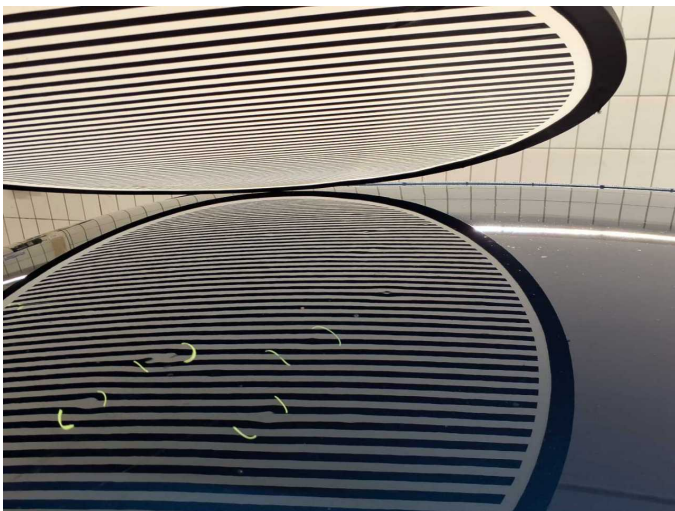
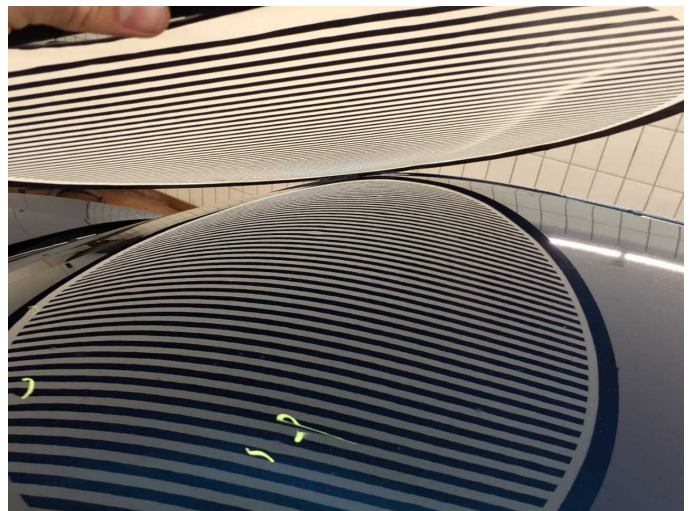
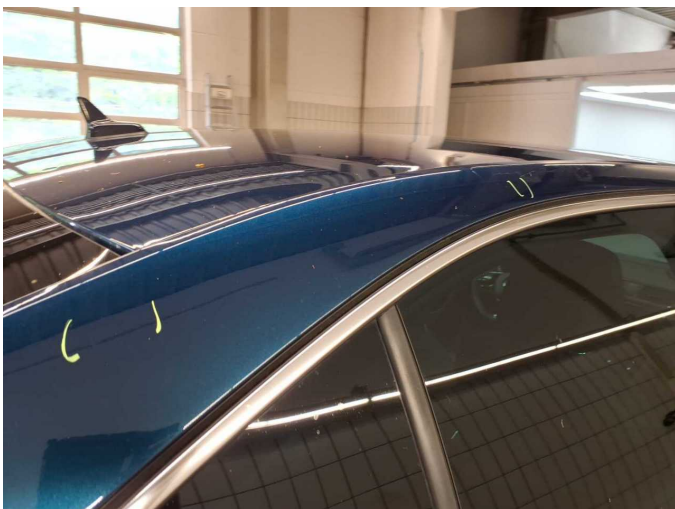
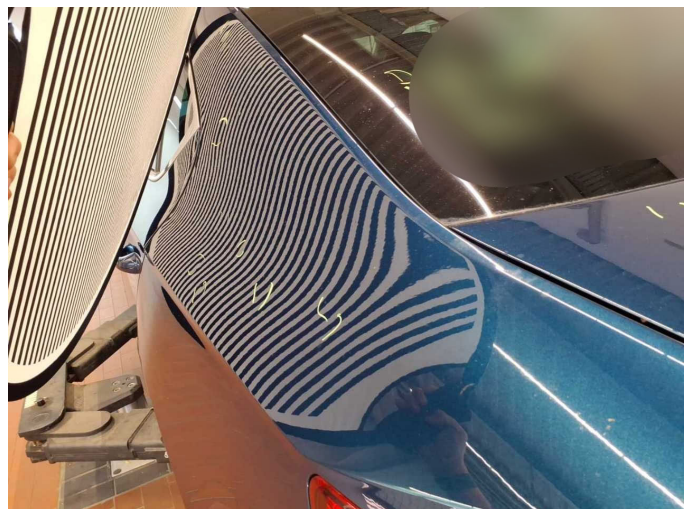
| No. | Component group | Description |
|---|---|---|
| 8 | Body | Body - Damage by hail - repair according to calculation |

**Damage 8:** Body: Body - Damage by hail - repair according to calculation

Die beigefügte Reparaturkostenkalkulation wurde nach bestem Wissen und Gewissen im demontagefreien Zustand erstellt. Es können Mehrkosten und somit Abweichung der für den Hagelschaden ausgewiesener Reparaturkosten nicht ausgeschlossen werden.

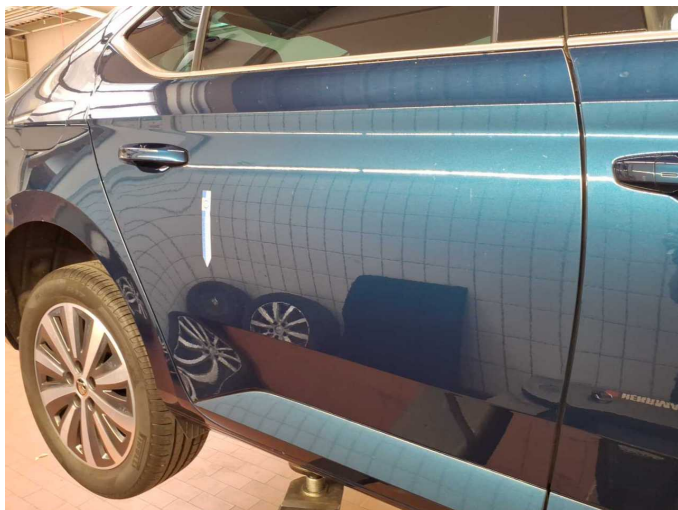
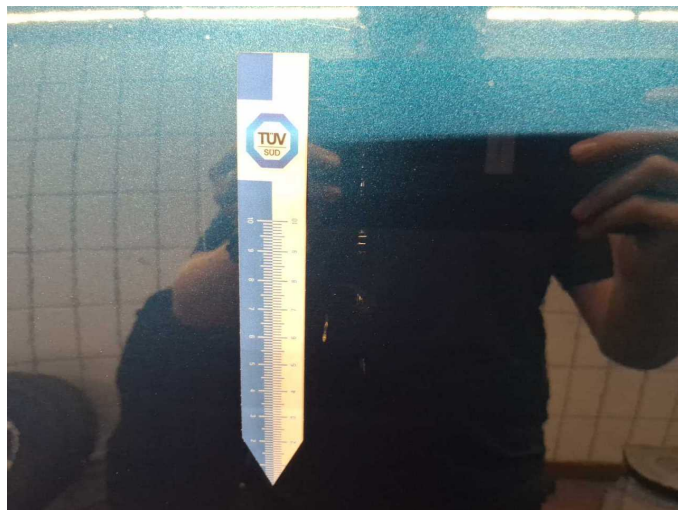
| No. | Component group | Description |
|---|---|---|
| 1 | Door - rear right side | Door - Scratch(es) - No deduction |

**Wear and tear 1:** Door - rear right side: Door - Scratch(es) - No deduction

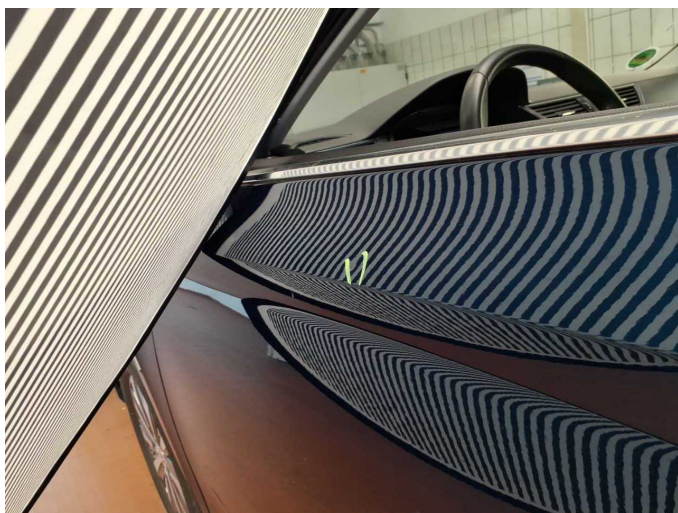
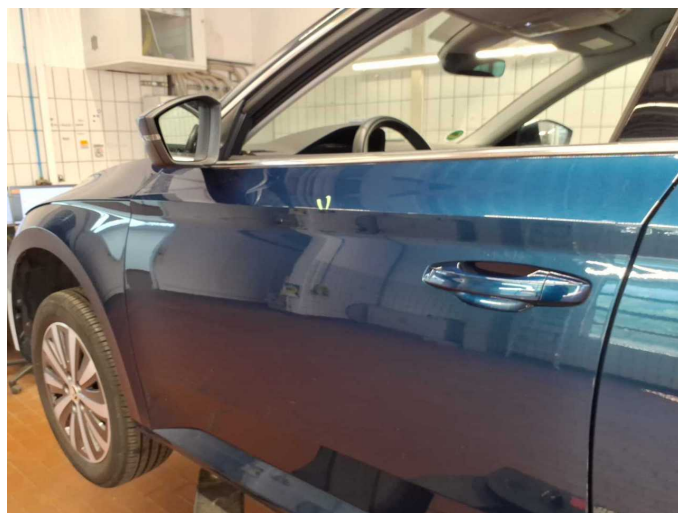
| No. | Component group | Description |
|---|---|---|
| 4 | Door - front left side | Door - dent(s) - Smooth repair work |

**Wear and tear 4:** Door - front left side: Door - dent(s) - Smooth repair work
