Expertise

Protocol number: 46277973  
Order No. / Reference: 26621659  
Inspection date: 30 Jun 2026

Manufacturer: Skoda  
VIN: TMBJJ7NX0MY084764

Model: Octavia Combi 2.0 TDI DSG First Edition

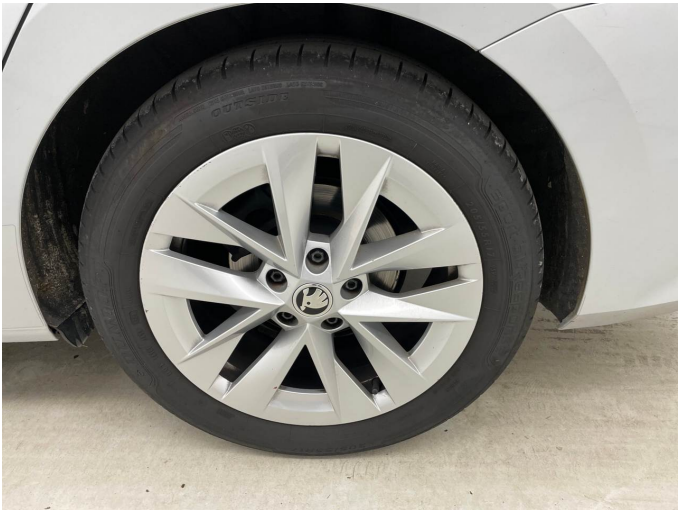
Figure 12: Mounted tyres

| # | Tyre size | Type of tyre | Manufacturer | Tread depth |
|---|---|---|---|---|
| 1) | 205/55 R17 95V | Summer tyres on Light alloy | Continental | 7mm / 7mm |
| 2) | 205/55 R17 95V | Summer tyres on Light alloy | Dunlop | 5mm / 5mm |

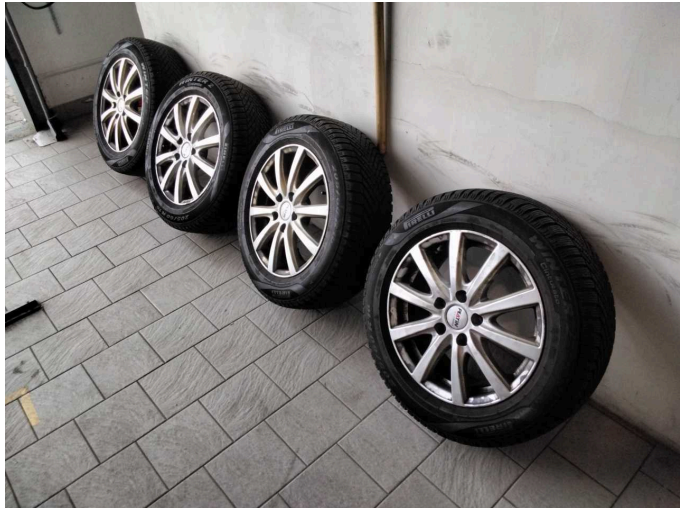
Figure 19: Additional tyres

| # | Tyre size | Type of tyre | Manufacturer | Tread depth |
|---|---|---|---|---|
| 1) | 205/60 R16 96H | Winter tyres on Light alloy | Pirelli | 5mm / 5mm |
| 2) | 205/60 R16 96H | Winter tyres on Light alloy | Pirelli | 6mm / 6mm |

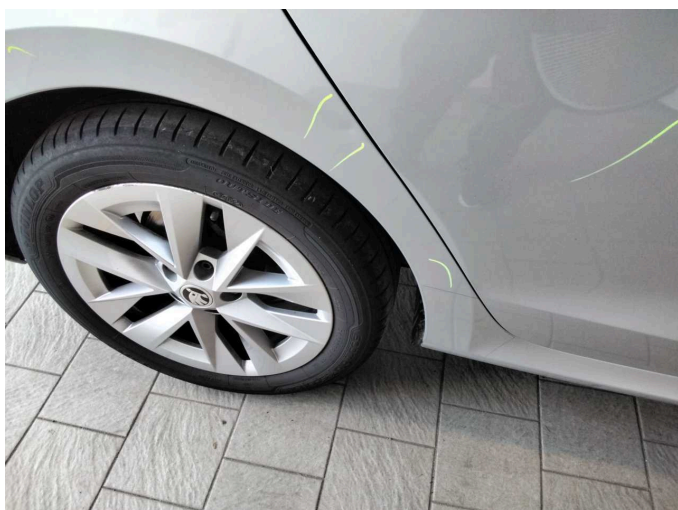
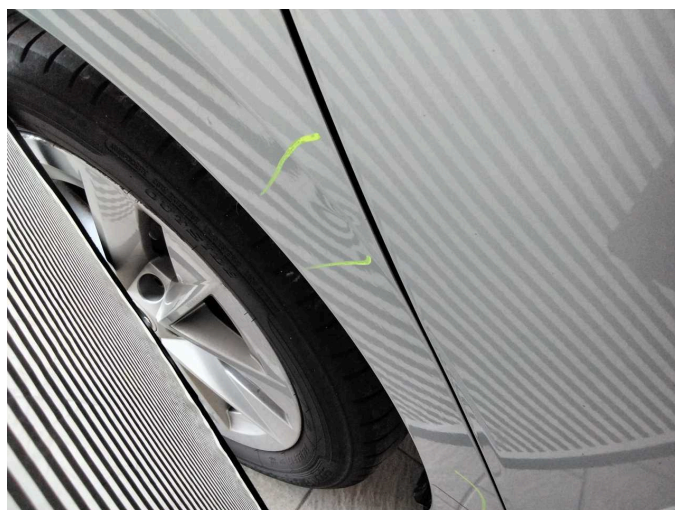
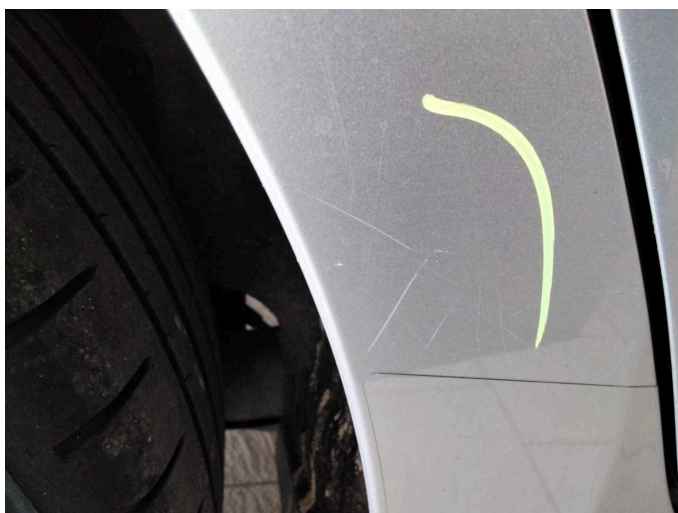
| No. | Component group | Description |
|---|---|---|
| 2 | Side panel - rear right side | Side panel - dent(s) - Smart repair |

**Damage 2:** Side panel - rear right side: Side panel - dent(s) - Smart repair

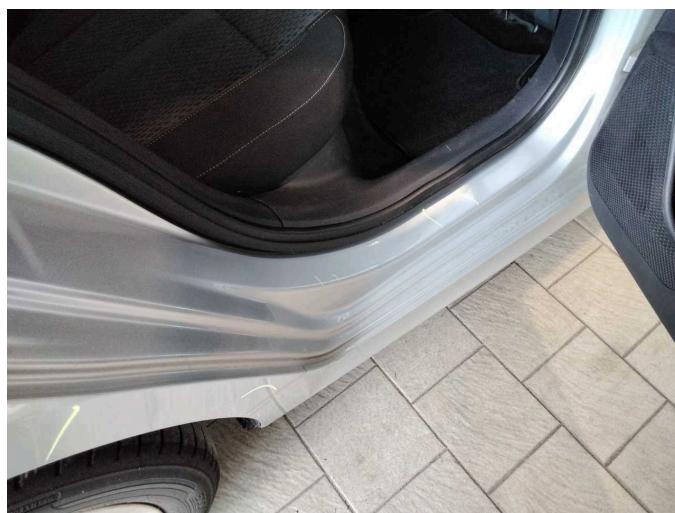
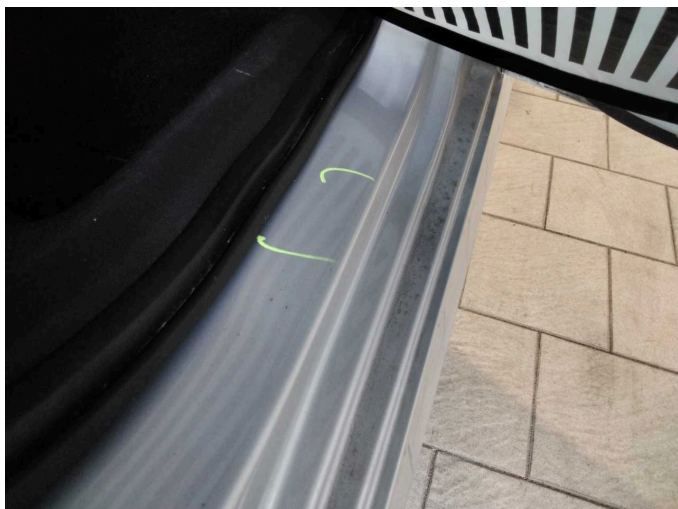
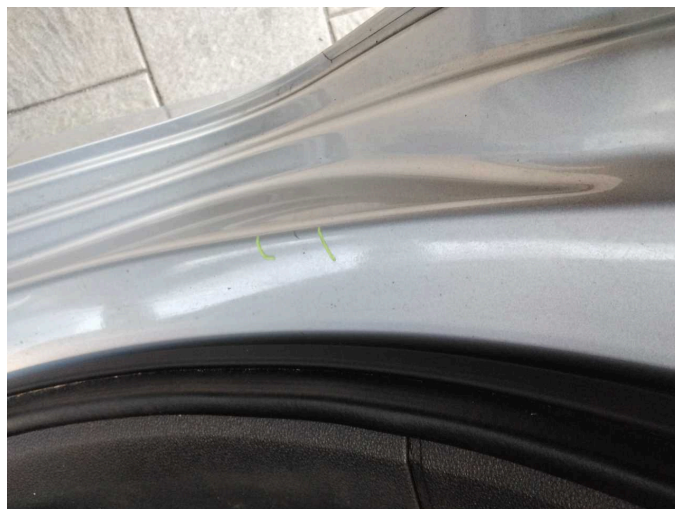
| No. | Component group | Description |
|---|---|---|
| 3 | Side panel - rear right side | Sill - Dent / paintcoat damage - Smart repair |

**Damage 3:** Side panel - rear right side: Sill - Dent / paintcoat damage - Smart repair

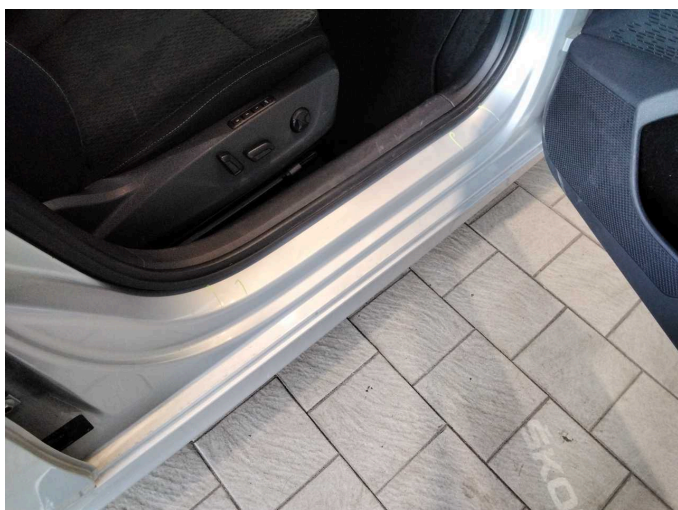
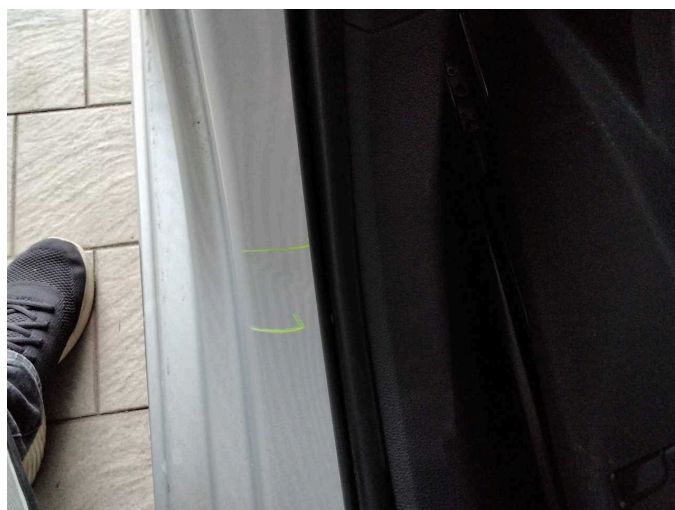
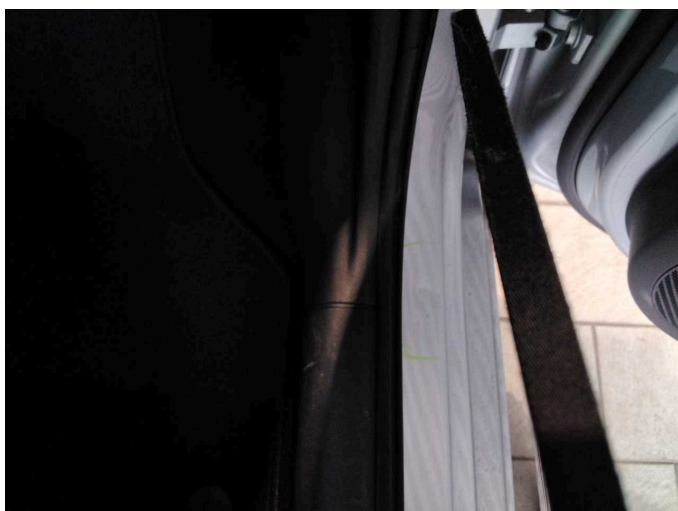
| No. | Component group | Description |
|---|---|---|
| 4 | Sill - right side | Sill - dent(s) - Smart repair |

**Damage 4:** Sill - right side: Sill - dent(s) - Smart repair

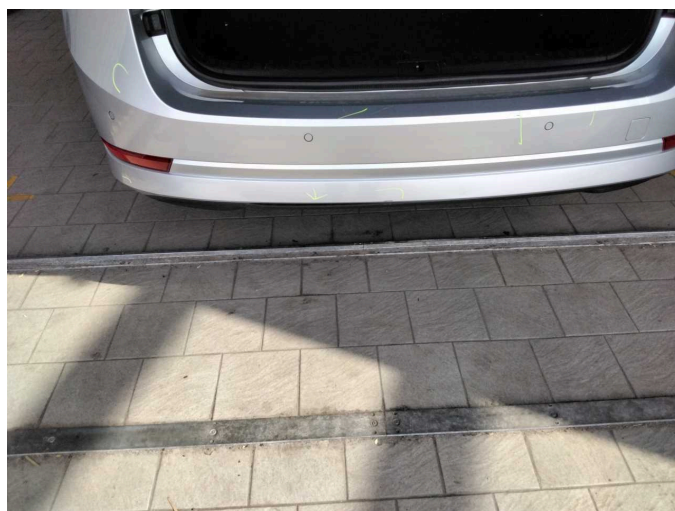
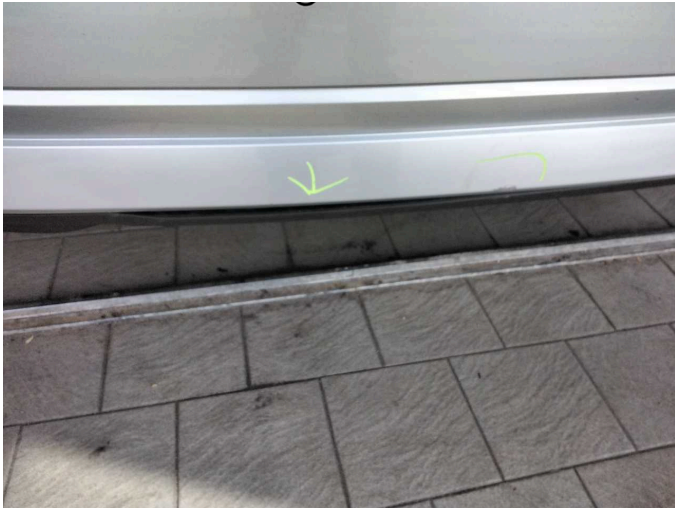
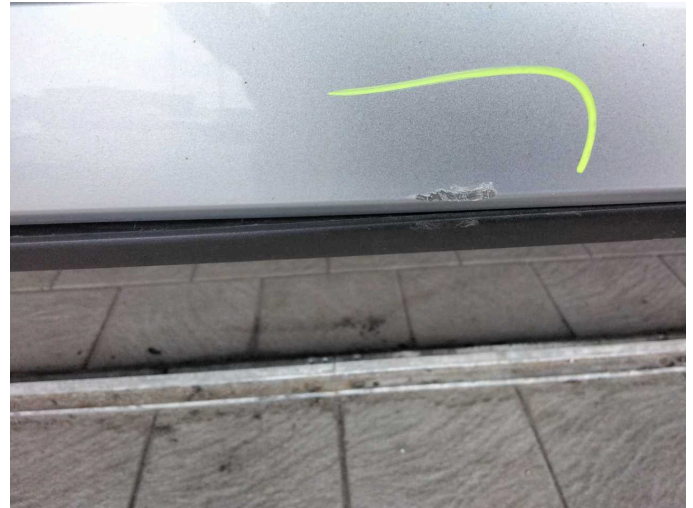
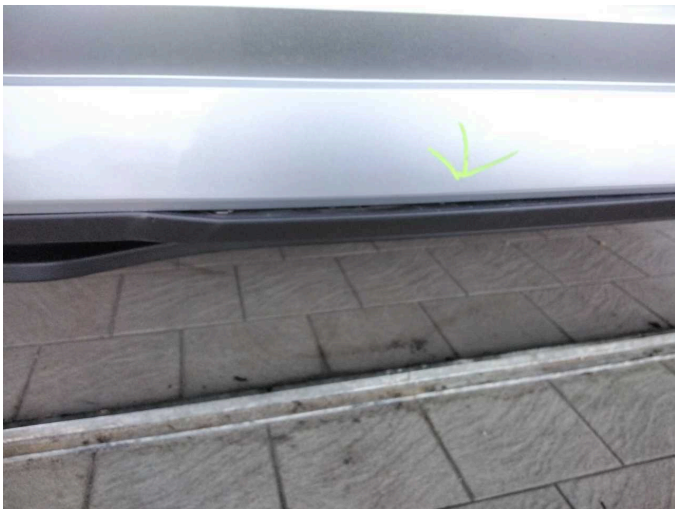
| No. | Component group | Description |
|---|---|---|
| 5 | Rear bumper | Spoiler - Scratch(es) - Replace |

**Damage 5:** Rear bumper: Spoiler - Scratch(es) - Replace

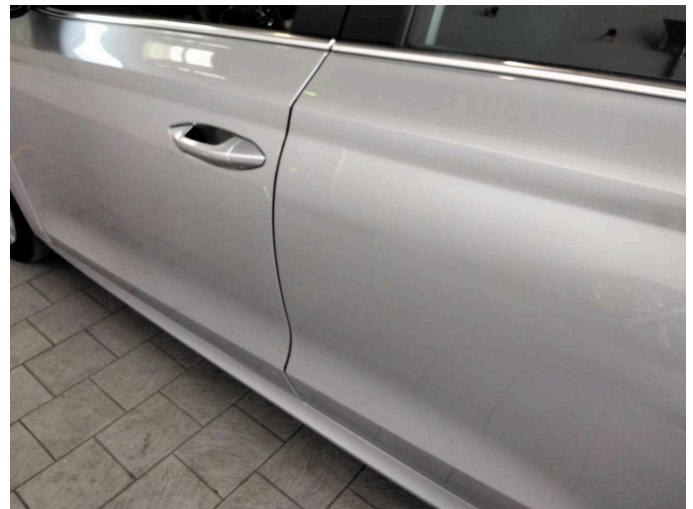
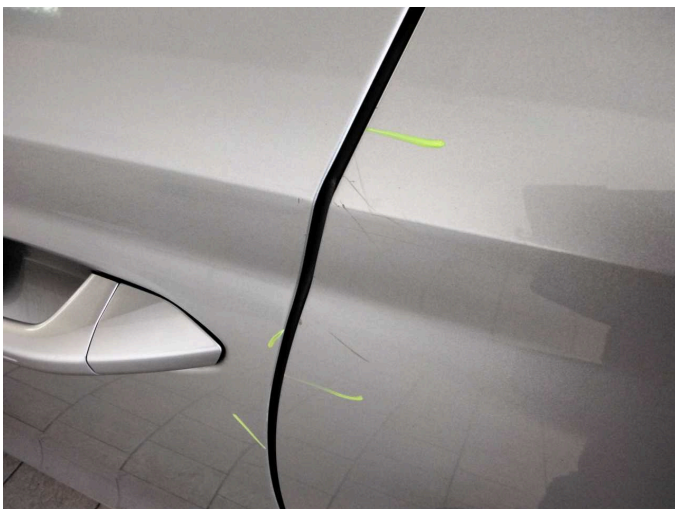
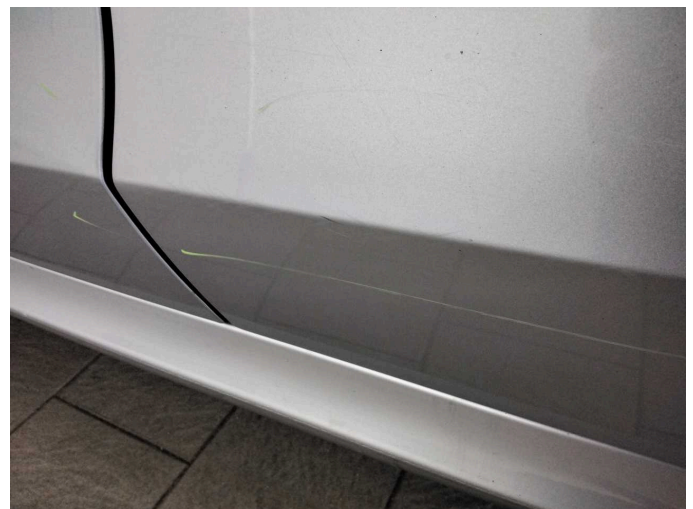
| No. | Component group | Description |
|---|---|---|
| 6 | Door - rear left side | Door - Scratch(es) - Paint |

**Damage 6:** Door - rear left side: Door - Scratch(es) - Paint

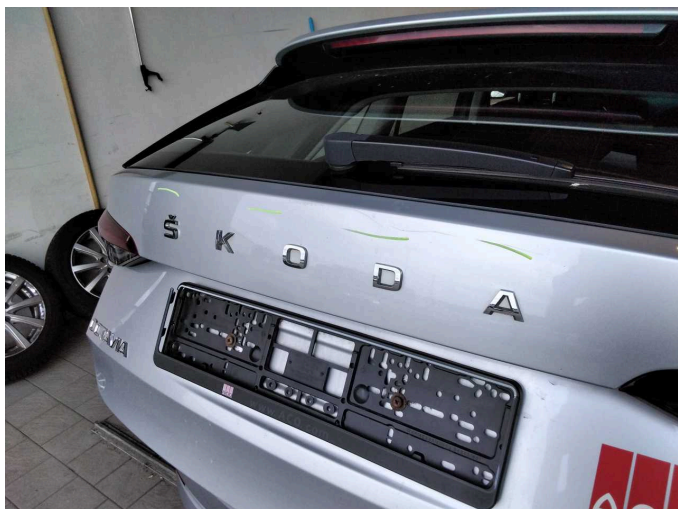
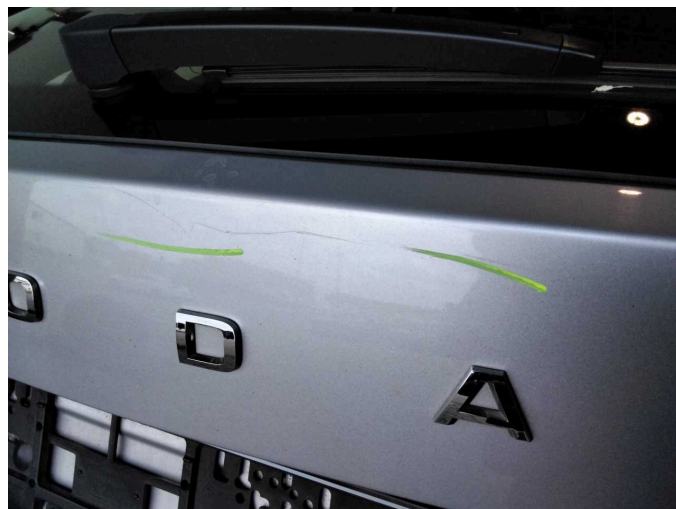
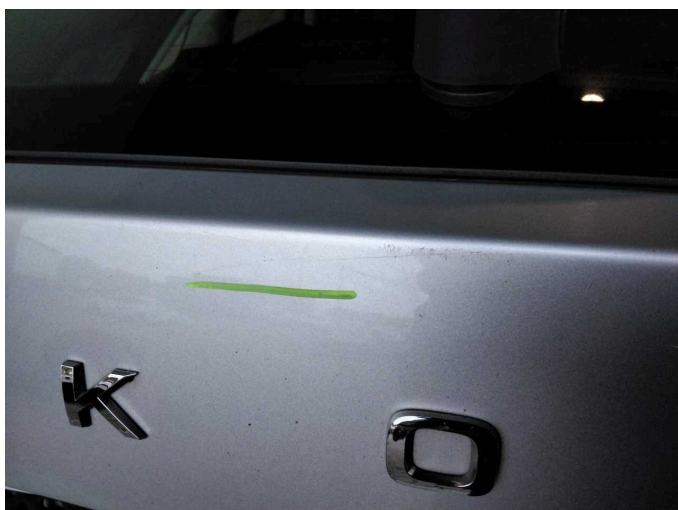
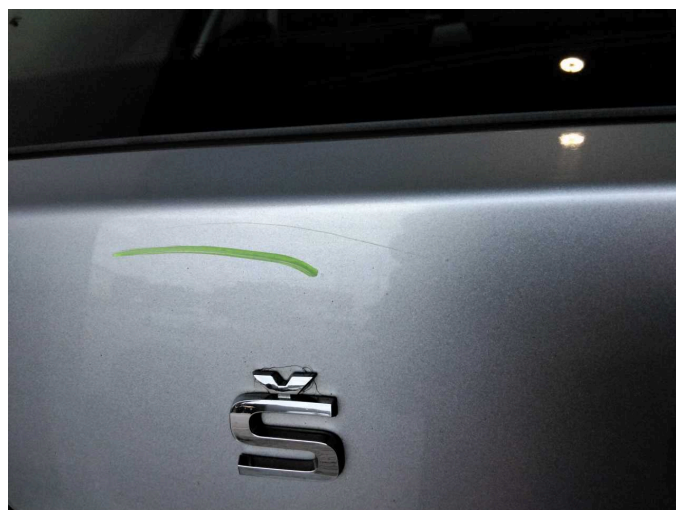
| No. | Component group | Description |
|---|---|---|
| 7 | Boot lid / rear door | Boot lid - Scratch(es) - Paint |

**Damage 7:** Boot lid / rear door: Boot lid - Scratch(es) - Paint

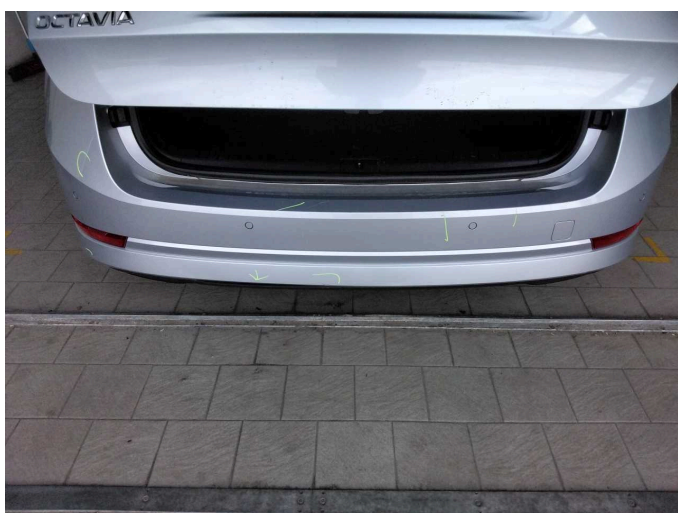
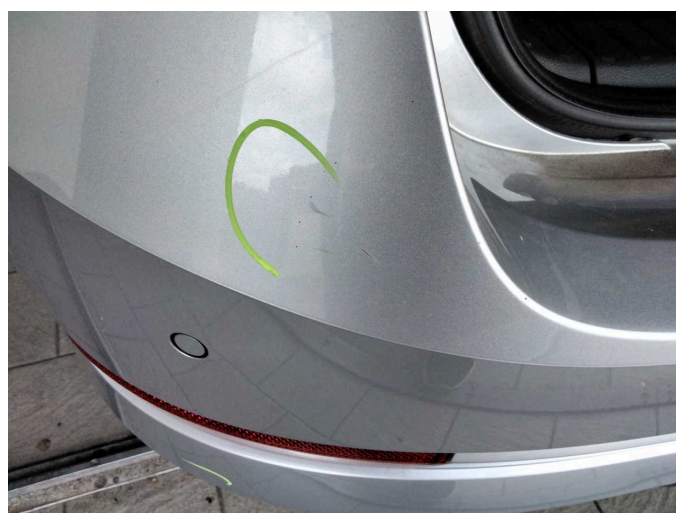
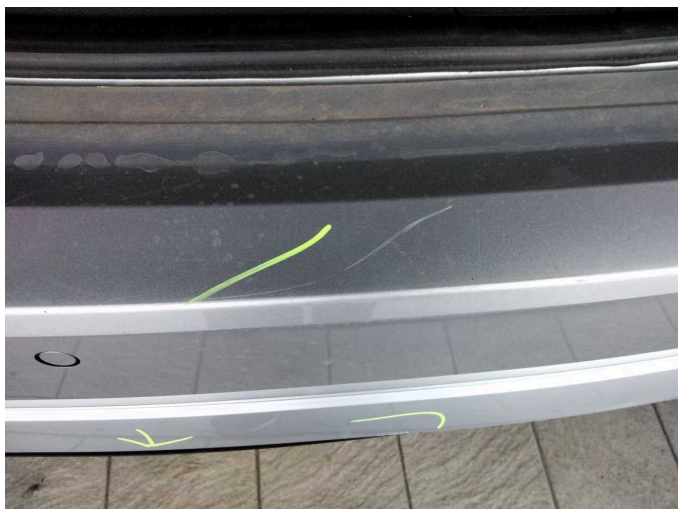
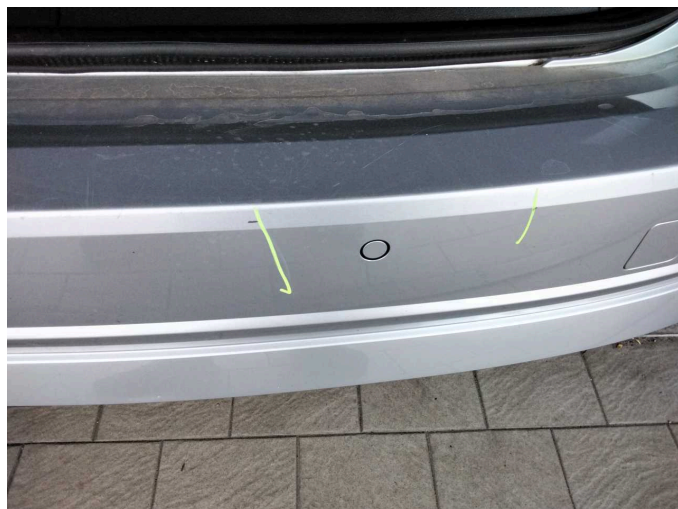
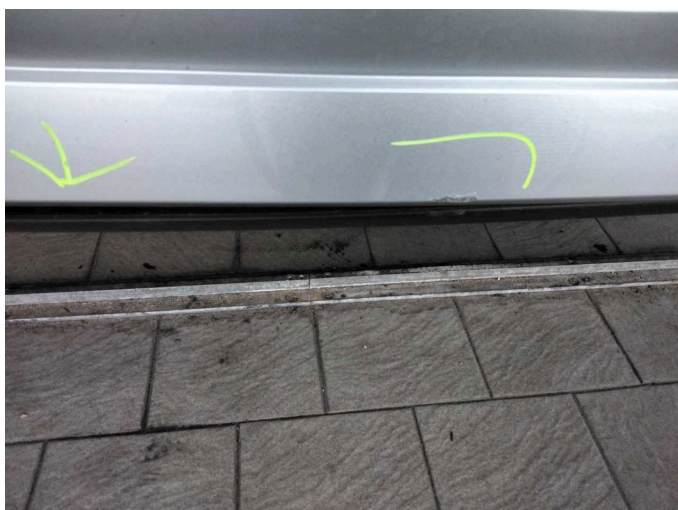
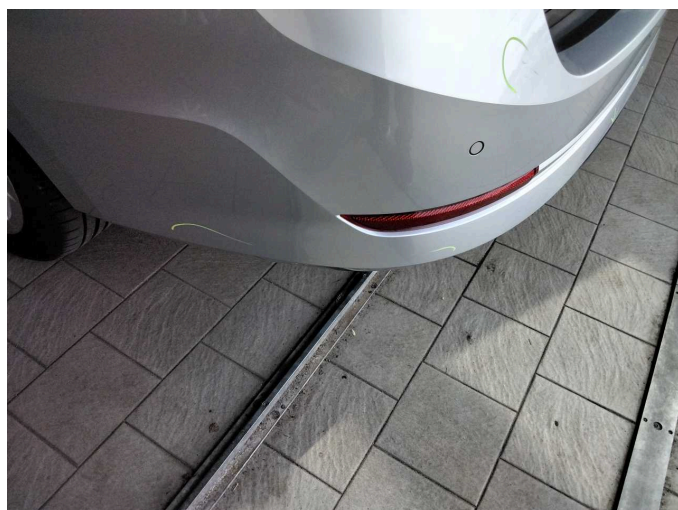
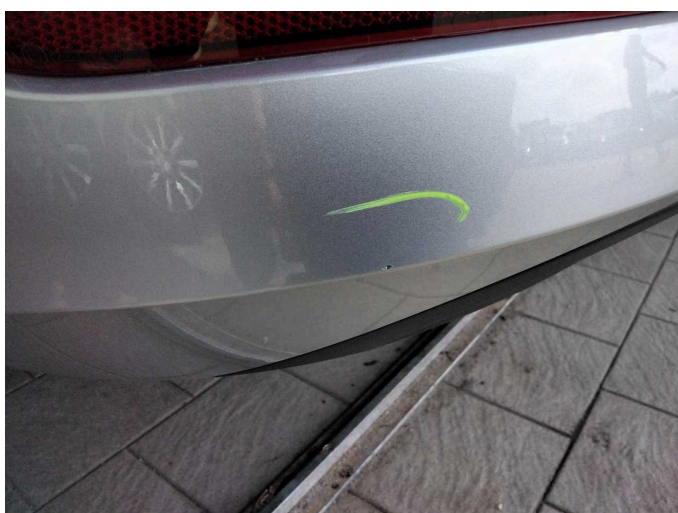
| No. | Component group | Description |
|---|---|---|
| 8 | Rear bumper | Rear bumper - Scratch(es) - Paint |

**Damage 8:** Rear bumper: Rear bumper - Scratch(es) - Paint

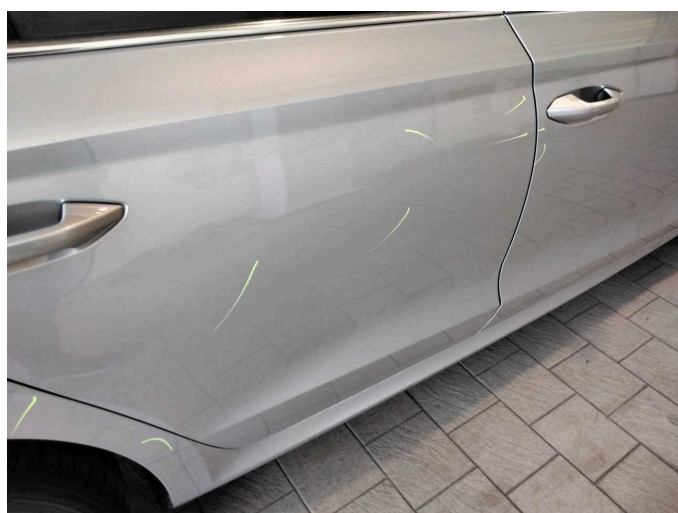
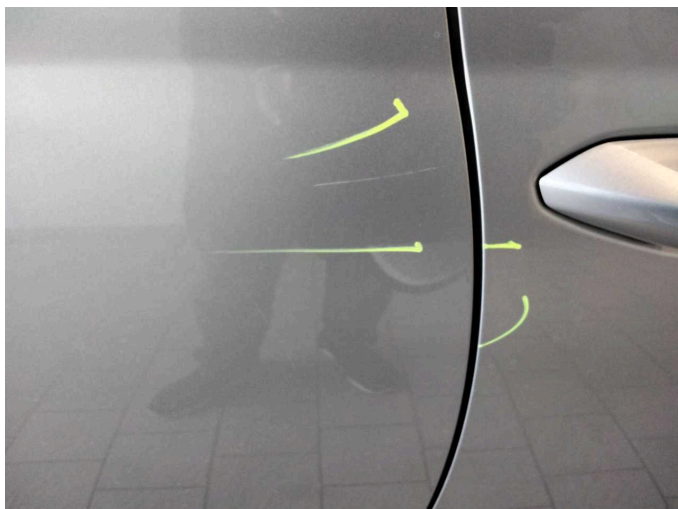
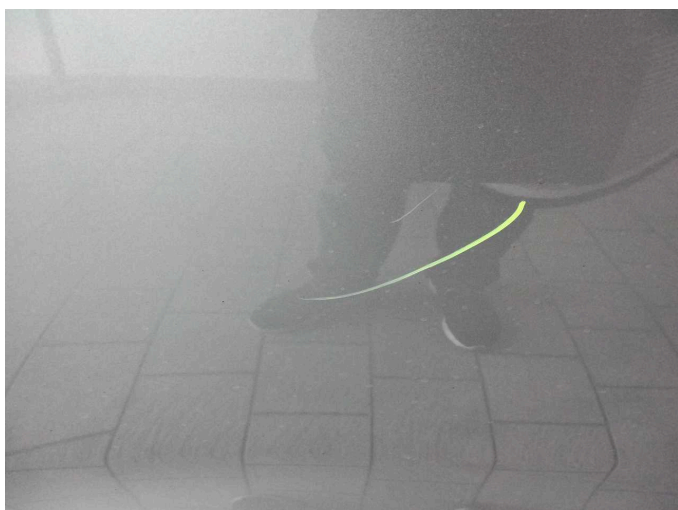
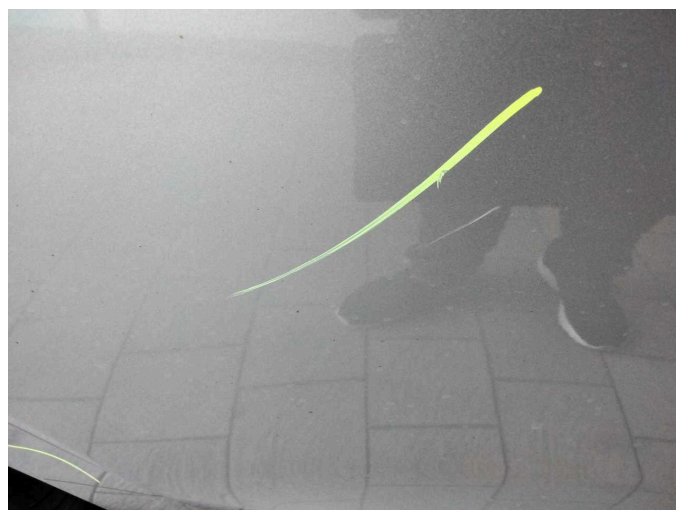
| No. | Component group | Description |
|---|---|---|
| 9 | Door - rear right side | Door - Scratch(es) - Paint |

**Damage 9:** Door - rear right side: Door - Scratch(es) - Paint

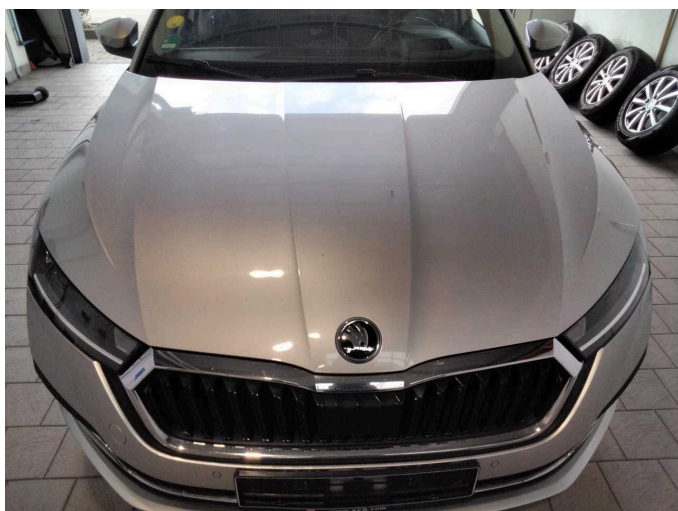
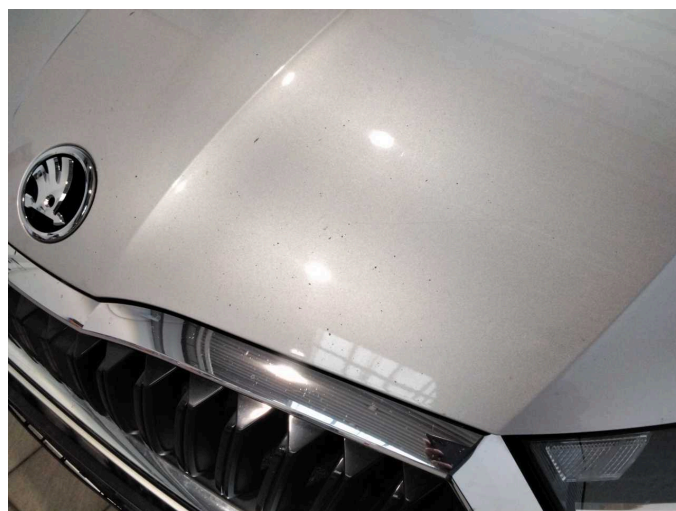
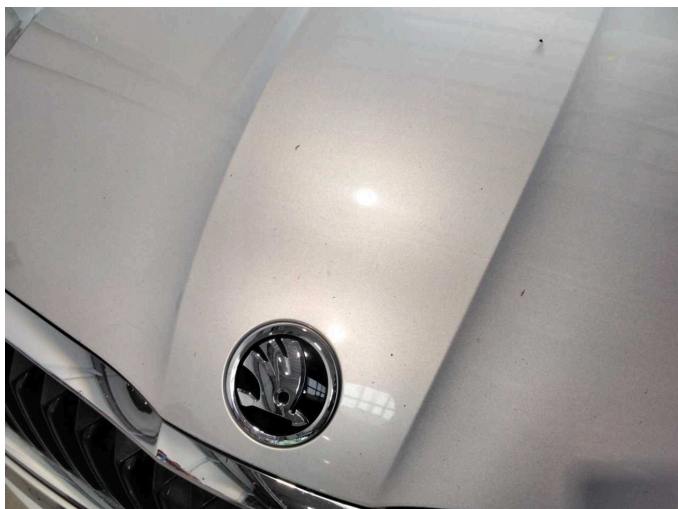
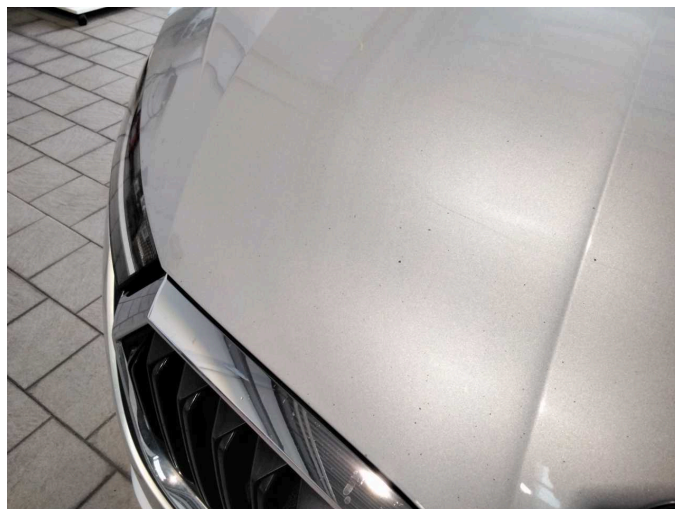
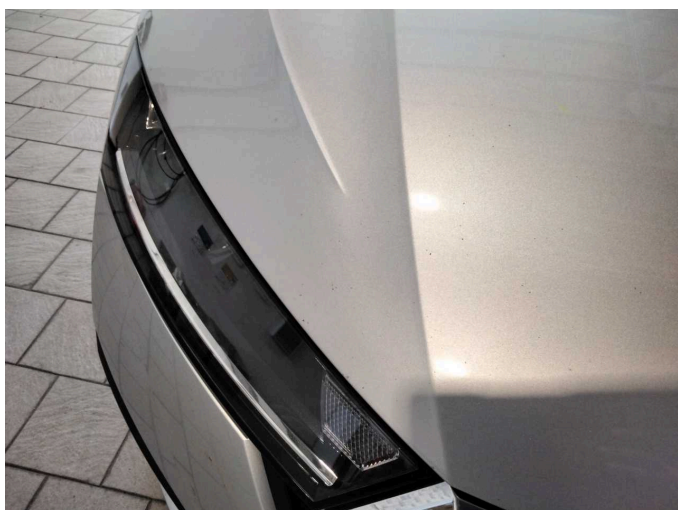
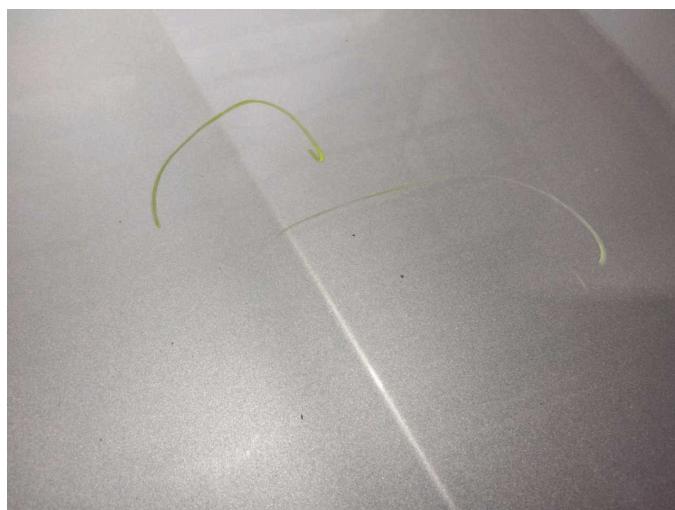
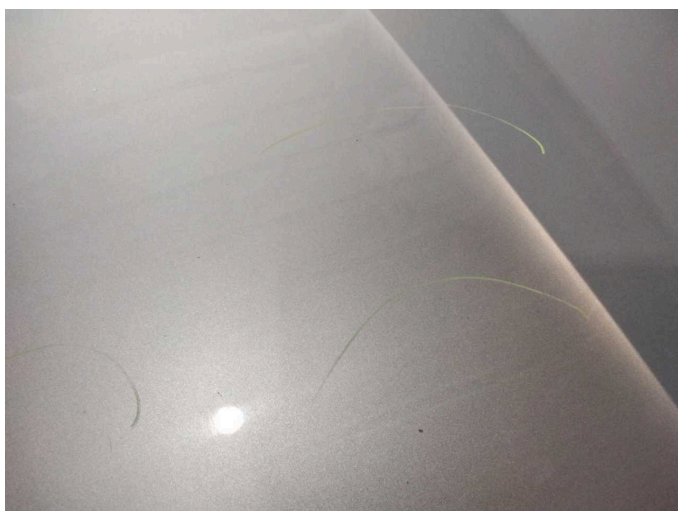
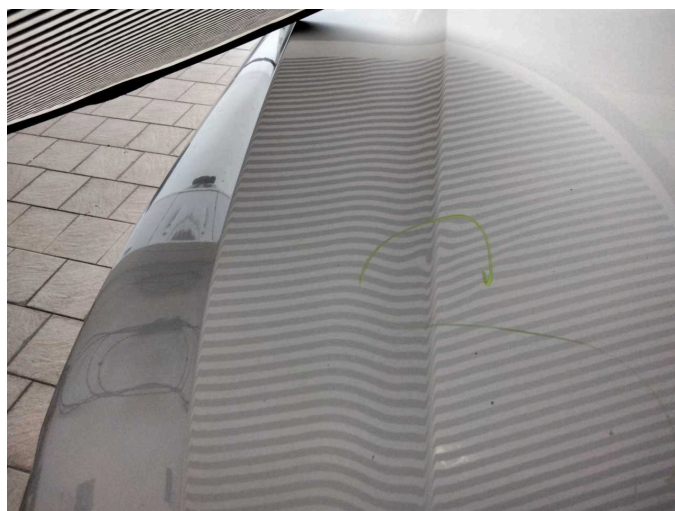
| No. | Component group | Description |
|---|---|---|
| 10 | Bonnet | Bonnet - Dent / paintcoat damage - Repair and paint |

**Damage 10:** Bonnet: Bonnet - Dent / paintcoat damage - Repair and paint

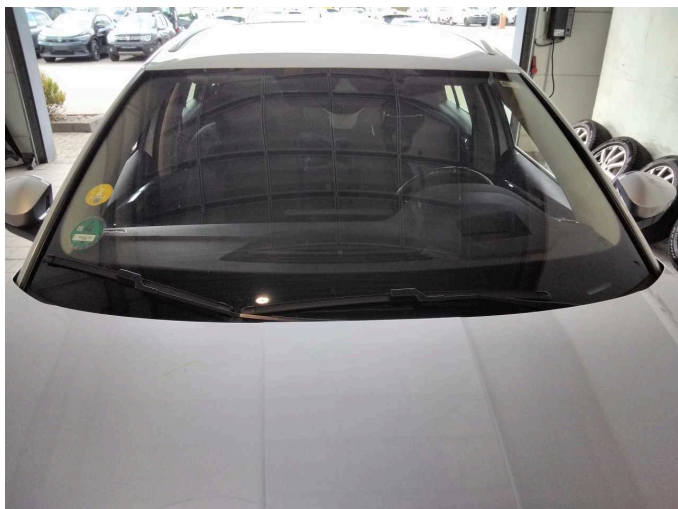
| No. | Component group | Description |
|---|---|---|
| 1 | Vehicle glazing | Windscreen - Stone chips - No deduction |

**Wear and tear 1:** Vehicle glazing: Windscreen - Stone chips - No deduction

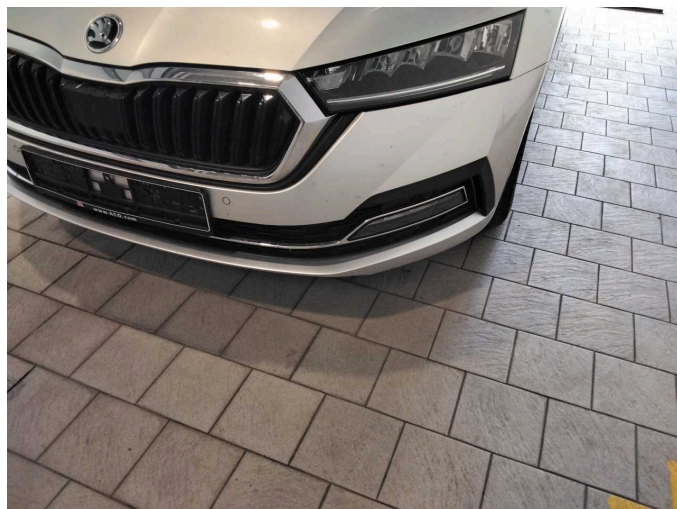
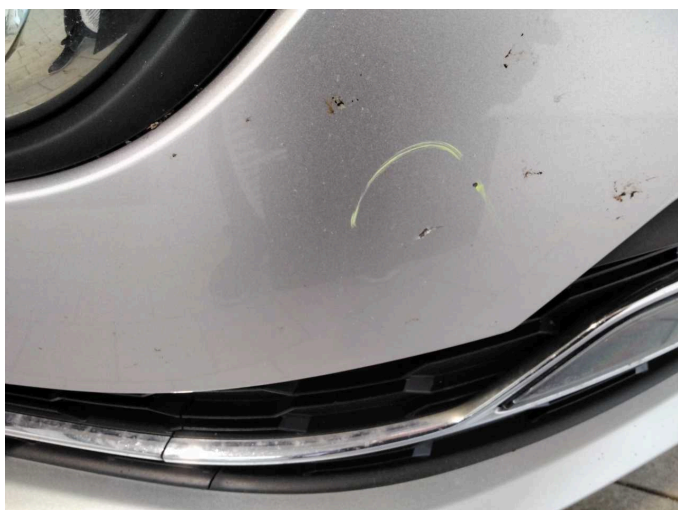
| No. | Component group | Description |
|---|---|---|
| 2 | Front bumper | Front bumper - Scratch(es) - No deduction |

**Wear and tear 2:** Front bumper: Front bumper - Scratch(es) - No deduction

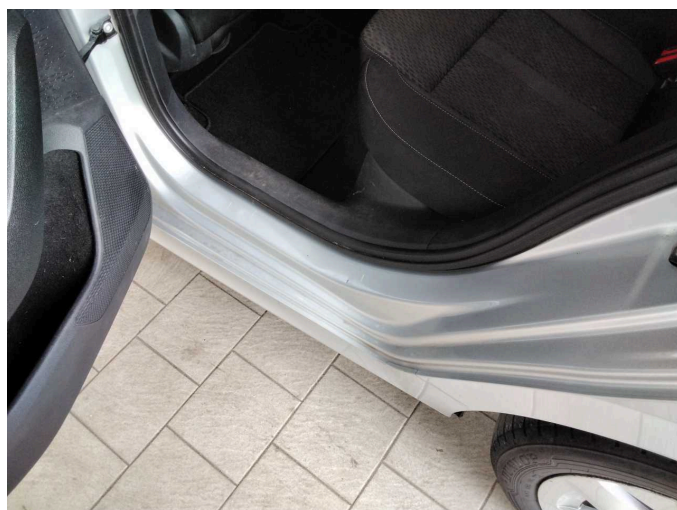
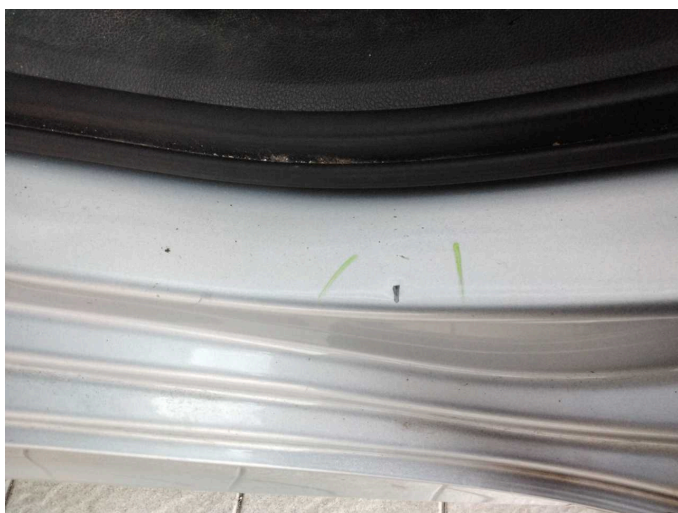
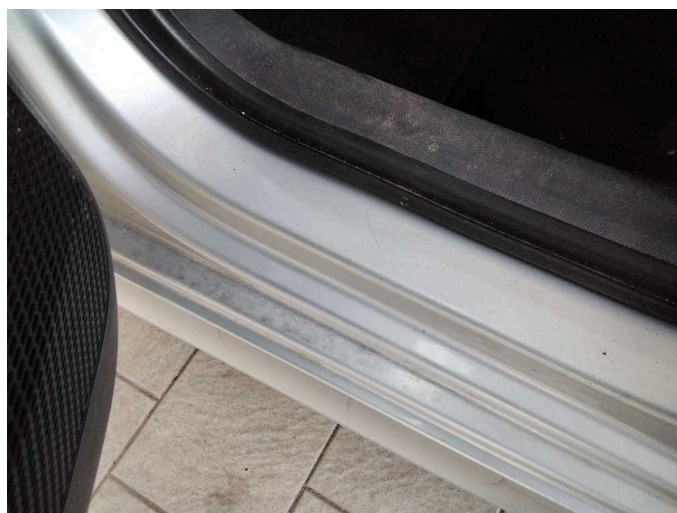
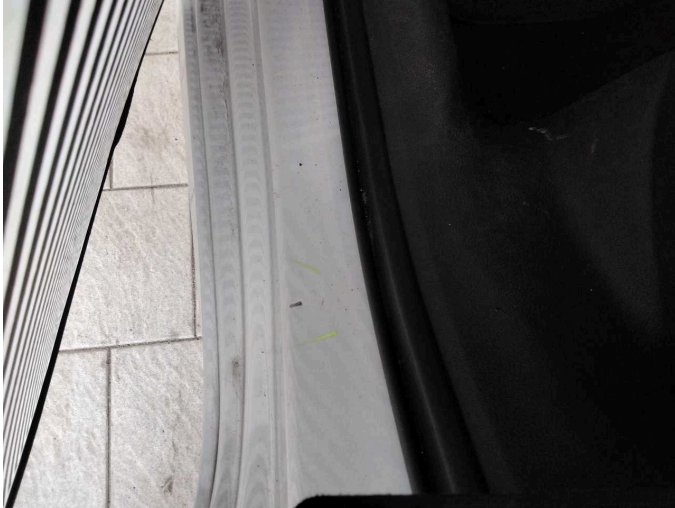
| No. | Component group | Description |
|---|---|---|
| 3 | Side panel - rear left side | Sill - Dent / paintcoat damage - Smart repair |

**Wear and tear 3:** Side panel - rear left side: Sill - Dent / paintcoat damage - Smart repair

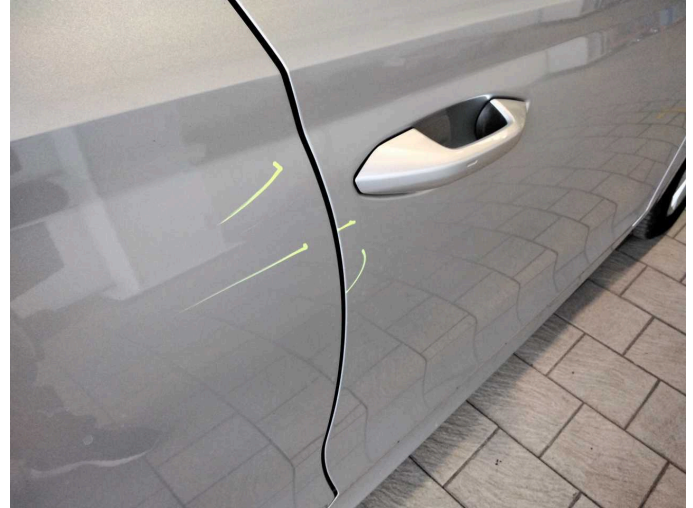
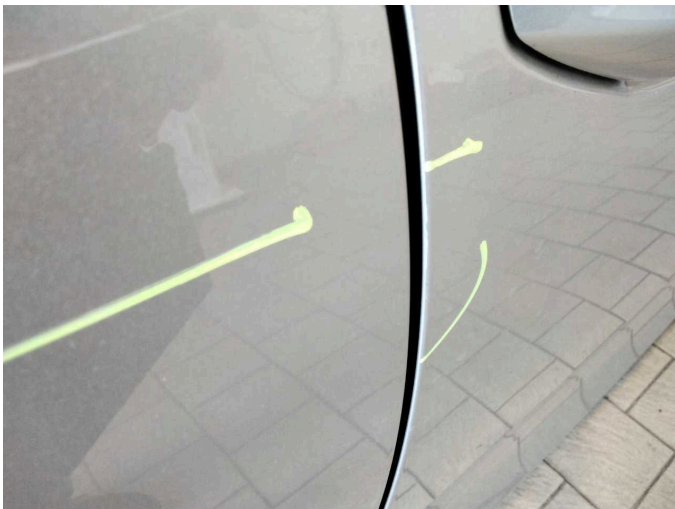
| No. | Component group | Description |
|---|---|---|
| 4 | Door - front right side | Door edge - Scratch(es) - Smart repair |

**Wear and tear 4:** Door - front right side: Door edge - Scratch(es) - Smart repair

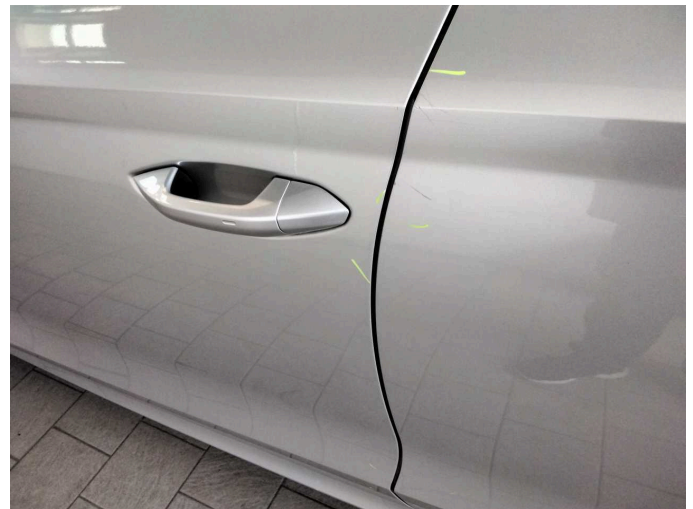
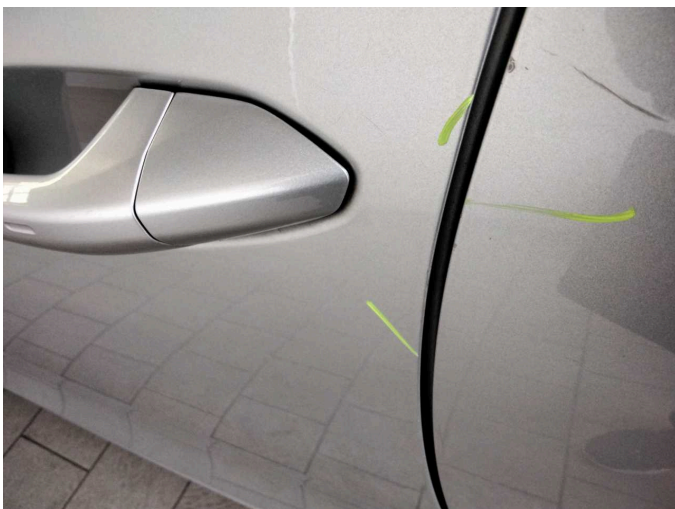
| No. | Component group | Description |
|---|---|---|
| 5 | Door - front left side | Door edge - Scratch(es) - Smart repair |

**Wear and tear 5:** Door - front left side: Door edge - Scratch(es) - Smart repair

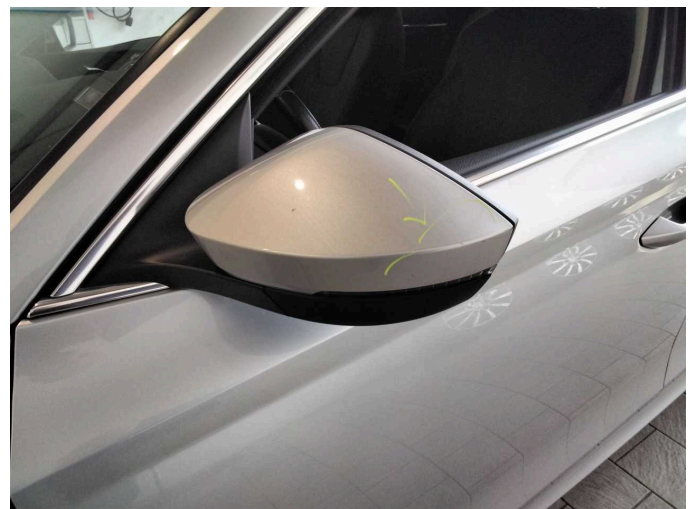
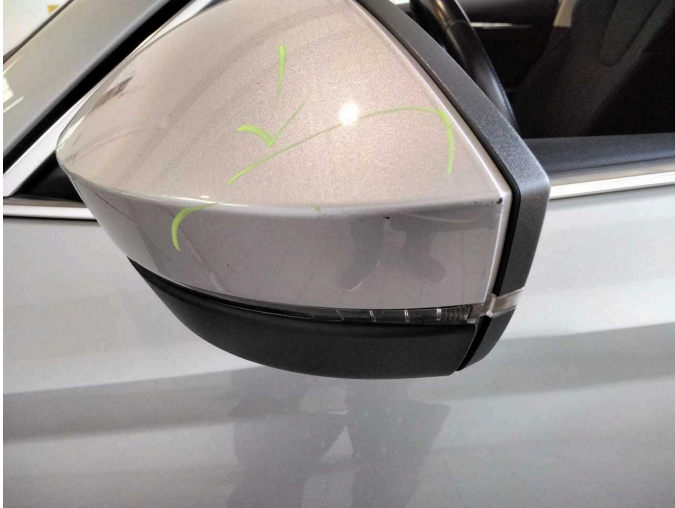
| No. | Component group | Description |
|---|---|---|
| 6 | Wing mirror - left side | Cap - Scratch(es) - Smart repair |

**Wear and tear 6:** Wing mirror - left side: Cap - Scratch(es) - Smart repair
