## Expertise

Protocol number: 44641305  
Order number / reference: 26062809  
Inspection date: 24 Mar 2026

Model: Transit Custom 340 L1H2 LKW VA Trend

VIN: WF0YXXTTGYMG34797

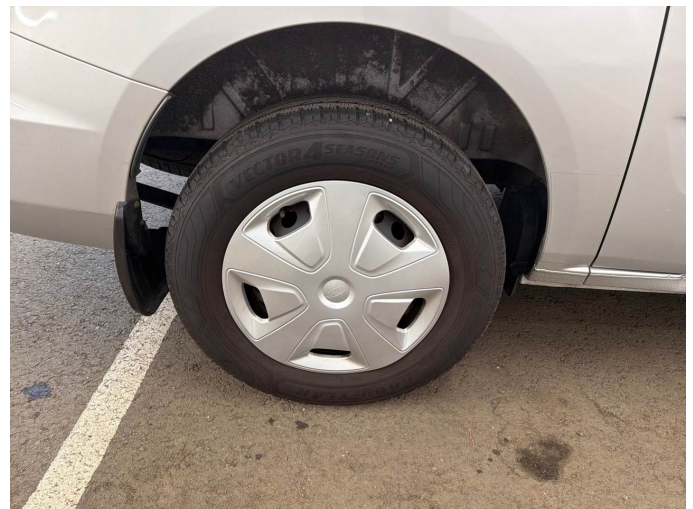
#	Tyre size	Type of tyre	Manufacturer	Tread depth
1)	215/65 R16 109T	All-season tyres on Steel rim with wheel cover	Goodyear	6mm / 6mm
2)	215/65 R16 109T	All-season tyres on Steel rim with wheel cover	Goodyear	6mm / 6mm

Figure 12: Mounted tyres

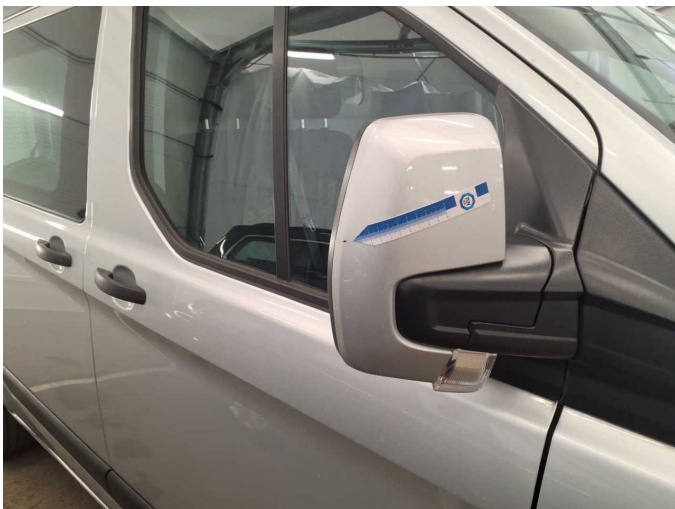
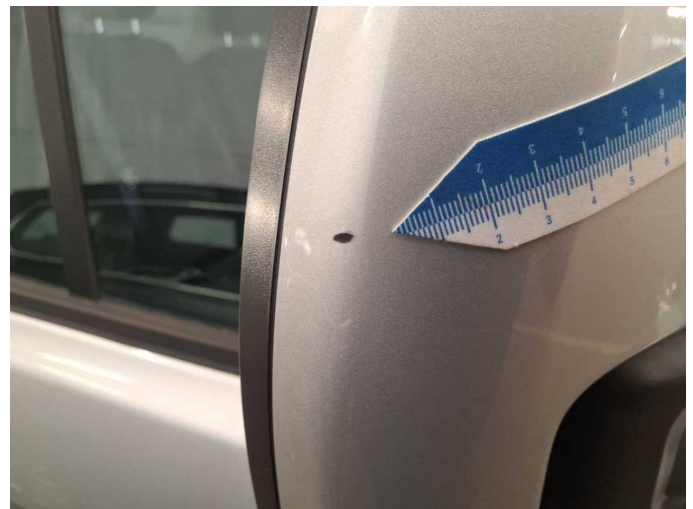
Damage 1: Wing mirror - right side: Cap - Scratched - Smart repair

No.	Component group	Description
1	Wing mirror - right side	Cap - Scratched - Smart repair
2	Bonnet	Bonnet - Dent / paintcoat damage - Repair and paint

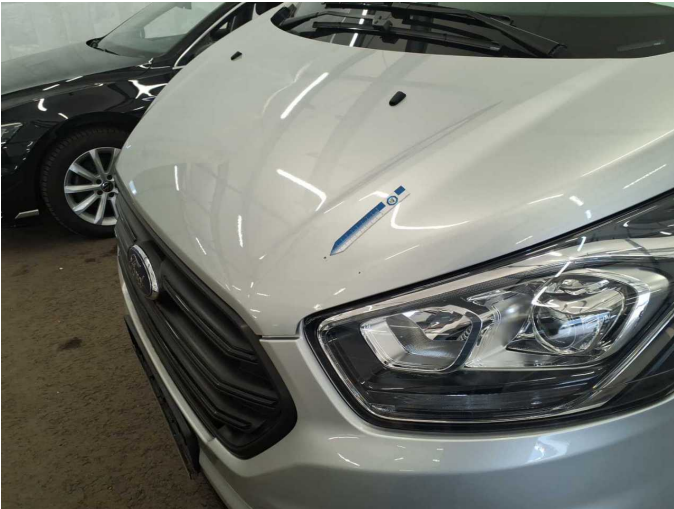
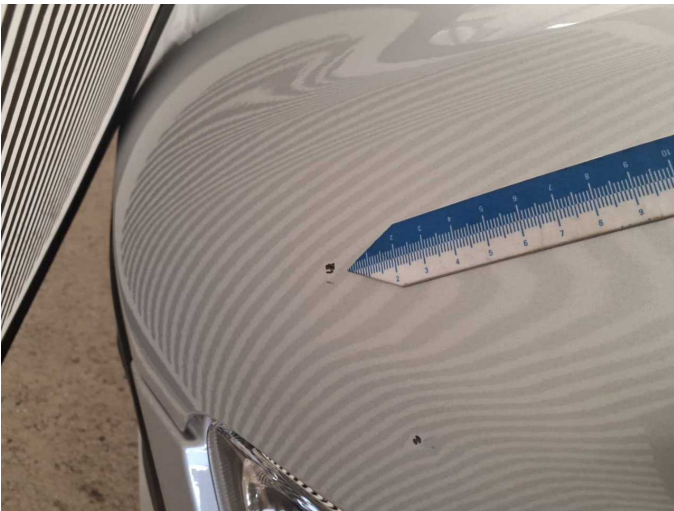
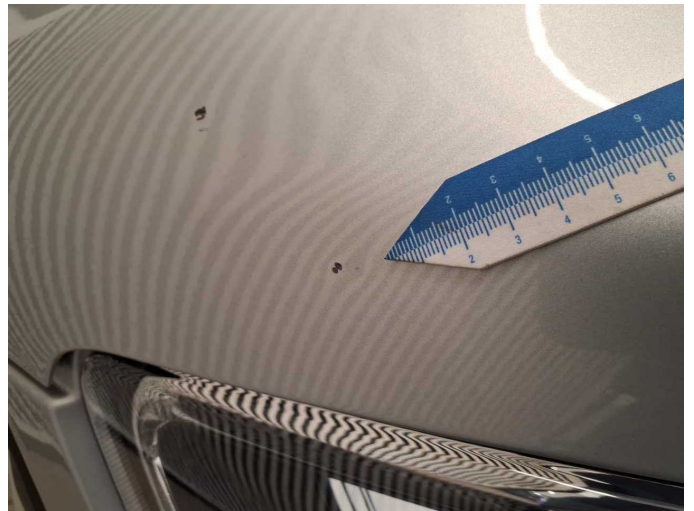
**Damage 2:** Bonnet: Bonnet - Dent / paintcoat damage - Repair and paint
