Expertise

Protocol number: 45583087  
Order No. / Reference: 26460687  
Inspection date: 22 May 2026

| Manufacturer: Ford | Model: S-Max 2.0 EcoBlue TITANIUM |
| VIN: WF0JXXWPCJNY67038 | |

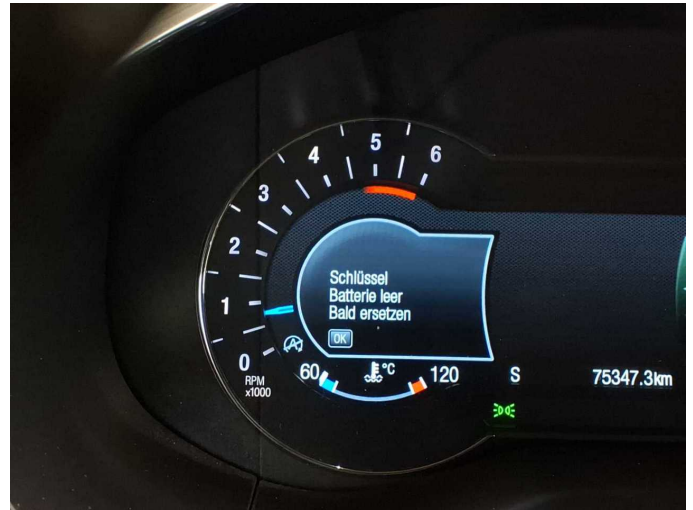
Damage 1: Equipment: Vehicle key with remote control (Batterie) - Empty - Replace

| No. | Component group | Description |
|---|---|---|
| 1 | Equipment | Vehicle key with remote control (Batterie) - Empty - Replace |

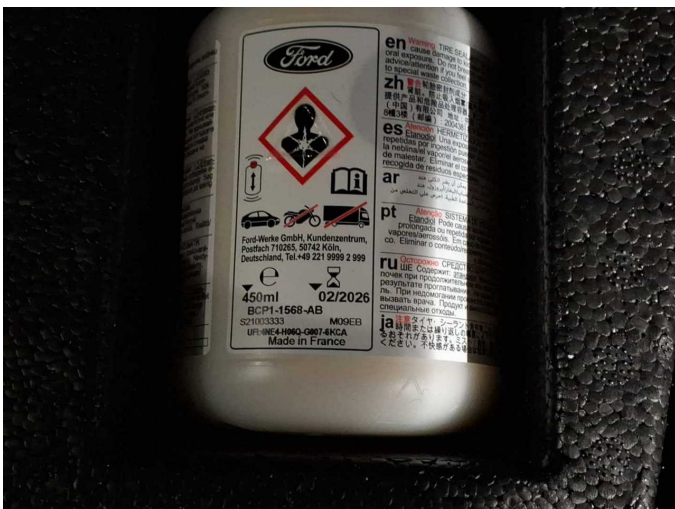
Damage 2: Equipment: Tirefit filler - Expired - Replace

| No. | Component group | Description |
|---|---|---|
| 2 | Equipment | Tirefit filler - Expired - Replace |

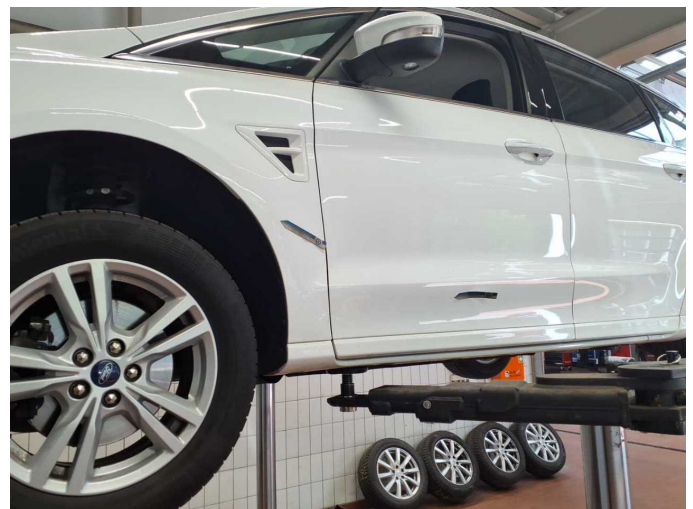
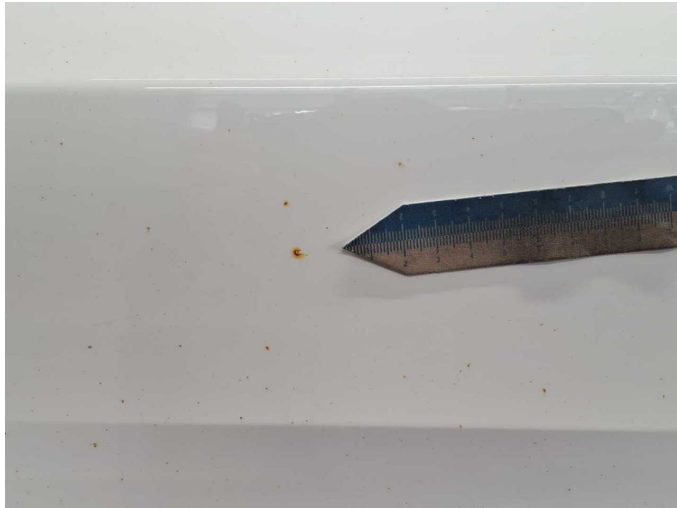
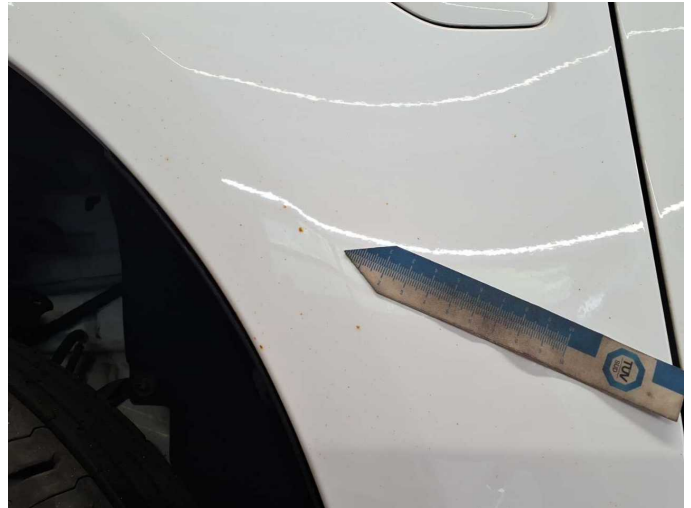
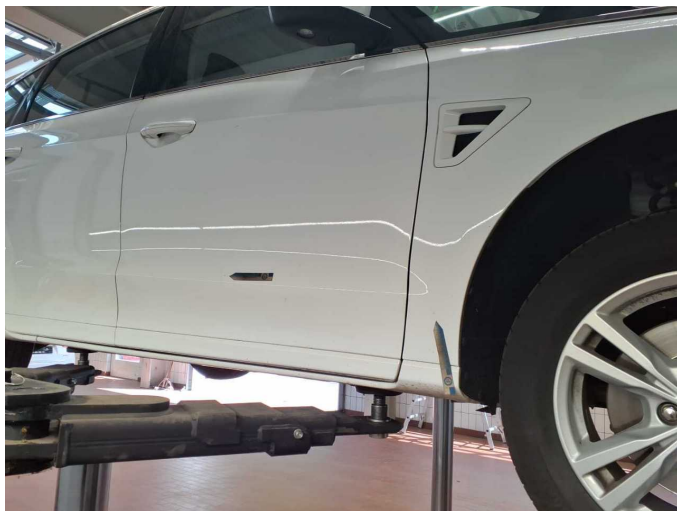
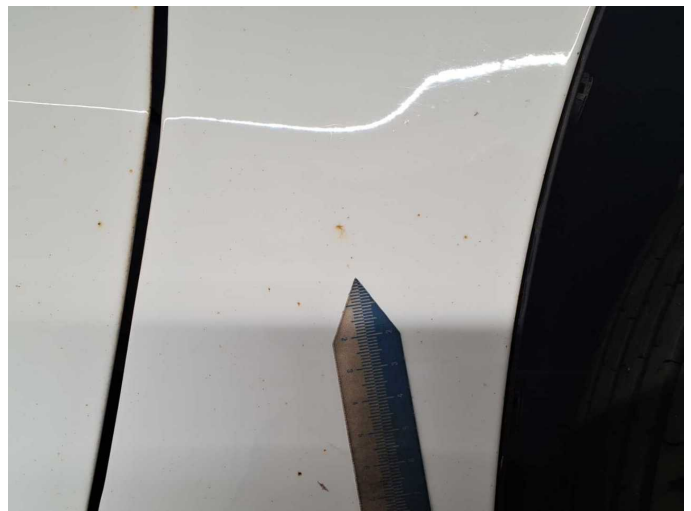
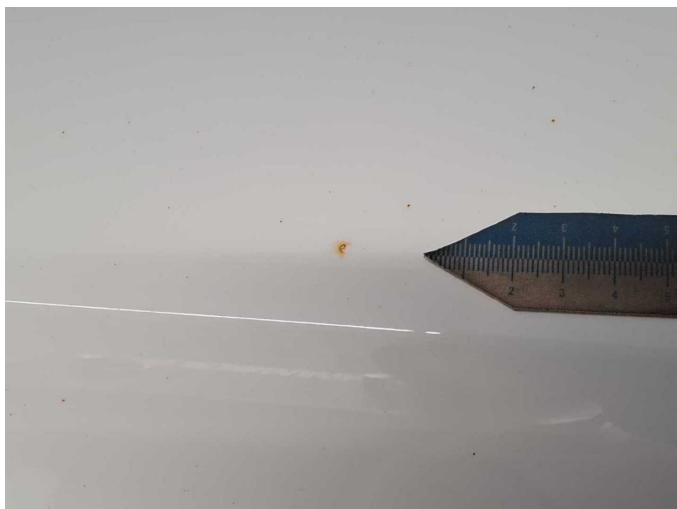
Damage 3: Body: Body (Flugrost) - Corrosion - Smart repair

**Damage 3:** Body: Body (Flugrost) - Corrosion - Smart repair

| No. | Component group | Description |
|---|---|---|
| 3 | Body | Body (Flugrost) - Corrosion - Smart repair |

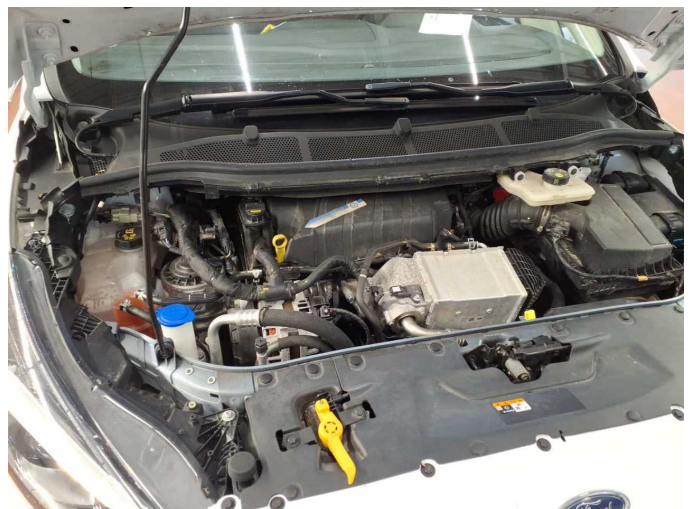
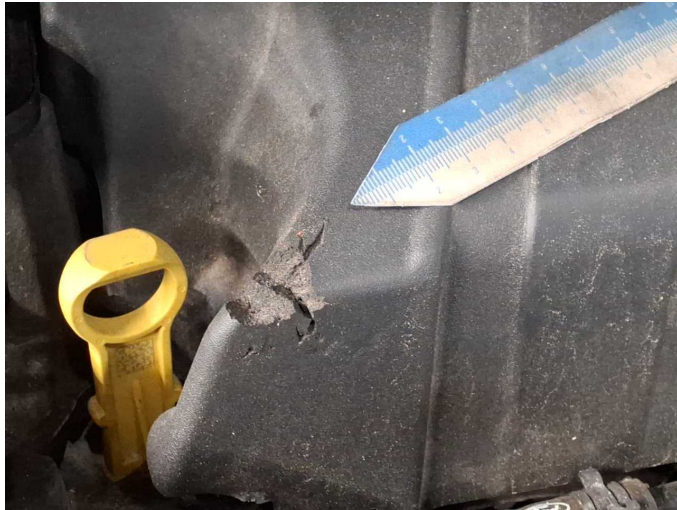
**Damage 4:** Engine: Engine cover - Damage caused by marten / rodent - Replace

| No. | Component group | Description |
|---|---|---|
| 4 | Engine | Engine cover - Damage caused by marten / rodent - Replace |

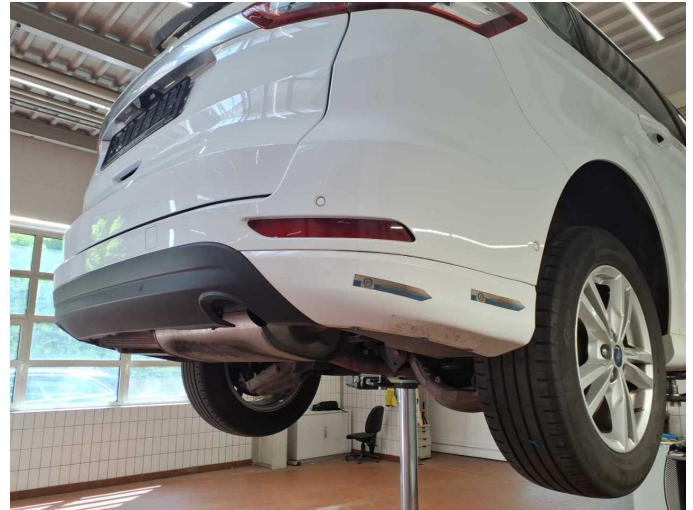
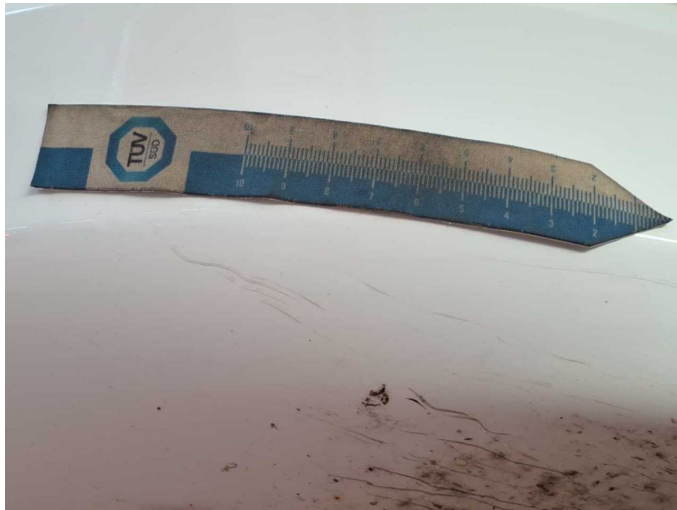
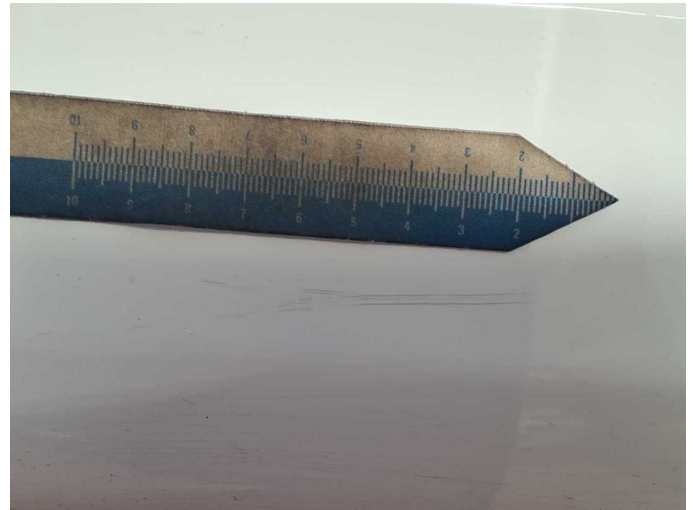
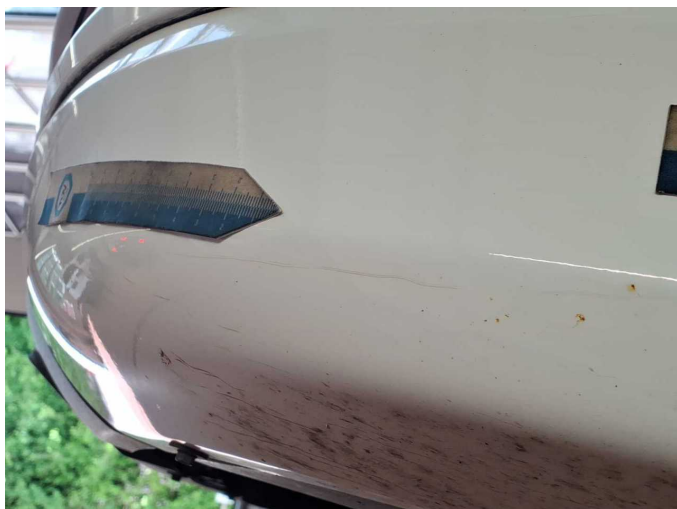
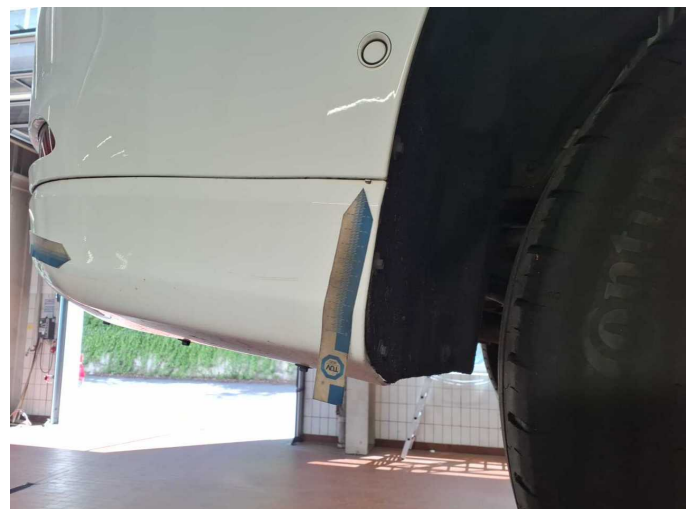
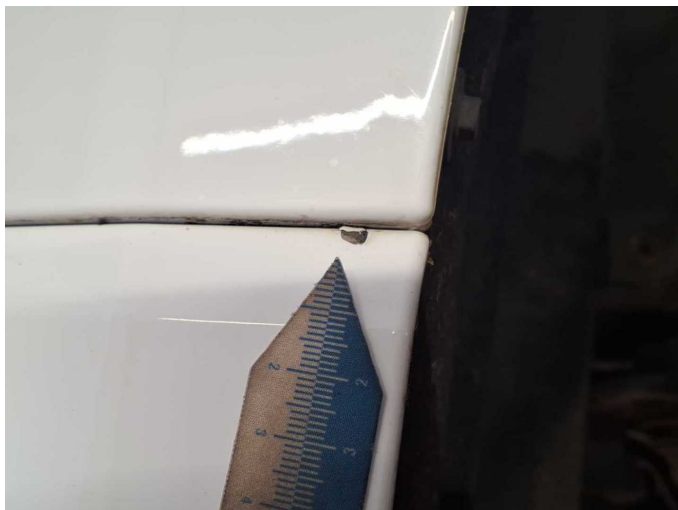
**Damage 5:** Rear bumper: Spoiler (Rechts) - Scratch(es) - Paint

| No. | Component group | Description |
|---|---|---|
| 5 | Rear bumper | Spoiler (Rechts) - Scratch(es) - Paint |

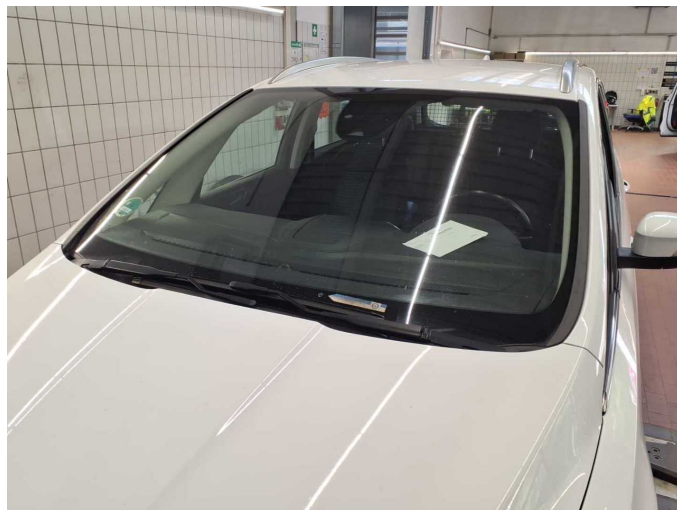
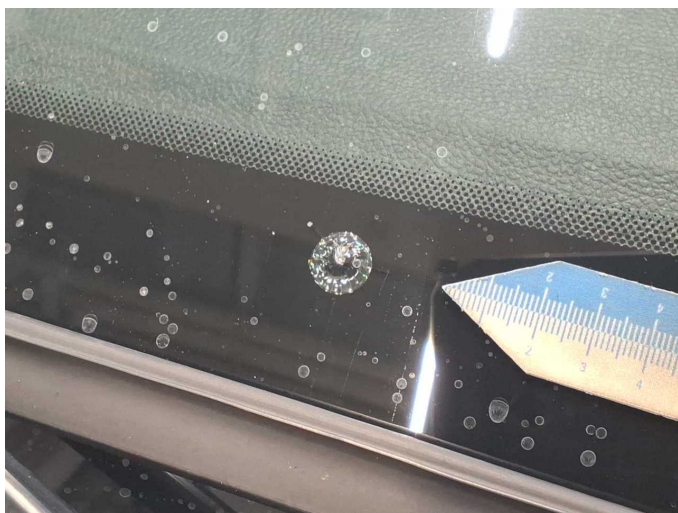
**Damage 6:** Vehicle glazing: Windscreen (Im Randbereich mit Rissbildung) - Stone chips - repair according to calculation

| No. | Component group | Description |
|---|---|---|
| 6 | Vehicle glazing | Windscreen (Im Randbereich mit Rissbildung) - Stone chips - repair according to calculation |

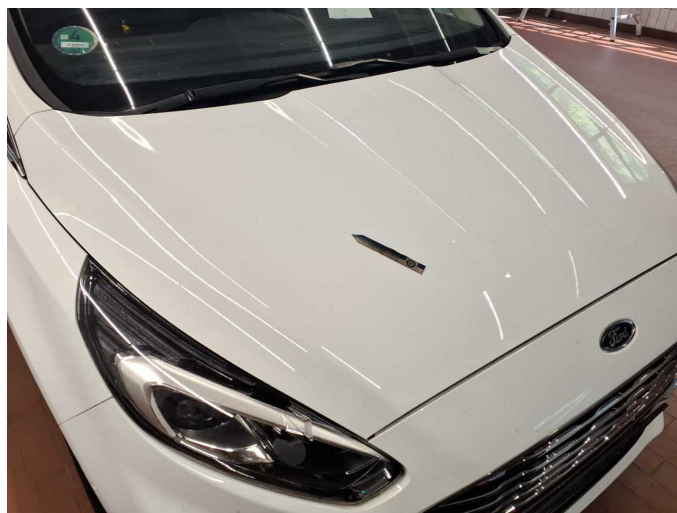
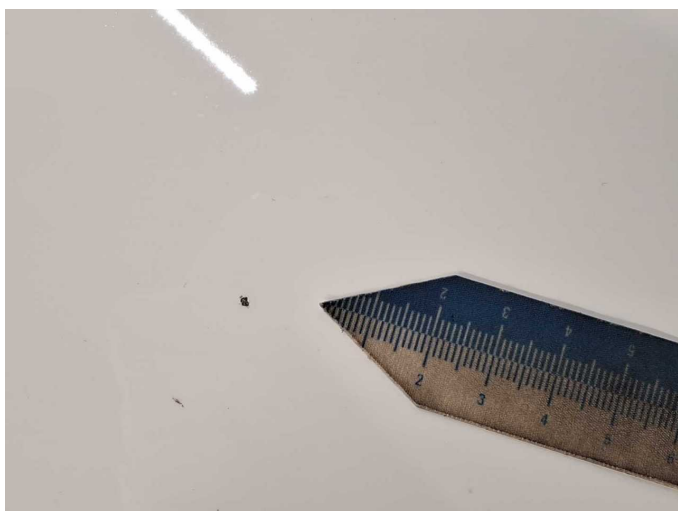
**Wear and tear 1:** Bonnet: Bonnet - Stone chips - No deduction

| No. | Component group | Description |
|---|---|---|
| 1 | Bonnet | Bonnet - Stone chips - No deduction |

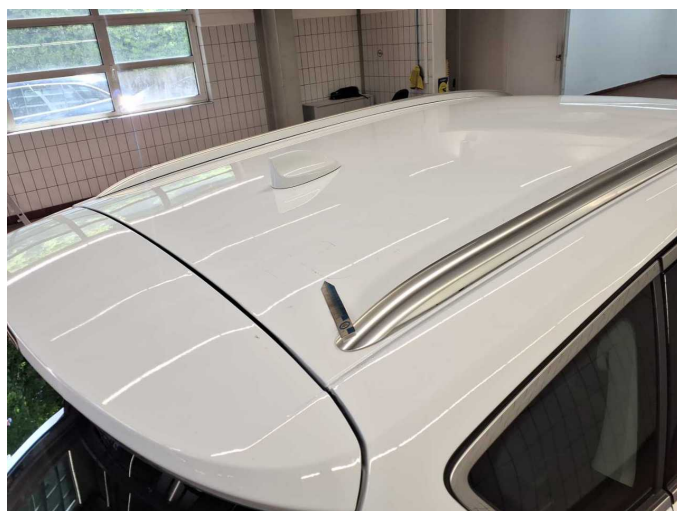
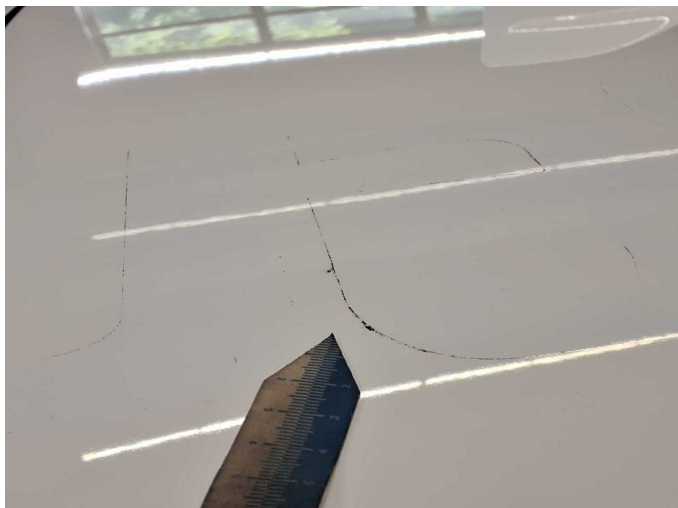
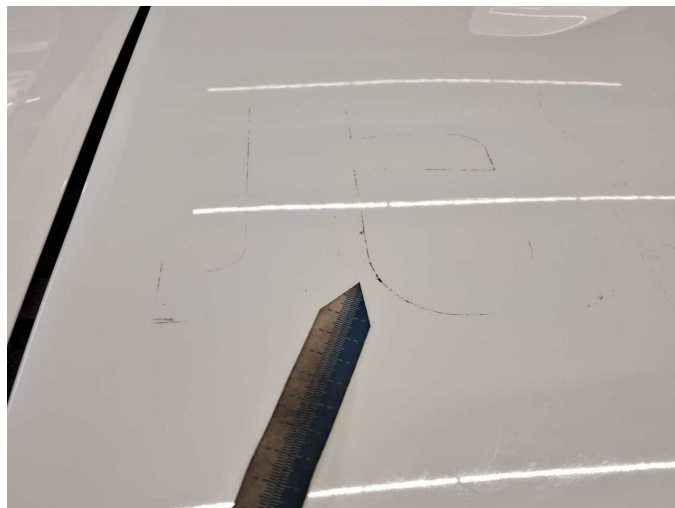
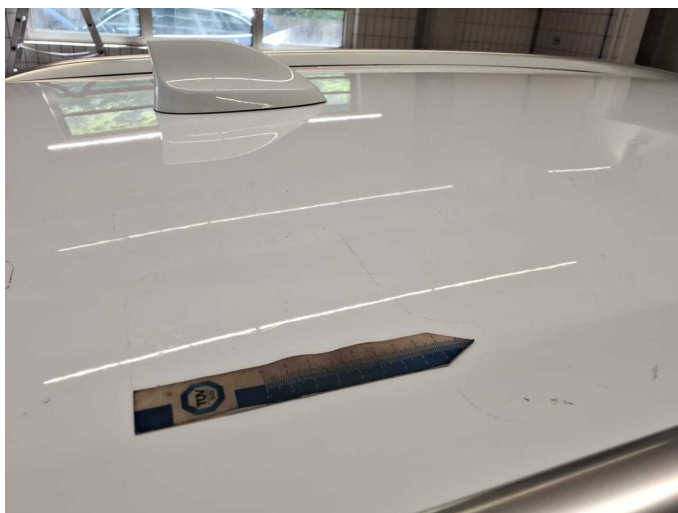
**Wear and tear 2:** Roof: Roof - Soiled - No deduction

| No. | Component group | Description |
|---|---|---|
| 2 | Roof | Roof - Soiled - No deduction |
