Expertise

Protocol number: 46512265  
Order No. / Reference: 26521592  
Inspection date: 14 Jul 2026

| Manufacturer: Audi | Model: S7 TDI quattro tiptronic |

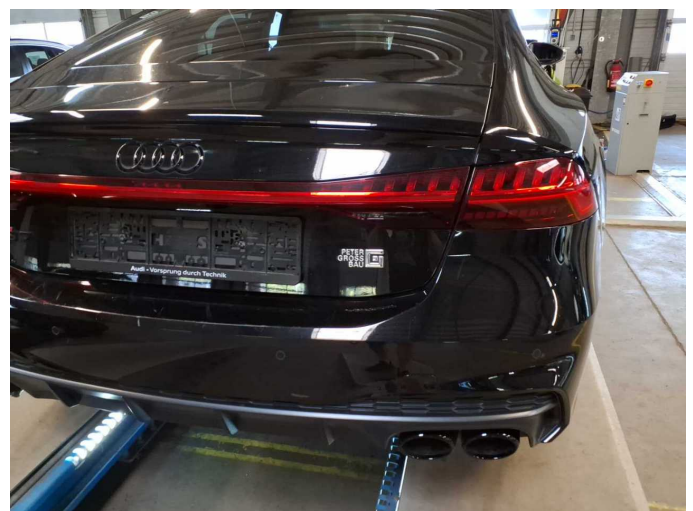
| No. | Component group | Description |
|---|---|---|
| 1 | Body | Body - Glued / labelled - De-glue / neutralise |

Damage 1: Body: Body - Glued / labelled - De-glue / neutralise

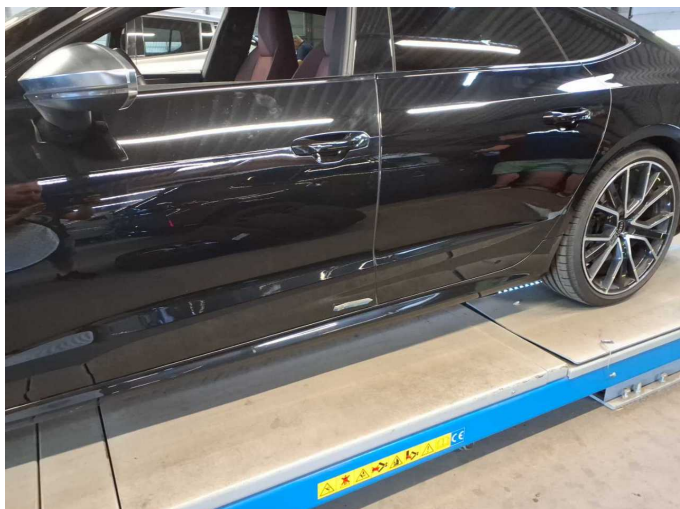
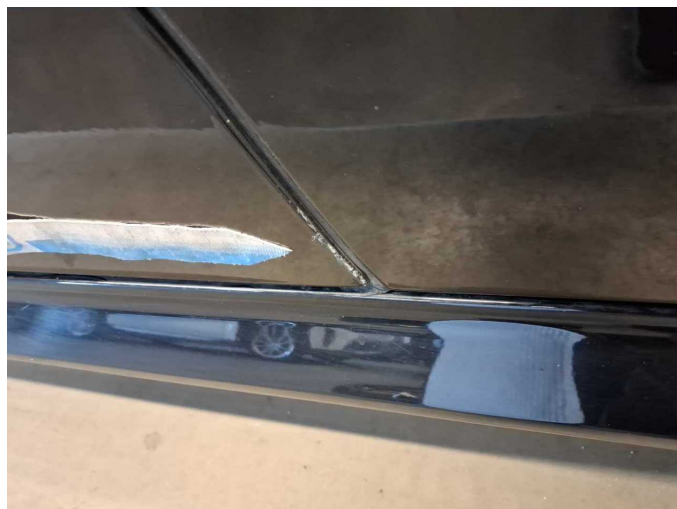
| No. | Component group | Description |
|---|---|---|
| 2 | Door - front left side | Door edge - Scratch(es) - Smart repair |

**Damage 2:** Door - front left side: Door edge - Scratch(es) - Smart repair

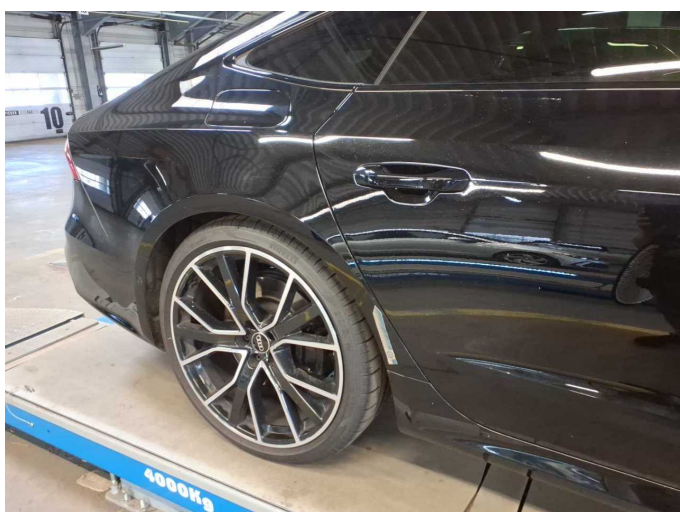
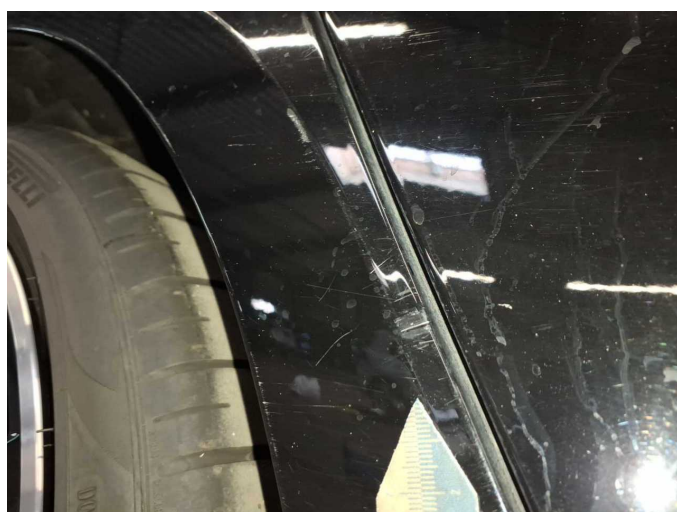
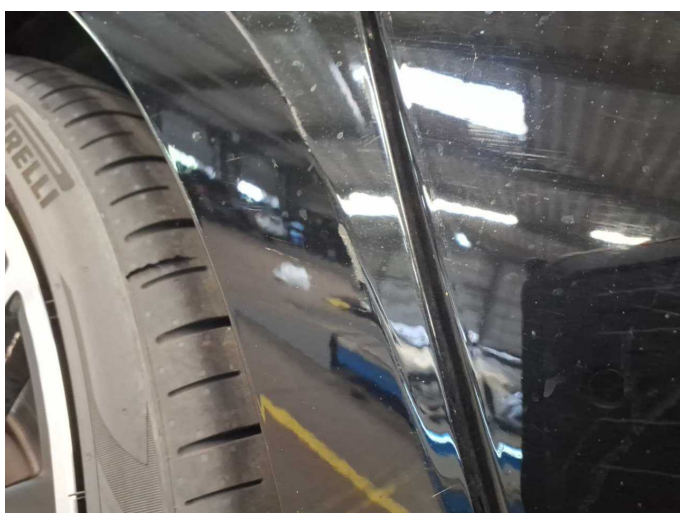
| No. | Component group | Description |
|---|---|---|
| 3 | Side panel - rear right side | Side panel - Scratch(es) - Smart repair |

**Damage 3:** Side panel - rear right side: Side panel - Scratch(es) - Smart repair

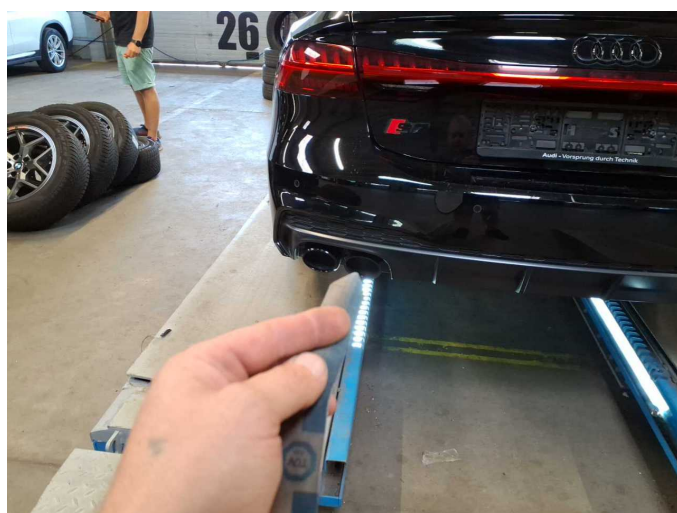
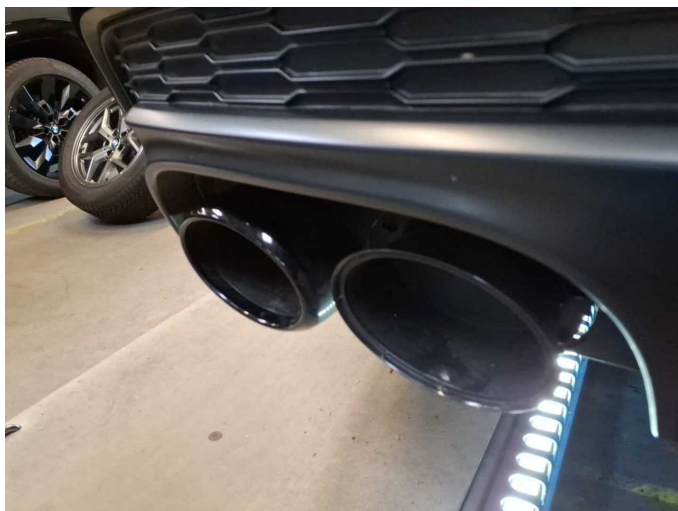
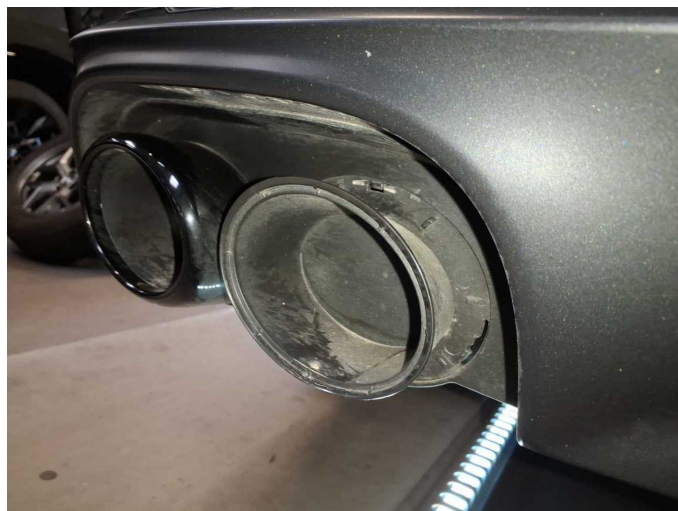
| No. | Component group | Description |
|---|---|---|
| 4 | Exhaust system | Exhaust system (Blende) - Missing - Replace |

**Damage 4:** Exhaust system: Exhaust system (Blende) - Missing - Replace

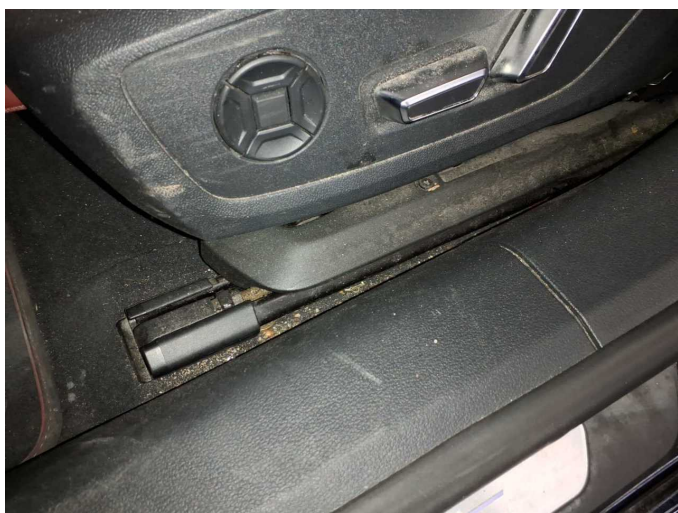
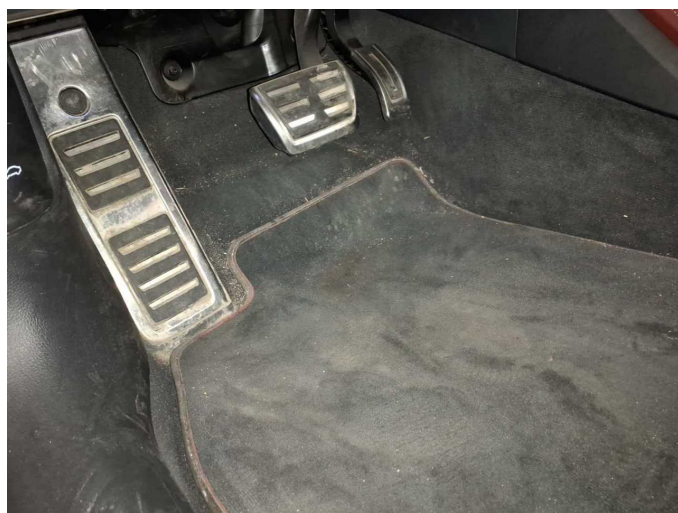
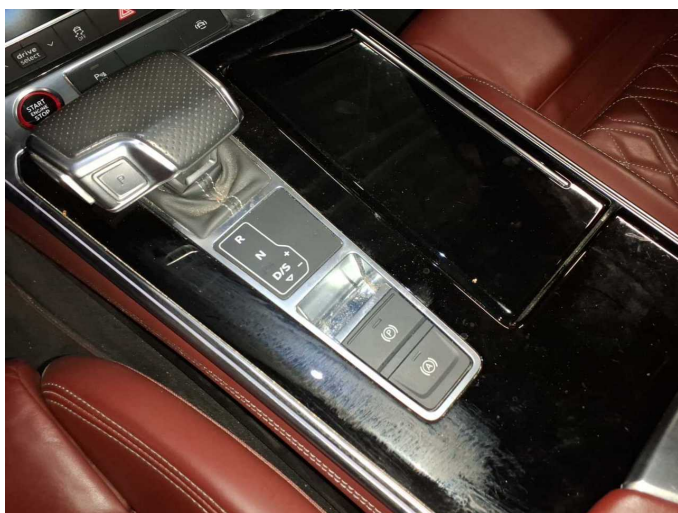
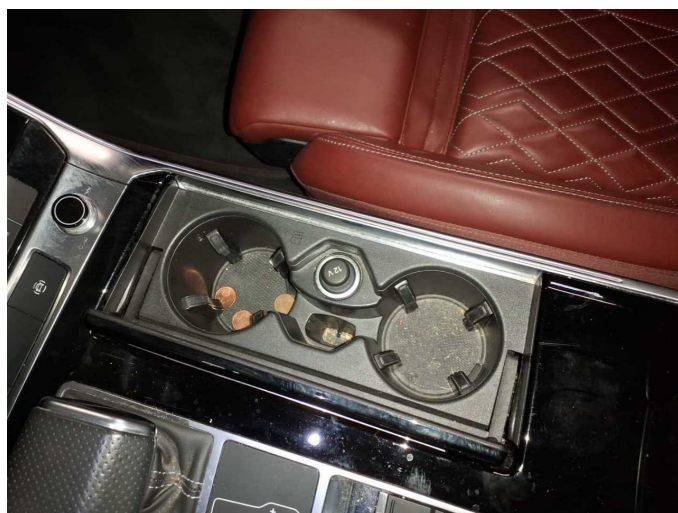
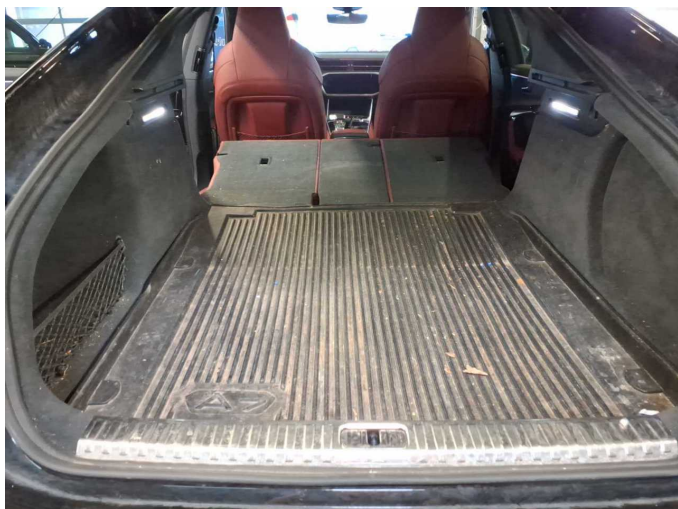
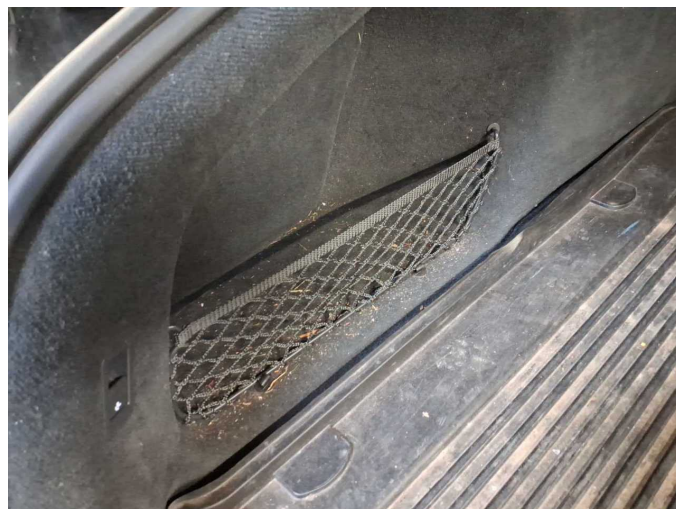
| No. | Component group | Description |
|---|---|---|
| 5 | Interior | Interior - Soiled - Clean |

**Damage 5:** Interior: Interior - Soiled - Clean

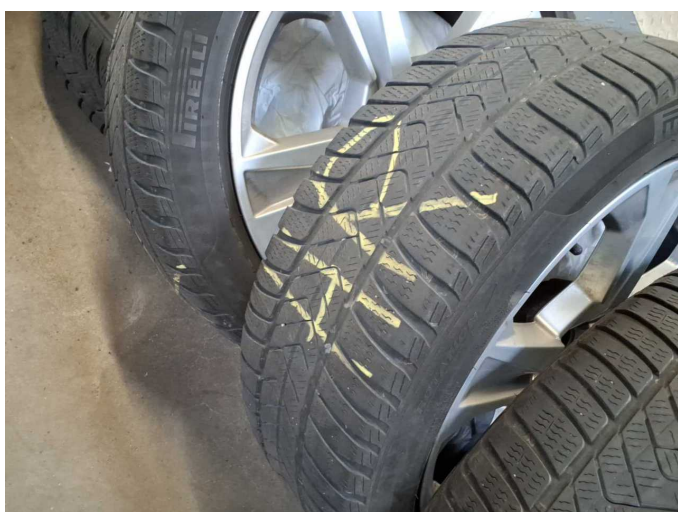
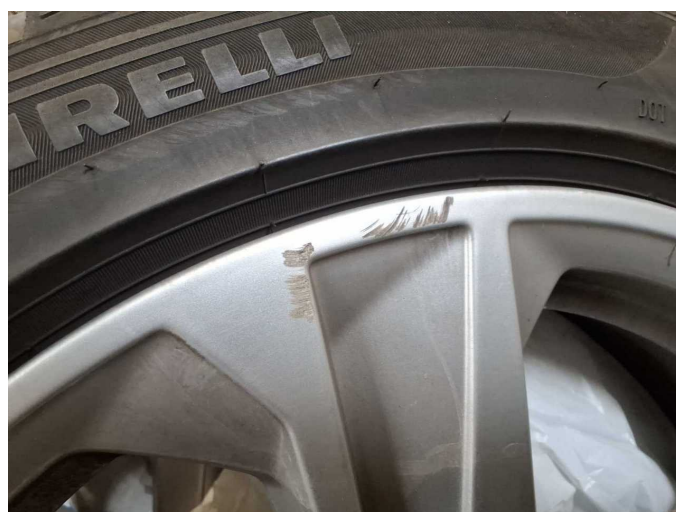
| No. | Component group | Description |
|---|---|---|
| 6 | 2nd wheel set | 1 alloy rim - Scratch(es) - Loss in value |

**Damage 6:** 2nd wheel set: 1 alloy rim - Scratch(es) - Loss in value

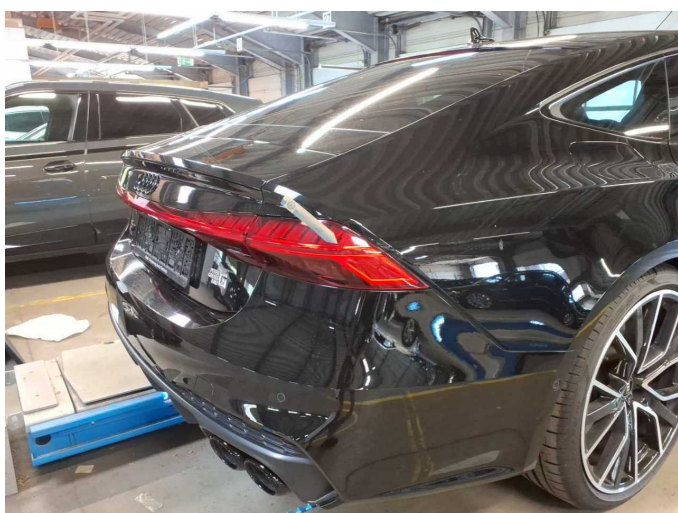
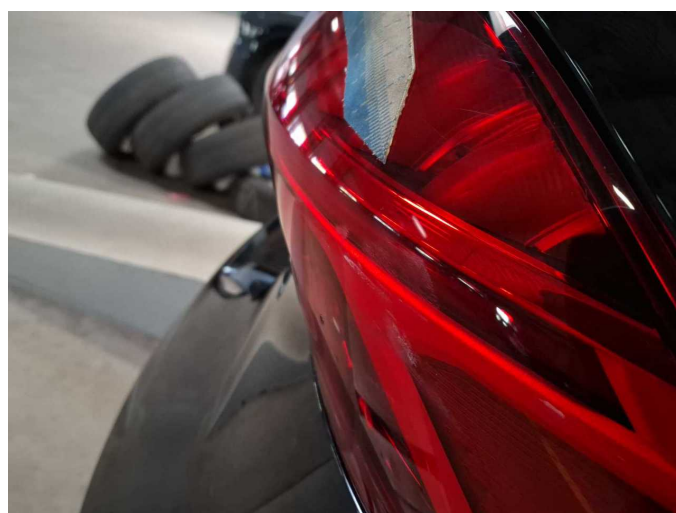
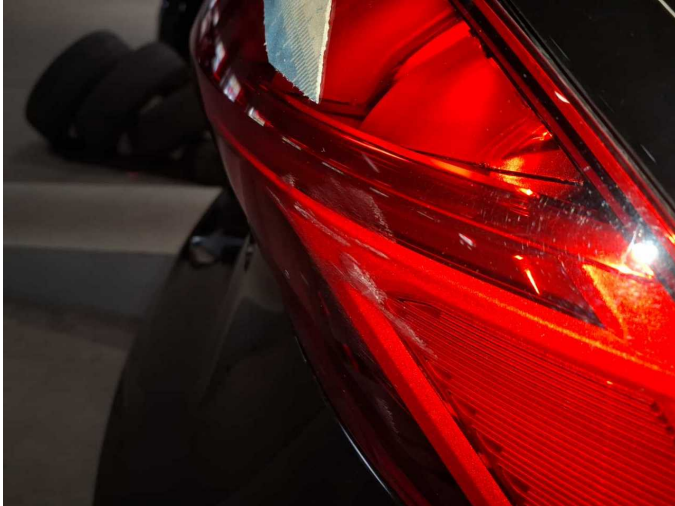
| No. | Component group | Description |
|---|---|---|
| 7 | Tail light | Tail lamp - right side (Materialabtrag) - Scratched - Replace |

**Damage 7:** Tail light: Tail lamp - right side (Materialabtrag) - Scratched - Replace

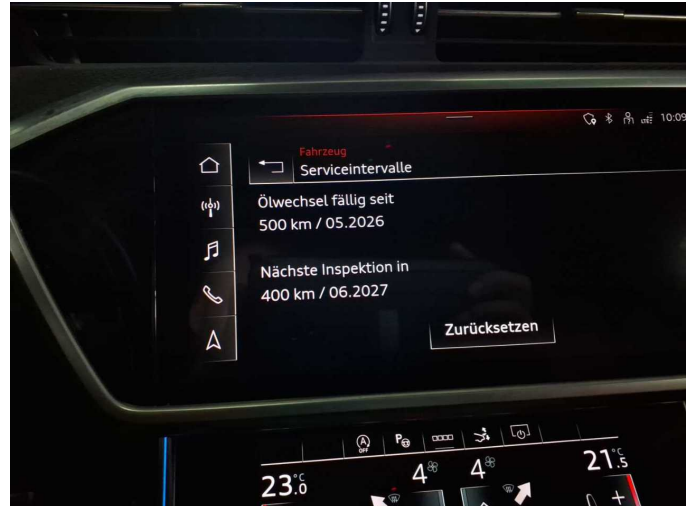
| No. | Component group | Description |
|---|---|---|
| 8 | Misc. | Inspection / maintenance - Due - Perform |

**Damage 8:** Misc.: Inspection / maintenance - Due - Perform

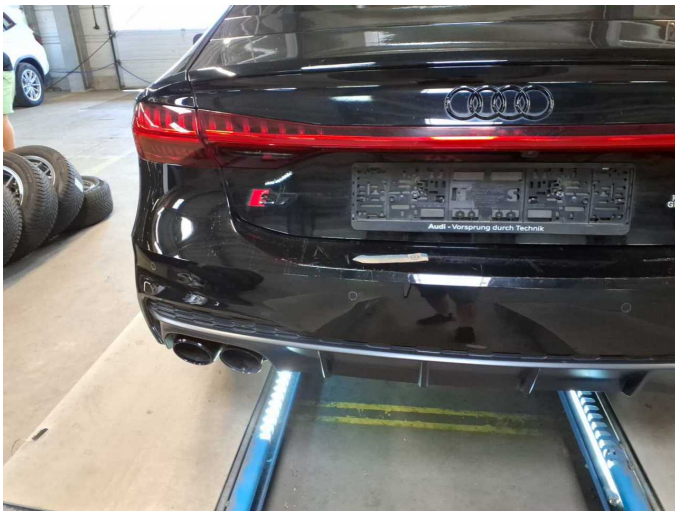
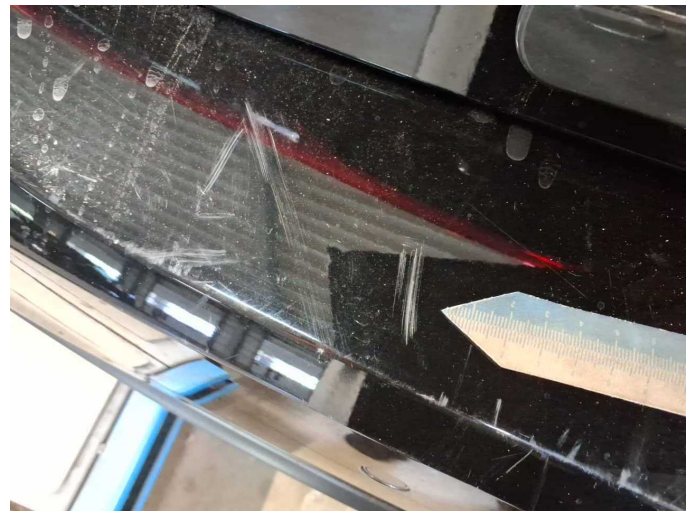
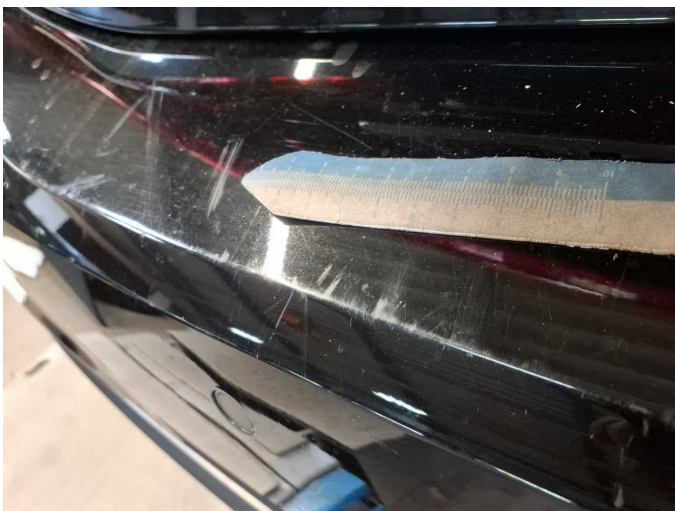
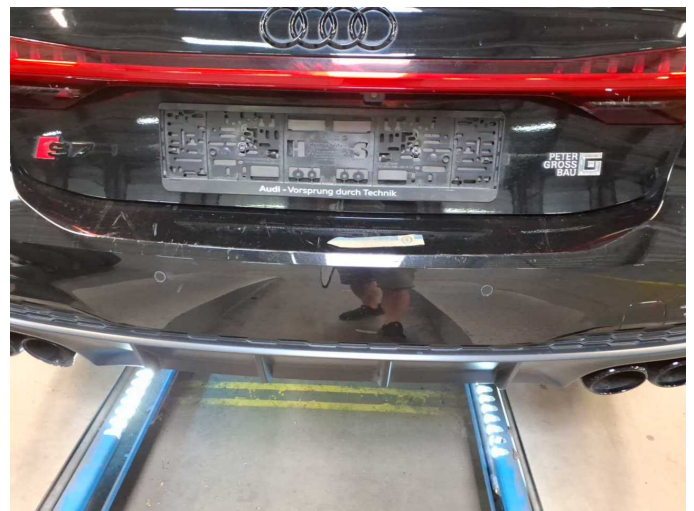
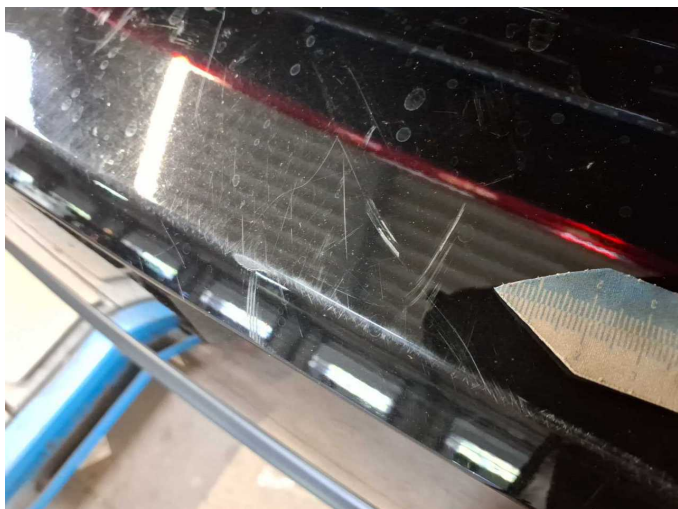
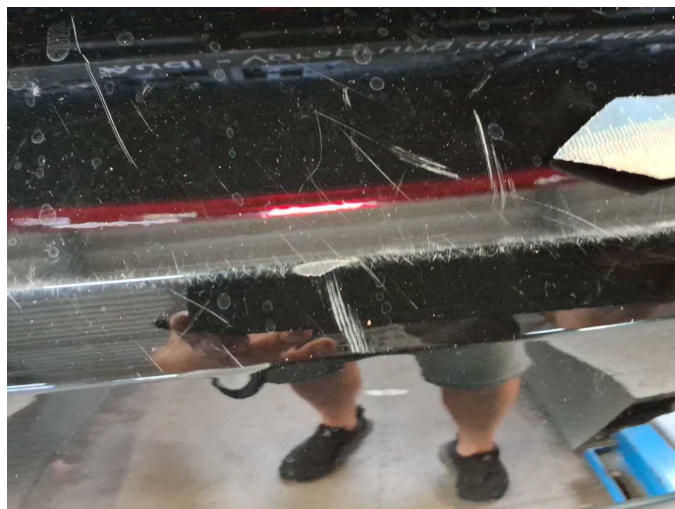
| No. | Component group | Description |
|---|---|---|
| 9 | Rear bumper | Rear bumper - Scratched - Paint |

**Damage 9:** Rear bumper: Rear bumper - Scratched - Paint

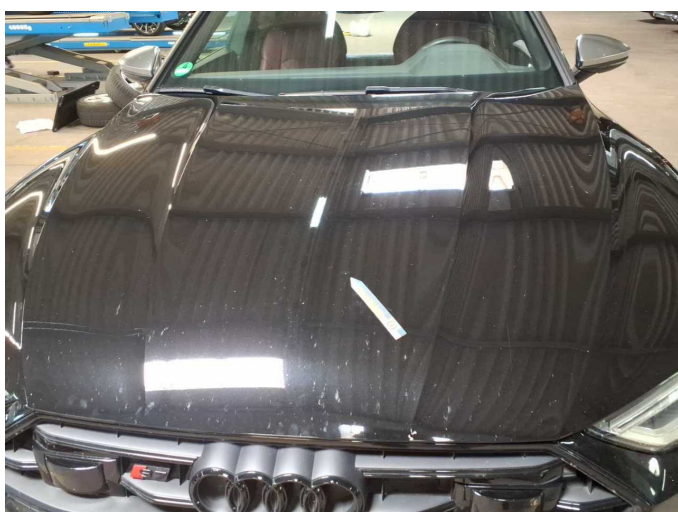
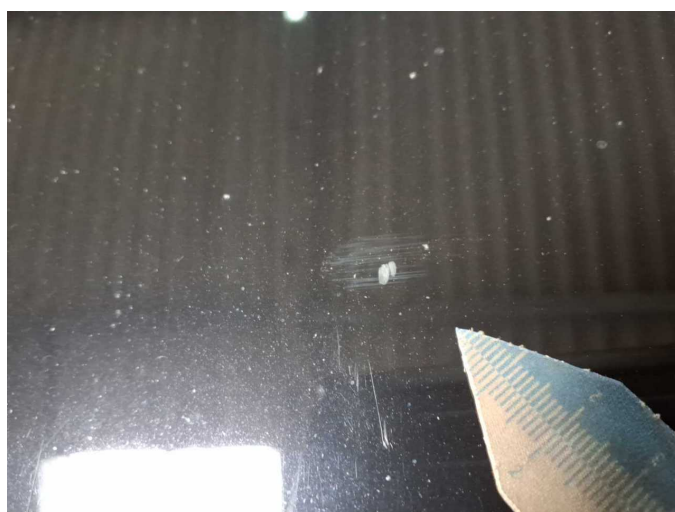
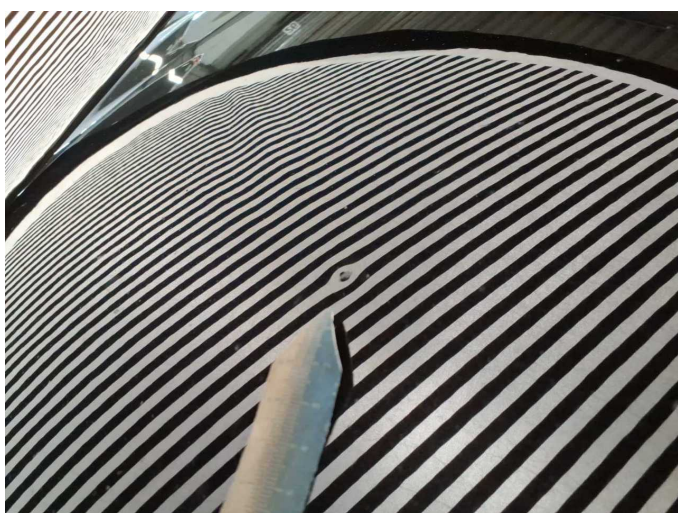
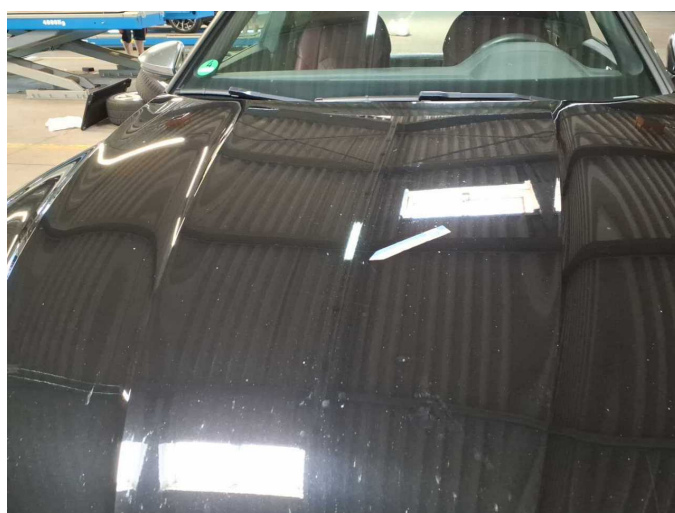
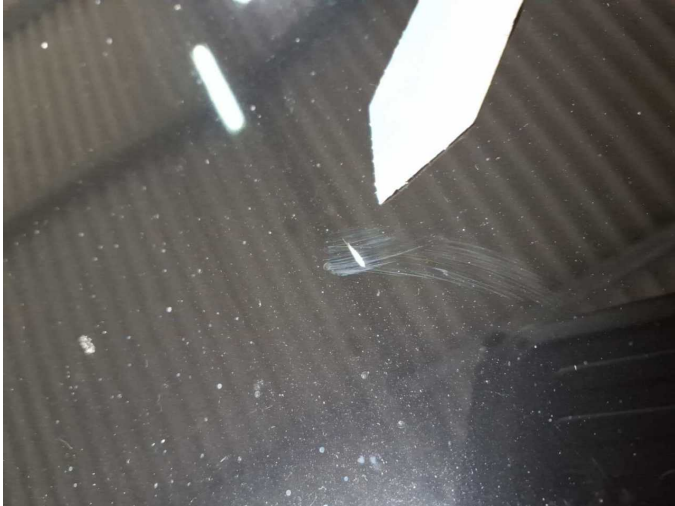
| No. | Component group | Description |
|---|---|---|
| 10 | Bonnet | Bonnet - Dent / paintcoat damage - Repair and paint |

**Damage 10:** Bonnet: Bonnet - Dent / paintcoat damage - Repair and paint

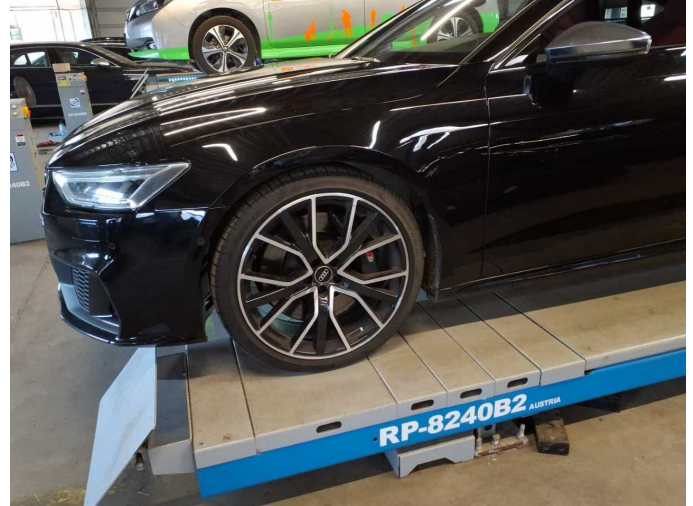
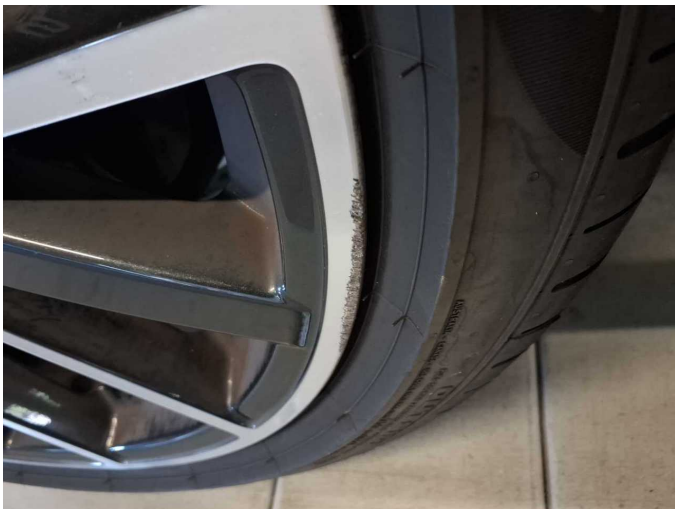
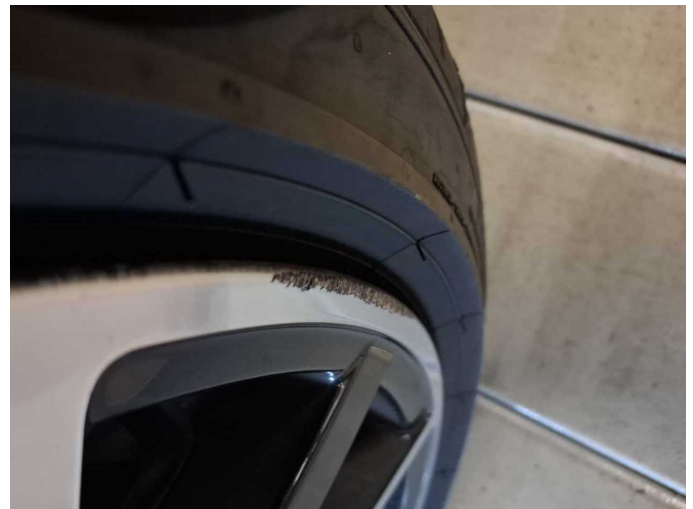
| No. | Component group | Description |
|---|---|---|
| 11 | Wheel / tyres | Alloy rim - front left side (Materialabtrag) - Scratched - Replace |

**Damage 11:** Wheel / tyres: Alloy rim - front left side (Materialabtrag) - Scratched - Replace

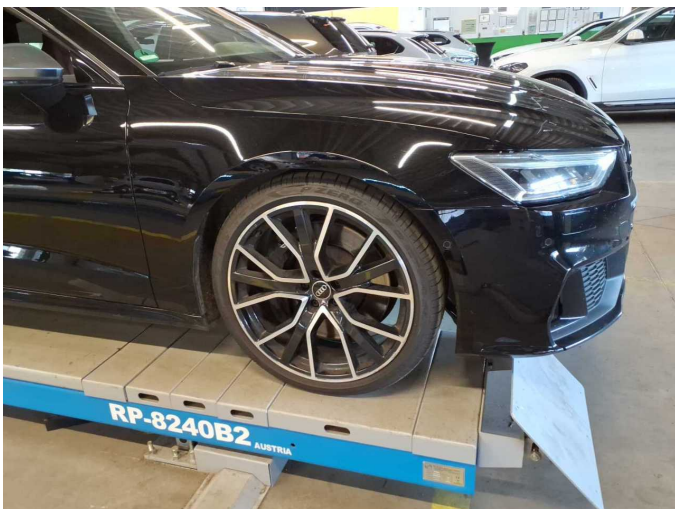
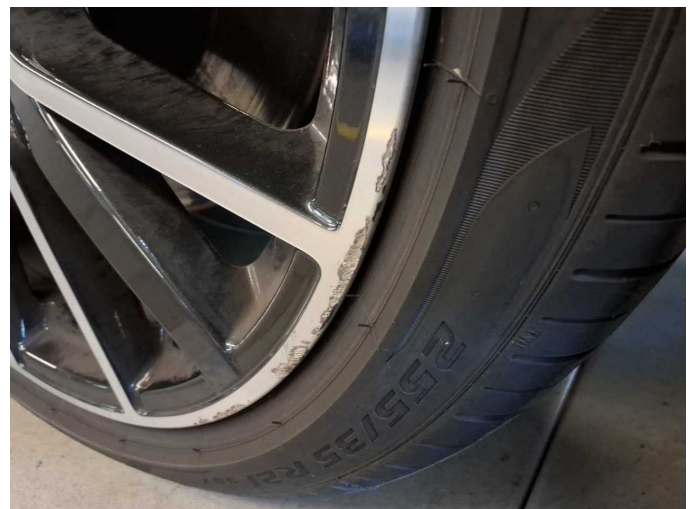
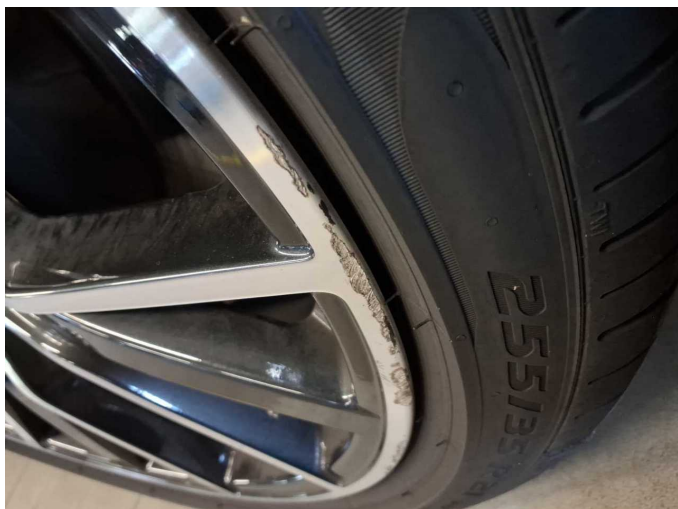
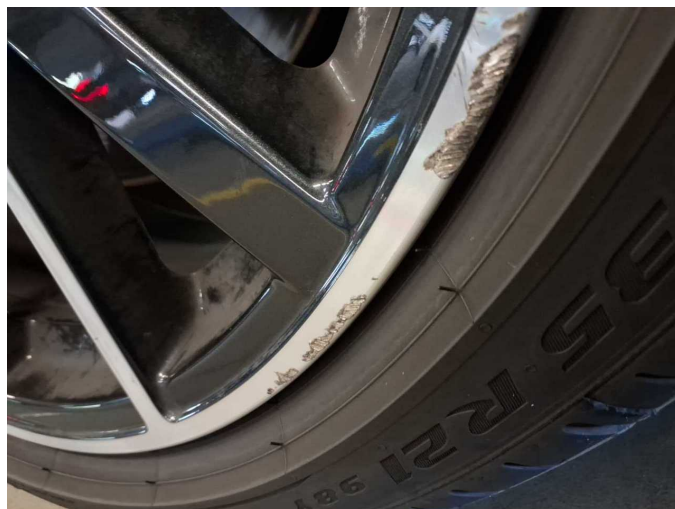
| No. | Component group | Description |
|---|---|---|
| 12 | Wheel / tyres | Alloy rim - front right side (Materialabtrag) - Scratched - Replace |

**Damage 12:** Wheel / tyres: Alloy rim - front right side (Materialabtrag) - Scratched - Replace

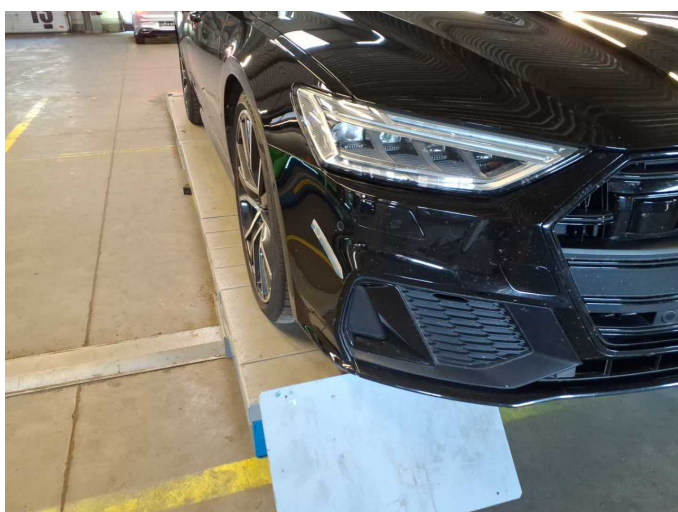
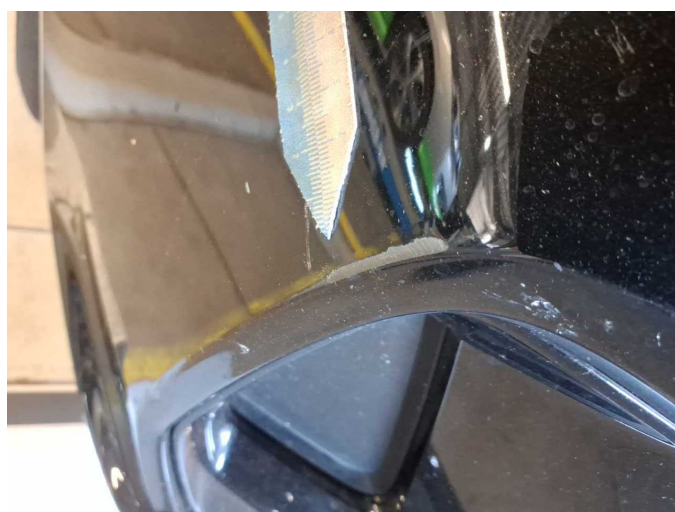
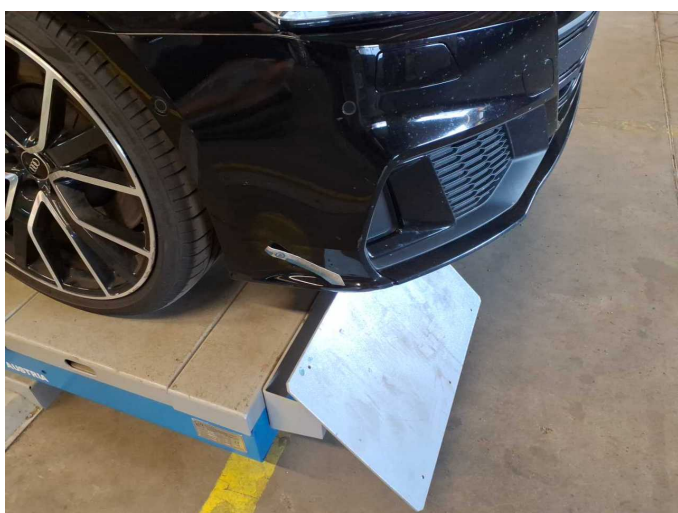
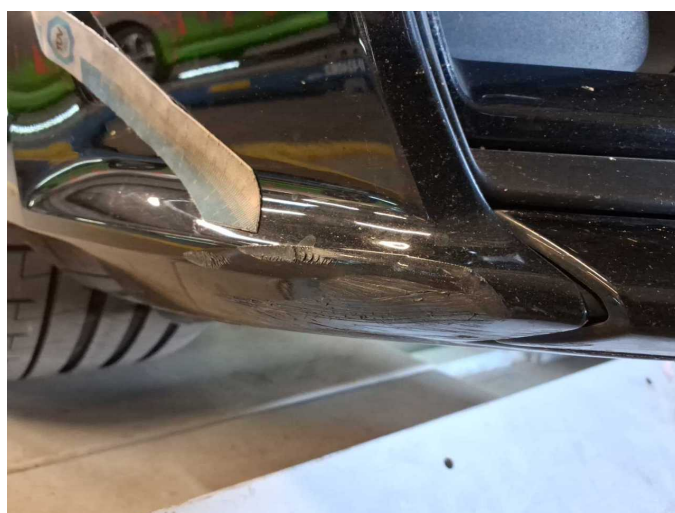
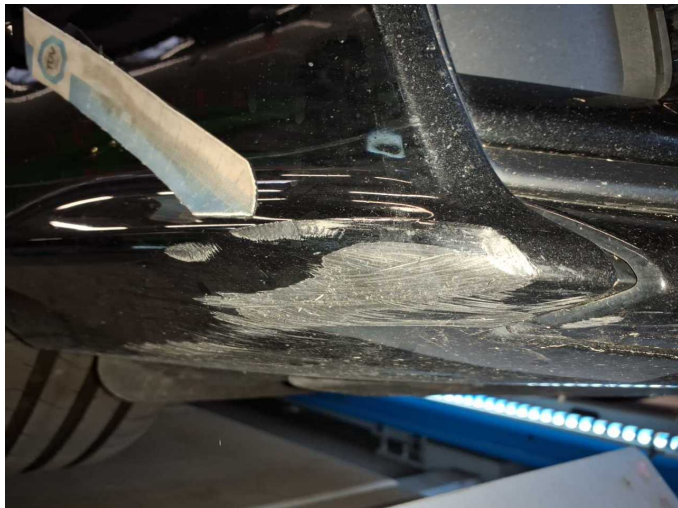
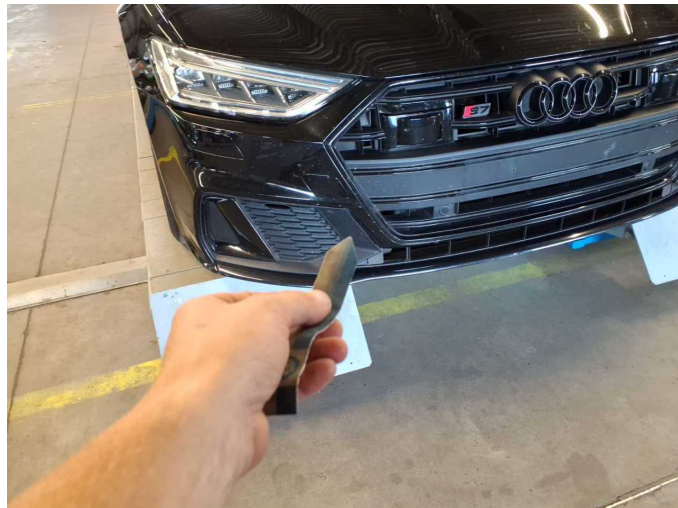
| No. | Component group | Description |
|---|---|---|
| 13 | Front bumper | Front bumper - Scratched - Replace |

**Damage 13:** Front bumper: Front bumper - Scratched - Replace

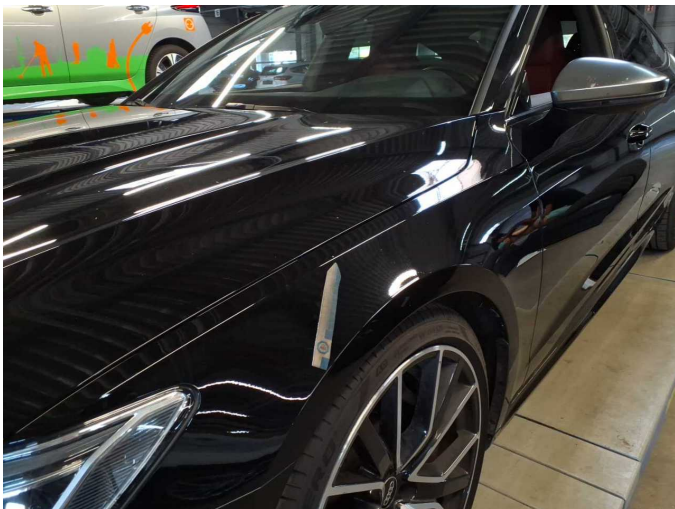
| No. | Component group | Description |
|---|---|---|
| 2 | Mudguard - left side | Mudguard - left side - Stone chips - No deduction |

**Wear and tear 2:** Mudguard - left side: Mudguard - left side - Stone chips  
- No deduction

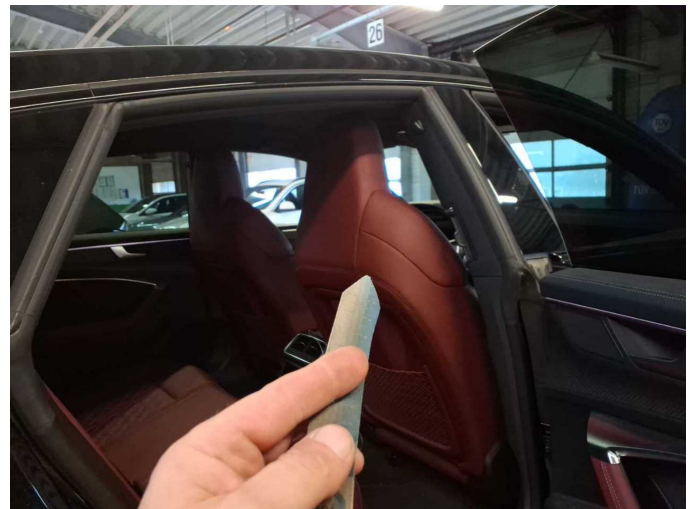
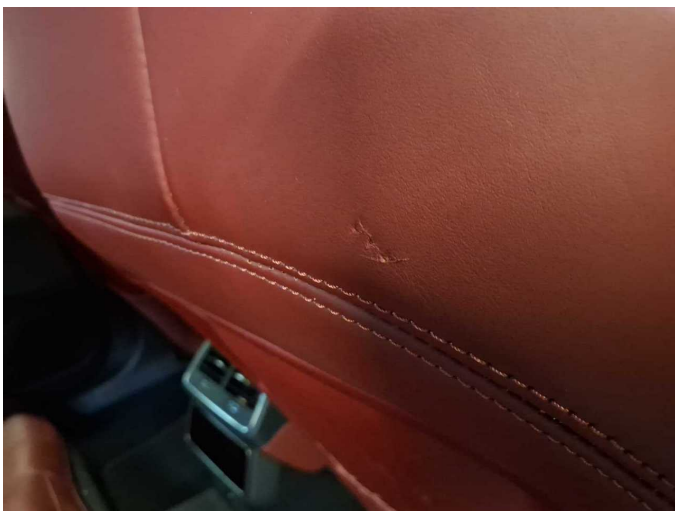
| No. | Component group | Description |
|---|---|---|
| 4 | Seat - front | Seat cover - right side (Hinten) - Scratch(es) - No deduction |

**Wear and tear 4:** Seat - front: Seat cover - right side (Hinten) -  
Scratch(es) - No deduction

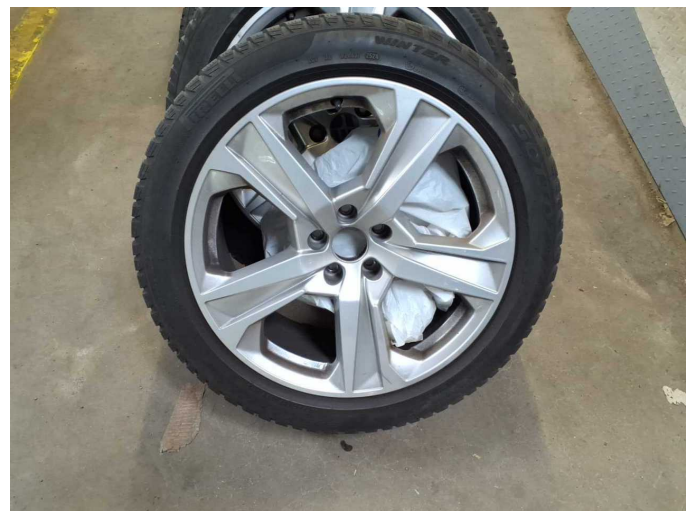
2nd wheel set - Wheel cover set - complete (4x Nabendeckel)

**Missing part 1:** 2nd wheel set: Wheel cover set - complete (4x  
Nabendeckel) - Missing - Replace

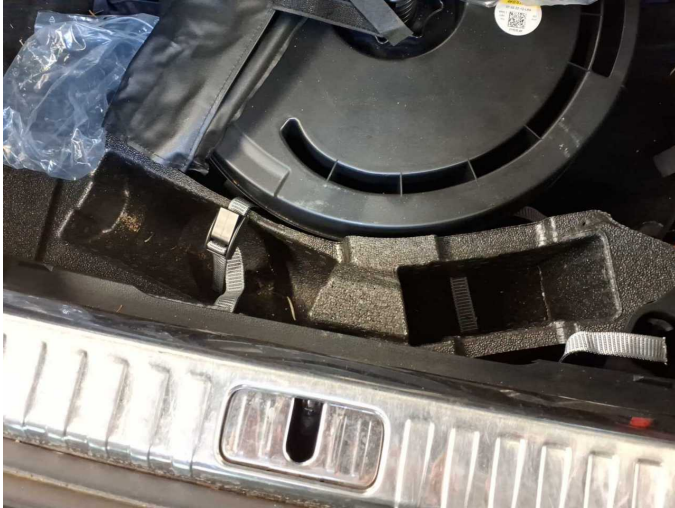
Equipment - Tirefit complete

**Missing part 2:** Equipment: Tirefit complete - Missing - Replace
