Expertise

Manufacturer: Volkswagen

Model: Tiguan 2.0 TDI SCR DSG Elegance

VIN: WVGZZZ5N1PW042833

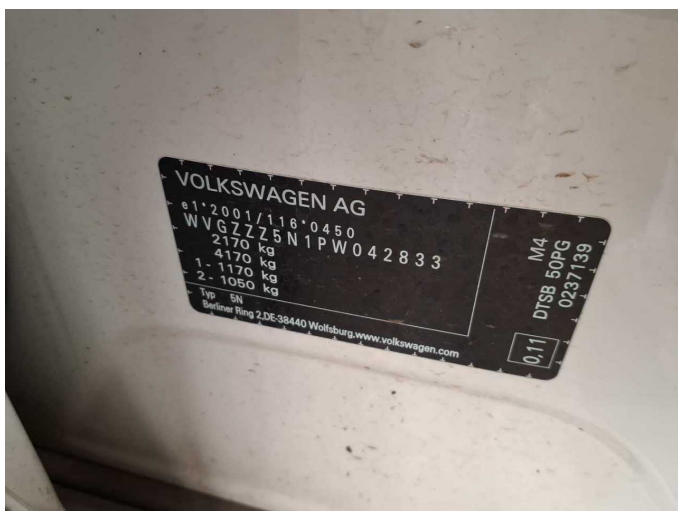
Figure 11: VIN

| VIN comparison | The vehicle identification number (VIN) was read from the vehicle and its conformity with the submitted documents was confirmed by the undersigned during the inspection. |

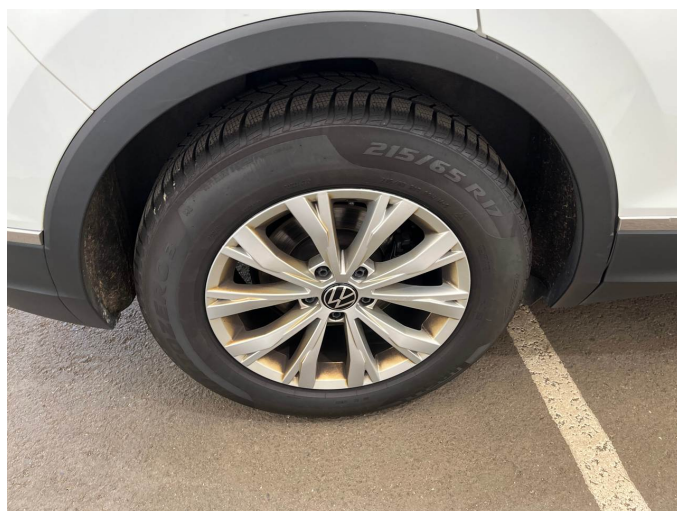
Figure 12: Mounted tyres

| # | Tyre size | Type of tyre | Manufacturer | Tread depth |
|---|---|---|---|---|
| 1) | 215/65 R17 99H | Winter tyres on Light alloy | Pirelli | 6mm / 6mm |
| 2) | 215/65 R17 99H | Winter tyres on Light alloy | Pirelli | 6mm / 6mm |

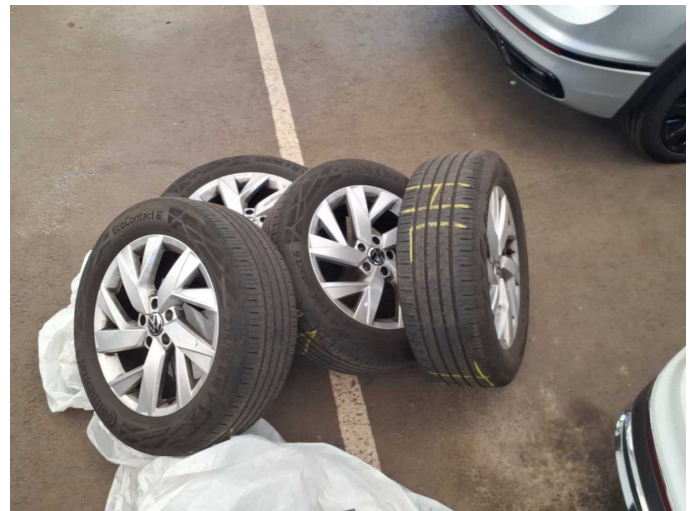
Figure 16: Additional tyres

| # | Tyre size | Type of tyre | Manufacturer | Tread depth |
|---|---|---|---|---|
| 1) | 235/55 R18 100V | Summer tyres on Light alloy | Continental | 4mm / 4mm |
| 2) | 235/55 R18 100V | Summer tyres on Light alloy | Continental | 5mm / 5mm |

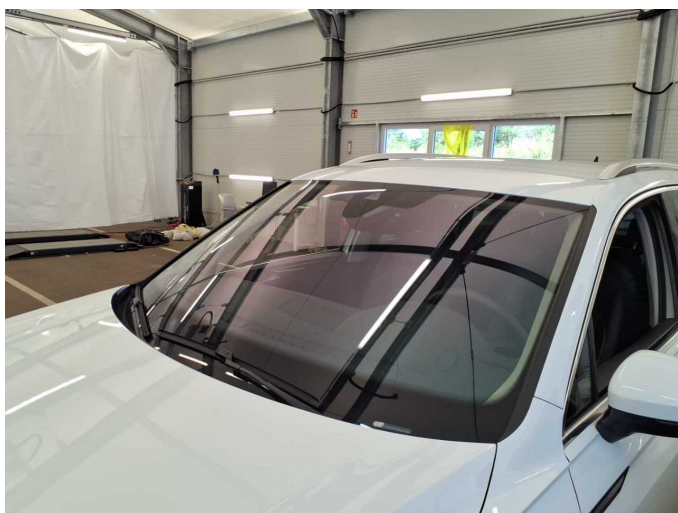
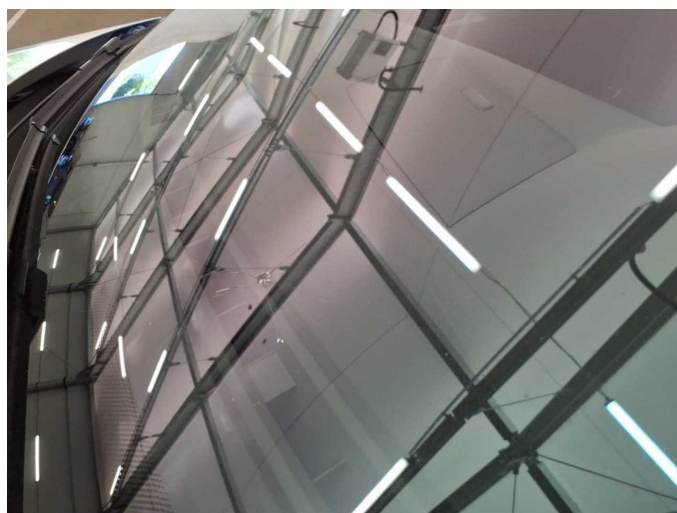
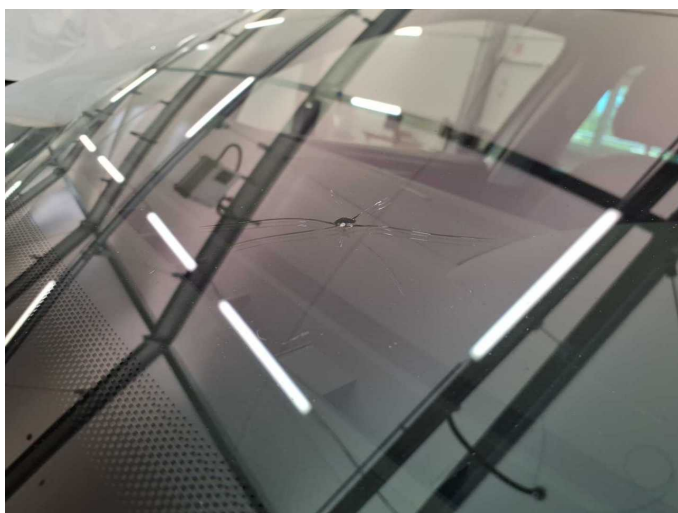
| No. | Component group | Description |
|---|---|---|
| 1 | Vehicle glazing | Windscreen (Mit Rissbildung im Fahrersichtfeld) - Stone chips - Replace |

**Damage 1:** Vehicle glazing: Windscreen (Mit Rissbildung im Fahrsichtfeld) - Stone chips - Replace
