Expertise

Protocol number: 46172483  
Order No. / Reference: 26389900  
Inspection date: 22 Jun 2026

Manufacturer: Ford

Model: S-Max 2.5 Duratec FHEV TITANIUM

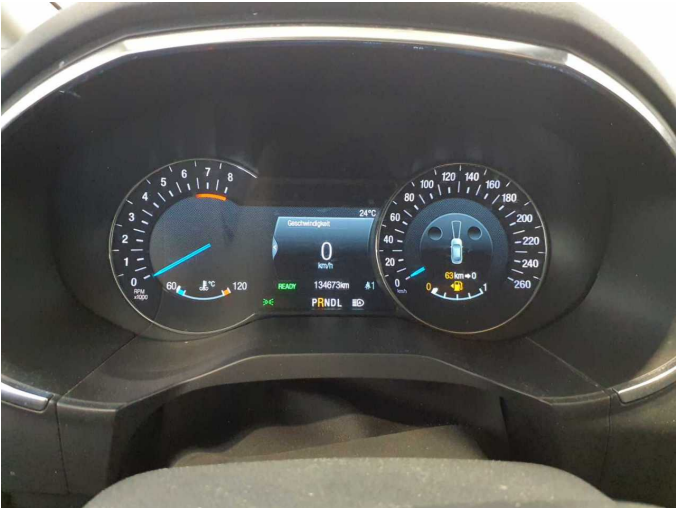
Figure 7: Instrument cluster

| Vehicle details | |
|---|---|
| Mileage (Read) | 134,673 km |

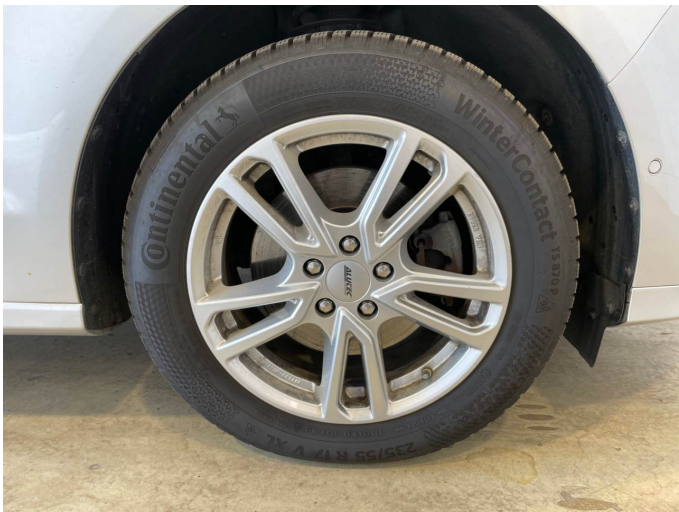
Figure 12: Mounted tyres

| Tyres | | | | |
|---|---|---|---|---|
| 1) | 235/55 R17 103V | Winter tyres on Light alloy | Continental | 6mm / 6mm |
| 2) | 235/55 R17 103V | Winter tyres on Light alloy | Continental | 7mm / 7mm |

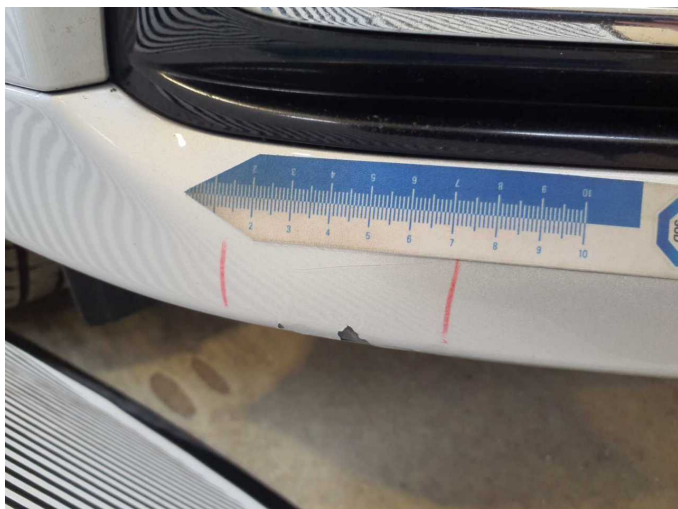
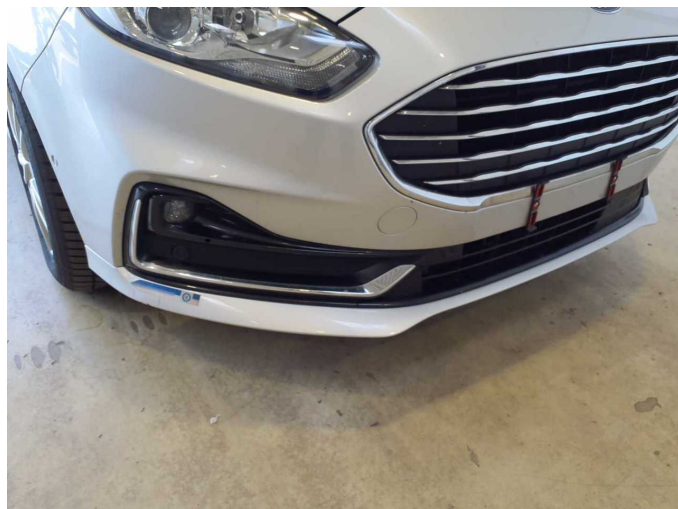
Damage 1: Front bumper: Spoiler - Scratch(es) - Smart repair

**Damage 1:** Front bumper: Spoiler - Scratch(es) - Smart repair

| No. | Component group | Description |
|---|---|---|
| 1 | Front bumper | Spoiler - Scratch(es) - Smart repair |

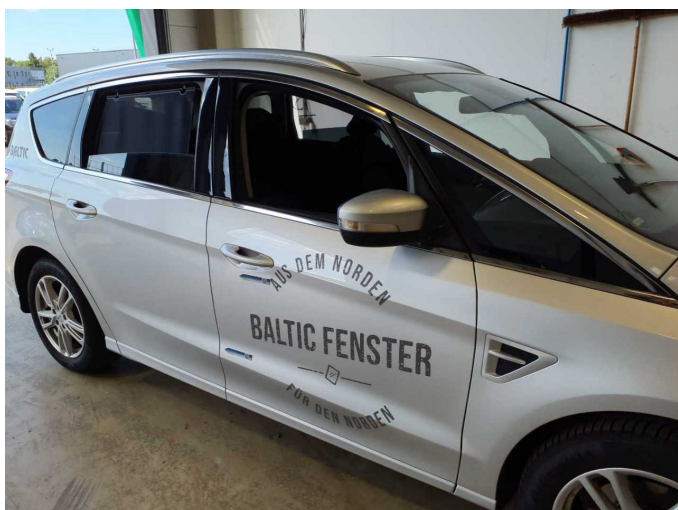
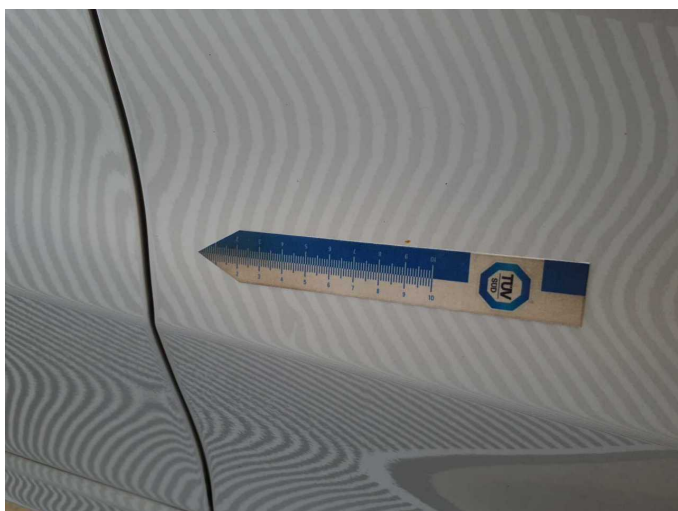
**Damage 2:** Door - front right side: Door - dent(s) - Smart repair

| No. | Component group | Description |
|---|---|---|
| 2 | Door - front right side | Door - dent(s) - Smart repair |

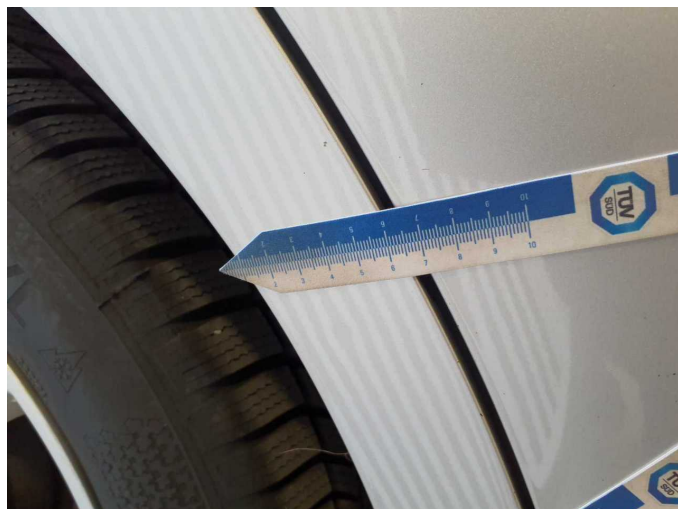
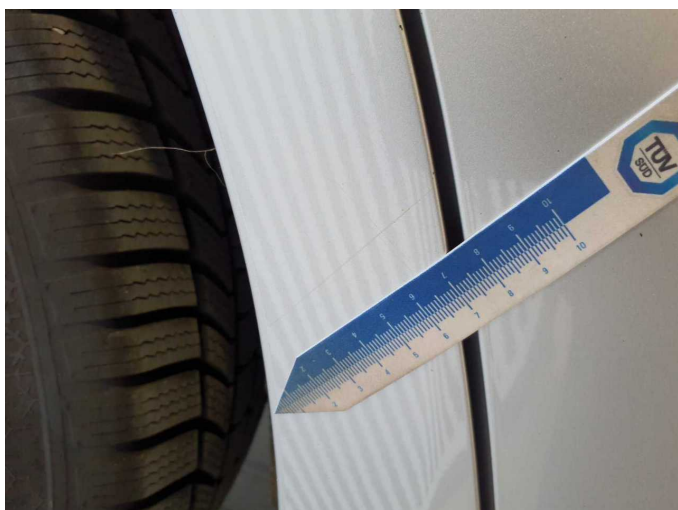
**Damage 3:** Side panel - rear right side: Side panel - Dent / paintcoat damage - Smart repair

| No. | Component group | Description |
|---|---|---|
| 3 | Side panel - rear right side | Side panel - Dent / paintcoat damage - Smart repair |

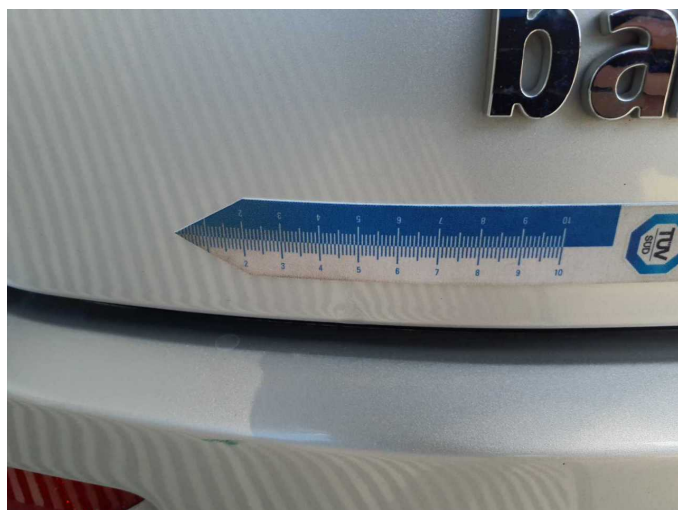
**Damage 4:** Boot lid / rear door: Boot lid - dent(s) - Smart repair

| No. | Component group | Description |
|---|---|---|
| 4 | Boot lid / rear door | Boot lid - dent(s) - Smart repair |

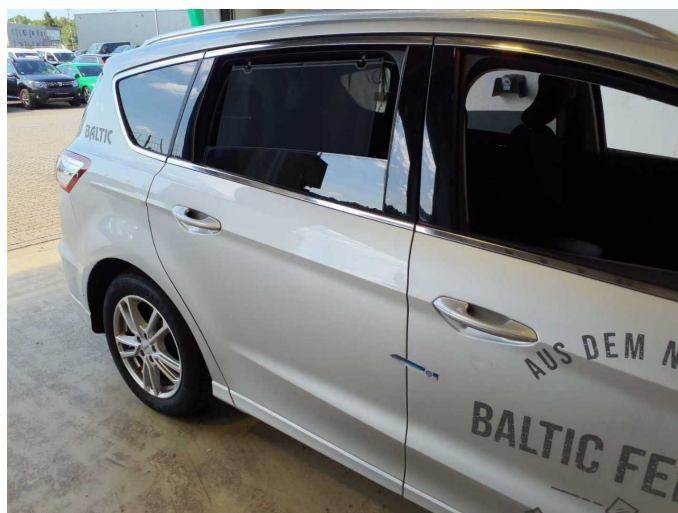
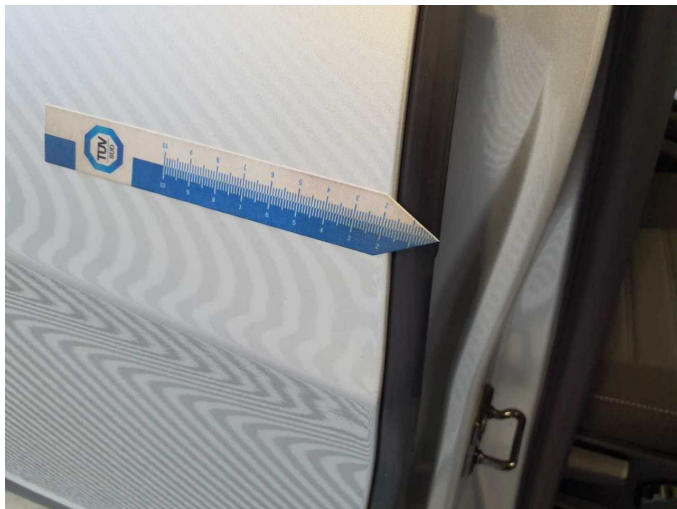
**Damage 5:** Door - rear right side: Door - Dent / paintcoat damage - Smart repair

| No. | Component group | Description |
|---|---|---|
| 5 | Door - rear right side | Door - Dent / paintcoat damage - Smart repair |

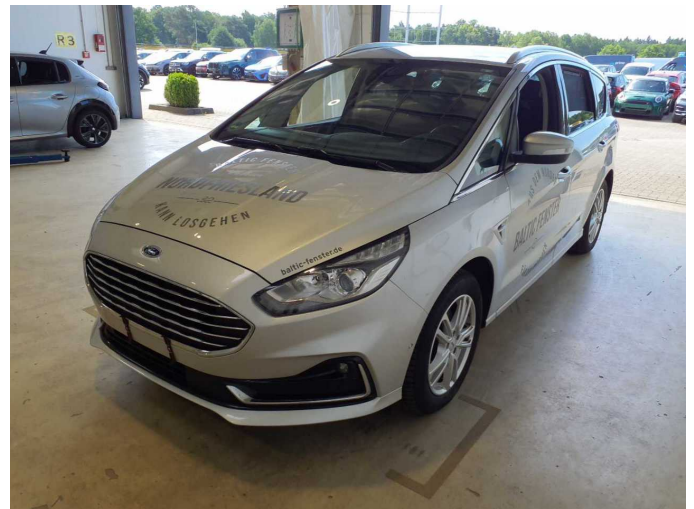
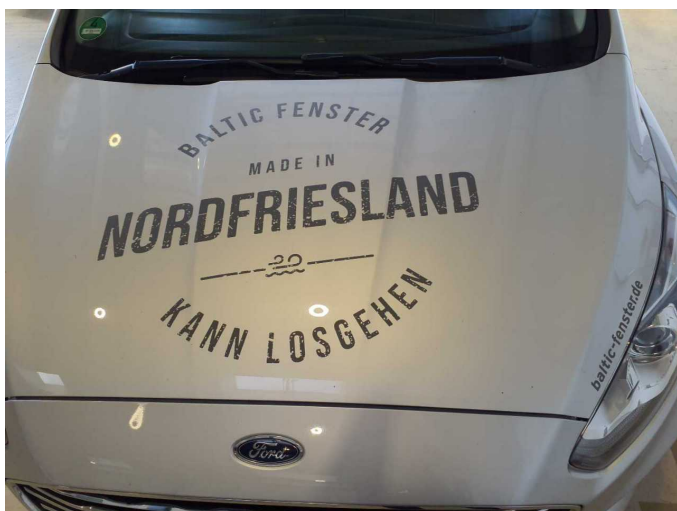
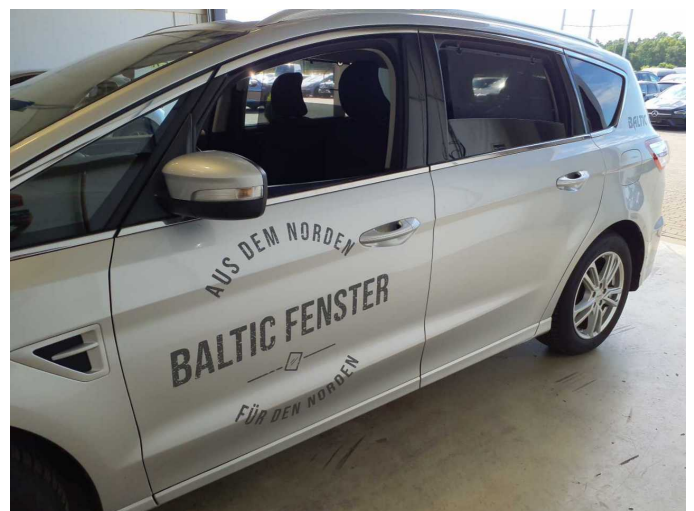
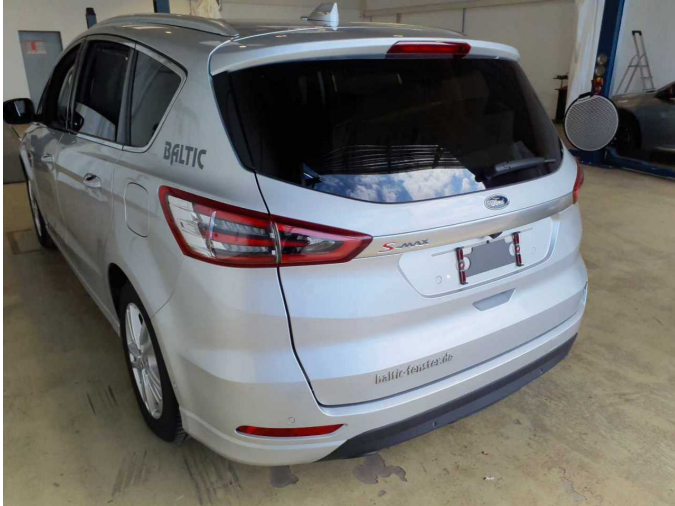
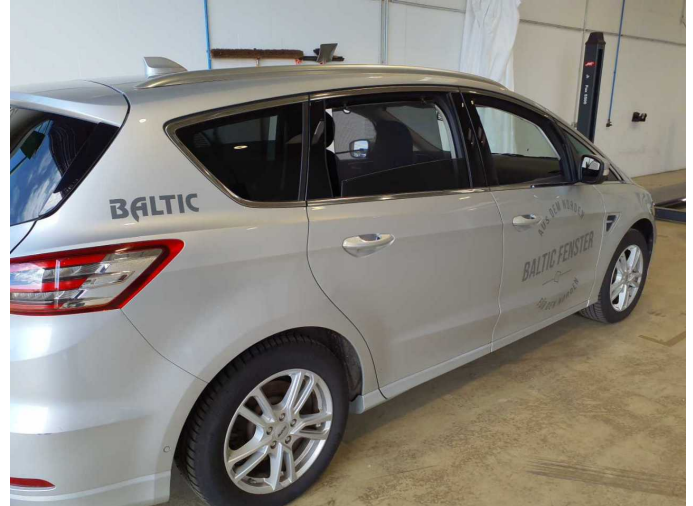
**Damage 7:** Body: Body - Glued / labelled - De-glue / neutralise

| No. | Component group | Description |
|---|---|---|
| 7 | Body | Body - Glued / labelled - De-glue / neutralise |

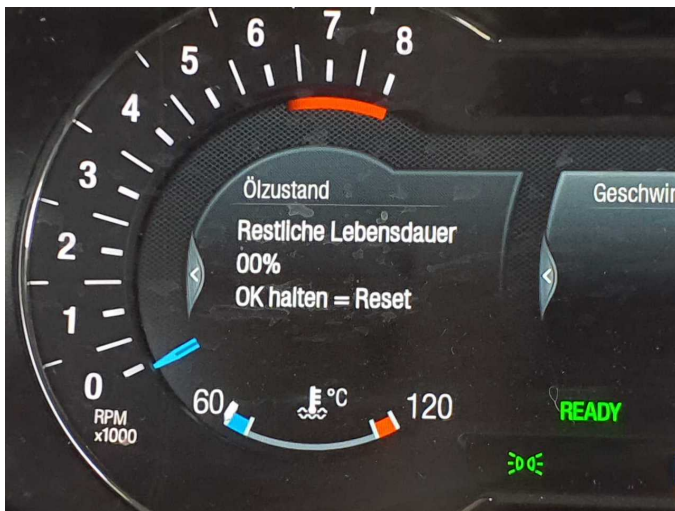
**Damage 8:** Misc.: Inspection / maintenance - Due - Perform

| No. | Component group | Description |
|---|---|---|
| 8 | Misc. | Inspection / maintenance - Due - Perform |

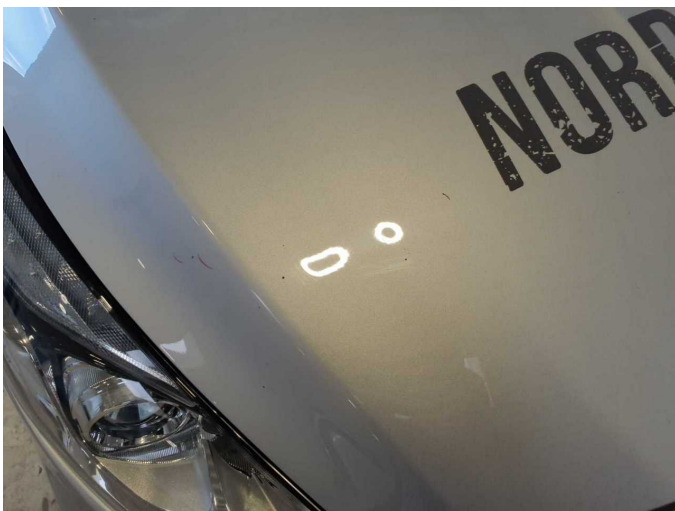
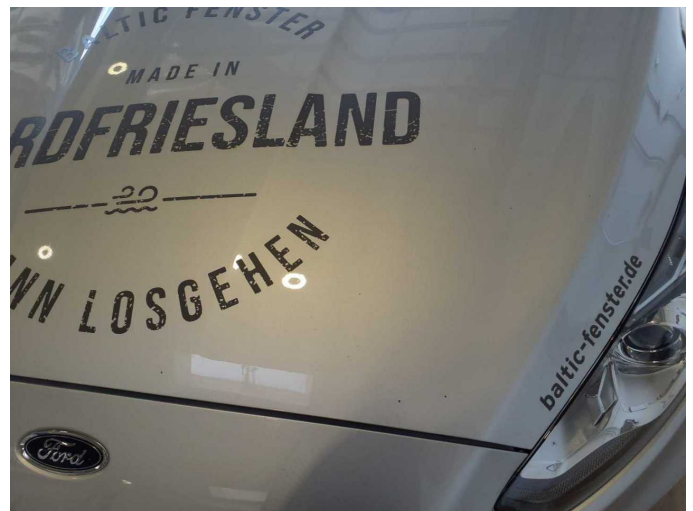
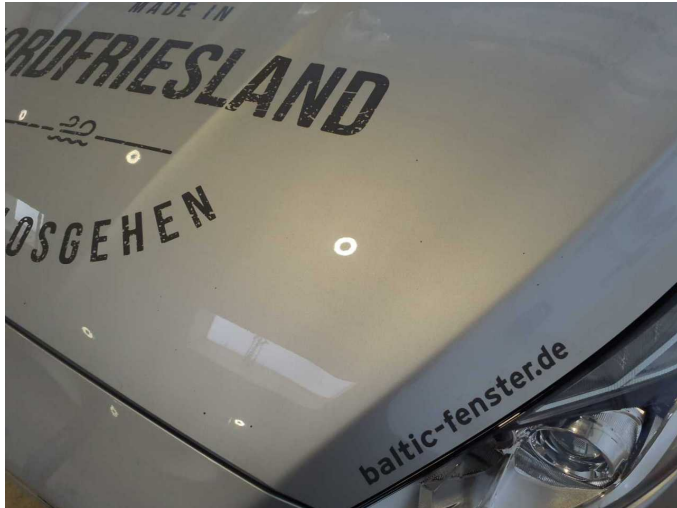
**Damage 9:** Bonnet: Bonnet - Stone chips - Paint

| No. | Component group | Description |
|---|---|---|
| 9 | Bonnet | Bonnet - Stone chips - Paint |

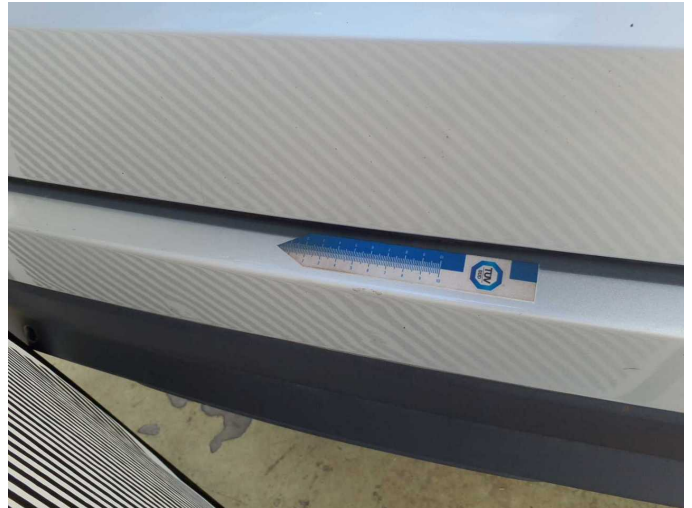
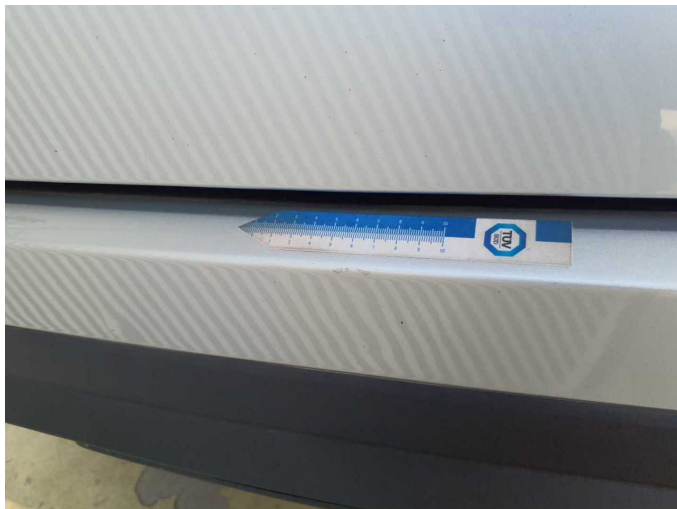
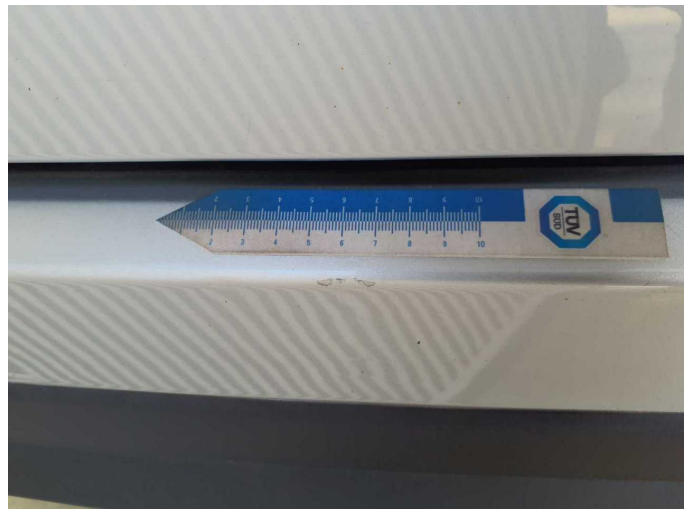
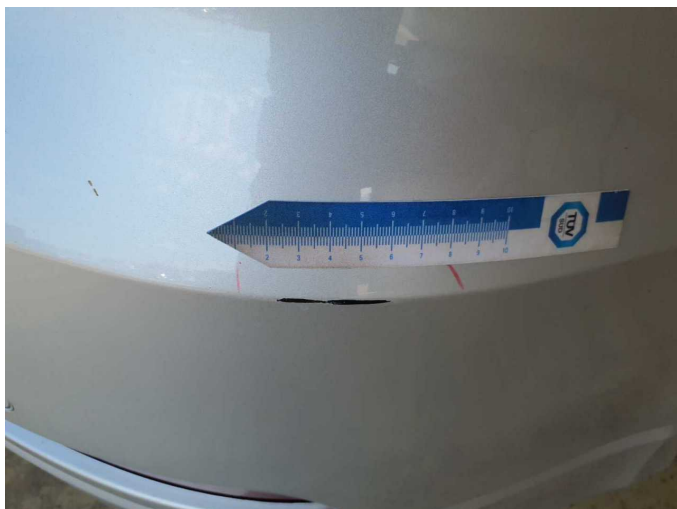
**Damage 10:** Rear bumper: Rear bumper - Dent / paintcoat damage - Repair and paint

| No. | Component group | Description |
|---|---|---|
| 10 | Rear bumper | Rear bumper - Dent / paintcoat damage - Repair and paint |

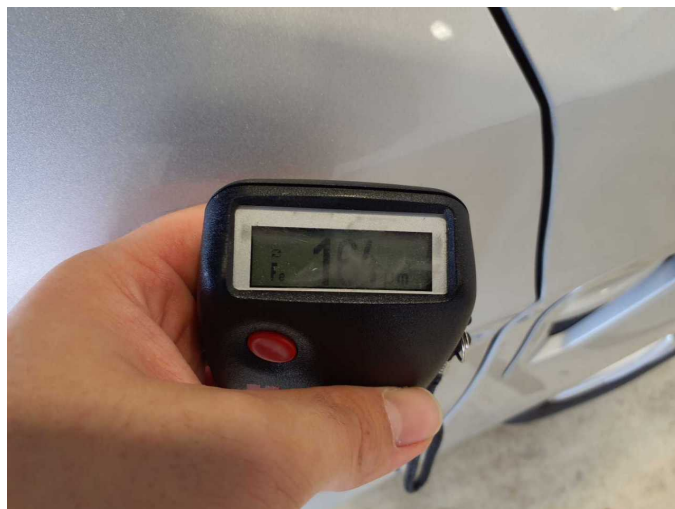
| No. | Repainting |
|---|---|
| 1 | Door - front right side, Professionally carried out |

| Door - front right side | 164 µm |

**Repainting 1:** Door - front right side
