Expertise

Protocol number: 46082005  
Order No. / Reference: 26348848  
Inspection date: 22 Jun 2026

Manufacturer: Mercedes-Benz  
VIN: W1KAH0DB2RF130967

Model: C 200 d T 9G-TRONIC Avantgarde Advanced

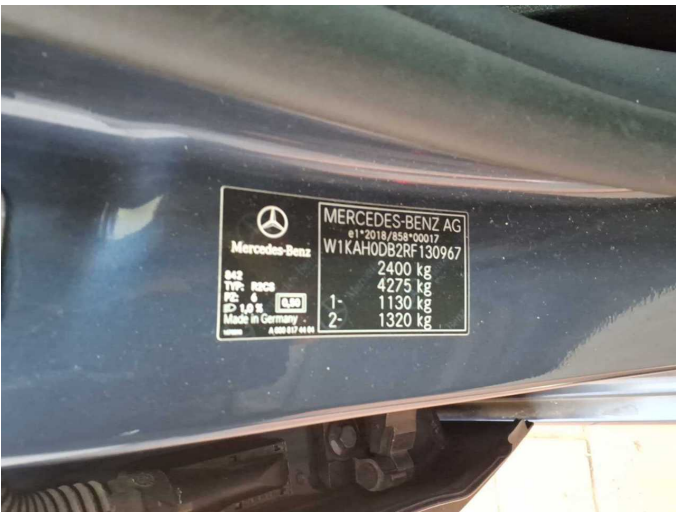
Figure 11: VIN

| VIN comparison | The vehicle identification number (VIN) was read from the vehicle and its conformity with the submitted documents was confirmed by the undersigned during the inspection. |

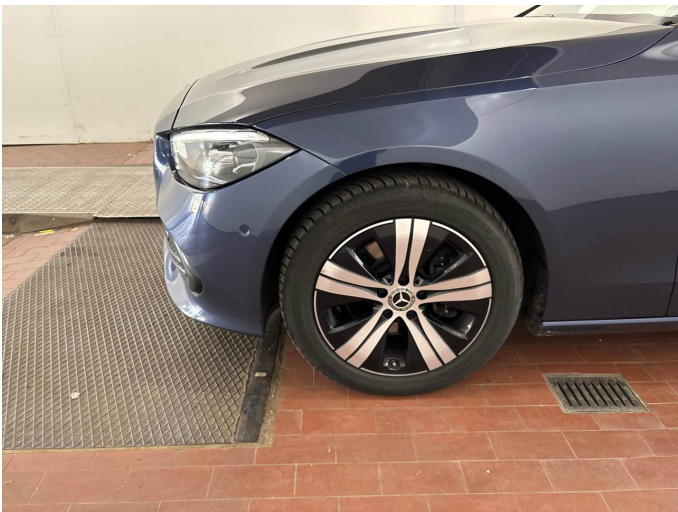
| # | Tyre size | Type of tyre | Manufacturer | Tread depth |
|---|---|---|---|---|
| 1) | 225/50 R17 94H | Winter tyres on Light alloy | Goodyear | 5mm / 5mm |
| 2) | 225/50 R17 94H | Winter tyres on Light alloy | Goodyear | 6mm / 6mm |

Figure 12: Mounted tyres

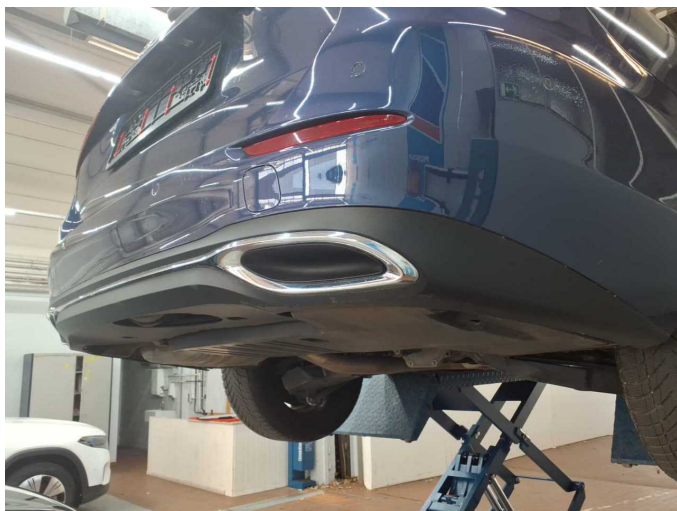
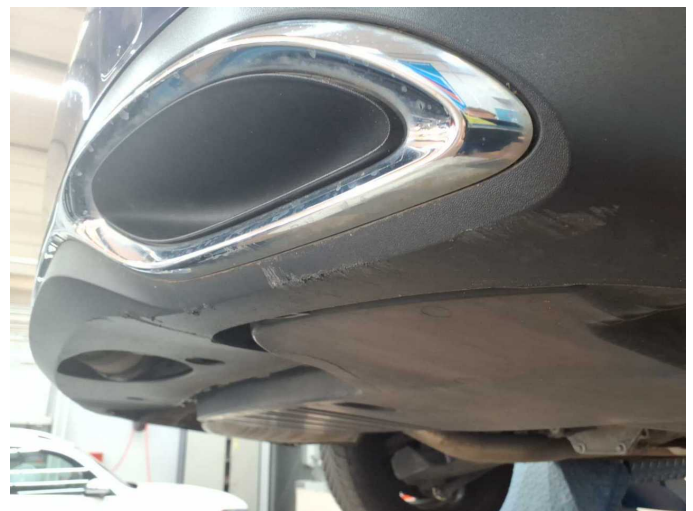
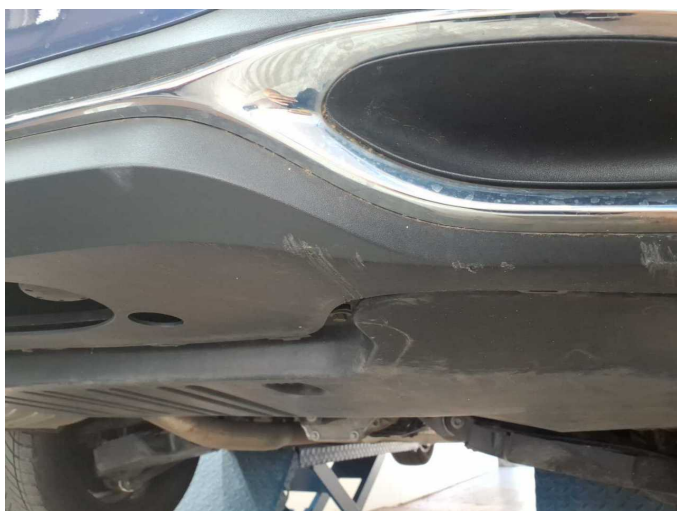
| No. | Component group | Description |
|---|---|---|
| 2 | Rear bumper | Spoiler - Scratch(es) - Loss in value |

**Damage 2:** Rear bumper: Spoiler - Scratch(es) - Loss in value

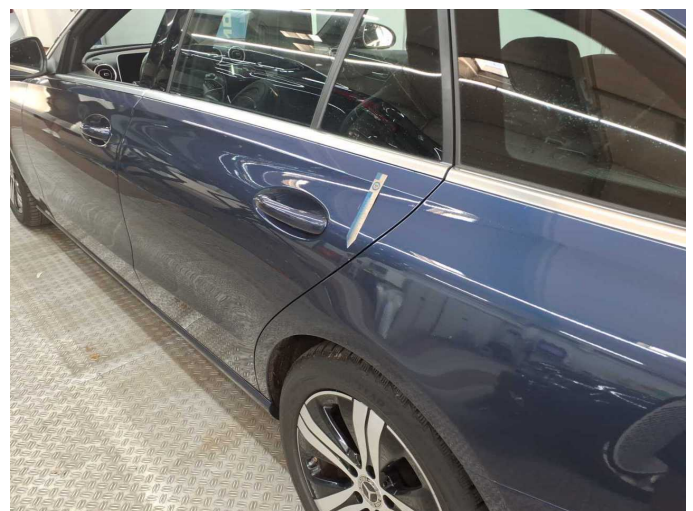
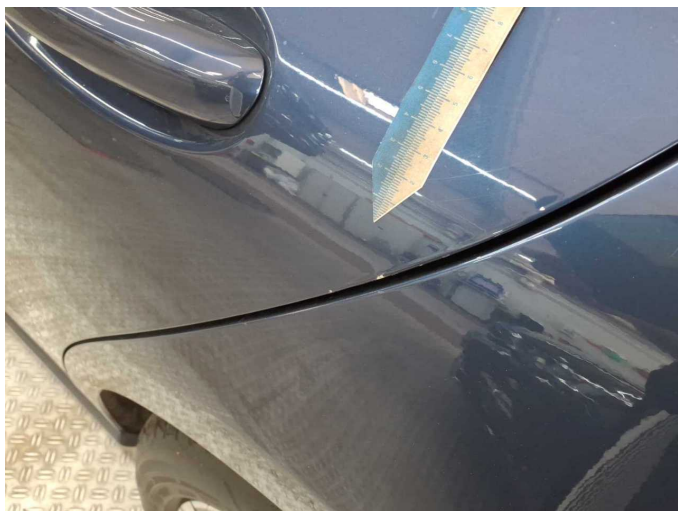
| No. | Component group | Description |
|---|---|---|
| 3 | Door - rear left side | Door - Scratch(es) - Smart repair |

**Damage 3:** Door - rear left side: Door - Scratch(es) - Smart repair

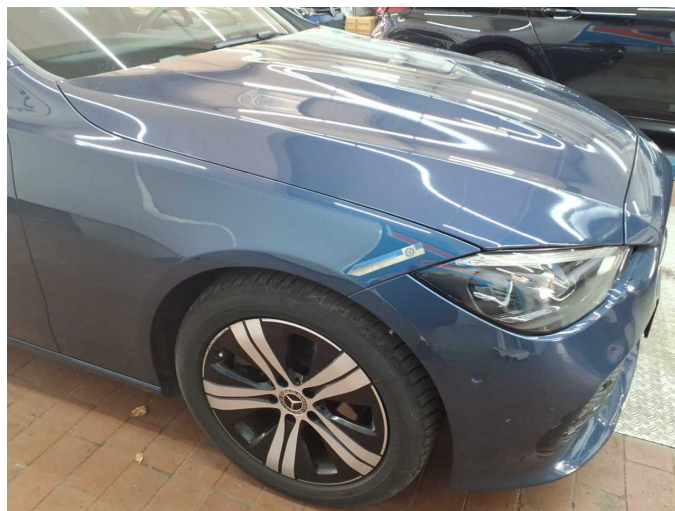
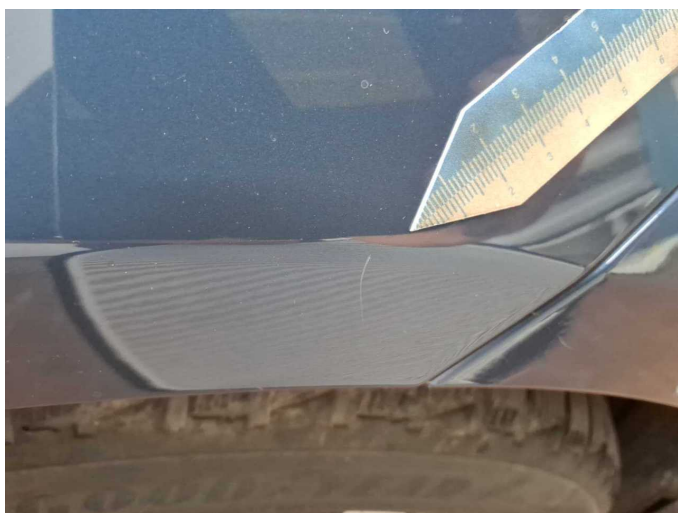
| No. | Component group | Description |
|---|---|---|
| 4 | Mudguard - right side | Mudguard - right side - Scratch(es) - Smart repair |

**Damage 4:** Mudguard - right side: Mudguard - right side - Scratch(es) - Smart repair

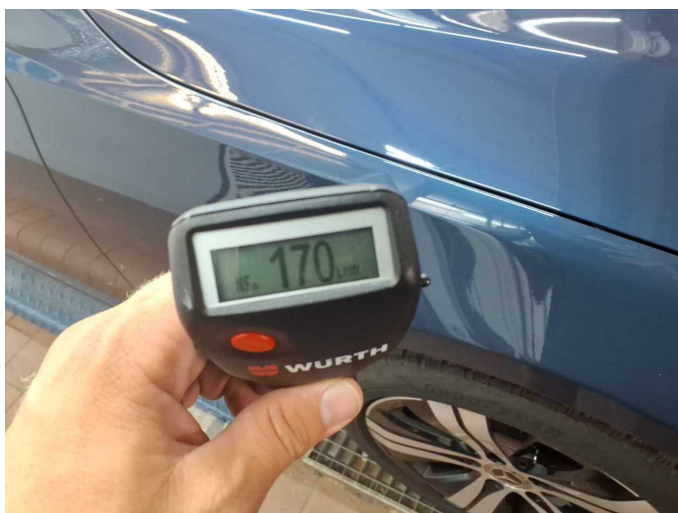
| No. | Repainting |
|---|---|
| 1 | Mudguard - right side, Professionally carried out, Invoice of repair done Non-existent |

| Mudguard - right side | 170 µm |

**Repainting 1:** Mudguard - right side
