Expertise

Protocol number: 46783208  
Order No. / Reference: 26733973  
Inspection date: 30 Jul 2026

Manufacturer: Skoda  
VIN: TMBJB7NS7P8014670

Model: Kodiah 1.5 TSI ACT DSG Ambition

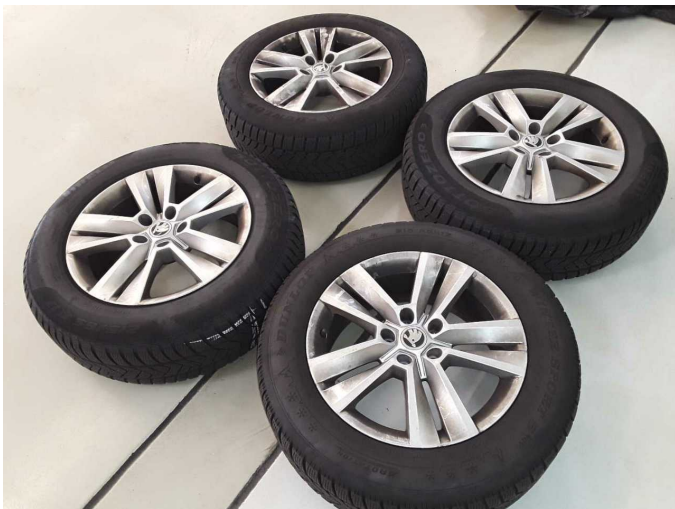
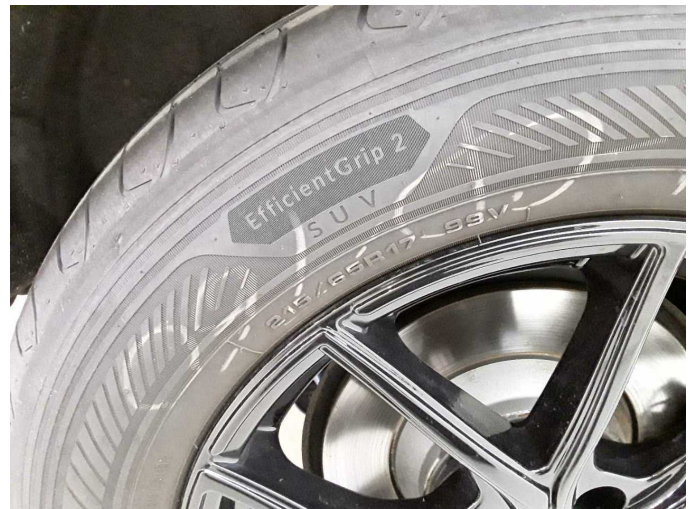
Damage 1: Wheel / tyres: Tyres - complete set (WR auf Originalfelgen / SR auf Zubehörfelgen)

| No. | Component group | Description |
|---|---|---|
| 1 | Wheel / tyres | Tyres - complete set (WR auf Originalfelgen / SR auf Zubehörfelgen) |

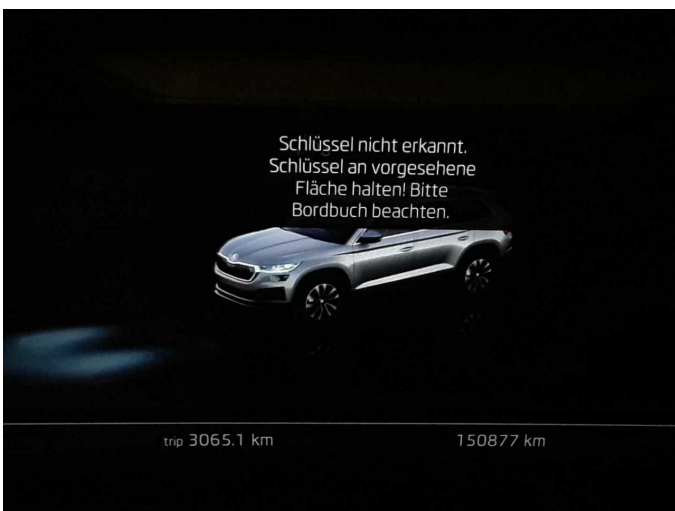
Damage 2: Equipment: Vehicle key - Empty - Replace

| No. | Component group | Description |
|---|---|---|
| 2 | Equipment | Vehicle key - Empty - Replace |

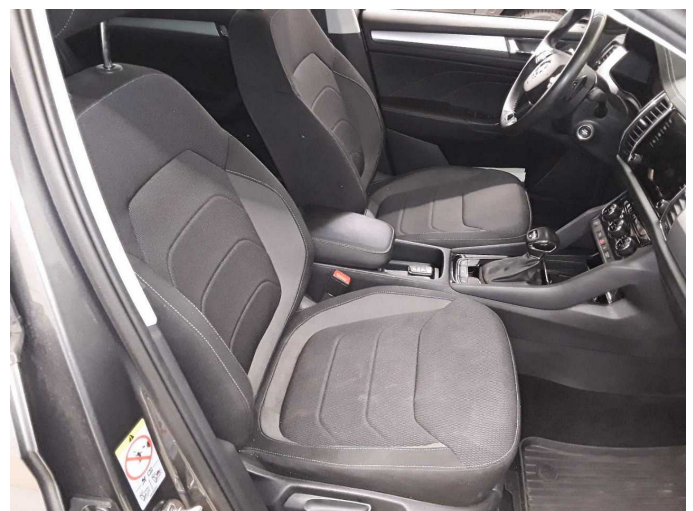
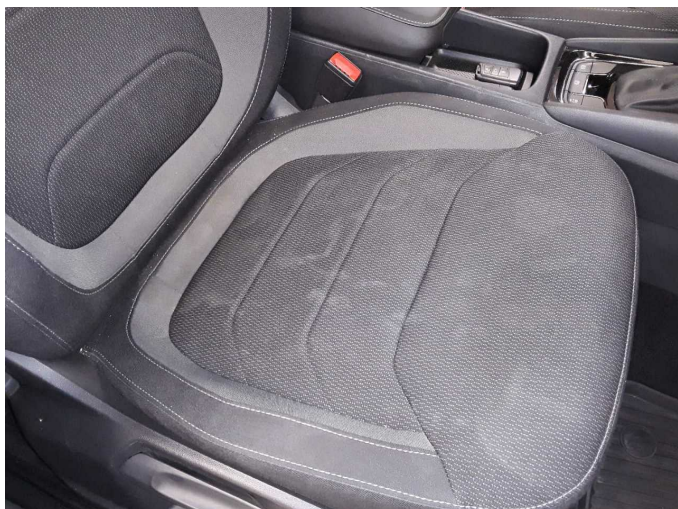
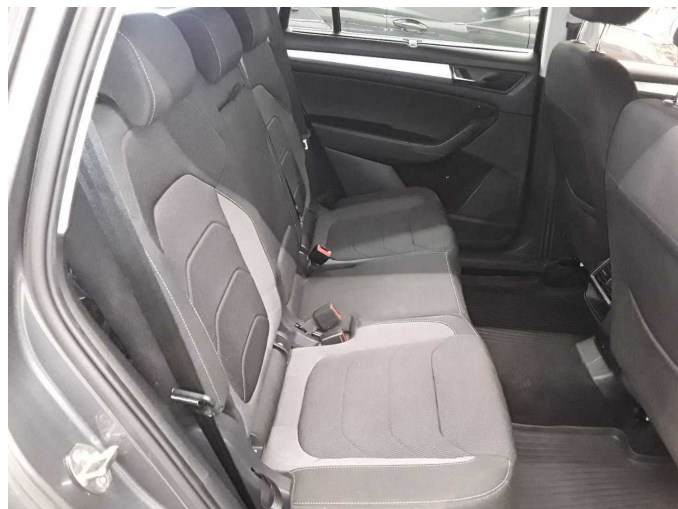
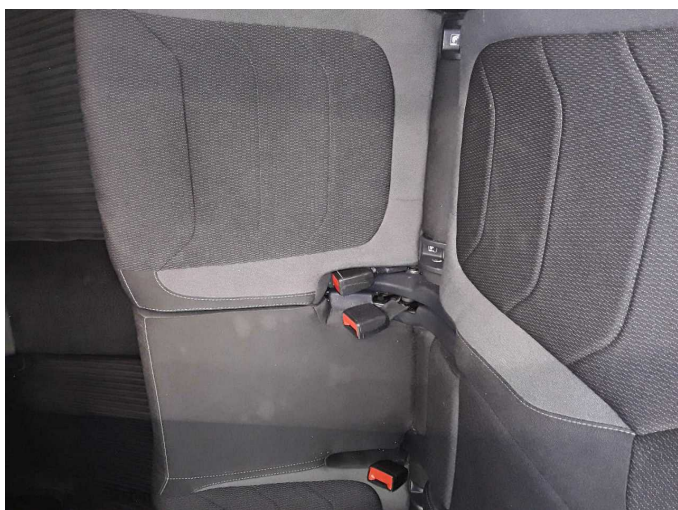
Damage 3: Seat - front: Seat cover - right side (Sitze) - Soiled - Clean

**Damage 3:** Seat - front: Seat cover - right side (Sitze) - Soiled - Clean

| No. | Component group | Description |
|---|---|---|
| 3 | Seat - front | Seat cover - right side (Sitze) - Soiled - Clean |

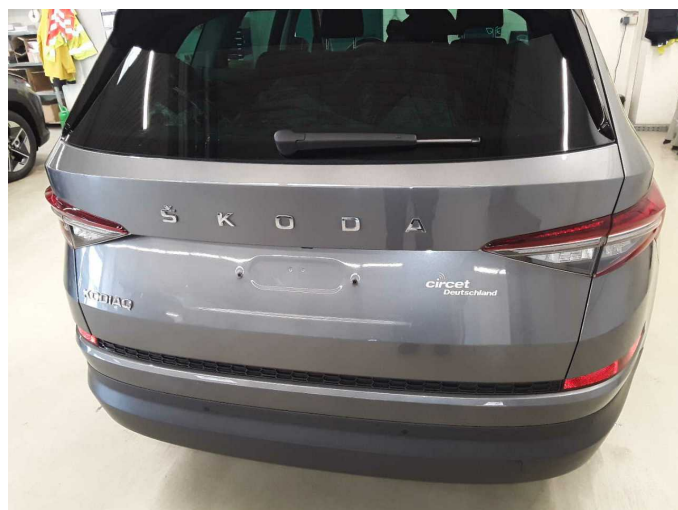
**Damage 4:** Boot lid / rear door: Boot lid - Glued / labelled - De-glue / neutralise

| No. | Component group | Description |
|---|---|---|
| 4 | Boot lid / rear door | Boot lid - Glued / labelled - De-glue / neutralise |

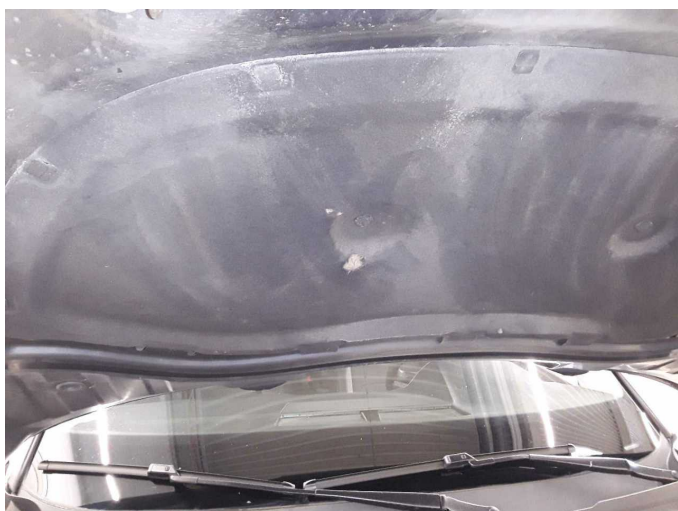
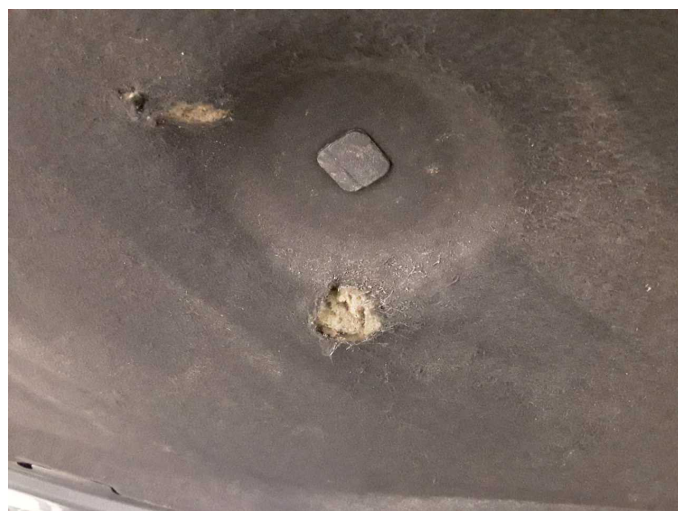
**Damage 5:** Bonnet: Insulation lining - Damage caused by marten / rodent - Replace

| No. | Component group | Description |
|---|---|---|
| 5 | Bonnet | Insulation lining - Damage caused by marten / rodent - Replace |

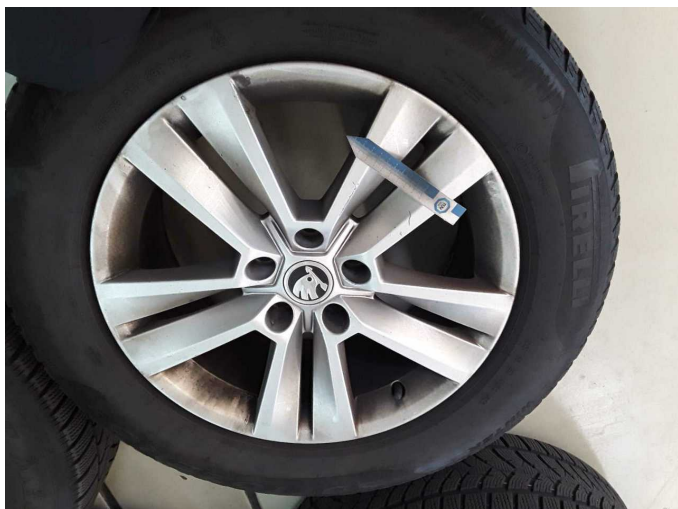
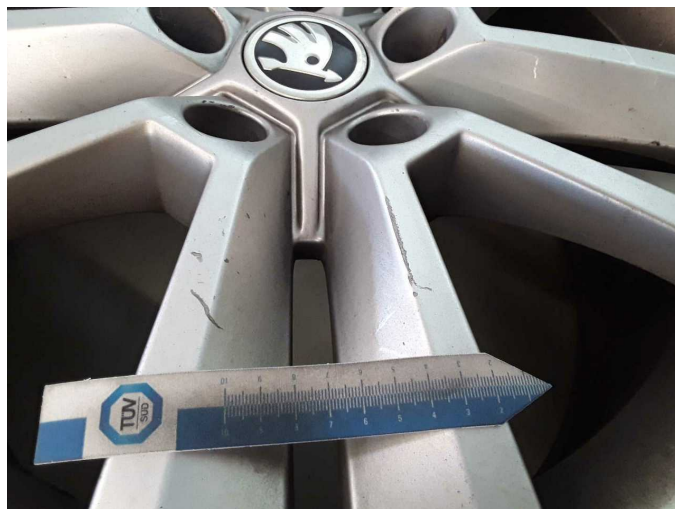
**Damage 6:** 2nd wheel set: 1 alloy rim - Scratch(es) - Loss in value

| No. | Component group | Description |
|---|---|---|
| 6 | 2nd wheel set | 1 alloy rim - Scratch(es) - Loss in value |

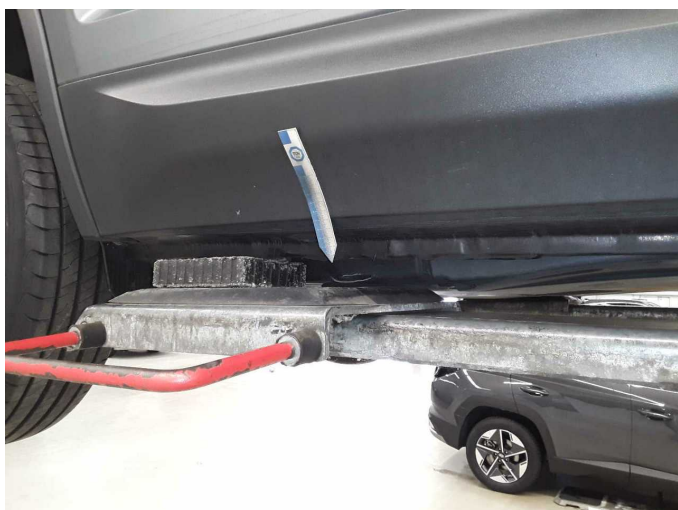
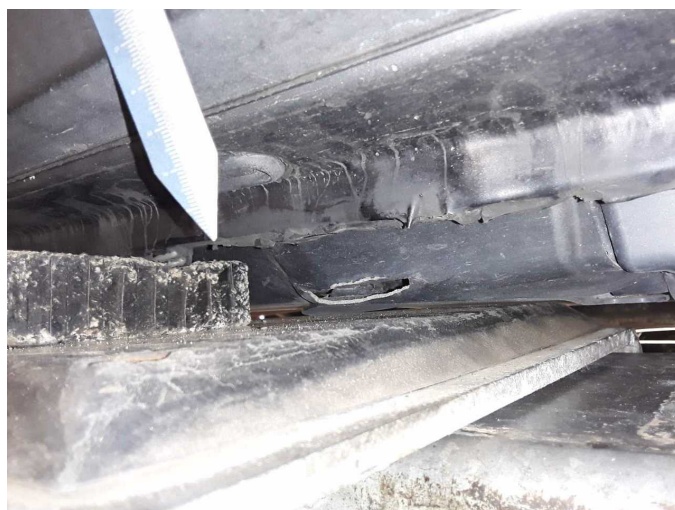
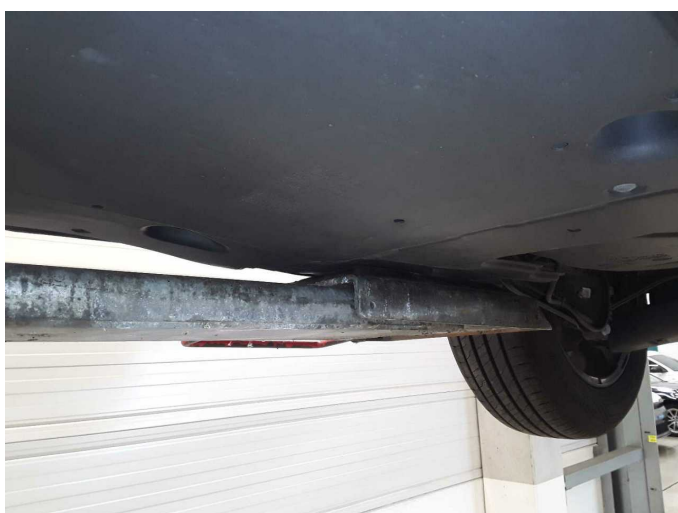
**Damage 7:** Body: Underbody panelling - Broken / torn - Replace

| No. | Component group | Description |
|---|---|---|
| 7 | Body | Underbody panelling - Broken / torn - Replace |

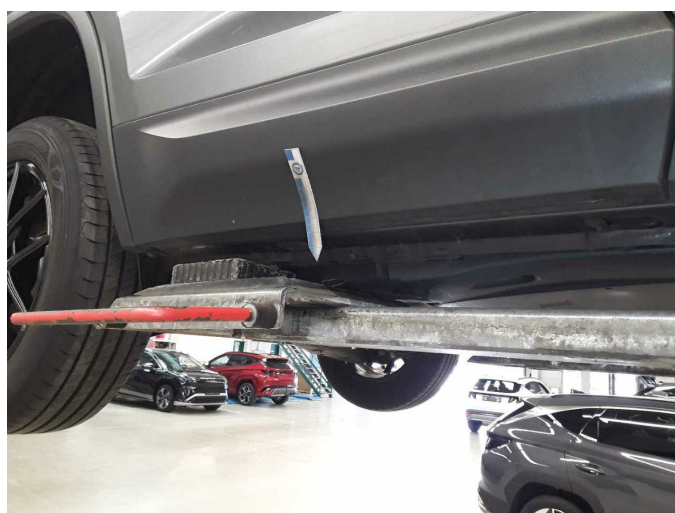
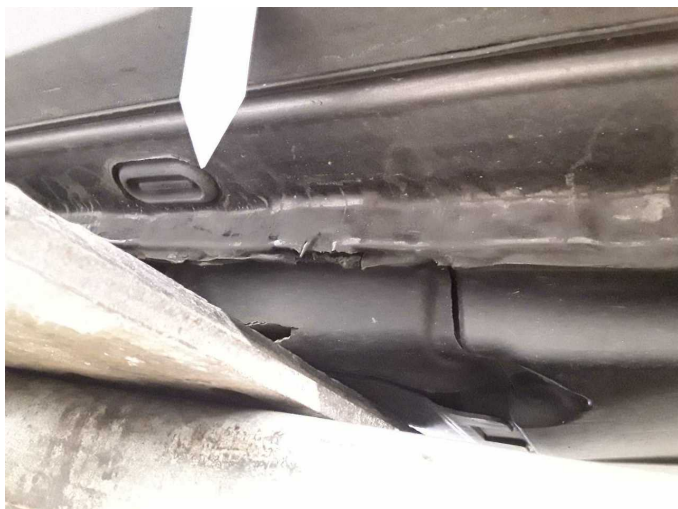
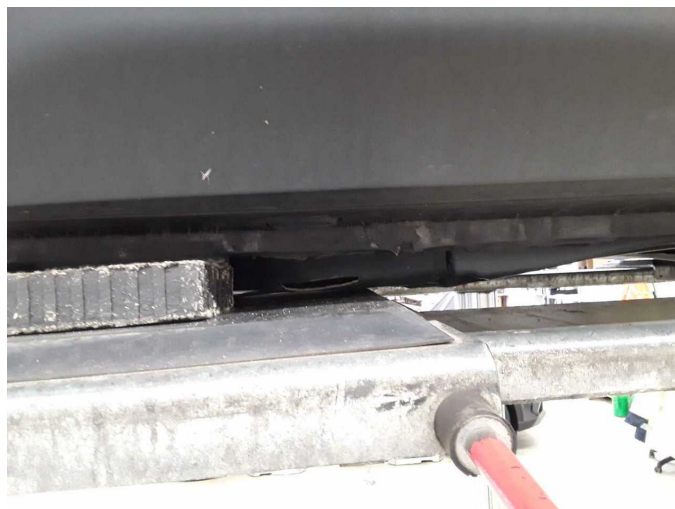
**Damage 8:** Sill - right side: Sill - Scratch(es) - Smart repair

| No. | Component group | Description |
|---|---|---|
| 8 | Sill - right side | Sill - Scratch(es) - Smart repair |

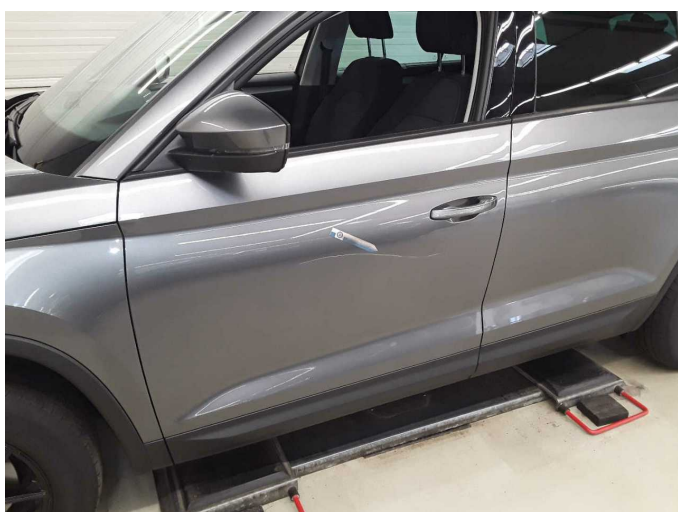
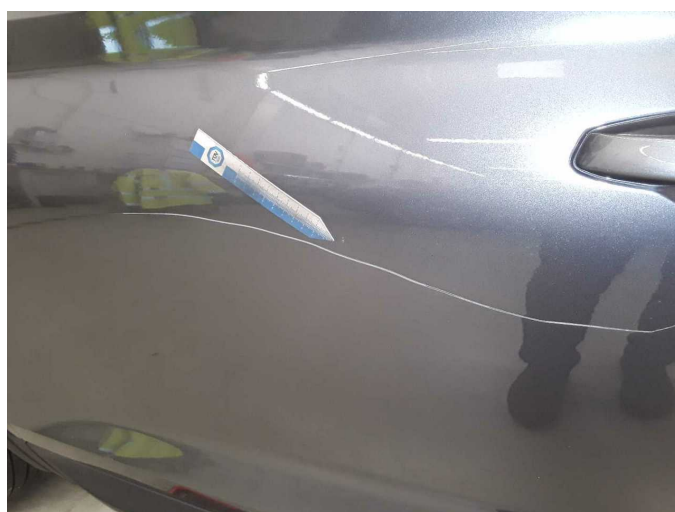
**Damage 9:** Door - front left side: Door (Gewaltschaden) - Scratch(es) - Repair and paint

| No. | Component group | Description |
|---|---|---|
| 9 | Door - front left side | Door (Gewaltschaden) - Scratch(es) - Repair and paint |

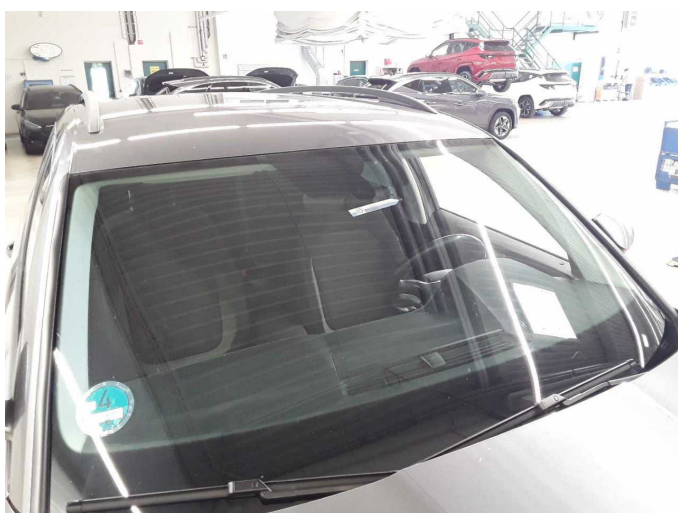
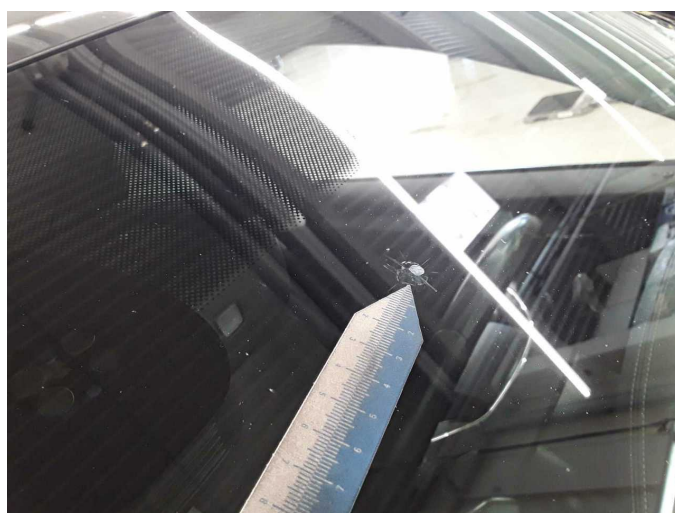
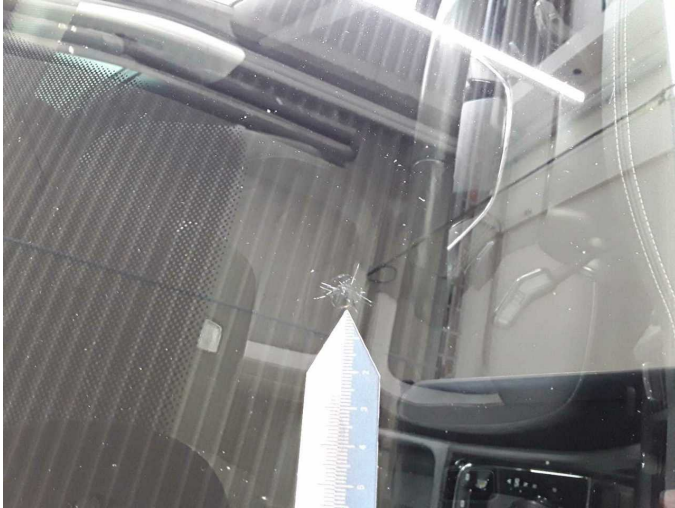
**Damage 10:** Vehicle glazing: Windscreen - Stone chips - Replace

| No. | Component group | Description |
|---|---|---|
| 10 | Vehicle glazing | Windscreen - Stone chips - Replace |

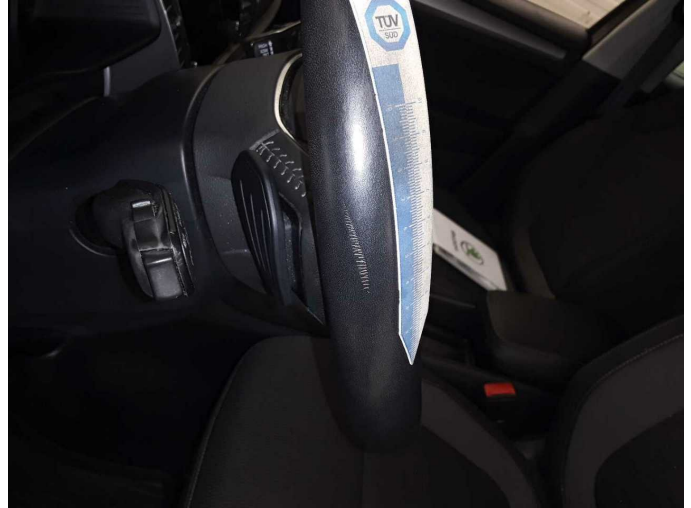
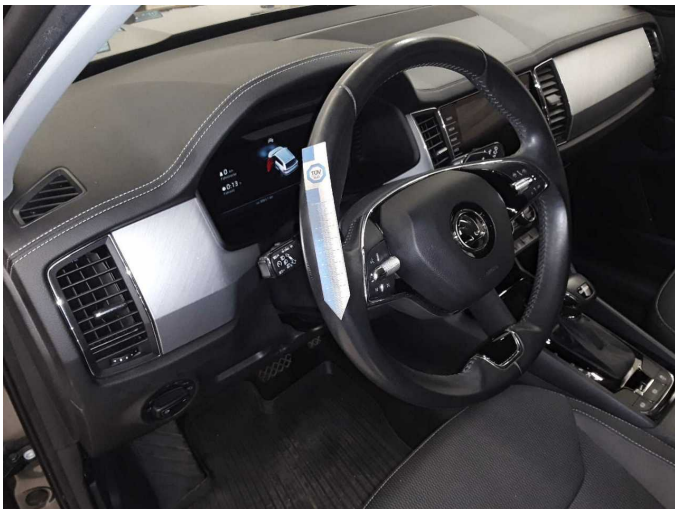
**Wear and tear 1:** Steering system: Steering wheel sheath - Scratch(es) - No deduction

| No. | Component group | Description |
|---|---|---|
| 1 | Steering system | Steering wheel sheath - Scratch(es) - No deduction |

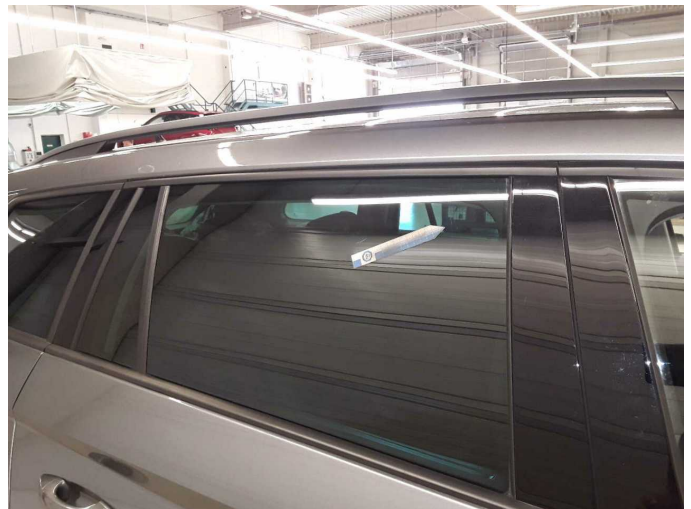
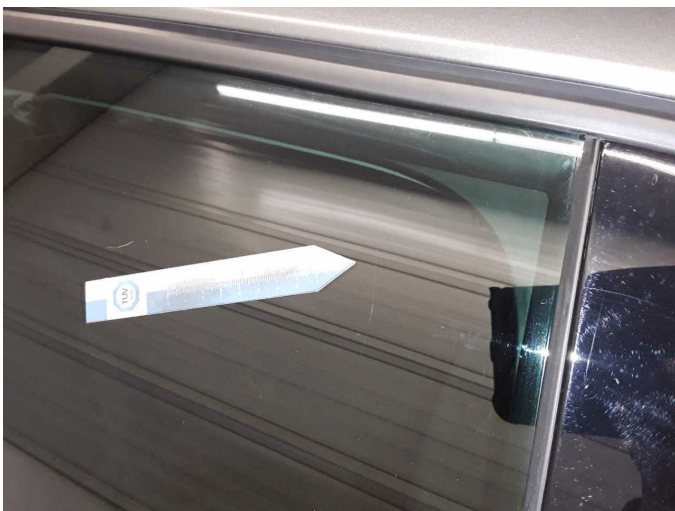
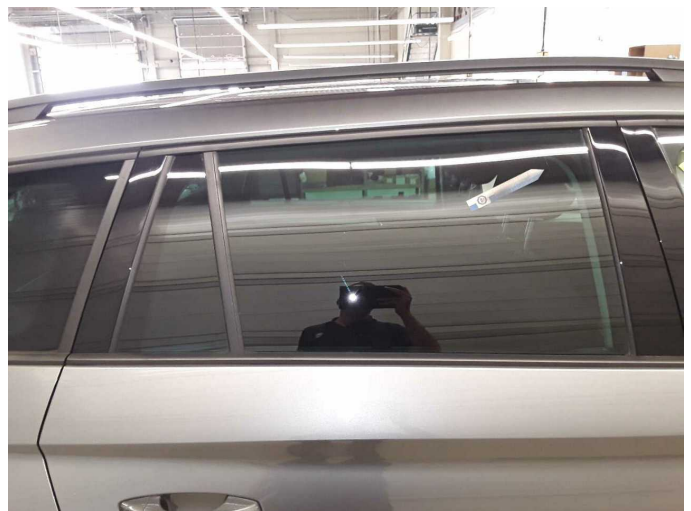
**Wear and tear 2:** Vehicle glazing: Side window - rear right side - Scratch(es) - No deduction

| No. | Component group | Description |
|---|---|---|
| 2 | Vehicle glazing | Side window - rear right side - Scratch(es) - No deduction |

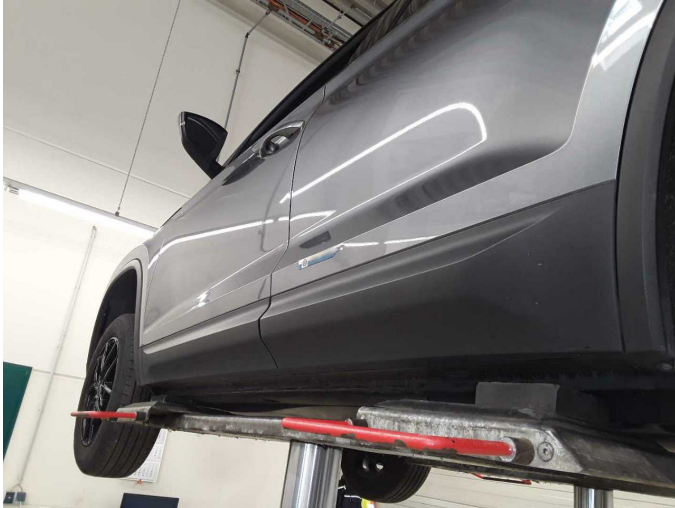
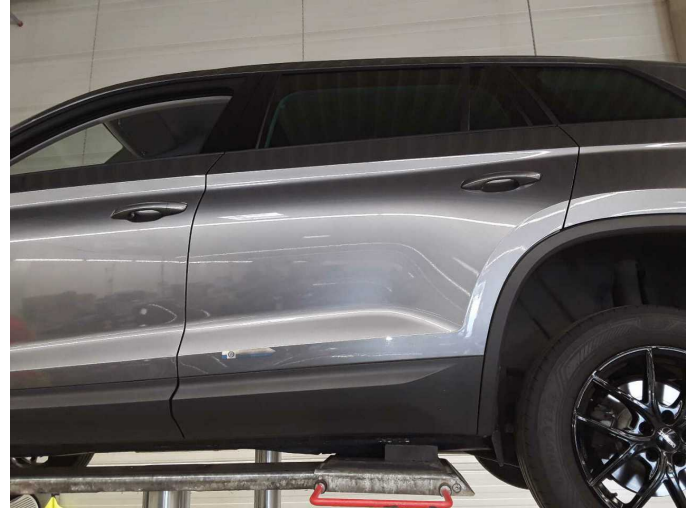
**Wear and tear 3:** Door - rear left side: Door - dent(s) - No deduction

| No. | Component group | Description |
|---|---|---|
| 3 | Door - rear left side | Door - dent(s) - No deduction |
