**Order number:** 1002406808  
**Order completed:** 14.04.2026 16:12  
**Report number:** 10424579  
**VIN:** WAUZZZFY3N2042671

- Vehicle Inspection Report -

Number: 10424579  
From: 15.04.2026

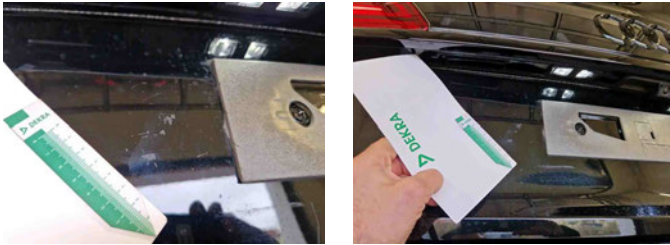
1 - Tailgate / Boot - Scratch(es) - Paint

| Nr | Location | Damage type | Repair type |
|---|---|---|---|
| 1 | Tailgate / Boot | Scratch(es) | Paint |

2 - Preparationtime metal painting - Paint preparation - Execute

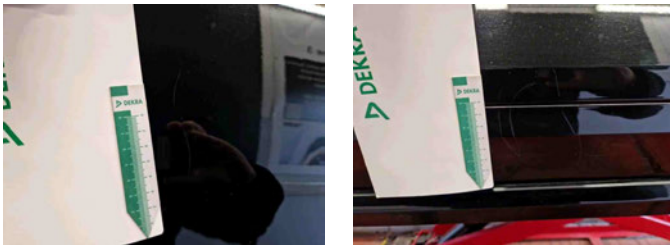
3 - Door FL - Scratch(es) - Polish

| Nr | Location | Damage type | Repair type |
|---|---|---|---|
| 3 | Door FL | Scratch(es) | Polish |

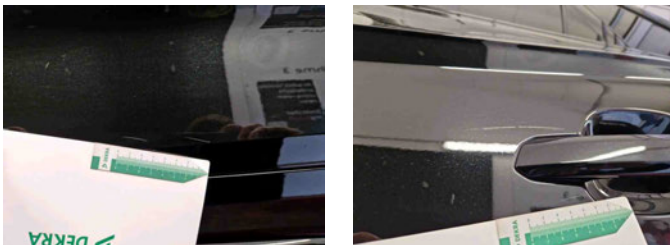
4 - Door RL - Scratch(es) - Polish

| Nr | Location | Damage type | Repair type |
|---|---|---|---|
| 4 | Door RL | Scratch(es) | Polish |

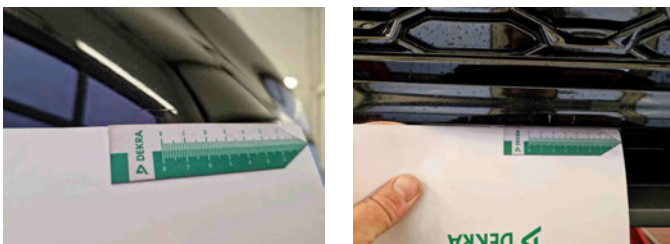
1 - Bumper F - Scratch(es) - Acceptable

| Nr | Location | Damage type | Repair type |
|---|---|---|---|
| 1 | Bumper F | Scratch(es) | Acceptable |
