Expertise

Protocol number: 46285090
Order No. / Reference: 26530376
Inspection date: 1 Jul 2026

Model: Octavia 2.0 TDI DSG Style

VIN: TMBAJ8NX7RY062452

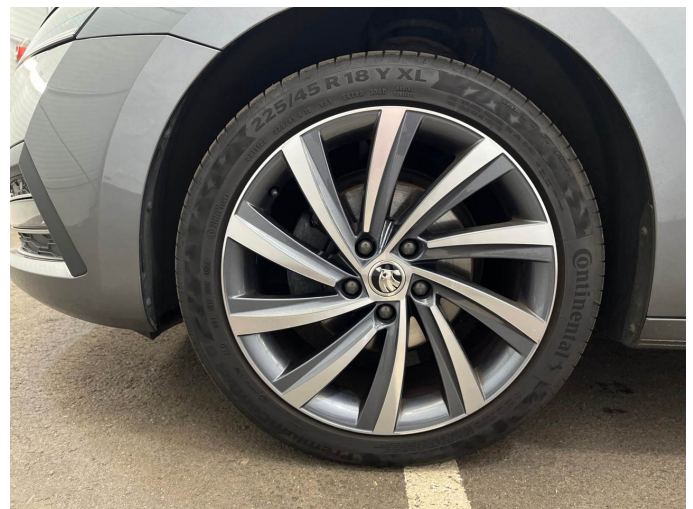
Figure 12: Mounted tyres

#	Tyre size	Type of tyre	Manufacturer	Tread depth
1)	225/45 R18 95Y	Summer tyres on Light alloy	Continental	5mm / 5mm
2)	225/45 R18 91Y	Summer tyres on Light alloy	Bridgestone	6mm / 6mm

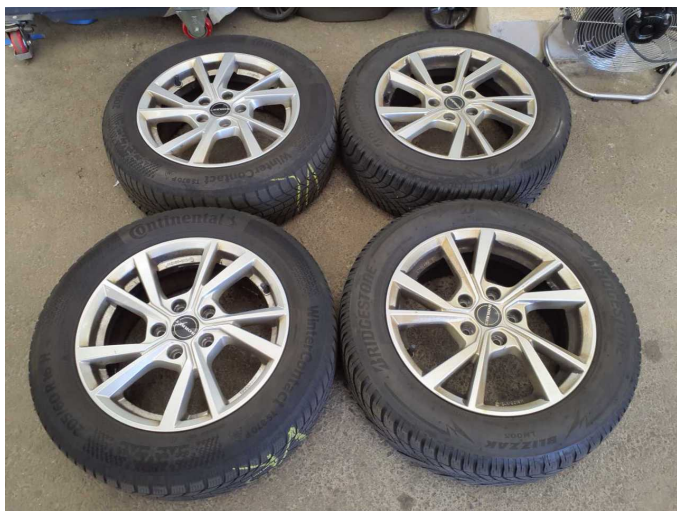
Figure 15: Additional tyres

#	Tyre size	Type of tyre	Manufacturer	Tread depth
1)	205/60 R16 92H	Winter tyres on Light alloy	Continental	5mm / 5mm
2)	205/60 R16 92H	Winter tyres on Light alloy	Bridgestone	5mm / 5mm

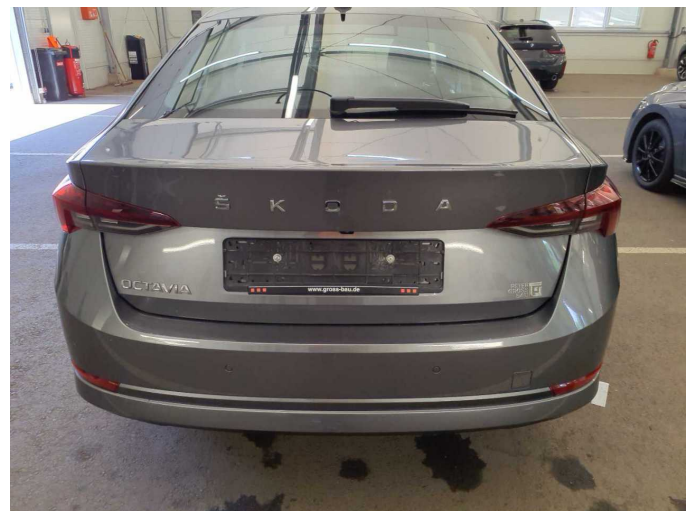
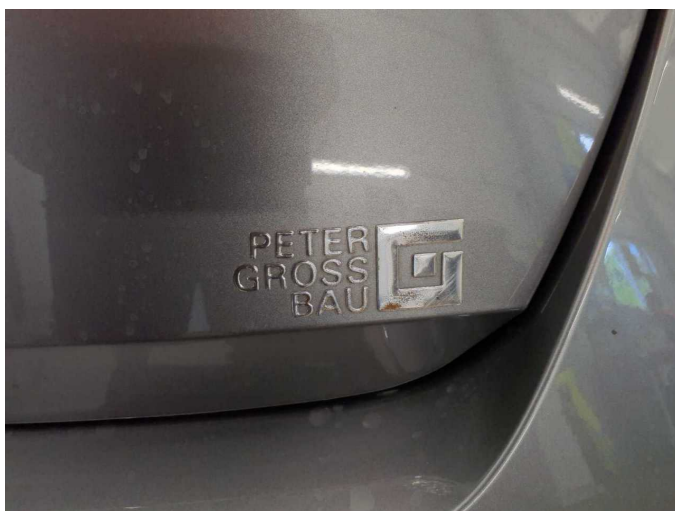
Damage 1: Boot lid / rear door: Boot lid - Glued / labelled - De-glu / neutralise

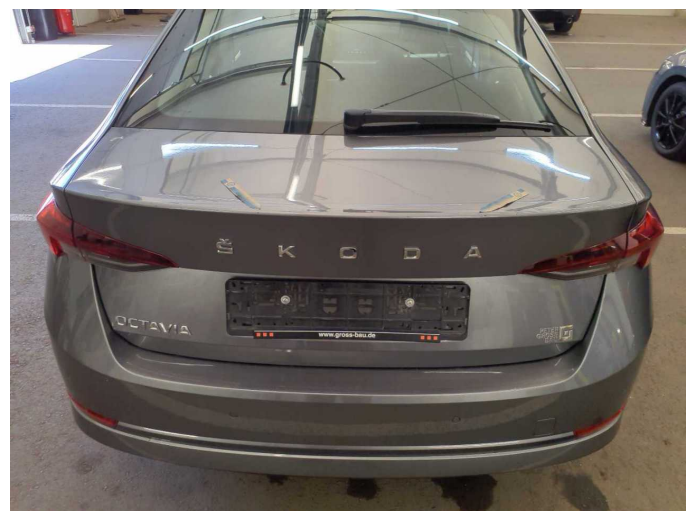
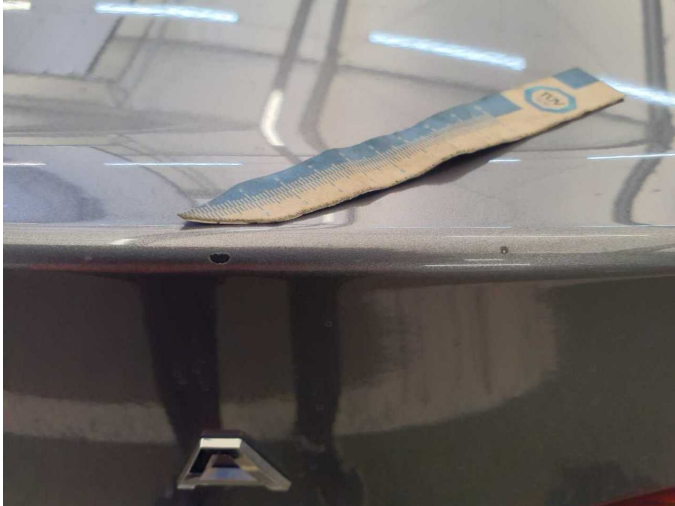
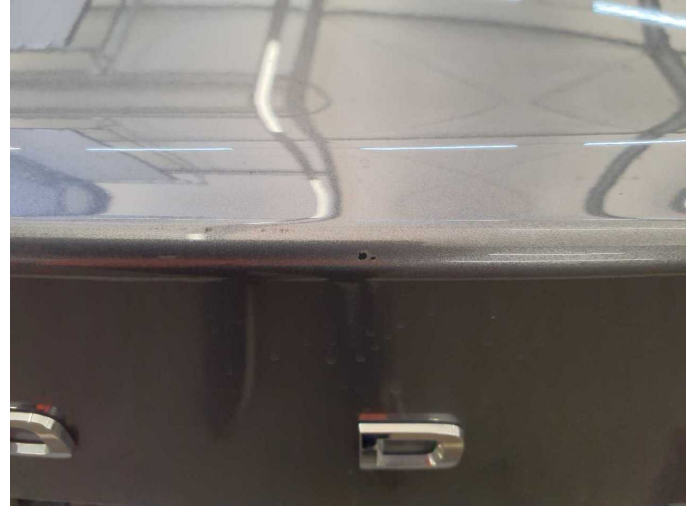
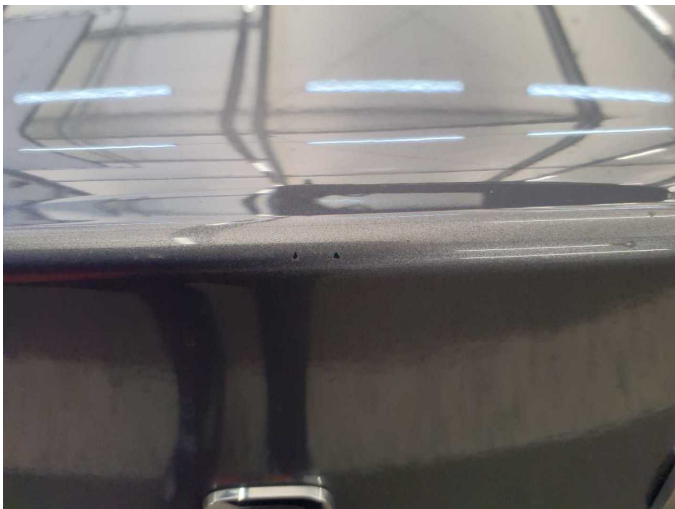
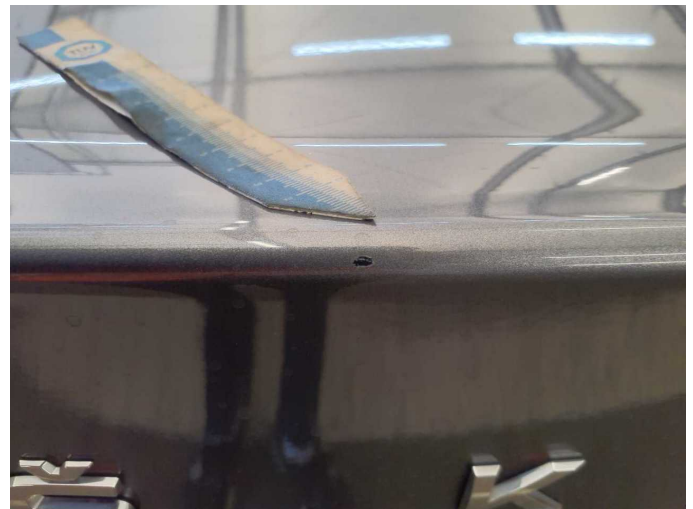
Damage 2: Boot lid / rear door: Boot lid - Scratch(es) - Smart repair

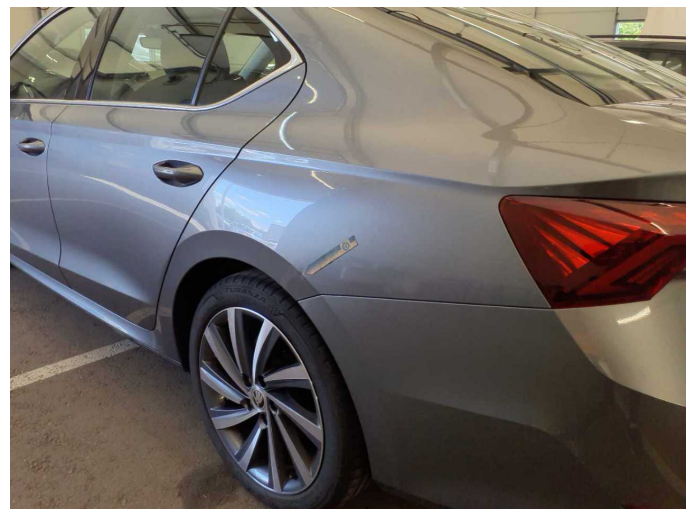
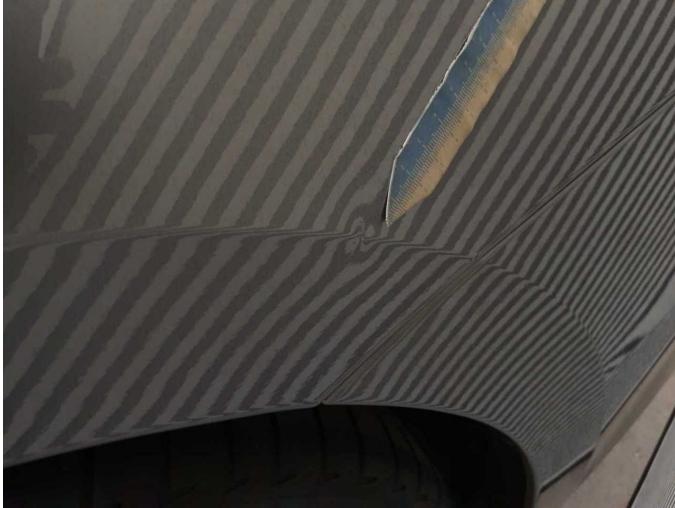
Damage 2: Boot lid / rear door: Boot lid - Scratch(es) - Smart repair

Damage 3: Side panel - rear left side: Side panel - Dent / paintcoat damage - Smart repair

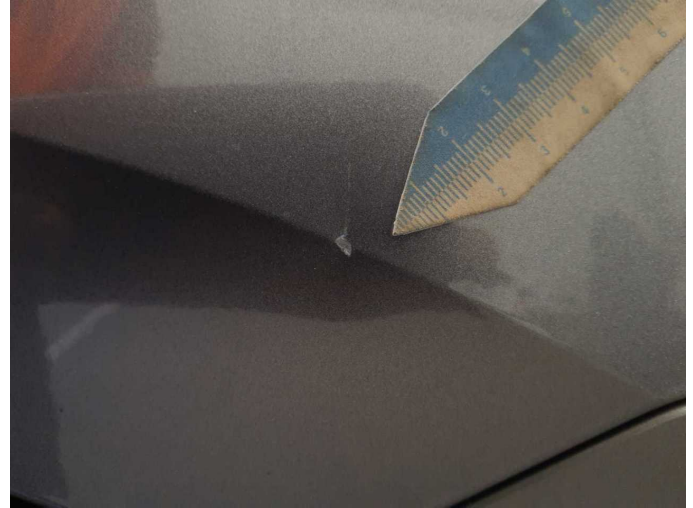
Damage 3: Side panel - rear left side: Side panel - Dent / paintcoat damage - Smart repair

Damage 4: Trim / covers: Carpet - front left side - Broken / torn - Smart repair

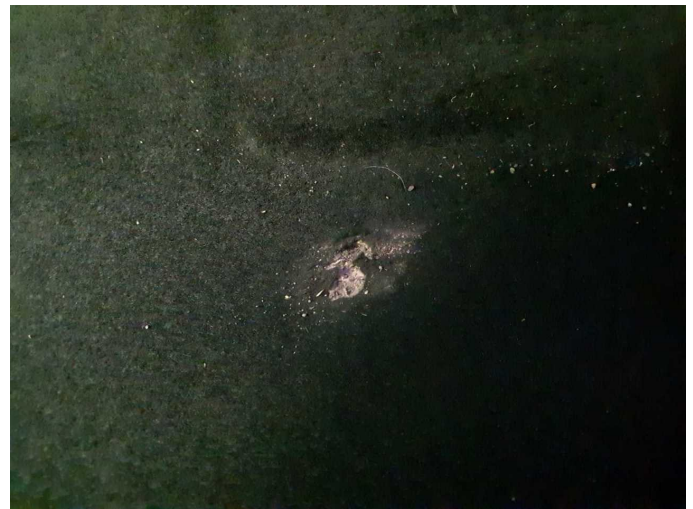
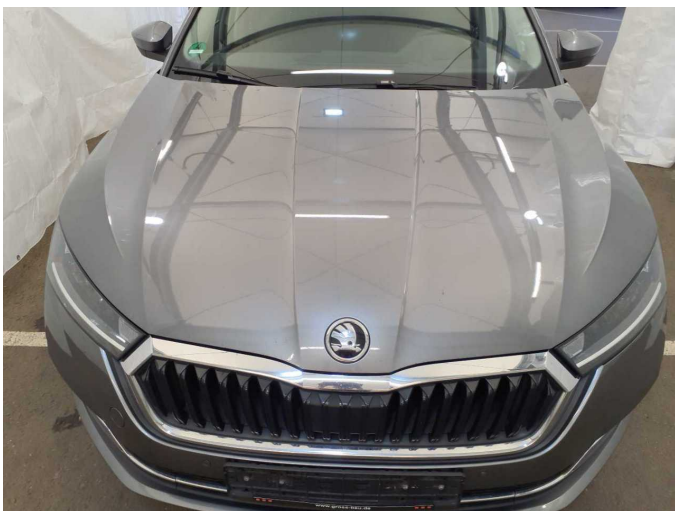
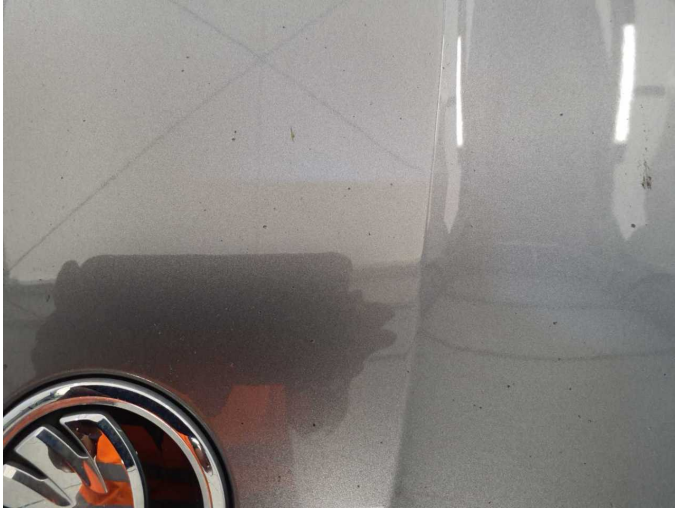
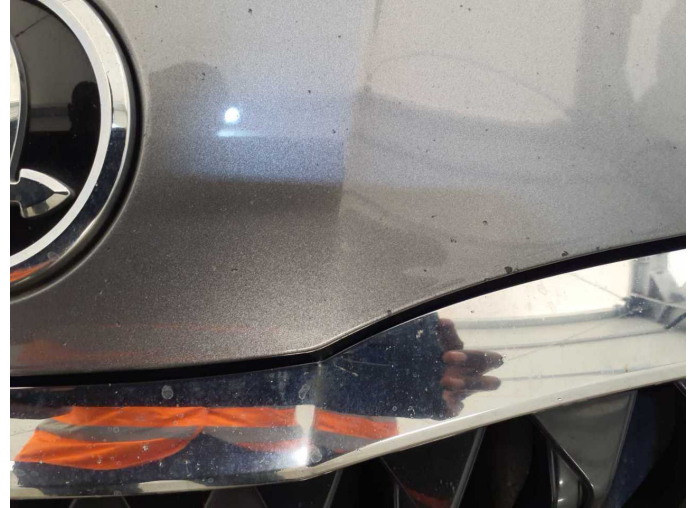
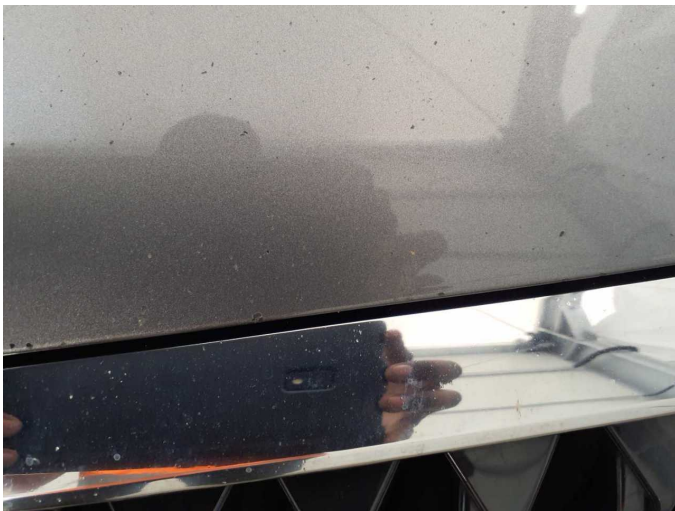
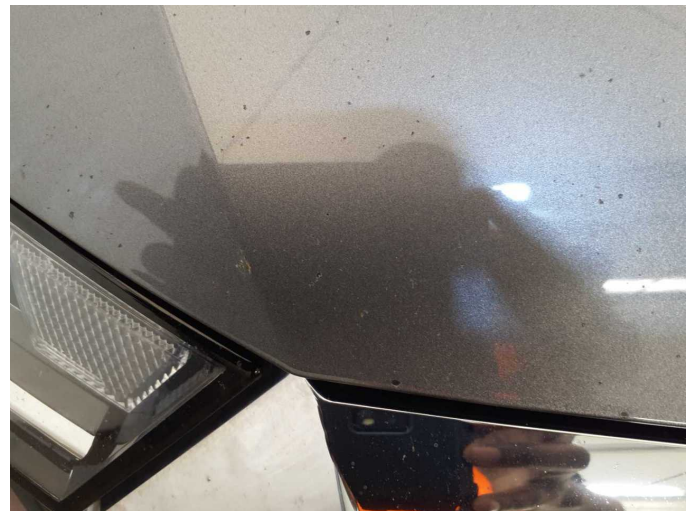
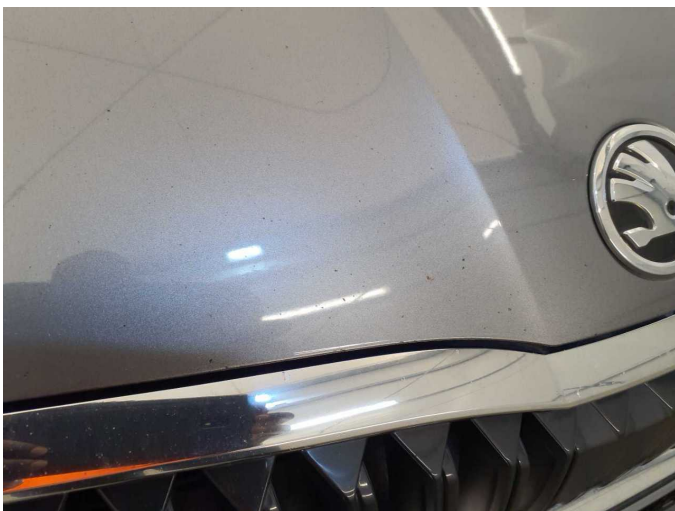
Damage 4: Trim / covers: Carpet - front left side - Broken / torn - Smart repair

Damage 5: Bonnet: Bonnet - Stone chips - Paint

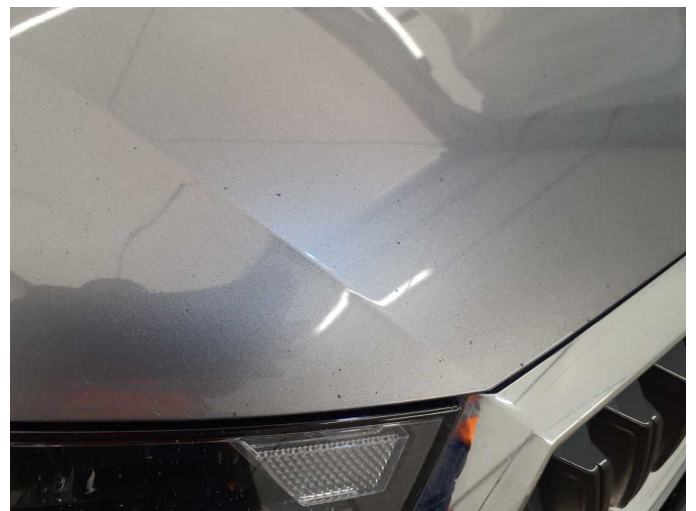
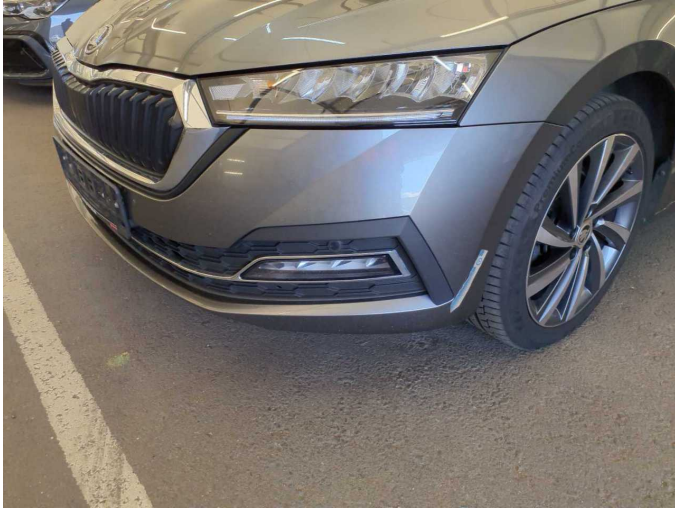
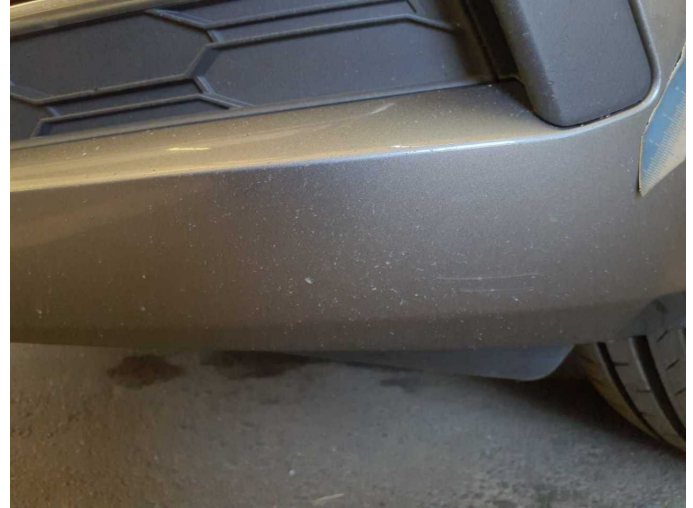
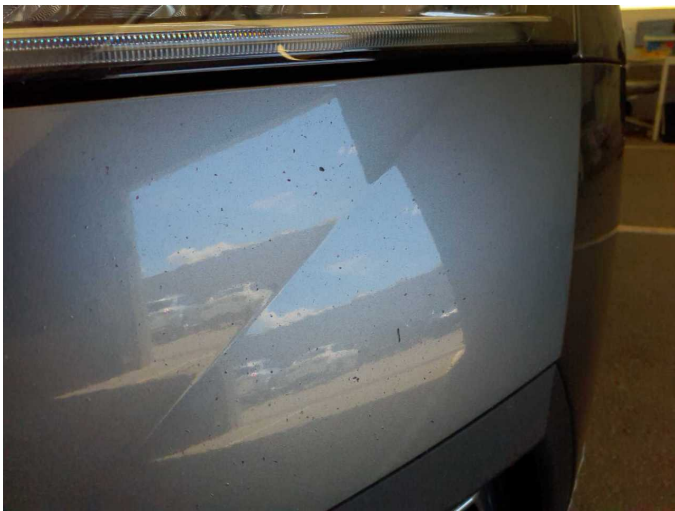
Damage 5: Bonnet: Bonnet - Stone chips - Paint

Damage 6: Front bumper: Front bumper - Stone chips - Paint

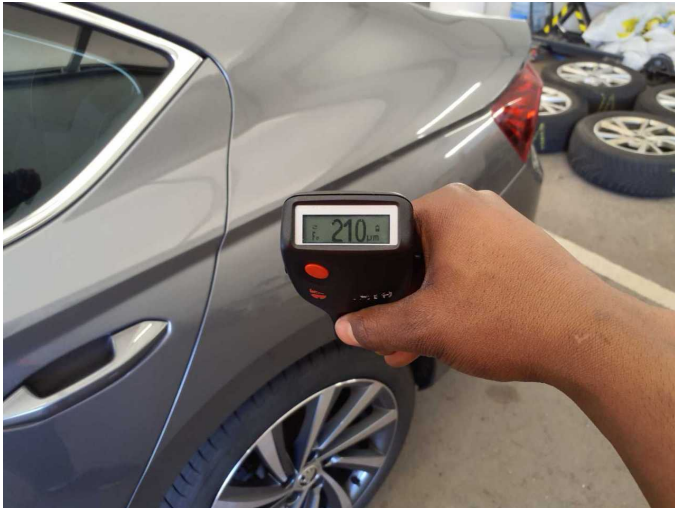
Side panel - rear left side	210 µm	Door - rear left side	250 µm
Door - front left side	257 µm

Wear and tear 1: Trim / covers: Floor mats - Broken / torn - No deduction

Repainting 1: Side panel - rear left side

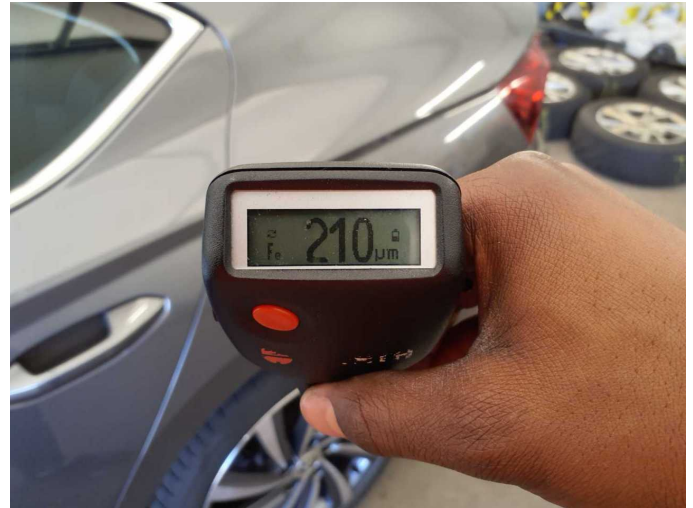
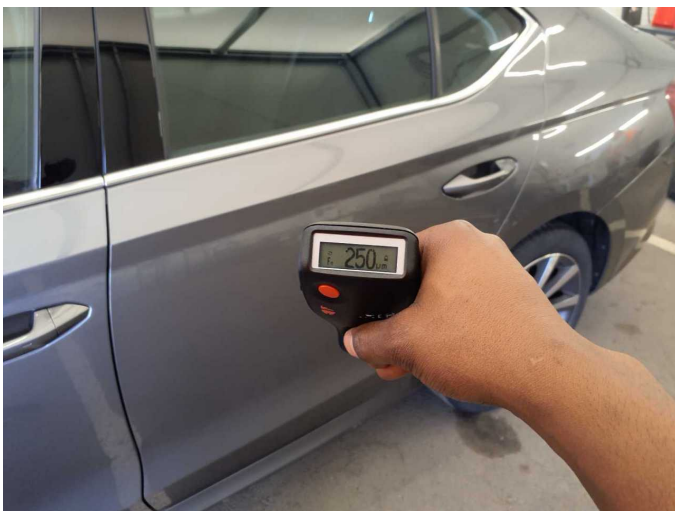
Repainting 1: Side panel - rear left side

Repainting 2: Door - rear left side

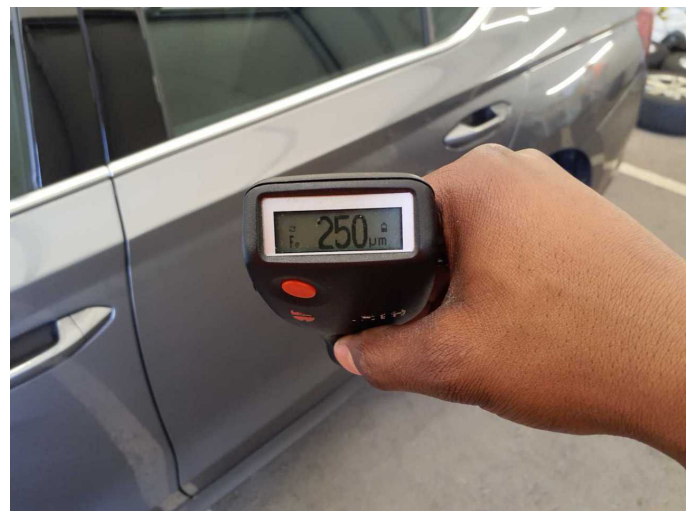
Repainting 2: Door - rear left side

Repainting 3: Door - front left side

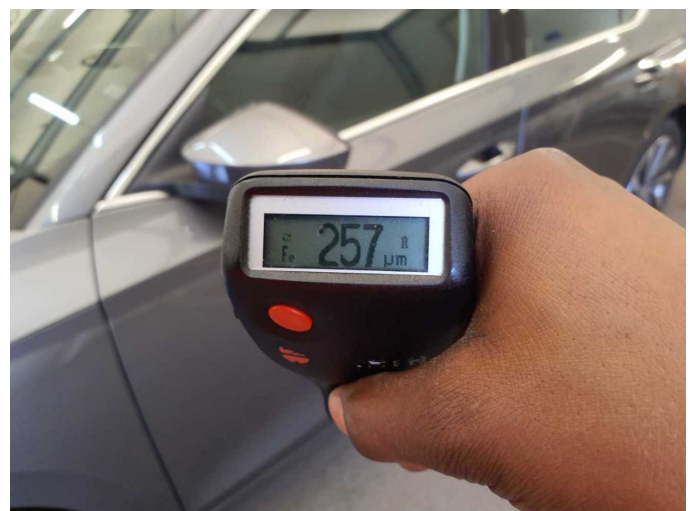
Repainting 3: Door - front left side

- 1 Side panel - rear left side, Professionally carried out, Invoice of repair done Non-existent
- 2 Door - rear left side, Professionally carried out, Invoice of repair done Non-existent
- 3 Door - front left side, Professionally carried out, Invoice of repair done Non-existent
