Expertise

Protocol number: 46531188  
Order No. / Reference: 26697080  
Inspection date: 15 Jul 2026

Manufacturer: Opel

Model: Grandland 1.5 D Automatik Elegance

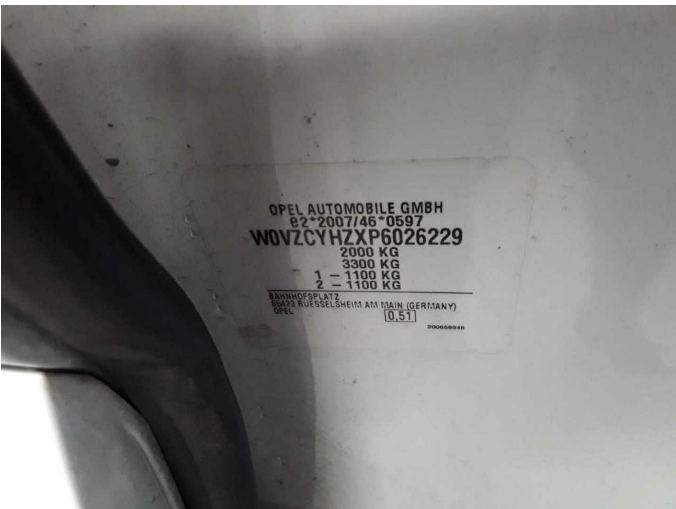
Figure 11: VIN

| VIN comparison | The vehicle identification number (VIN) was read from the vehicle and its conformity with the submitted documents was confirmed by the undersigned during the inspection. |

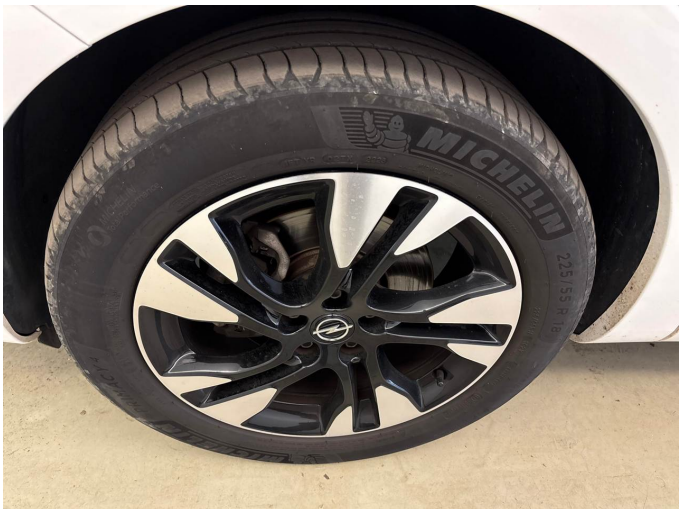
| # | Tyre size | Type of tyre | Manufacturer | Tread depth |
|---|---|---|---|---|
| 1) | 225/55 R18 102V | Summer tyres on Light alloy | Michelin | 3mm / 3mm |
| 2) | 225/55 R18 102V | Summer tyres on Light alloy | Michelin | 4mm / 4mm |

Figure 12: Mounted tyres

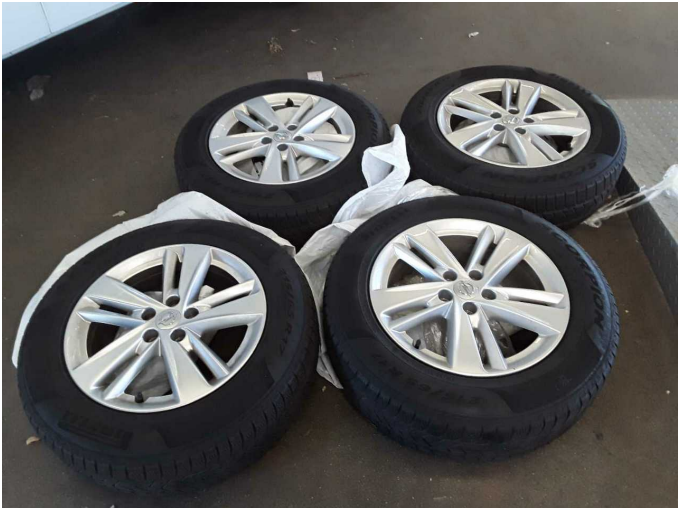
| # | Tyre size | Type of tyre | Manufacturer | Tread depth |
|---|---|---|---|---|
| 1) | 215/65 R17 103H | Winter tyres on Light alloy | Pirelli | 3mm / 3mm |
| 2) | 215/65 R17 103H | Winter tyres on Light alloy | Pirelli | 5mm / 5mm |

Figure 16: Additional tyres

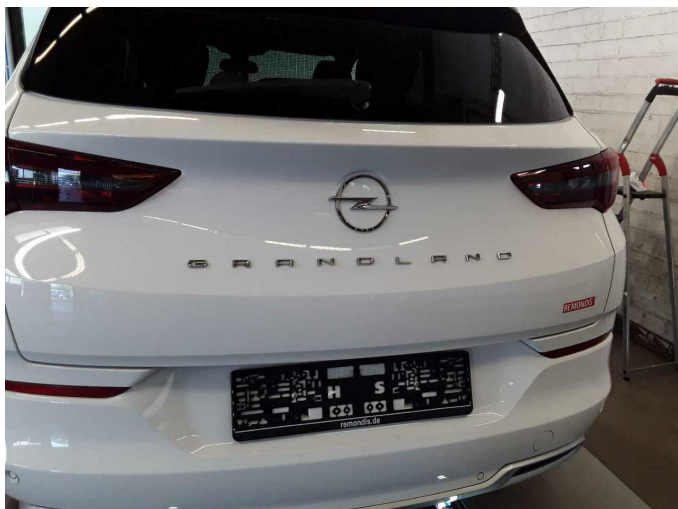
| No. | Component group | Description |
|---|---|---|
| 1 | Boot lid / rear door | Boot lid - Glued / labelled - De-glue / neutralise |

**Damage 1:** Boot lid / rear door: Boot lid - Glued / labelled - De-glue / neutralise

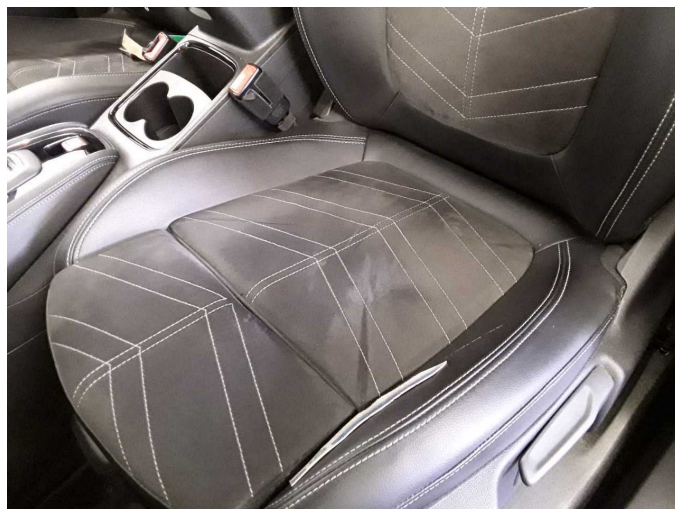
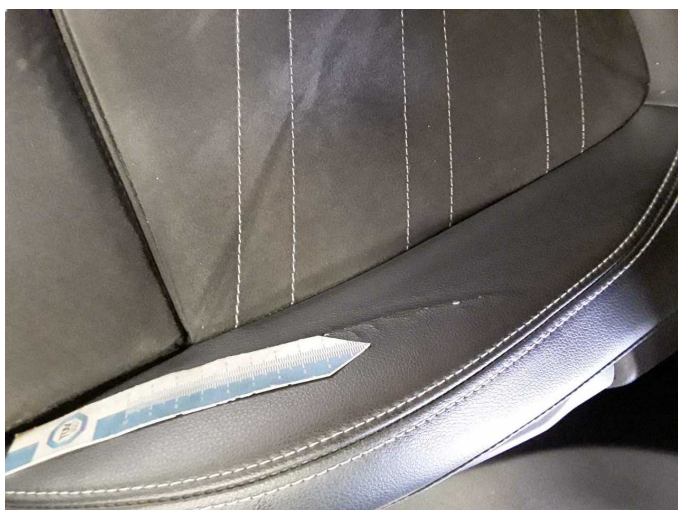
| No. | Component group | Description |
|---|---|---|
| 2 | Seat - front | Seat cover - left side - Worn - Smart repair |

**Damage 2:** Seat - front: Seat cover - left side - Worn - Smart repair

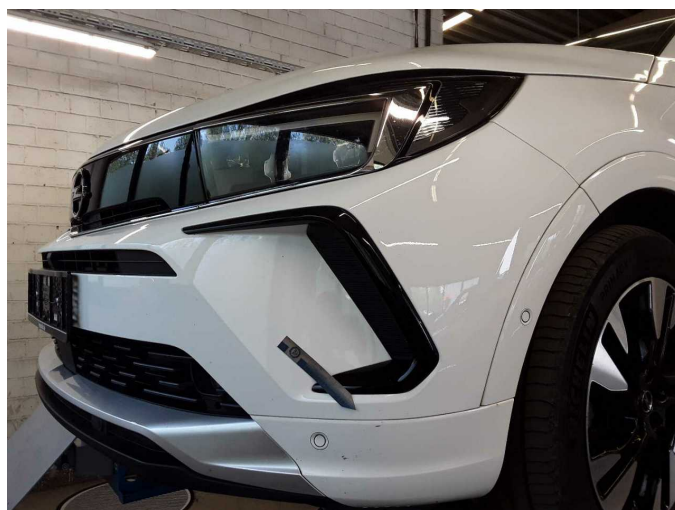
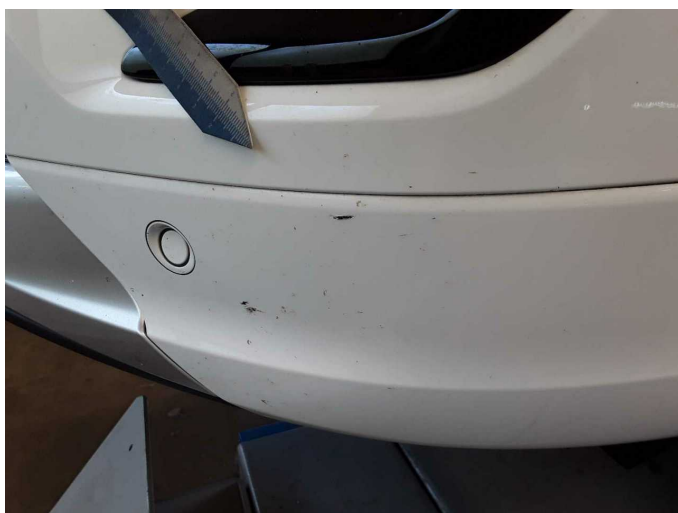
| No. | Component group | Description |
|---|---|---|
| 3 | Front bumper | Front bumper - Scratch(es) - Smart repair |

**Damage 3:** Front bumper: Front bumper - Scratch(es) - Smart repair

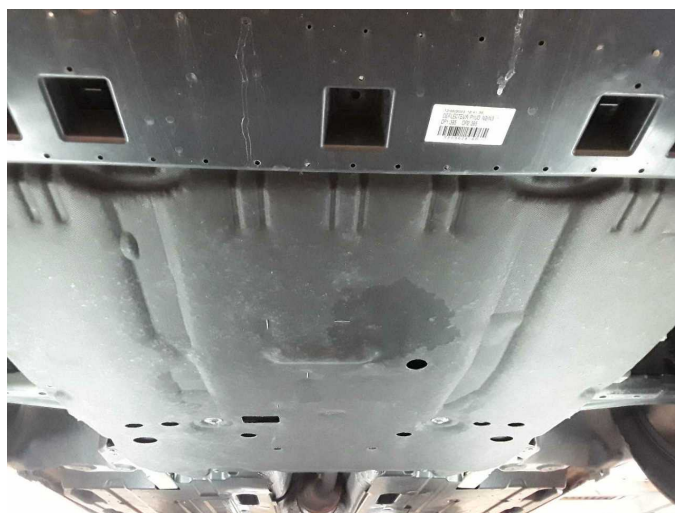
| No. | Component group | Description |
|---|---|---|
| 4 | Engine | Engine - Leaking - Diagnosed and repair if necessary |

**Damage 4:** Engine: Engine - Leaking - Diagnosed and repair if necessary
