Expertise

Protocol number: 47190922  
Order No. / Reference: 26775288  
Inspection date: 30 Jul 2026

Manufacturer: Hyundai  
VIN: KMHK3812ANU909839

Model: KONA 1.0 T-GDI EDITION 30+

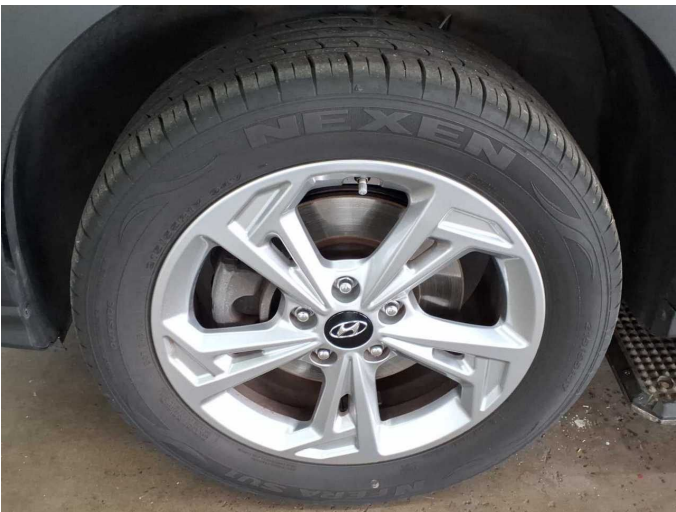
Figure 11: Mounted tyres

| # | Tyre size | Type of tyre | Manufacturer | Tread depth |
|---|---|---|---|---|
| 1) | 215/55 R17 94V | Summer tyres on Light alloy | Nexen | 5mm / 5mm |
| 2) | 215/55 R17 98Y | Summer tyres on Light alloy | Pirelli | 6mm / 6mm |

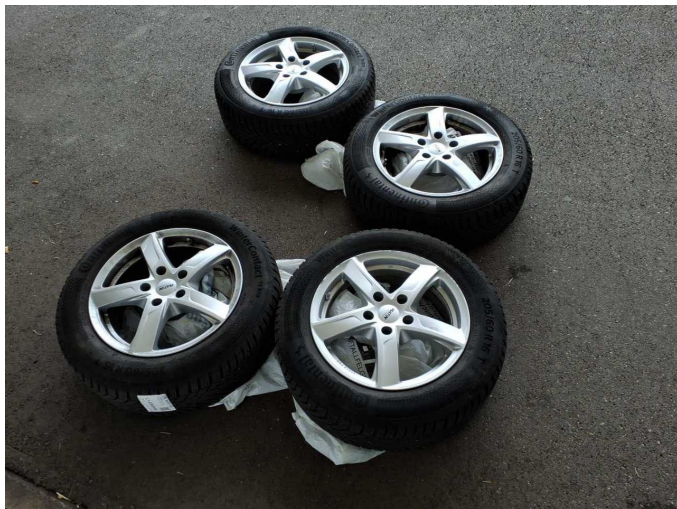
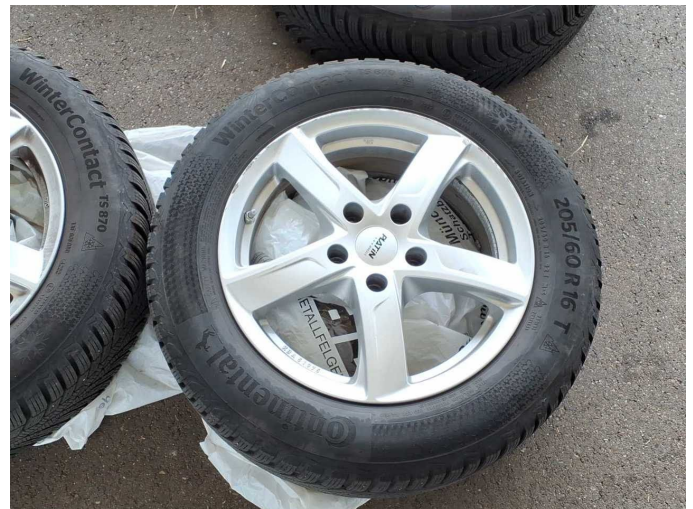
Figure 15: Additional tyres

| # | Tyre size | Type of tyre | Manufacturer | Tread depth |
|---|---|---|---|---|
| 1) | 205/60 R16 92T | Winter tyres on Light alloy | Continental | 7mm / 7mm |
| 2) | 205/60 R16 92T | Winter tyres on Light alloy | Continental | 7mm / 7mm |

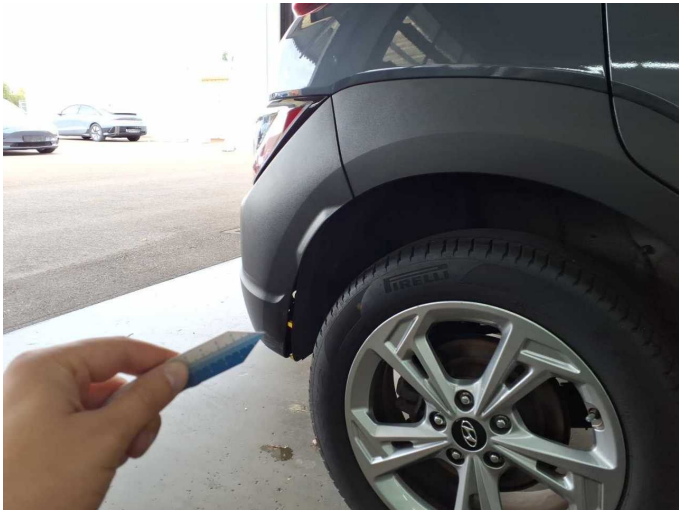
| No. | Component group | Description |
|---|---|---|
| 1 | Body | Wheel well - rear right side - Loose - Un- / install |

Damage 1: Body: Wheel well - rear right side - Loose - Un- / install

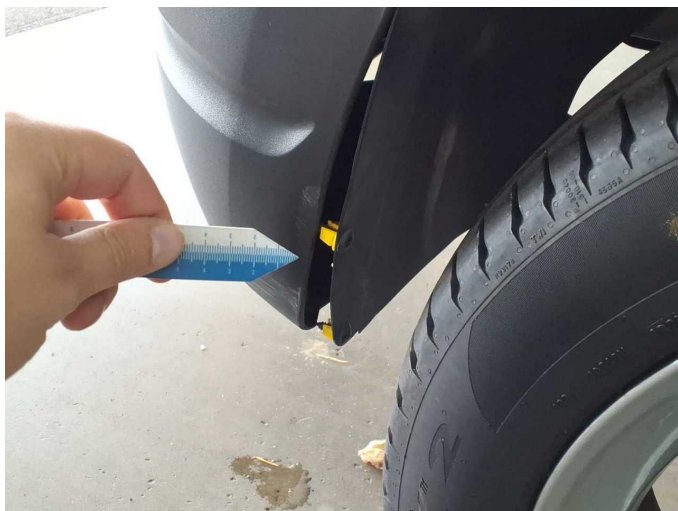
**Damage 1:** Body: Wheel well - rear right side - Loose - Un- / install

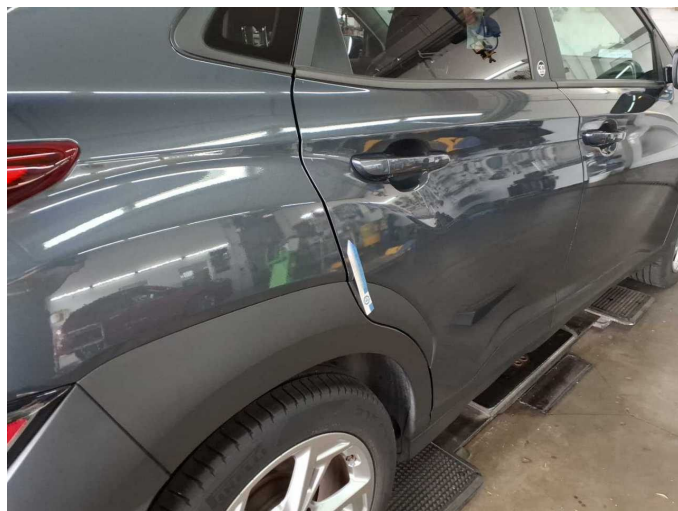
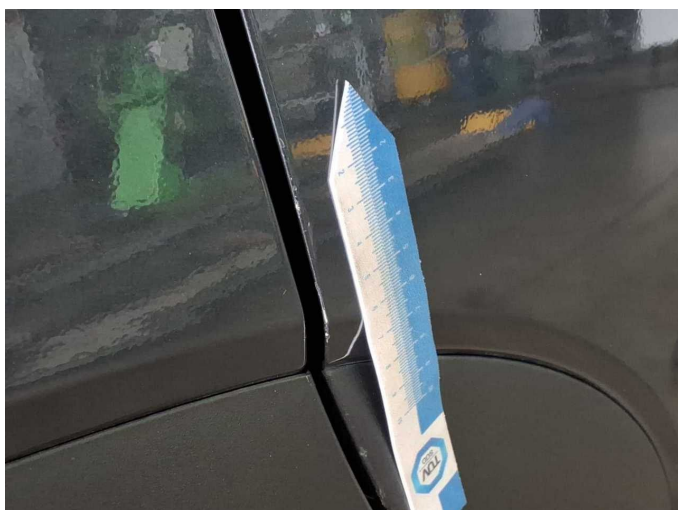
| No. | Component group | Description |
|---|---|---|
| 2 | Door - rear right side | Door edge - Scratch(es) - Smart repair |

**Damage 2:** Door - rear right side: Door edge - Scratch(es) - Smart repair

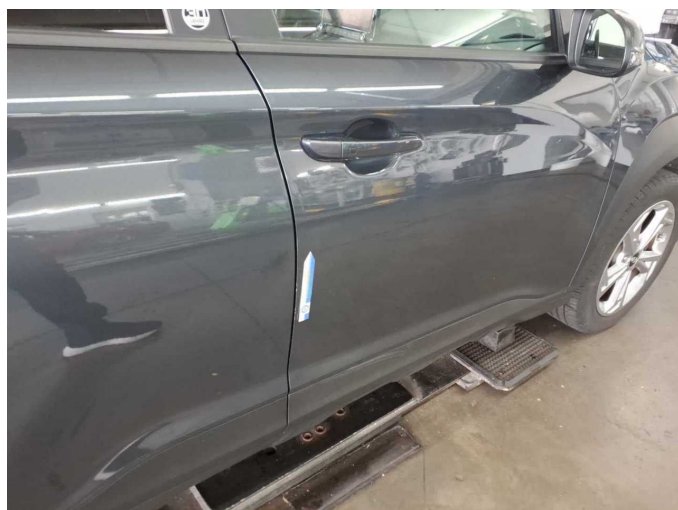
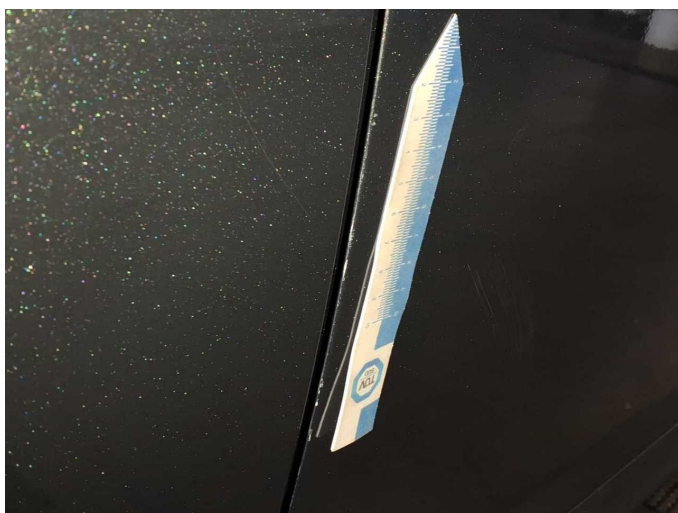
| No. | Component group | Description |
|---|---|---|
| 3 | Door - front right side | Door edge - Scratch(es) - Smart repair |

**Damage 3:** Door - front right side: Door edge - Scratch(es) - Smart repair

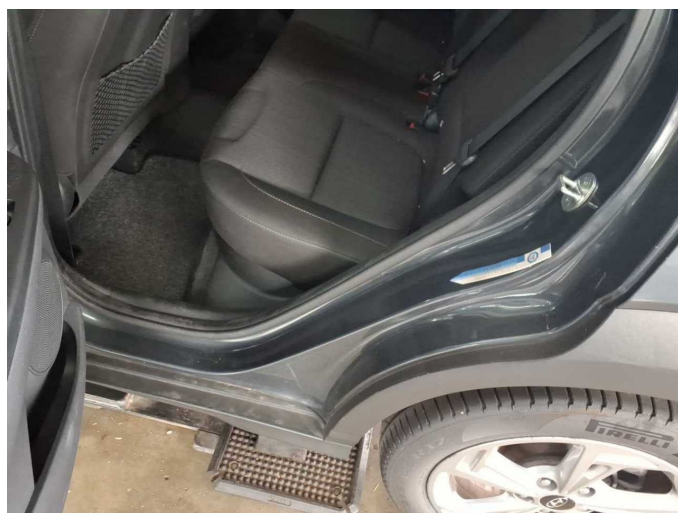
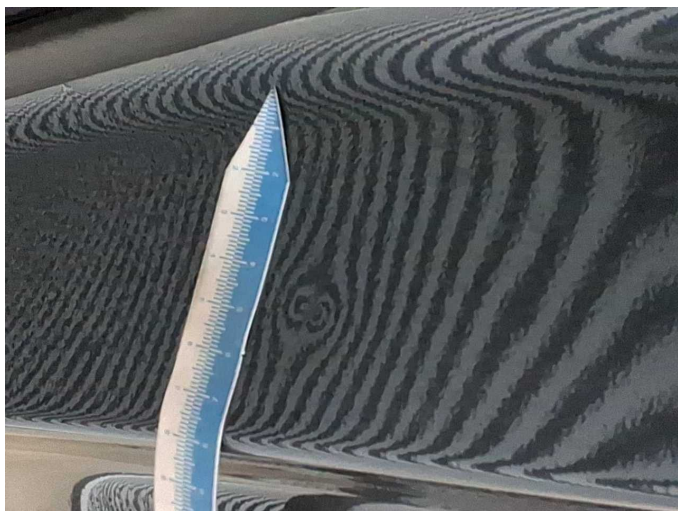
| No. | Component group | Description |
|---|---|---|
| 4 | Side panel - rear left side | Sill - dent(s) - Smart repair |

**Damage 4:** Side panel - rear left side: Sill - dent(s) - Smart repair

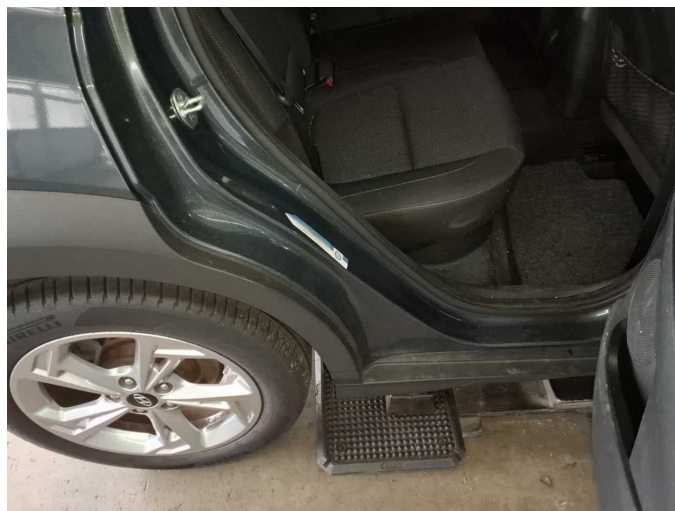
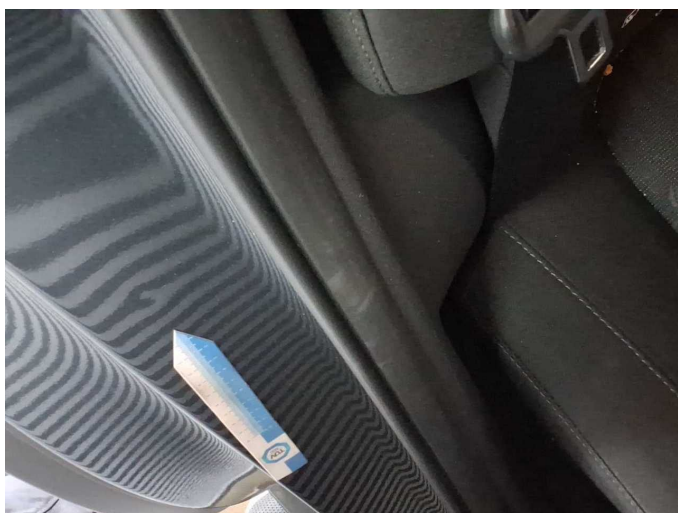
| No. | Component group | Description |
|---|---|---|
| 5 | Side panel - rear right side | Sill - dent(s) - Smart repair |

**Damage 5:** Side panel - rear right side: Sill - dent(s) - Smart repair

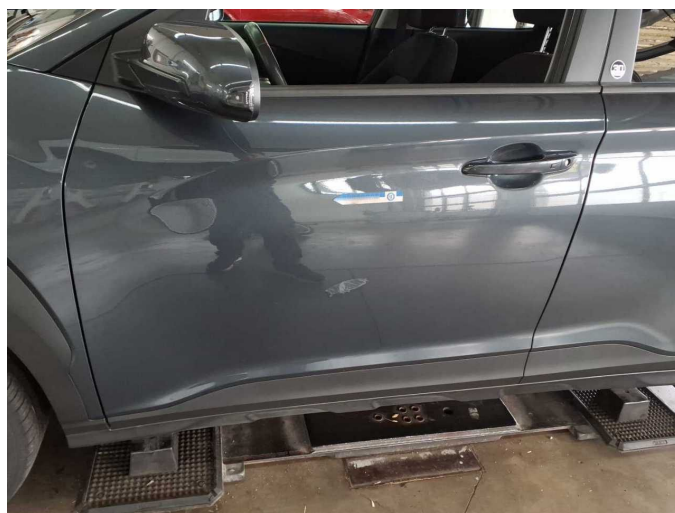
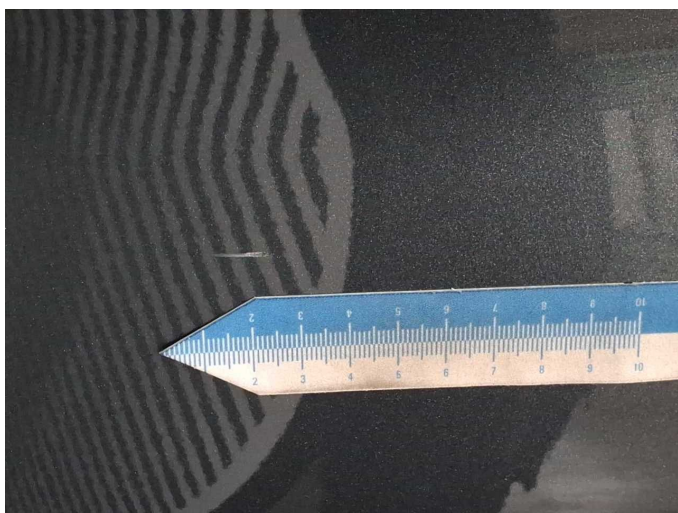
| No. | Component group | Description |
|---|---|---|
| 6 | Door - front left side | Door - Scratch(es) - Smart repair |

**Damage 6:** Door - front left side: Door - Scratch(es) - Smart repair

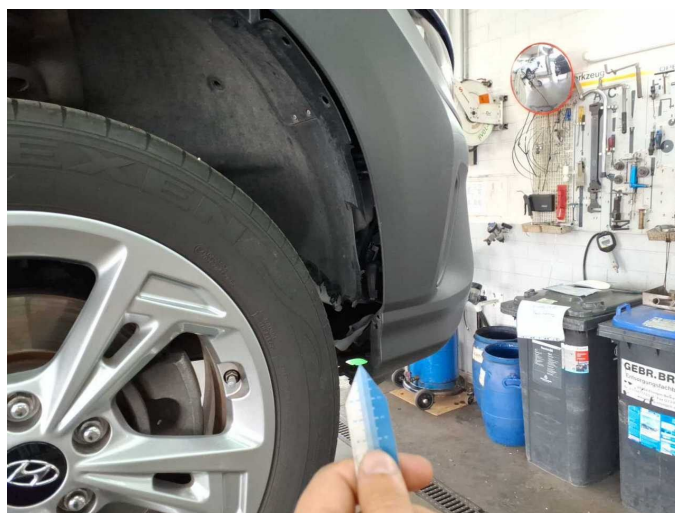
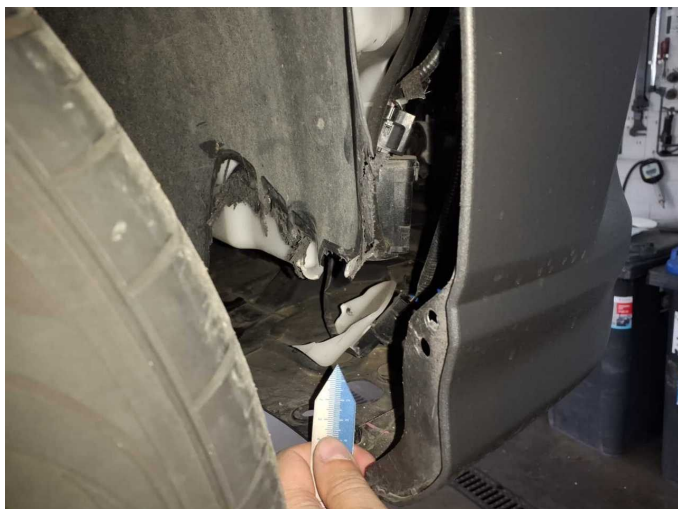
| No. | Component group | Description |
|---|---|---|
| 7 | Screen cleaning | Washing container - Broken / torn - Replace |

**Damage 7:** Screen cleaning: Washing container - Broken / torn - Replace

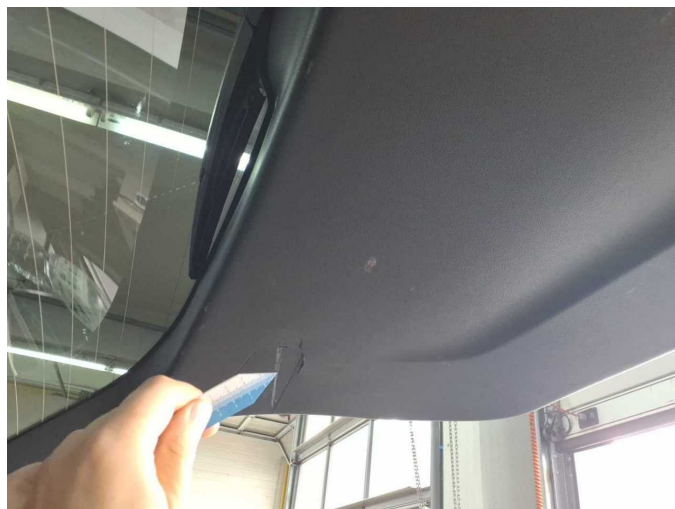
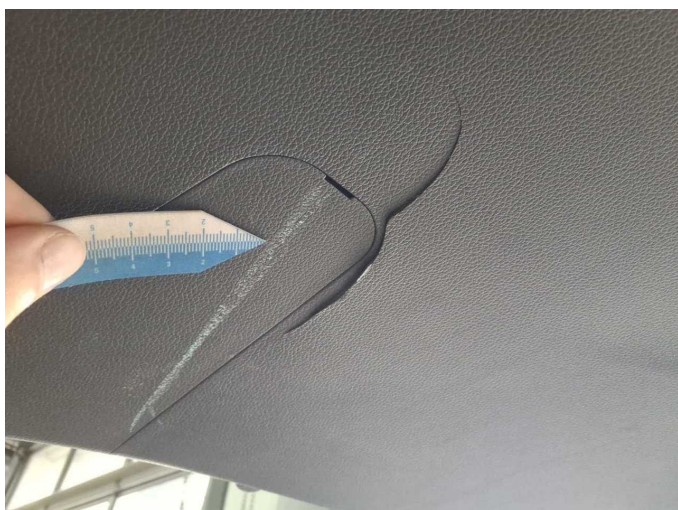
| No. | Component group | Description |
|---|---|---|
| 8 | Trim / covers | Boot lid - interior trim - Broken / torn - Replace |

**Damage 8:** Trim / covers: Boot lid - interior trim - Broken / torn - Replace

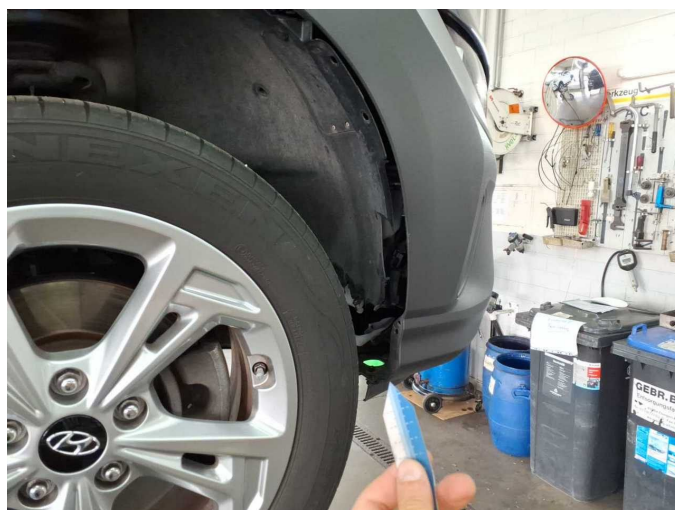
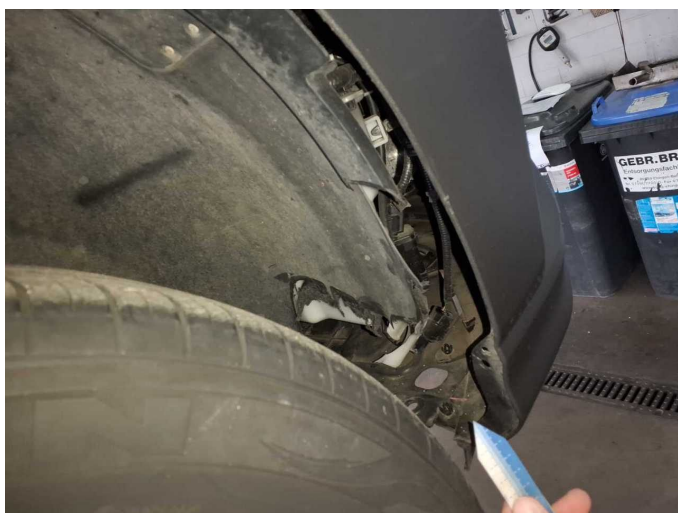
| No. | Component group | Description |
|---|---|---|
| 9 | Body | Wheel well - front right side - Broken / torn - Replace |

**Damage 9:** Body: Wheel well - front right side - Broken / torn - Replace

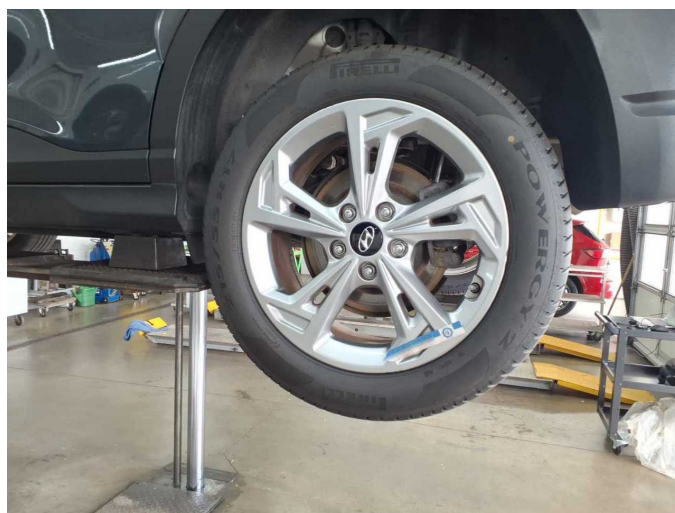
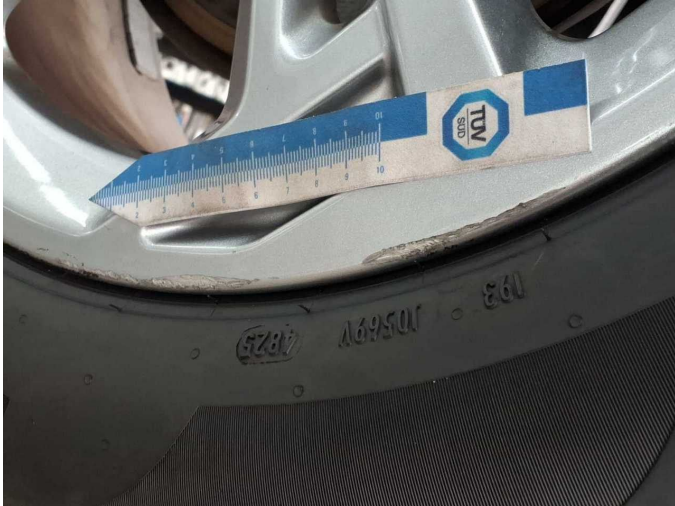
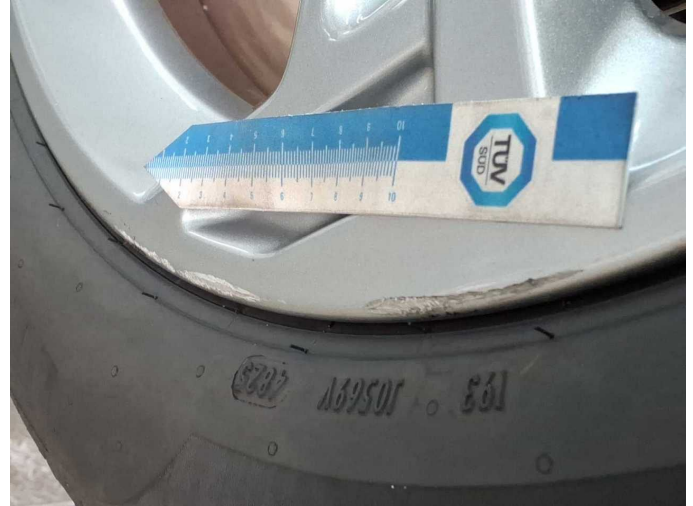
| No. | Component group | Description |
|---|---|---|
| 10 | Wheel / tyres | Alloy rim - rear left side - Scratched - Loss in value |

**Damage 10:** Wheel / tyres: Alloy rim - rear left side - Scratched - Loss in value

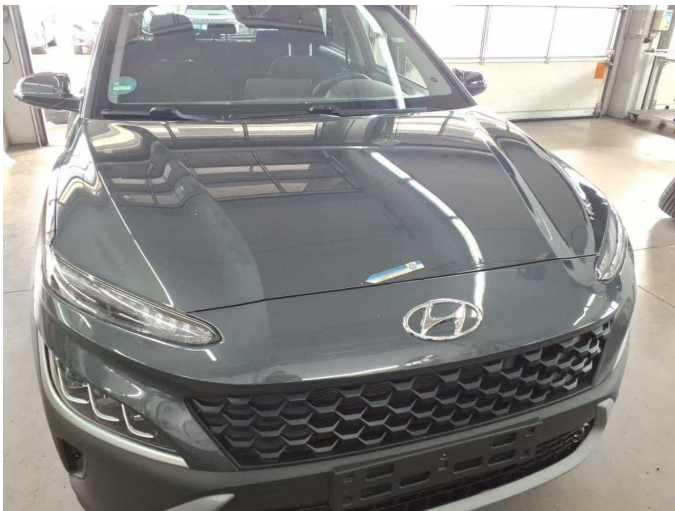
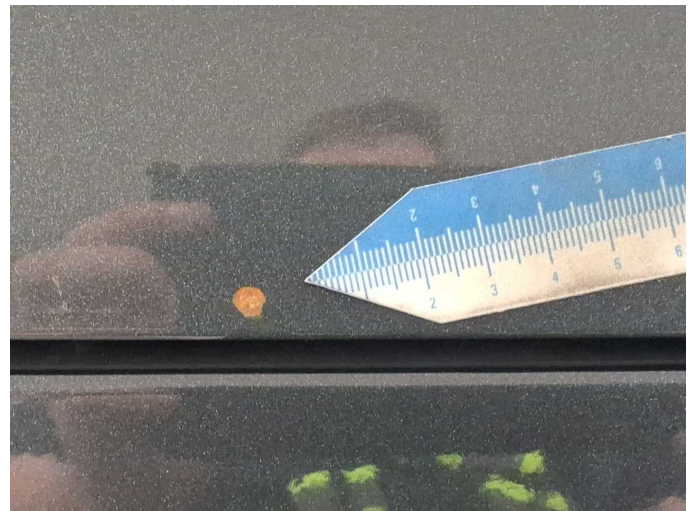
| No. | Component group | Description |
|---|---|---|
| 11 | Bonnet | Bonnet - Corrosion - Paint |

**Damage 11:** Bonnet: Bonnet - Corrosion - Paint

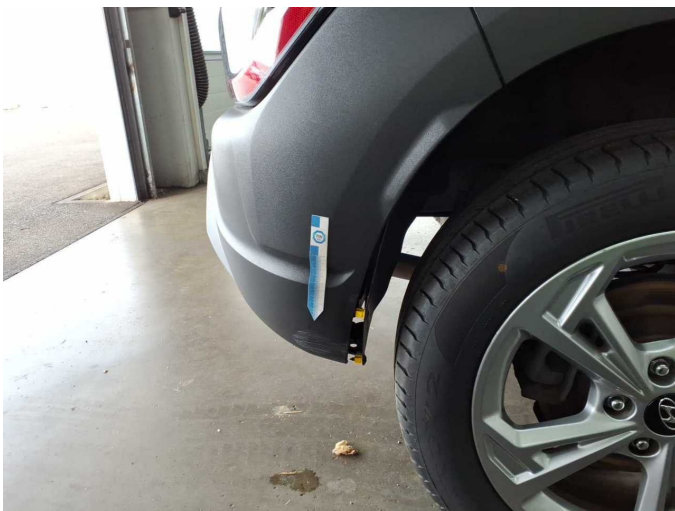
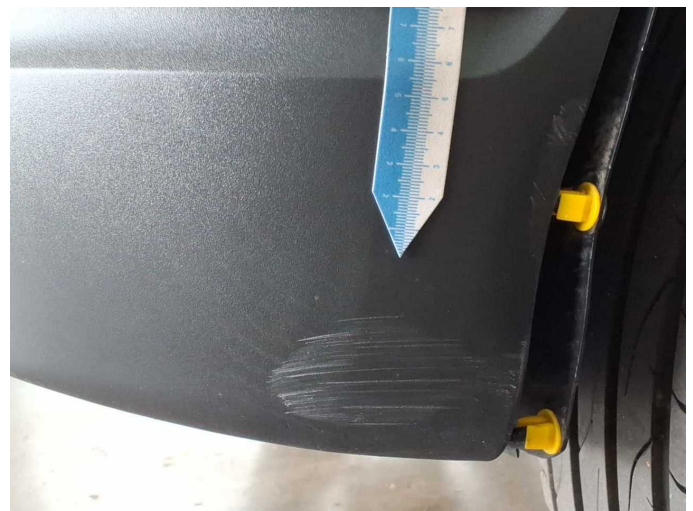
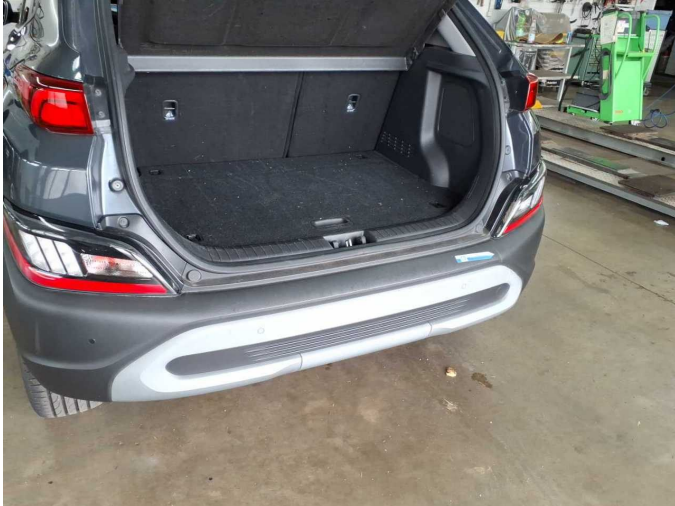
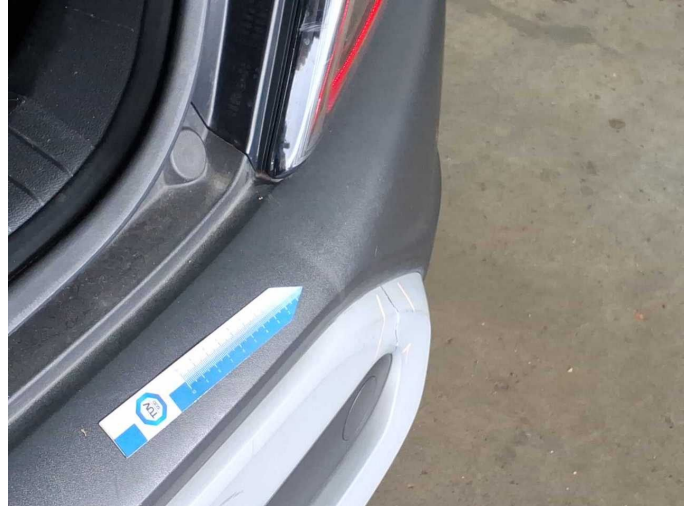
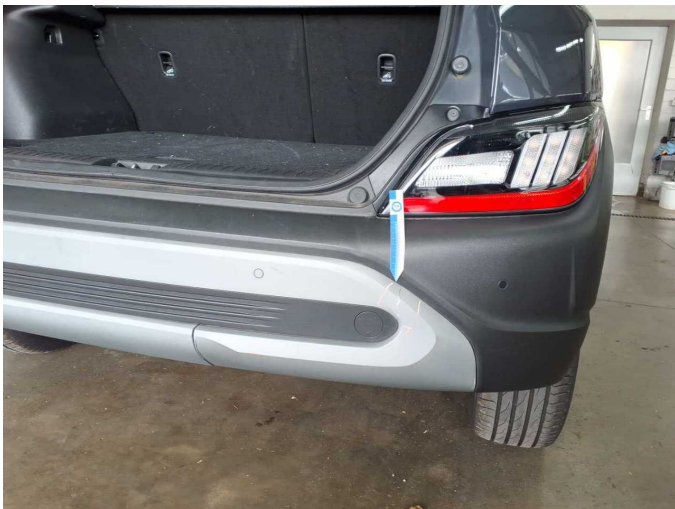
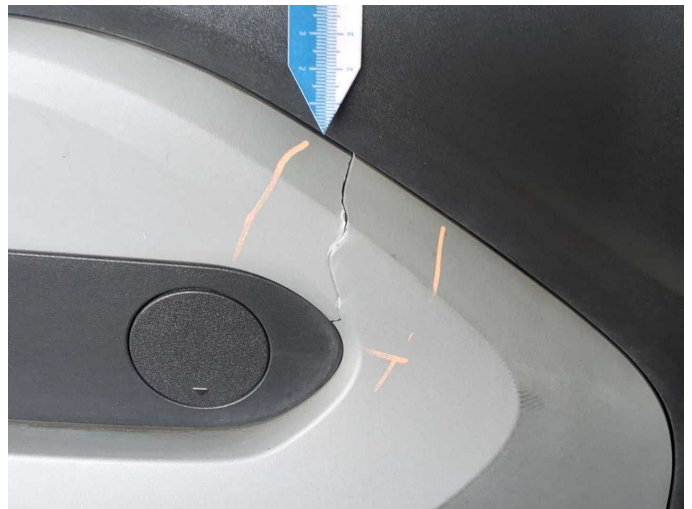
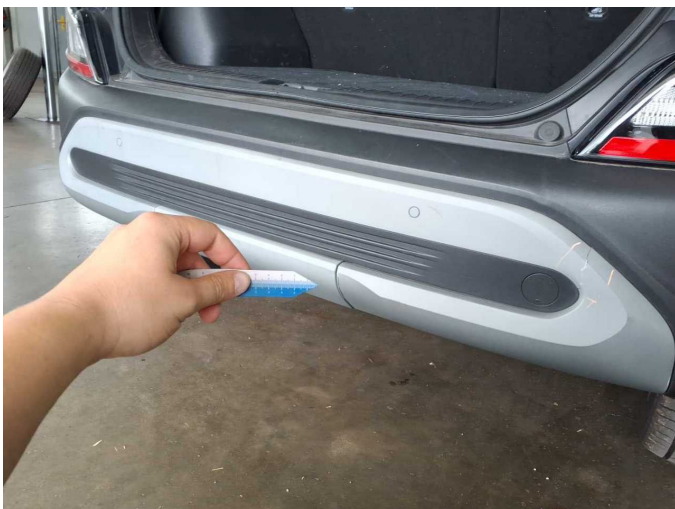
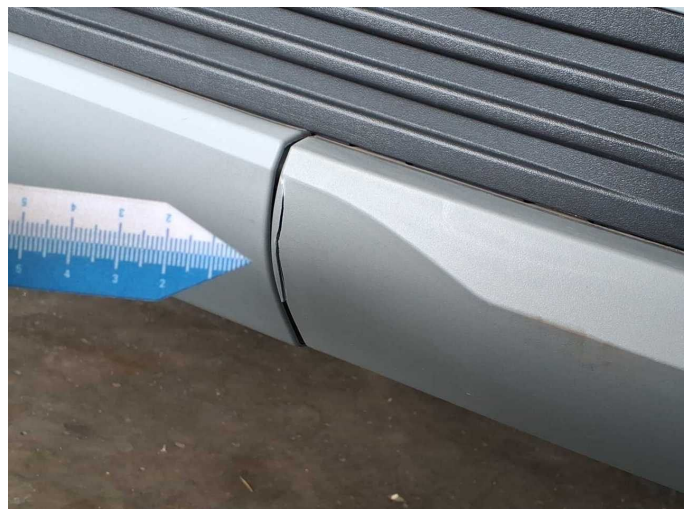
| No. | Component group | Description |
|---|---|---|
| 12 | Rear bumper | Rear bumper (Gestaucht + Spoiler gebrochen erneuern) - Deformed - Replace |

**Damage 12:** Rear bumper: Rear bumper (Gestaucht + Spoiler gebrochen erneuern) - Deformed - Replace
