Expertise

Protocol number: 46828069  
Order No. / Reference: 26555016  
Inspection date: 31 Jul 2026

| Manufacturer: Volvo | Model: XC60 T6 AWD Plug-in Hybrid Ultra Black Edition |
| VIN: LYVUZH1V6TB304442 | |

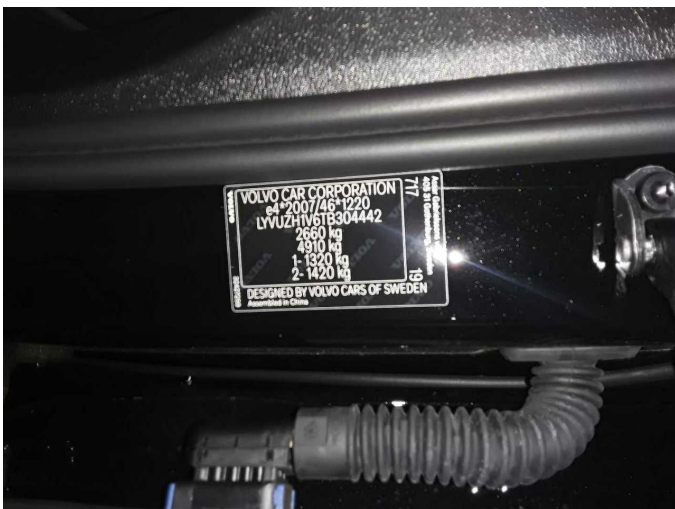
| VIN comparison | The vehicle identification number (VIN) was read from the vehicle and its conformity with the submitted documents was confirmed by the undersigned during the inspection. |

Figure 11: VIN

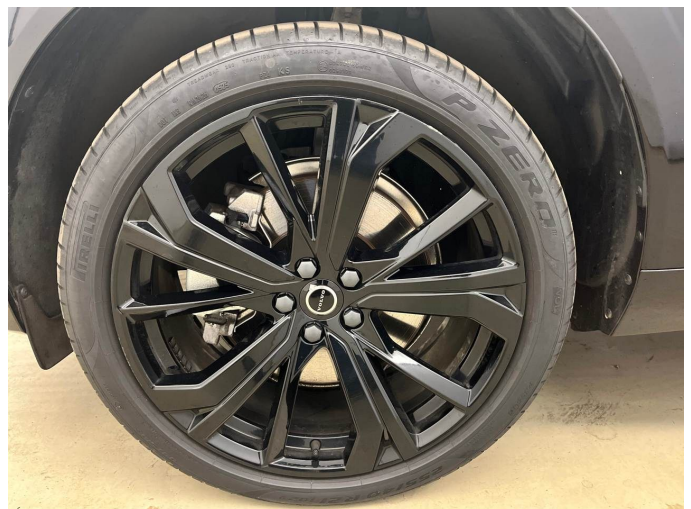
| # | Tyre size | Type of tyre | Manufacturer | Tread depth |
|---|---|---|---|---|
| 1) | 255/40 R21 102V | Summer tyres on Light alloy | Pirelli | 7mm / 7mm |
| 2) | 255/40 R21 102V | Summer tyres on Light alloy | Pirelli | 7mm / 7mm |

Figure 12: Mounted tyres

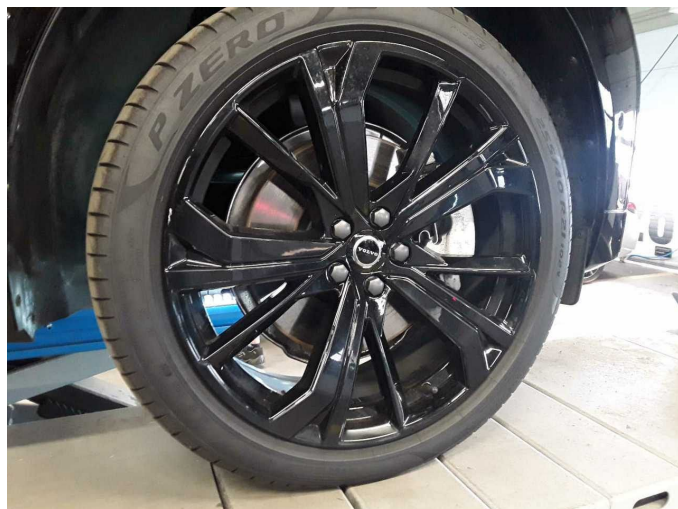
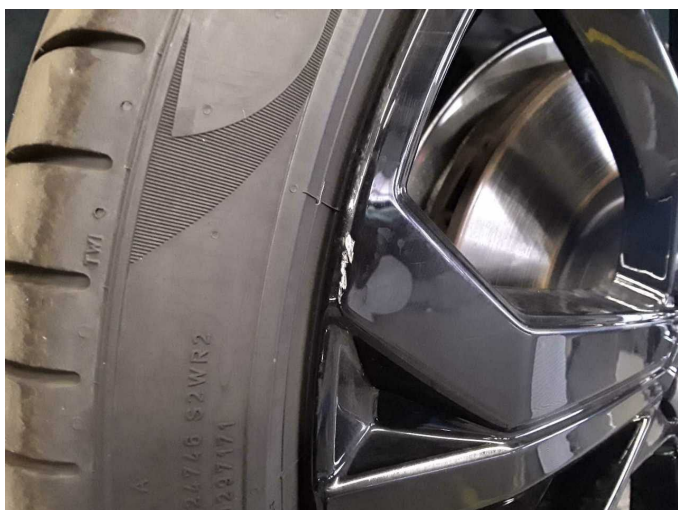
| No. | Component group | Description |
|---|---|---|
| 2 | Wheel / tyres | Alloy rim - front right side - Scratch(es) - Smart repair |

**Damage 2:** Wheel / tyres: Alloy rim - front right side - Scratch(es) - Smart repair

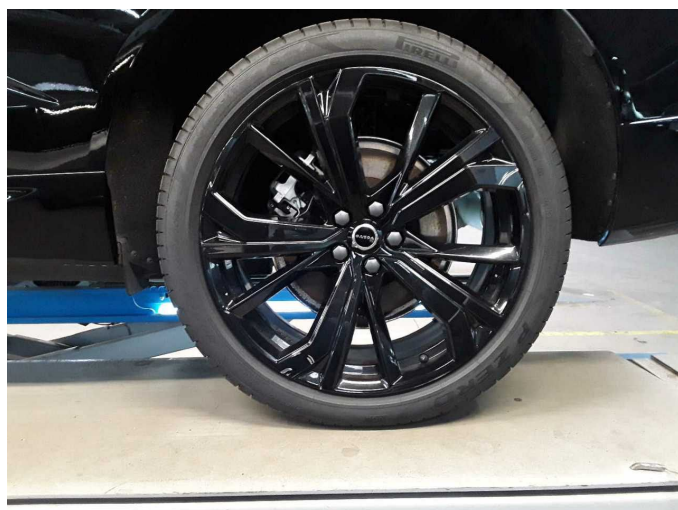
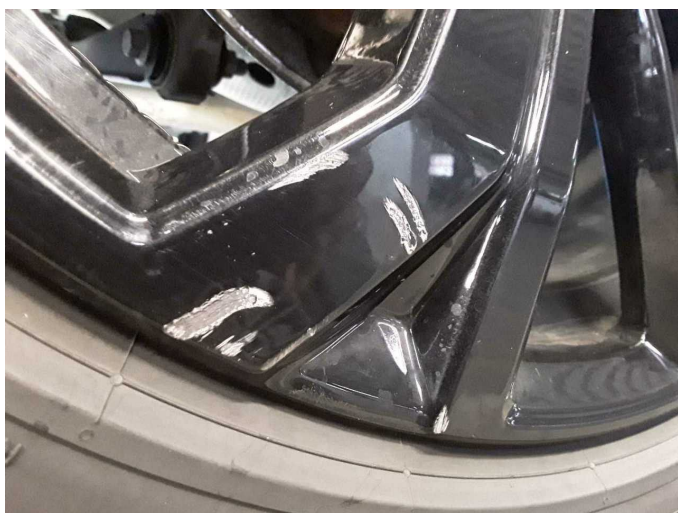
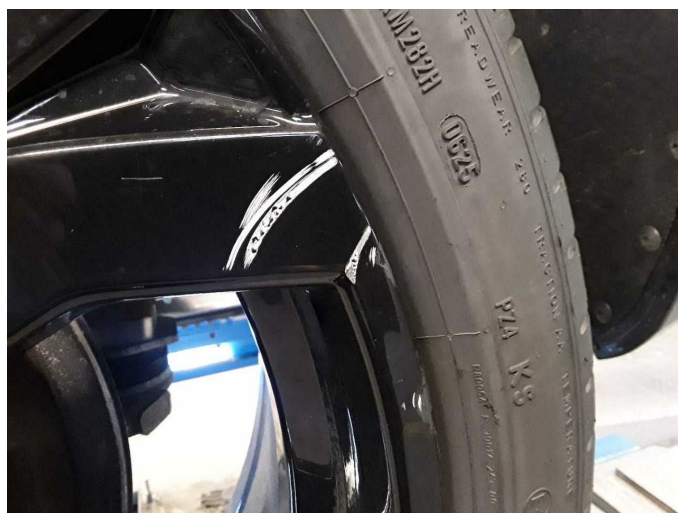
| No. | Component group | Description |
|---|---|---|
| 3 | Wheel / tyres | Alloy rim - rear left side (Materialabtrag) - Scratch(es) - Loss in value |

**Damage 3:** Wheel / tyres: Alloy rim - rear left side (Materialabtrag) - Scratch(es) - Loss in value

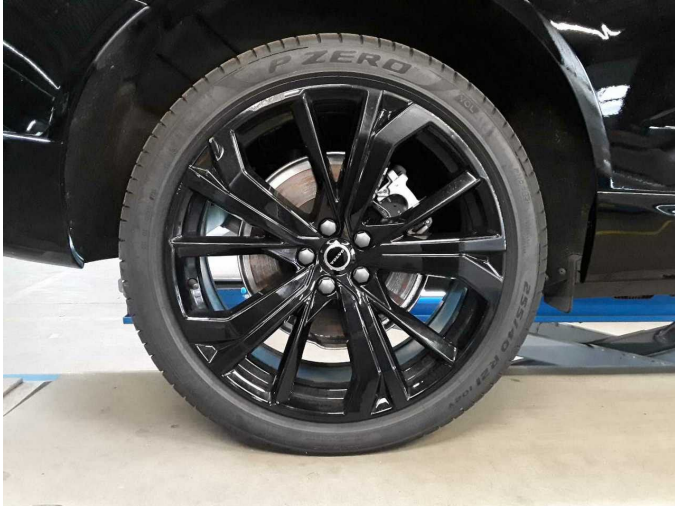
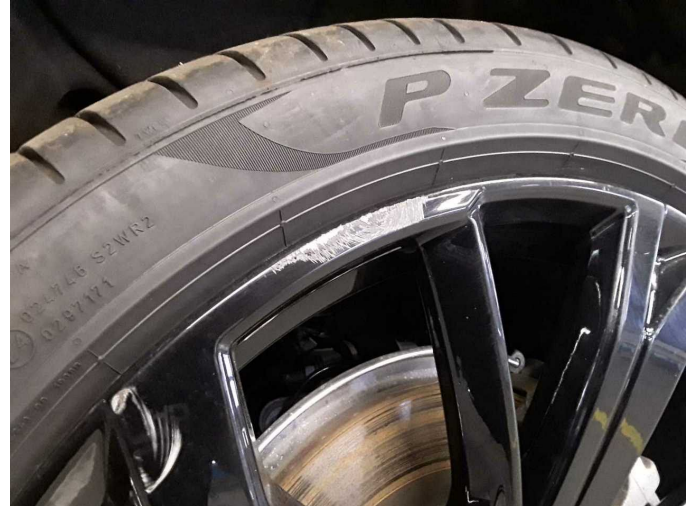
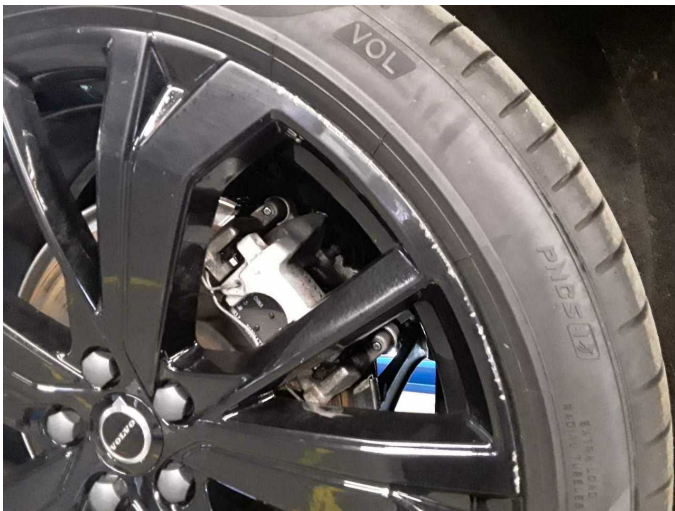
| No. | Component group | Description |
|---|---|---|
| 4 | Wheel / tyres | Alloy rim - rear right side (Materialabtrag) - Scratch(es) - Loss in value |

**Damage 4:** Wheel / tyres: Alloy rim - rear right side (Materialabtrag) - Scratch(es) - Loss in value

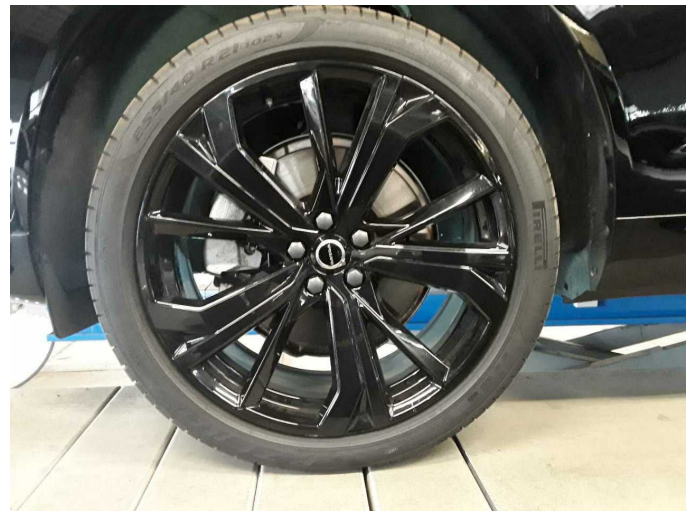
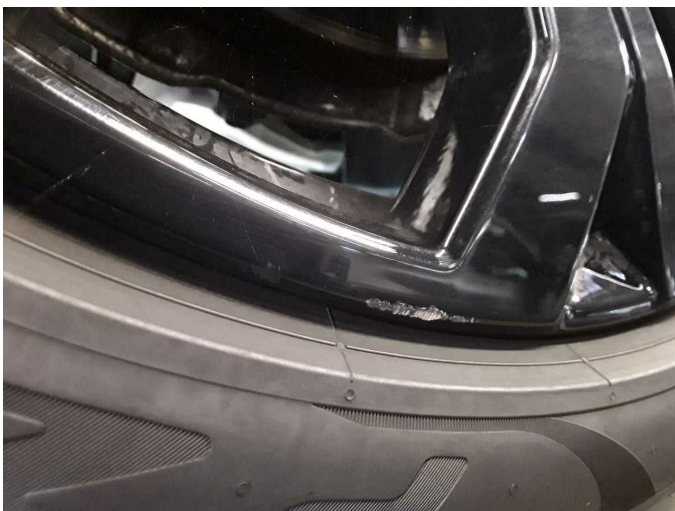
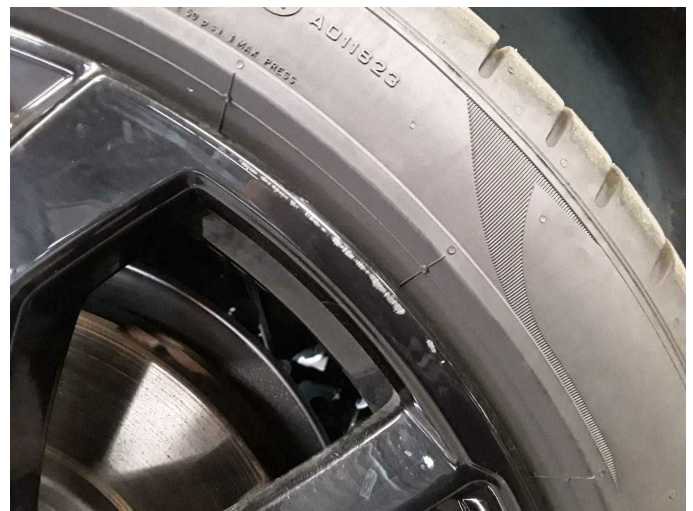
| No. | Component group | Description |
|---|---|---|
| 5 | Wheel / tyres | Alloy rim - front left side - Scratch(es) - Loss in value |

**Damage 5:** Wheel / tyres: Alloy rim - front left side - Scratch(es) - Loss in value

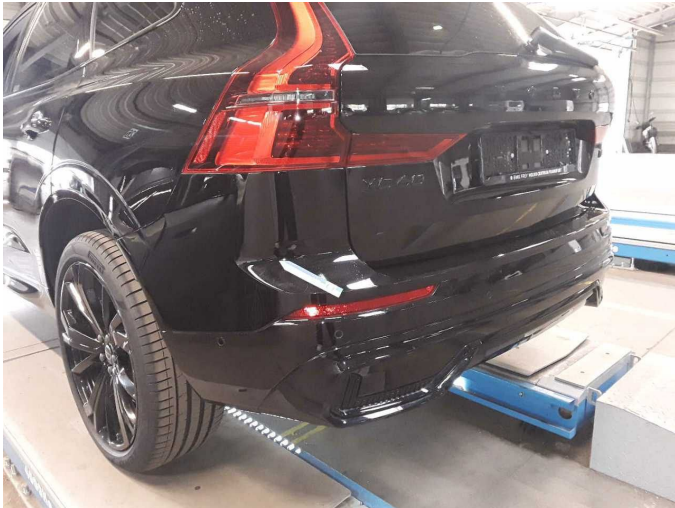
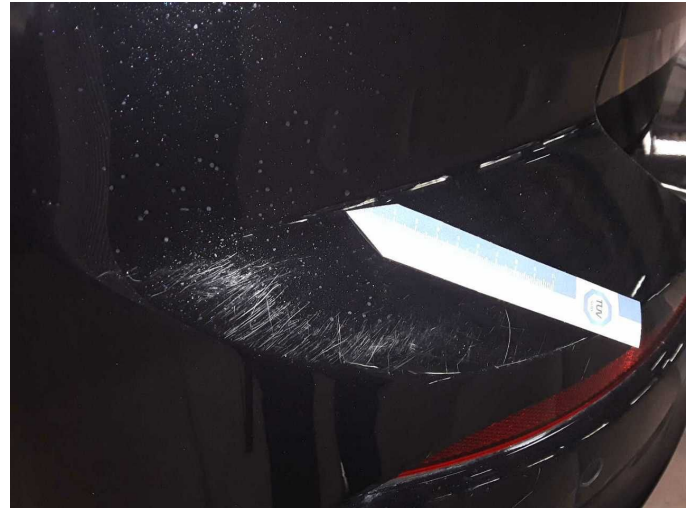
| No. | Component group | Description |
|---|---|---|
| 6 | Rear bumper | Rear bumper - Scratch(es) - Paint |

**Damage 6:** Rear bumper: Rear bumper - Scratch(es) - Paint

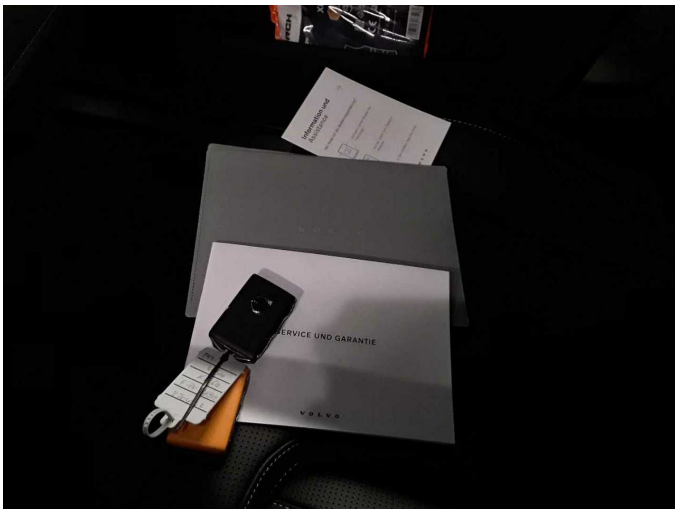
Documents - Log book

**Missing part 1:** Documents: Log book - Missing - Replace
