Protocol number: 45483134
Order No. / Reference: 26366876
Inspection date: 18 May 2026

Manufacturer: Mercedes-Benz

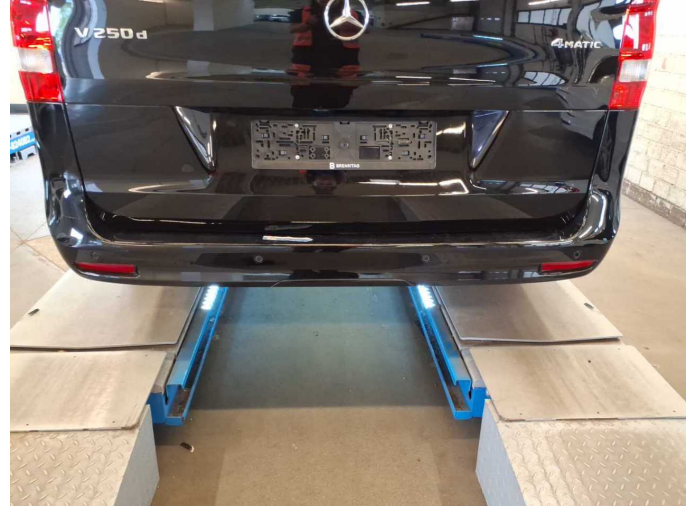
Damage 1: Rear bumper: Rear bumper - Scratched - Paint

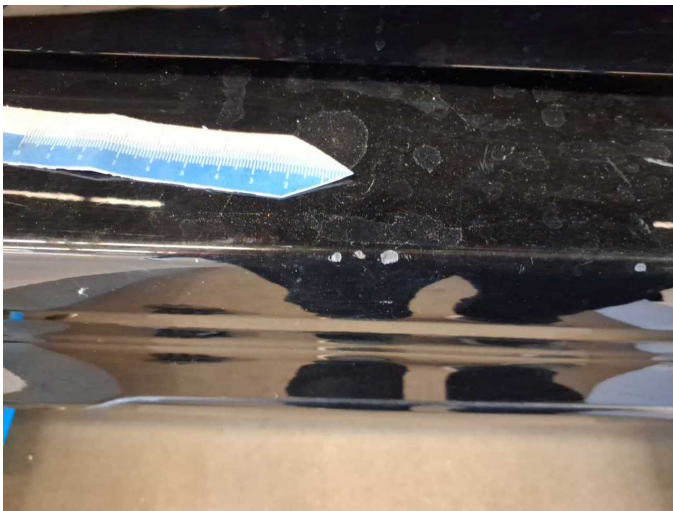
Damage 1: Rear bumper: Rear bumper - Scratched - Paint

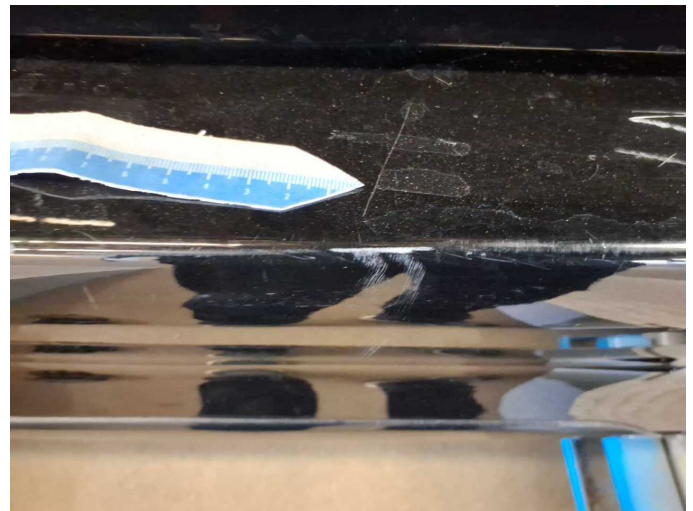
Damage 1: Rear bumper: Rear bumper - Scratched - Paint

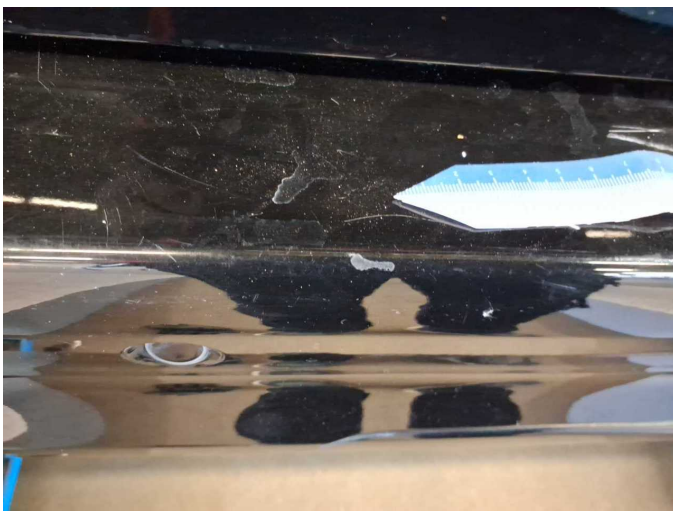
Damage 1: Rear bumper: Rear bumper - Scratched - Paint

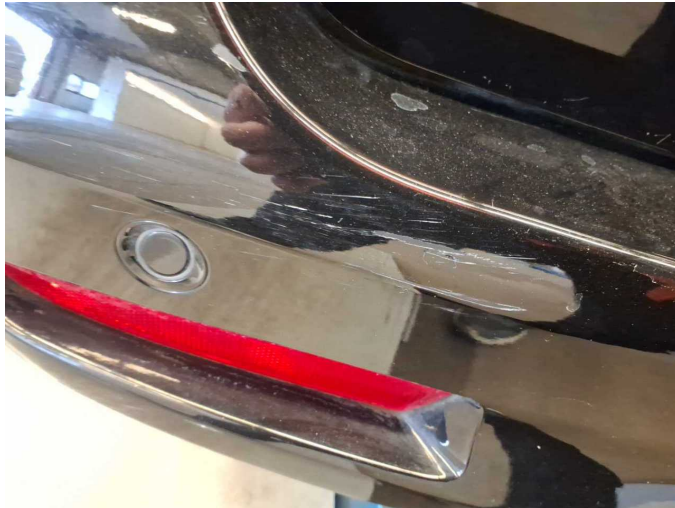
Damage 1: Rear bumper: Rear bumper - Scratched - Paint

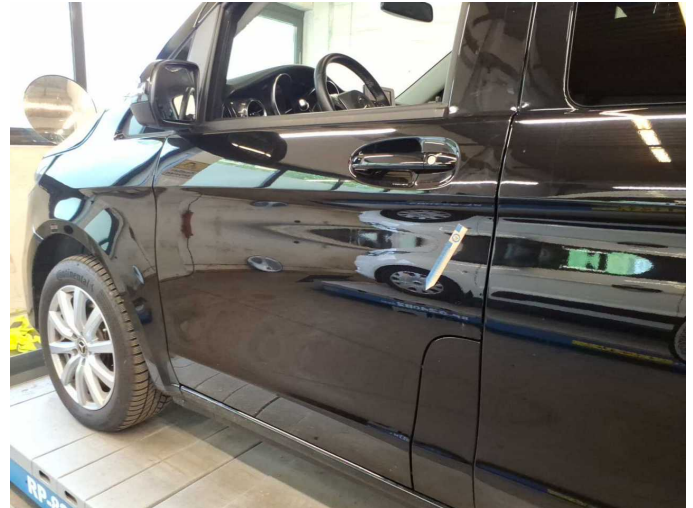
Damage 2: Door - front left side: Door - Dent / paintcoat damage - Repair and paint

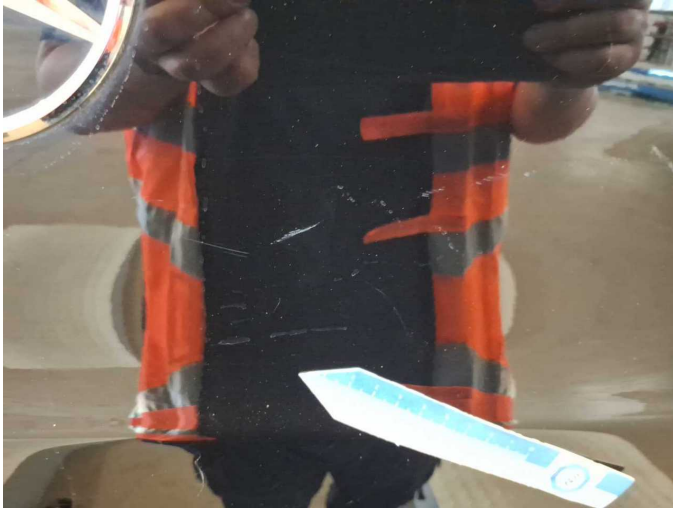
Damage 3: Boot lid / rear door: Boot lid - Scratched - Paint

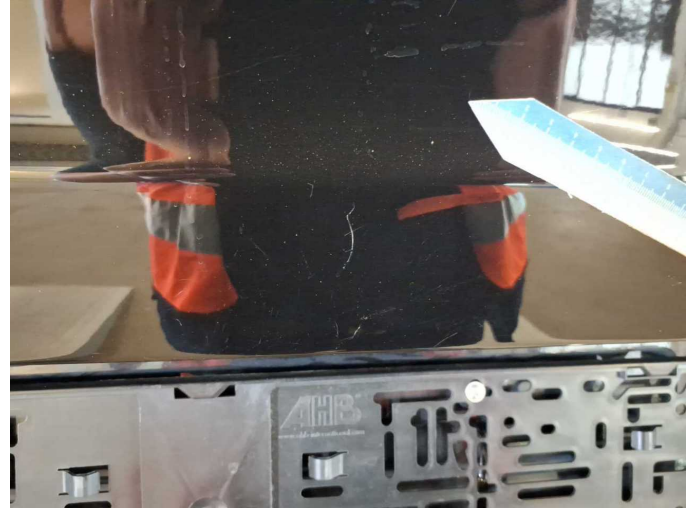
Damage 3: Boot lid / rear door: Boot lid - Scratched - Paint

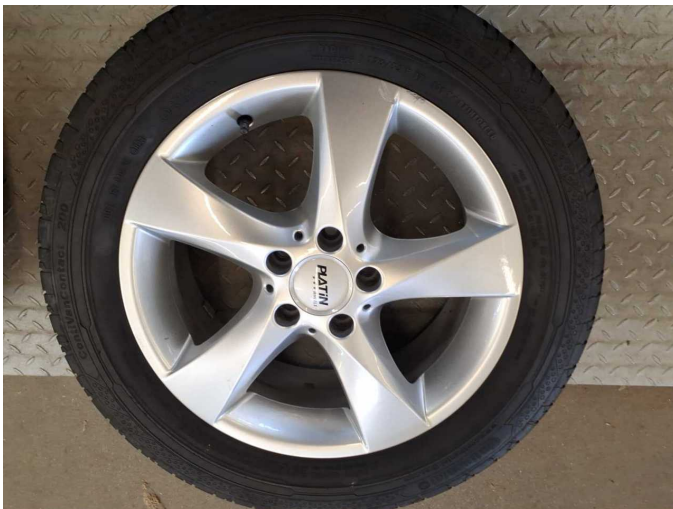
Wear and tear 1: 2nd wheel set: 2 alloy rims - Scratched - No deduction

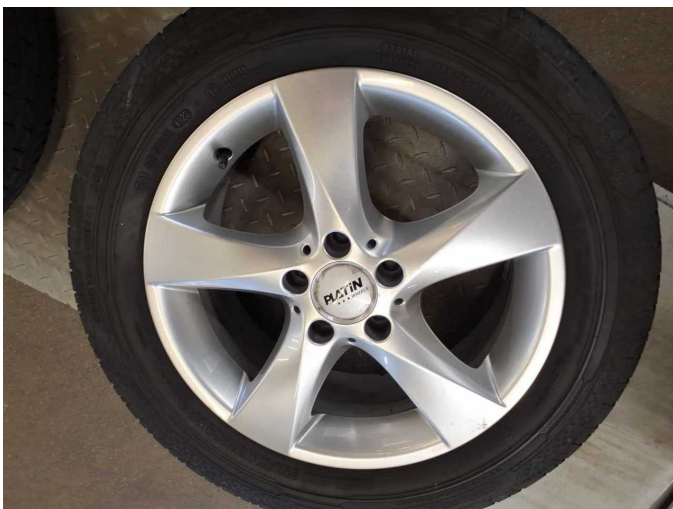
Wear and tear 1: 2nd wheel set: 2 alloy rims - Scratched - No deduction

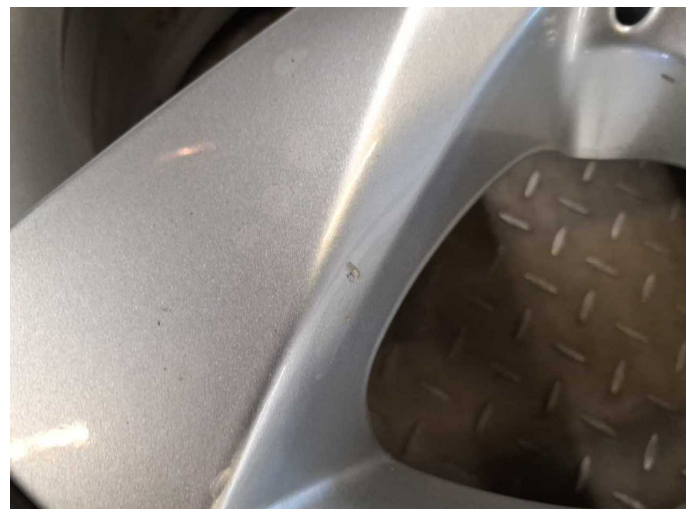
Wear and tear 1: 2nd wheel set: 2 alloy rims - Scratched - No deduction

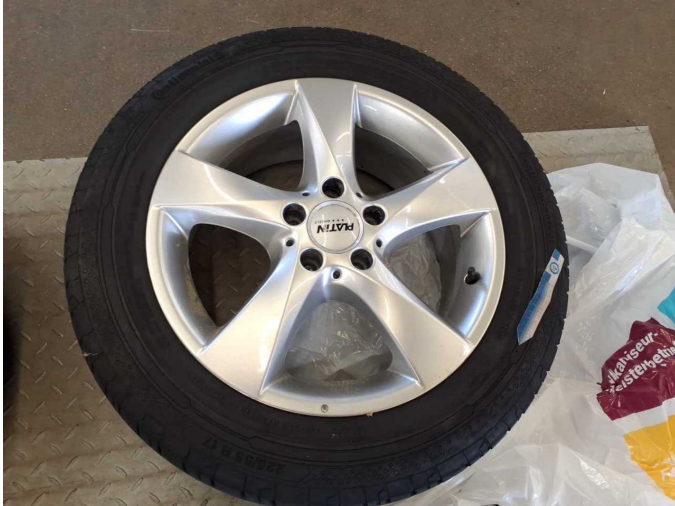
Wear and tear 2: 2nd wheel set: 3 tyres (225.55.17 Sommer) - Broken / torn - No deduction

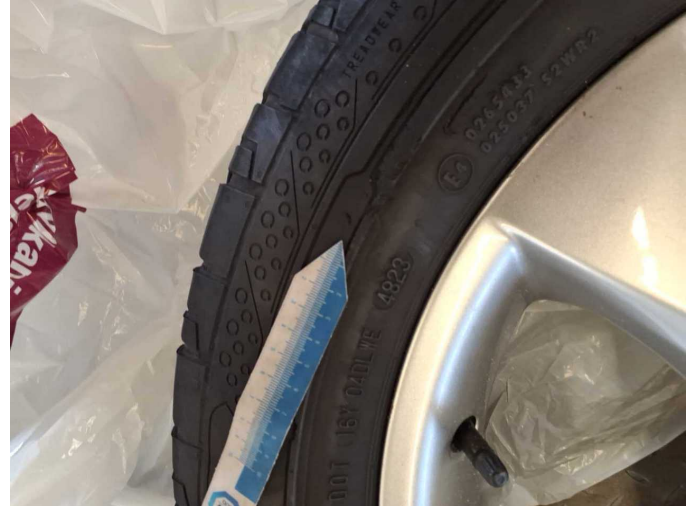
Wear and tear 2: 2nd wheel set: 3 tyres (225.55.17 Sommer) - Broken / torn - No deduction

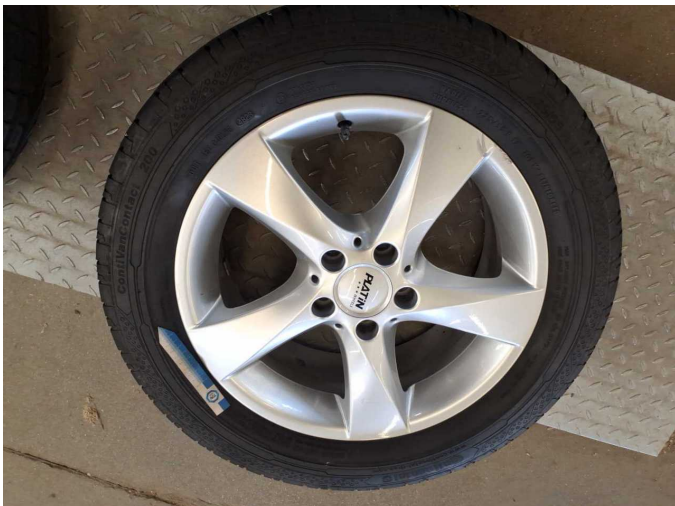
Wear and tear 2: 2nd wheel set: 3 tyres (225.55.17 Sommer) - Broken / torn - No deduction

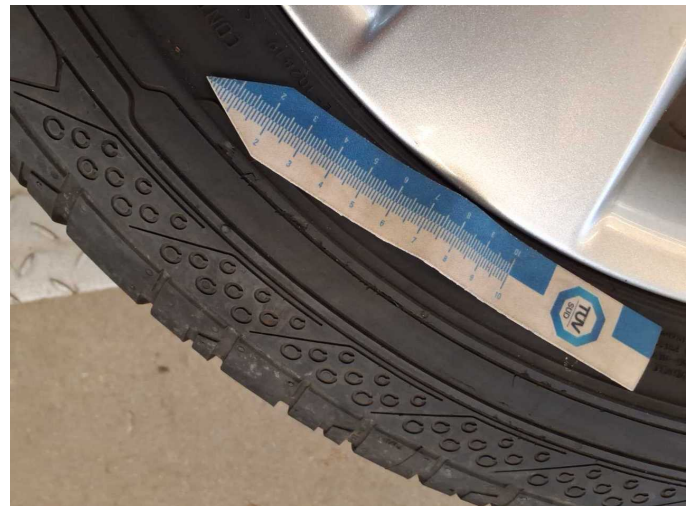
Wear and tear 2: 2nd wheel set: 3 tyres (225.55.17 Sommer) - Broken / torn - No deduction

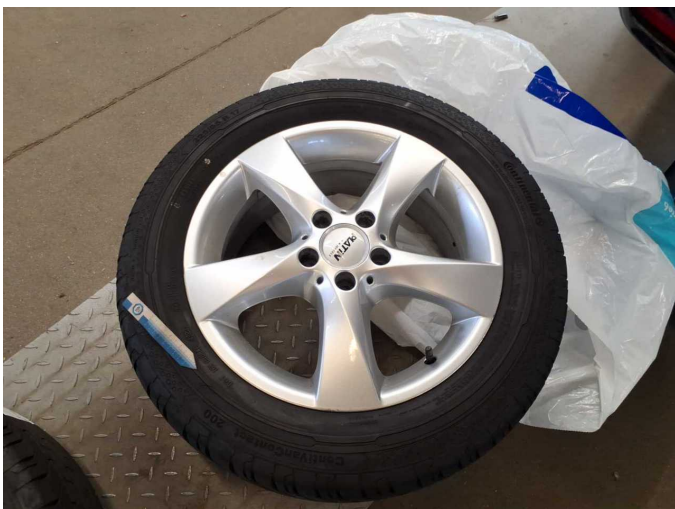
Wear and tear 2: 2nd wheel set: 3 tyres (225.55.17 Sommer) - Broken / torn - No deduction

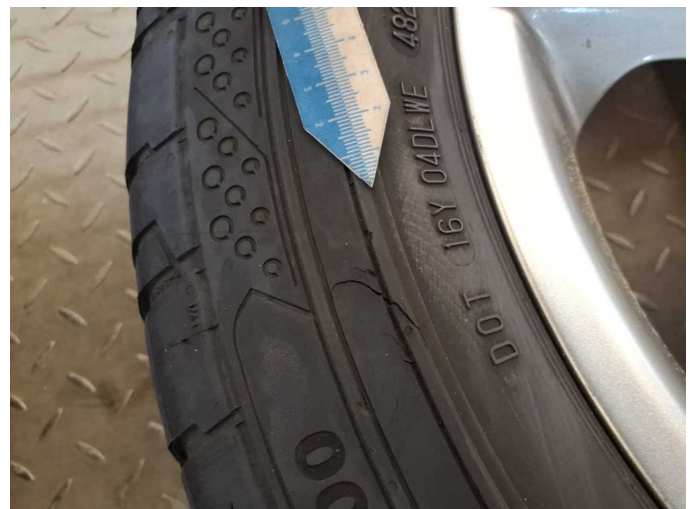
Wear and tear 2: 2nd wheel set: 3 tyres (225.55.17 Sommer) - Broken / torn - No deduction

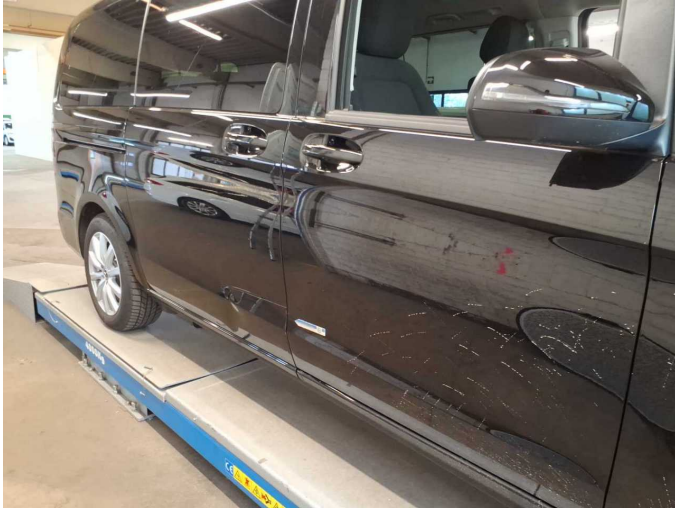
Accident 1: Side right
