Expertise

Protocol number: 46467162  
Order No. / Reference: 26664419  
Inspection date: 13 Jul 2026

| Manufacturer: Opel | Model: Insignia Sports Tourer 2.0 Diesel Aut. Business |
| VIN: W0VZT8EP2M1031582 | |

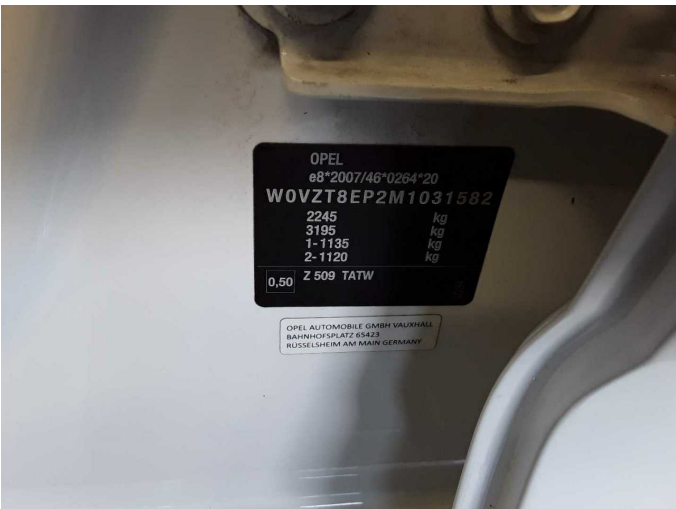
Figure 11: VIN

| VIN comparison | The vehicle identification number (VIN) was read from the vehicle and its conformity with the submitted documents was confirmed by the undersigned during the inspection. |

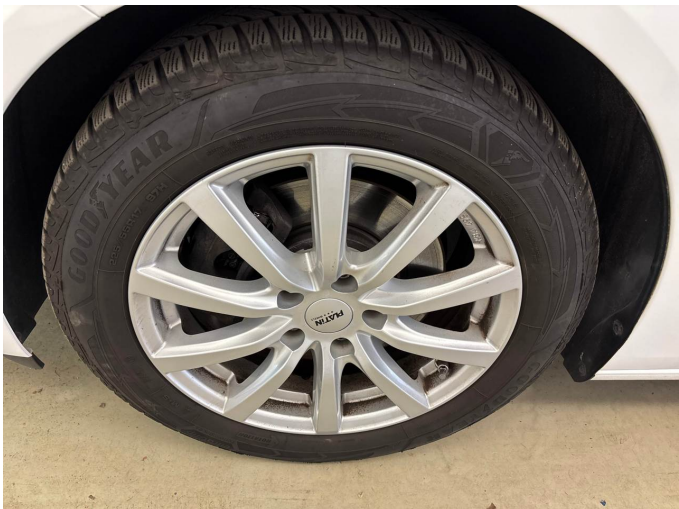
Figure 12: Mounted tyres

| Tyres | | | | |
|---|---|---|---|---|
| 1) | 225/55 R17 97H | Winter tyres on Light alloy | Goodyear | 5mm / 5mm |
| 2) | 225/55 R17 97H | Winter tyres on Light alloy | Goodyear | 5mm / 5mm |

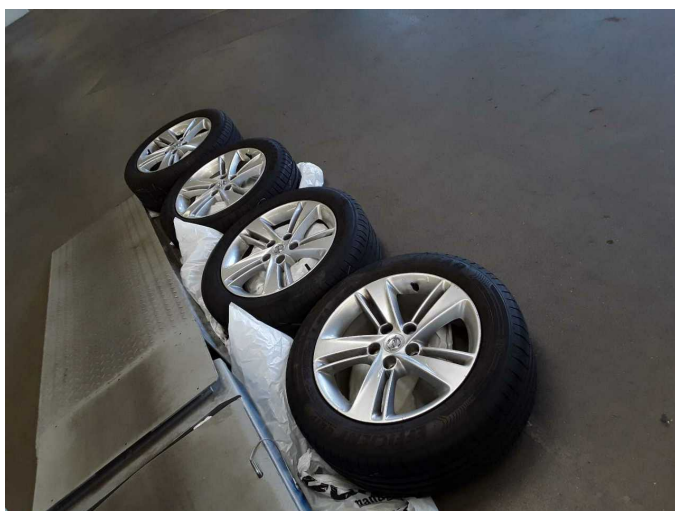
Figure 17: Additional tyres

| Tyres | | | | |
|---|---|---|---|---|
| 1) | 225/55 R17 97Y | Summer tyres on Light alloy | Dunlop | 3mm / 3mm |
| 2) | 225/55 R17 97Y | Summer tyres on Light alloy | Dunlop | 5mm / 5mm |

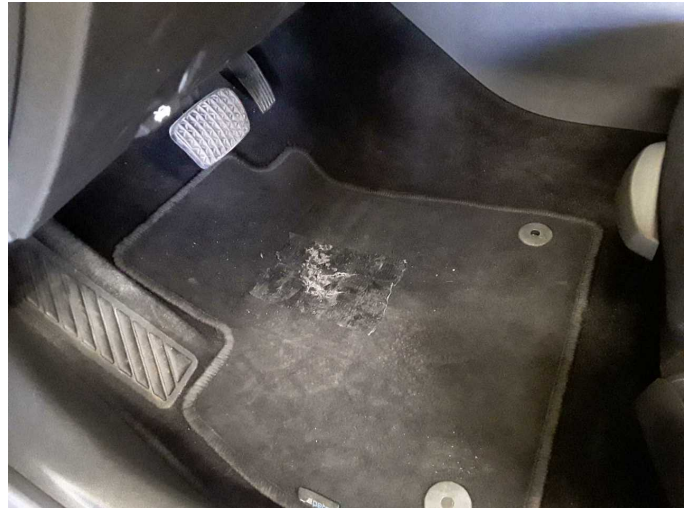
| No. | Component group | Description |
|---|---|---|
| 1 | Trim / covers | Floor mats - Damaged - Replace |

**Damage 1:** Trim / covers: Floor mats - Damaged - Replace

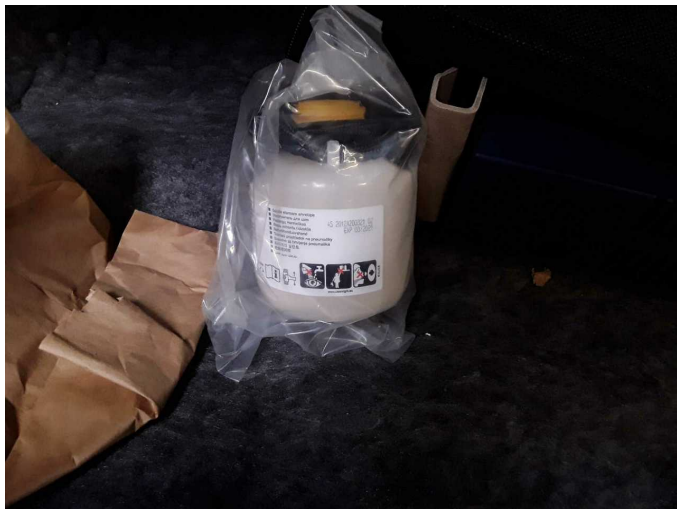
| Tyres | | | | |
|---|---|---|---|---|
| | Tirefit | Expiration date 03/2025 | | |

| No. | Component group | Description |
|---|---|---|
| 2 | Equipment | Tirefit filler - Expired - Replace |

**Damage 2:** Equipment: Tirefit filler - Expired - Replace

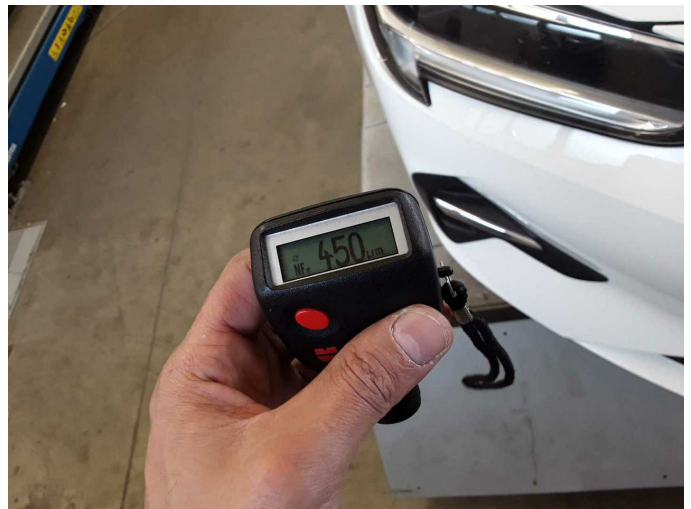
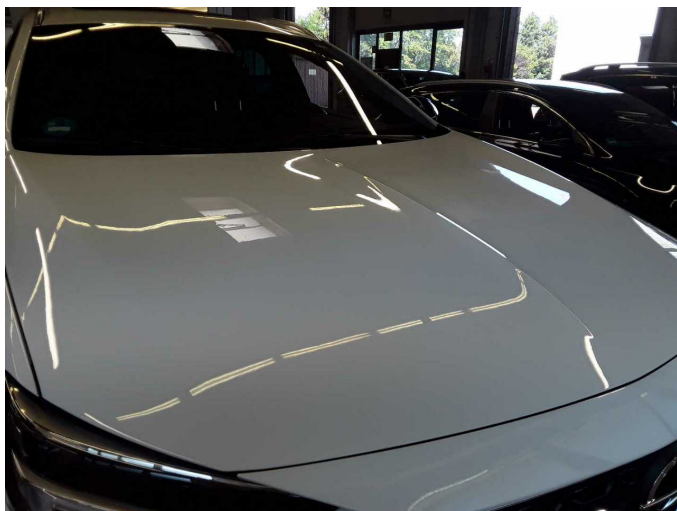
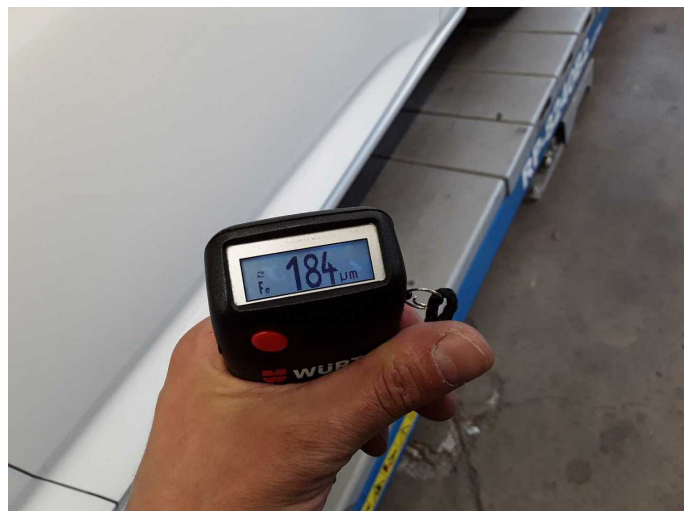
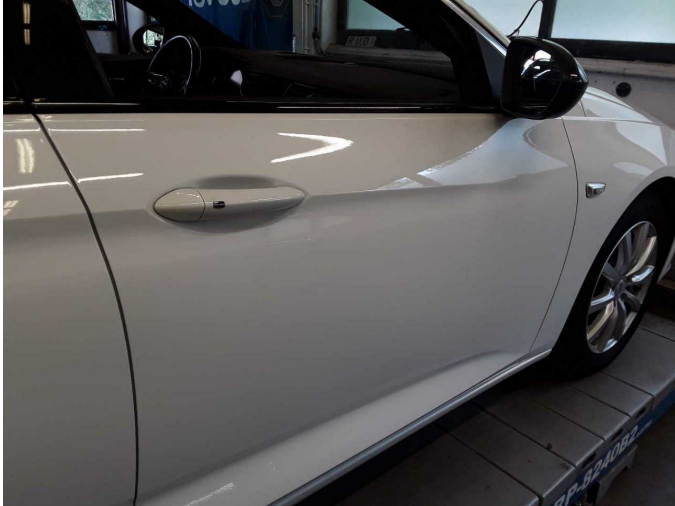
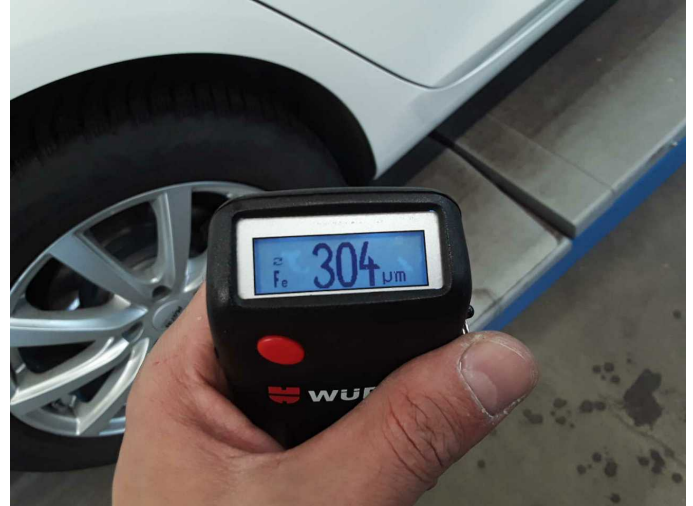
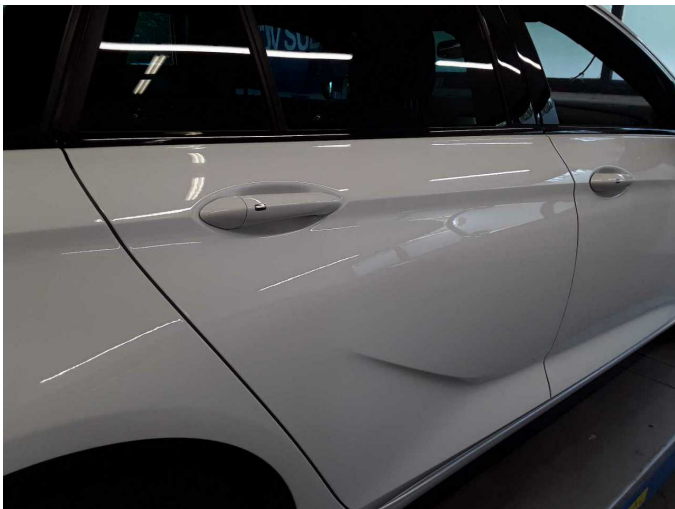
| No. | Repainting |
|---|---|
| 1 | Boot lid / rear door, Bonnet, Side panel - rear right side, Door - rear left side, Door - rear right side, Door - front right side, Professionally carried out, Invoice of repair done Non-existent |

| Boot lid / rear door | 261 µm | Bonnet | 450 µm |
| Side panel - rear right side | 270 µm | Door - rear left side | 180 µm |
| Door - rear right side | 304 µm | Door - front right side | 184 µm |

**Repainting 1:** Boot lid / rear door, Bonnet, Side panel - rear right side, Door - rear left side, Door - rear right side, Door - front right side

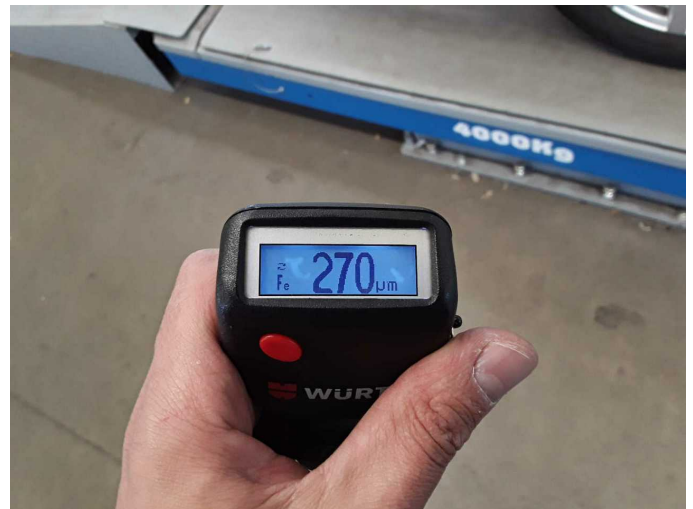
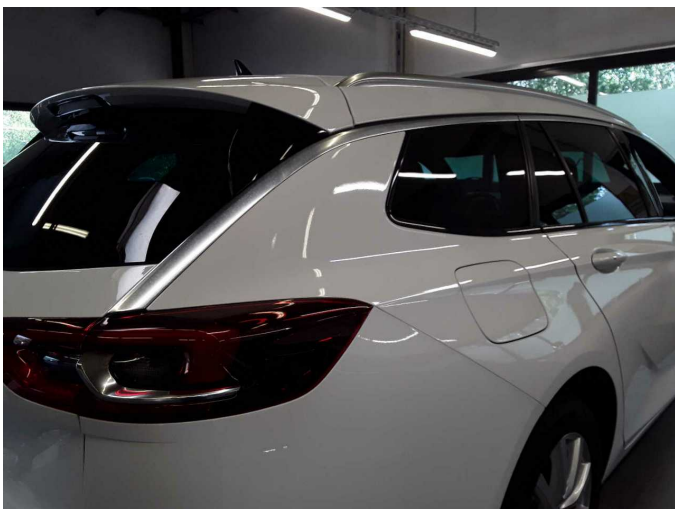
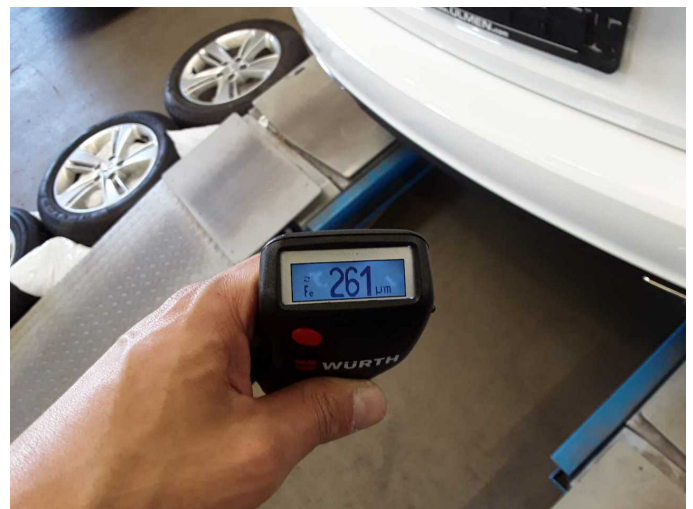
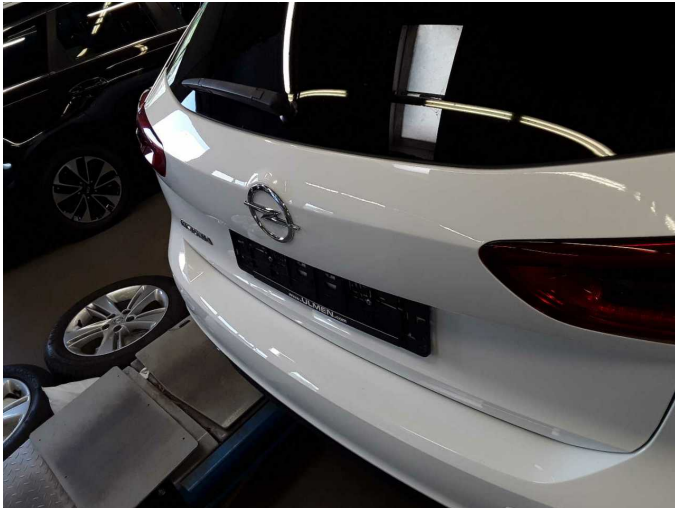
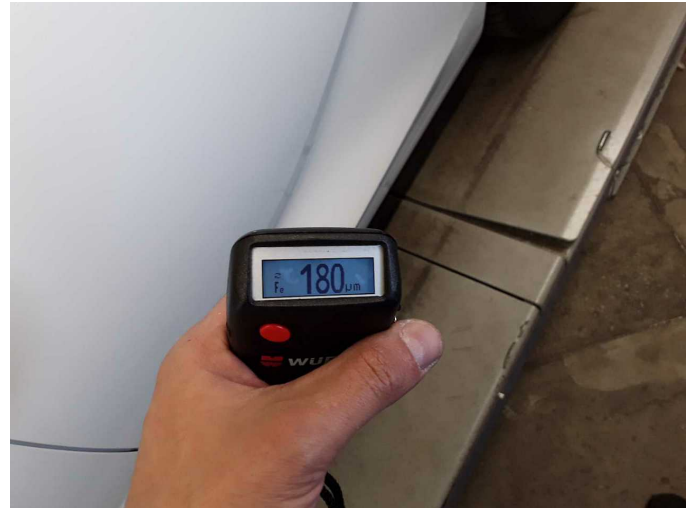
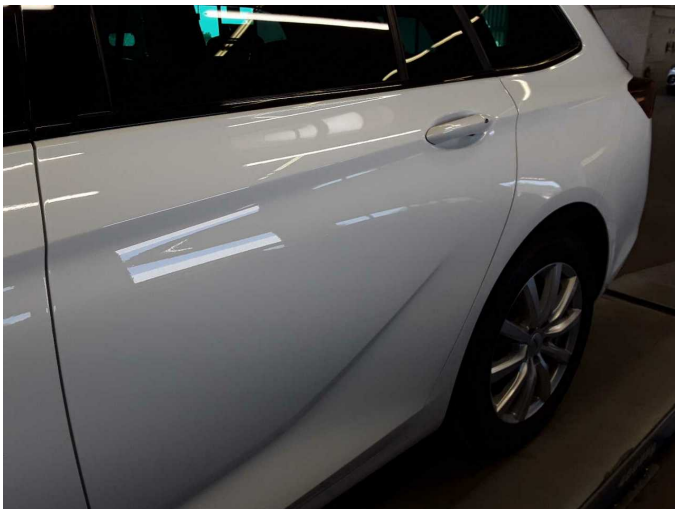
**Repainting 1:** Boot lid / rear door, Bonnet, Side panel - rear right side, Door - rear left side, Door - rear right side, Door - front right side
