Expertise

Protocol number: 46274240  
Order No. / Reference: 26568747  
Inspection date: 1 Jul 2026

Manufacturer: Audi  
VIN: WAUZZZFY3M2095448

Model: Q5 40 TDI quattro S tronic

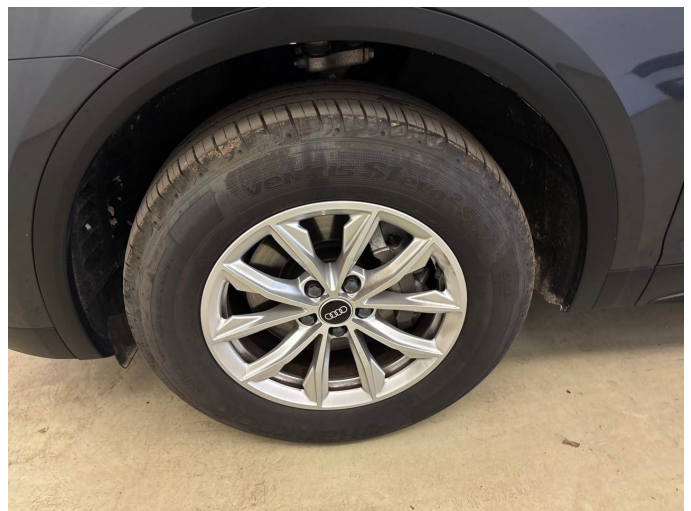
Figure 12: Mounted tyres

| # | Tyre size | Type of tyre | Manufacturer | Tread depth |
|---|---|---|---|---|
| 1) | 235/65 R17 104W | Summer tyres on Light alloy | Hankook | 4mm / 4mm |
| 2) | 235/65 R17 104W | Summer tyres on Light alloy | Hankook | 4mm / 4mm |

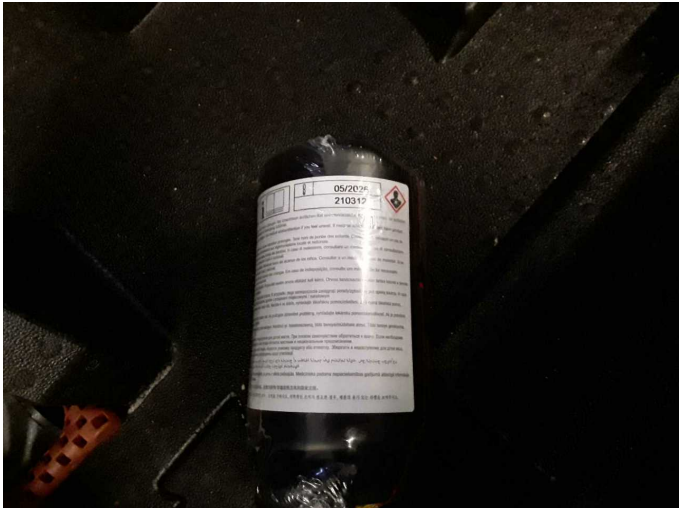
| No. | Component group | Description |
|---|---|---|
| 1 | Equipment | Tirefit filler - Expired - Replace |

Damage 1: Equipment: Tirefit filler - Expired - Replace

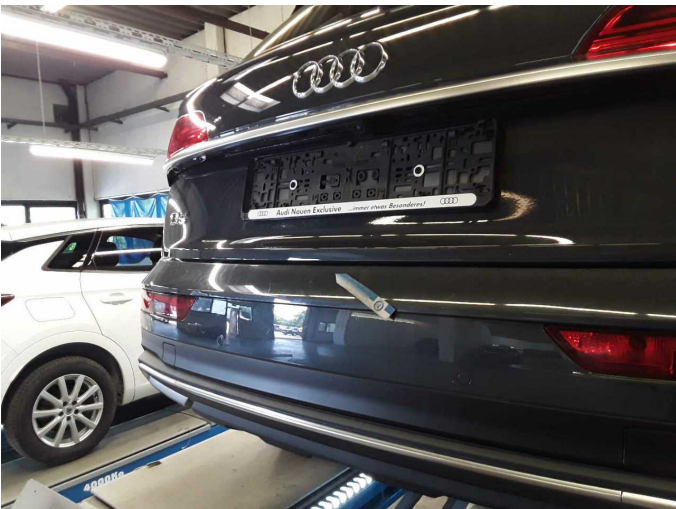
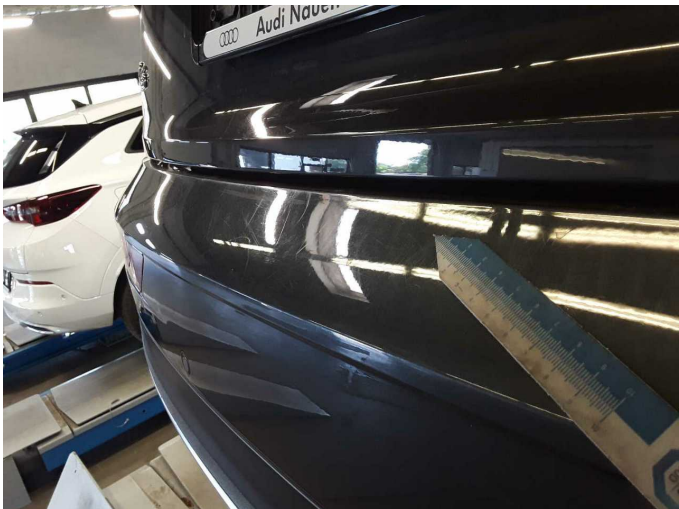
| No. | Component group | Description |
|---|---|---|
| 2 | Rear bumper | Rear bumper - Scratch(es) - Smart repair |

Damage 2: Rear bumper: Rear bumper - Scratch(es) - Smart repair

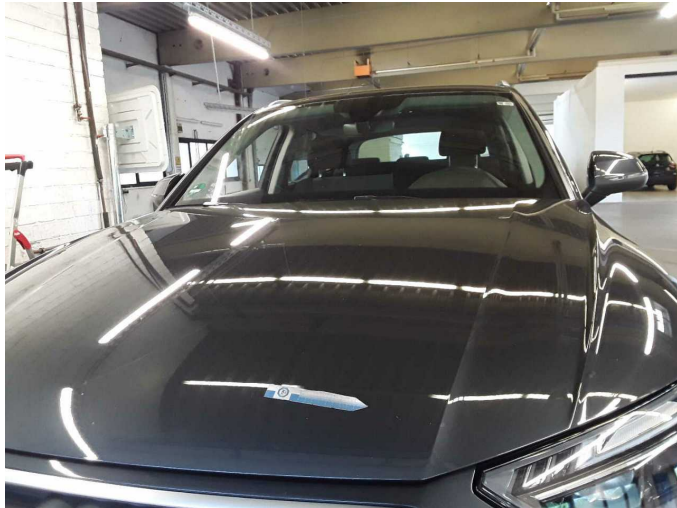
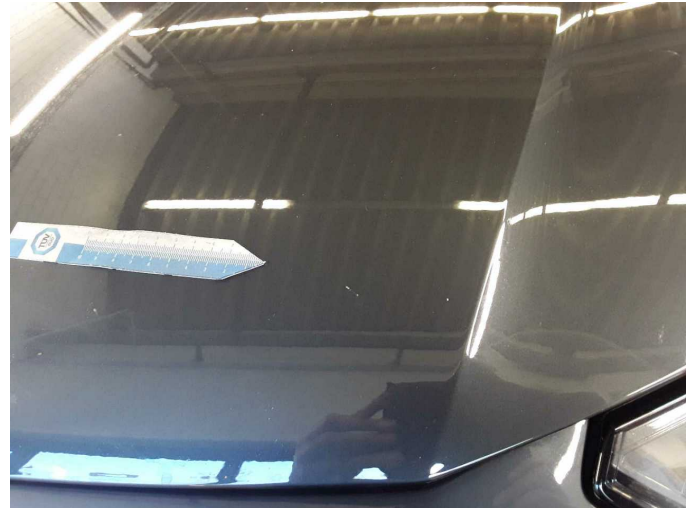
| No. | Component group | Description |
|---|---|---|
| 1 | Bonnet | Bonnet - Stone chips - No deduction |

**Wear and tear 1:** Bonnet: Bonnet - Stone chips - No deduction

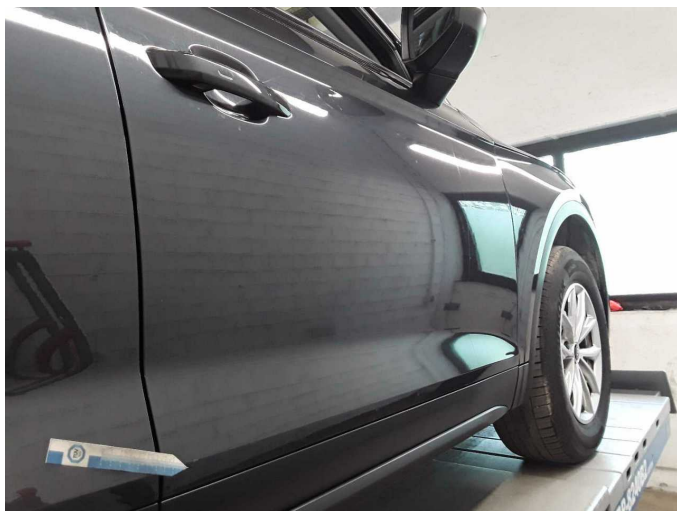
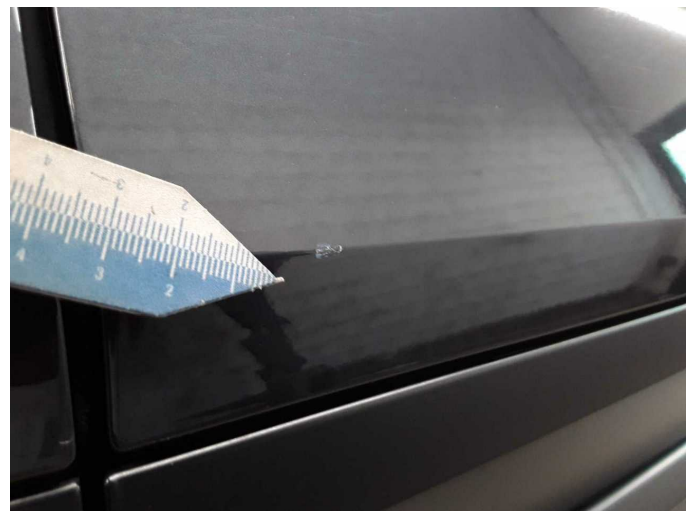
| No. | Component group | Description |
|---|---|---|
| 2 | Door - front right side | Door - Scratch(es) - No deduction |

**Wear and tear 2:** Door - front right side: Door - Scratch(es) - No deduction

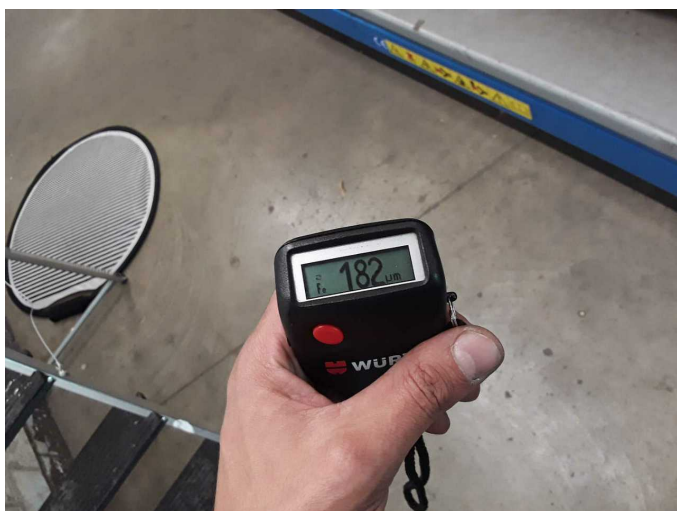
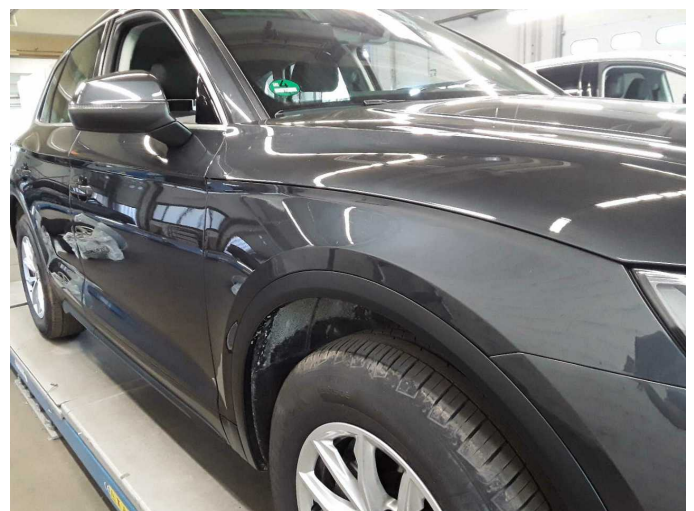
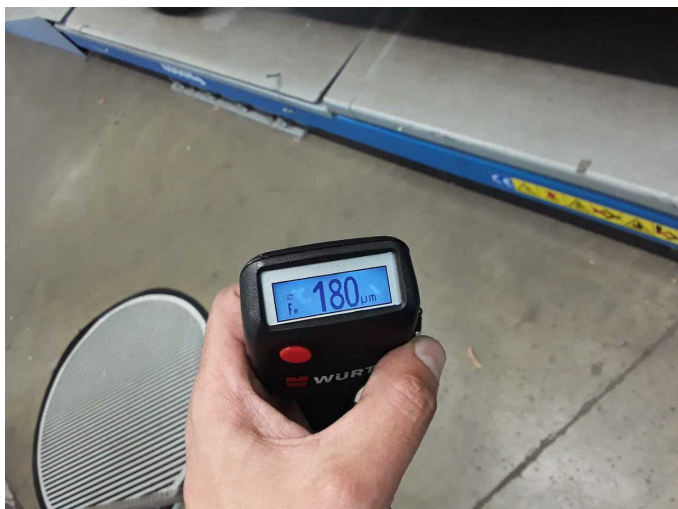
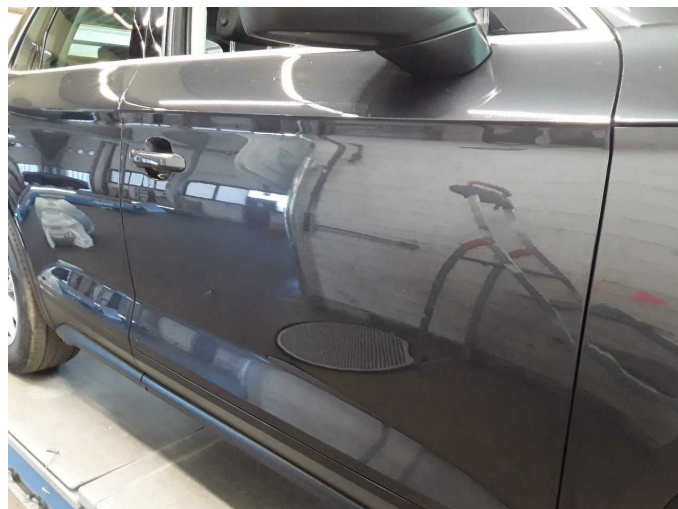
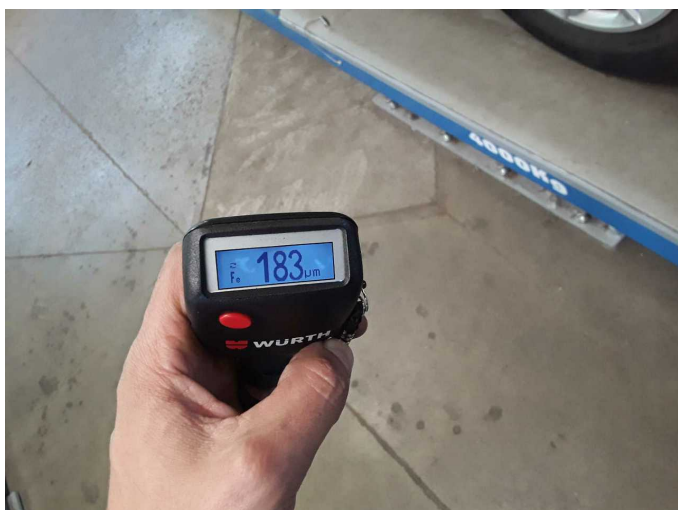
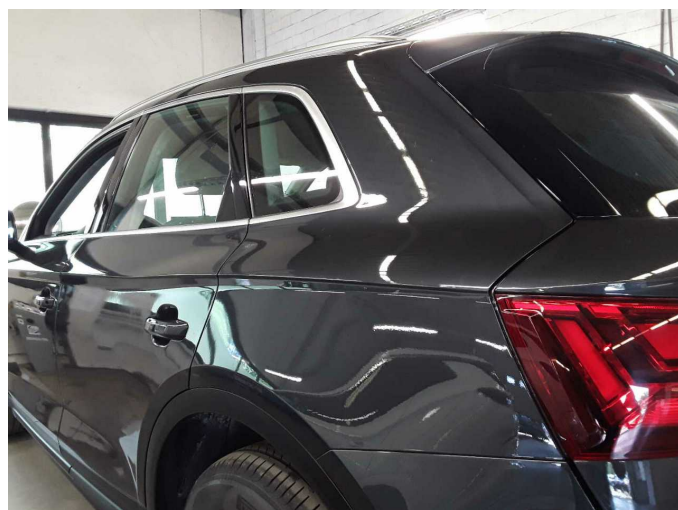
| No. | Repainting |
|---|---|
| 1 | Mudguard - right side, Side panel - rear left side, Door - rear left side, Door - front left side, Door - front right side, Professionally carried out, Invoice of repair done Non-existent |

**Repainting 1:** Mudguard - right side, Side panel - rear left side, Door - rear left side, Door - front left side, Door - front right side

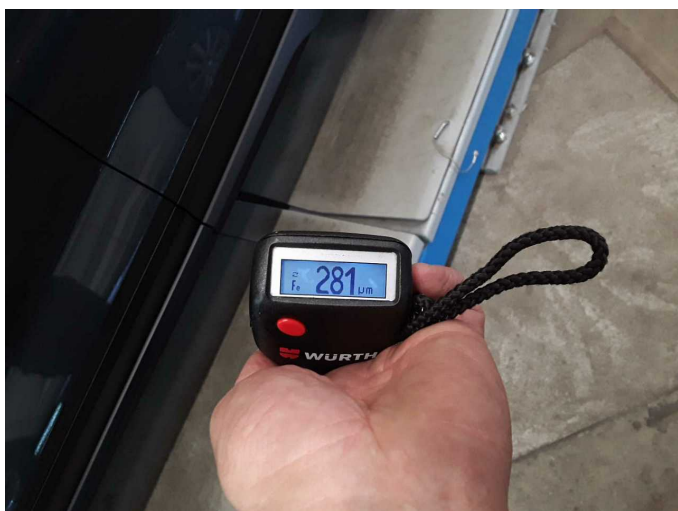
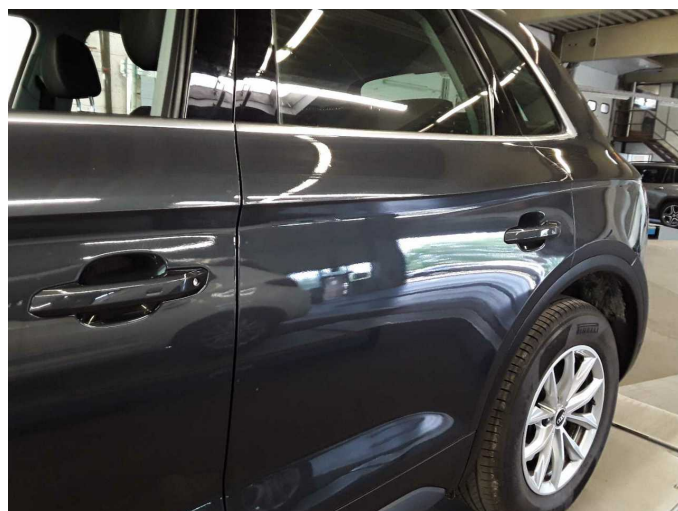
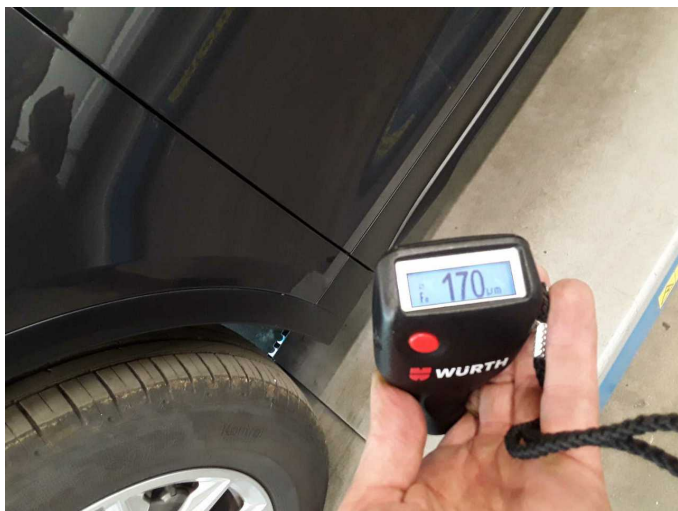
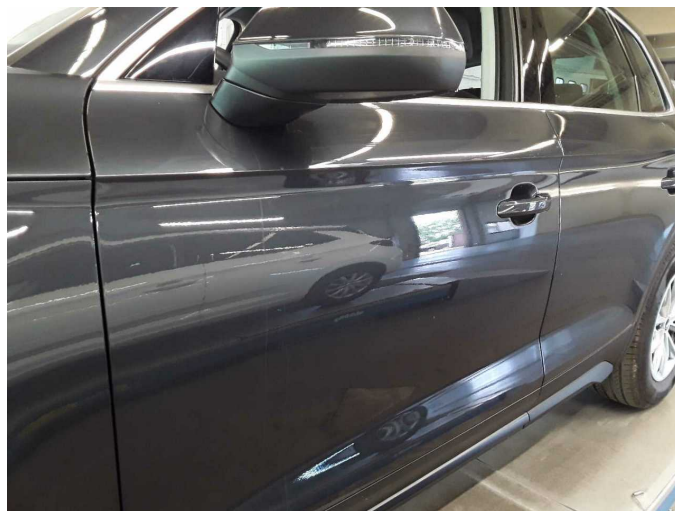
**Repainting 1:** Mudguard - right side, Side panel - rear left side, Door - rear left side, Door - front left side, Door - front right side
