Expertise

Protocol number: 46874822  
Order No. / Reference: 26741821  
Inspection date: 4 Aug 2026

| Manufacturer: Ford | Model: Focus Turnier 1.5 EcoBlue Start-Stopp-System Aut. TITANIUM |

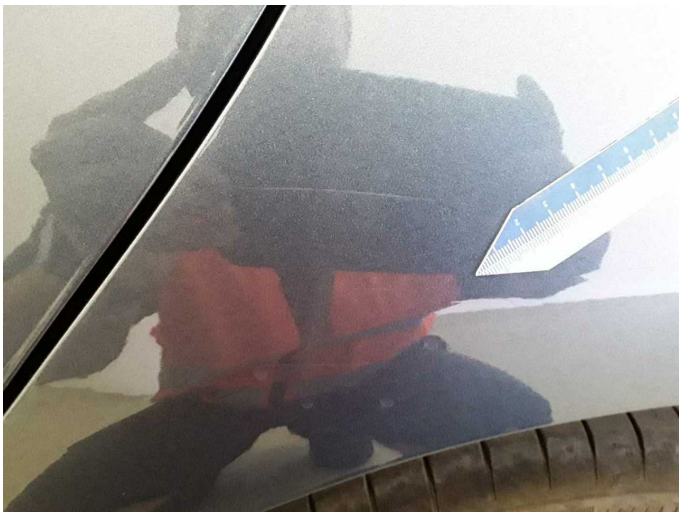
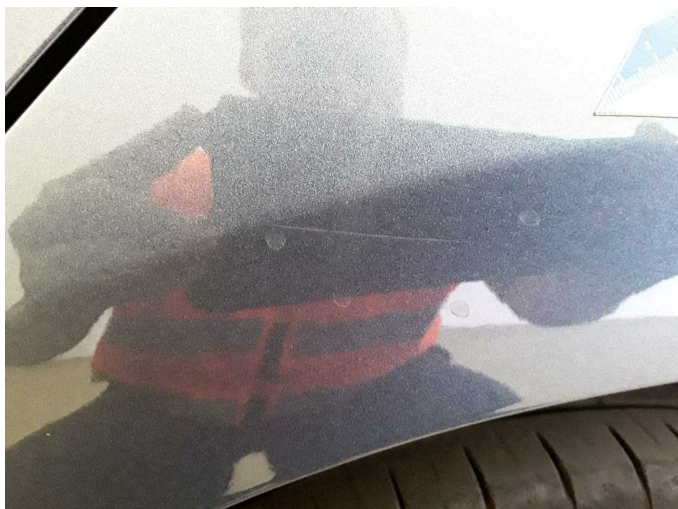
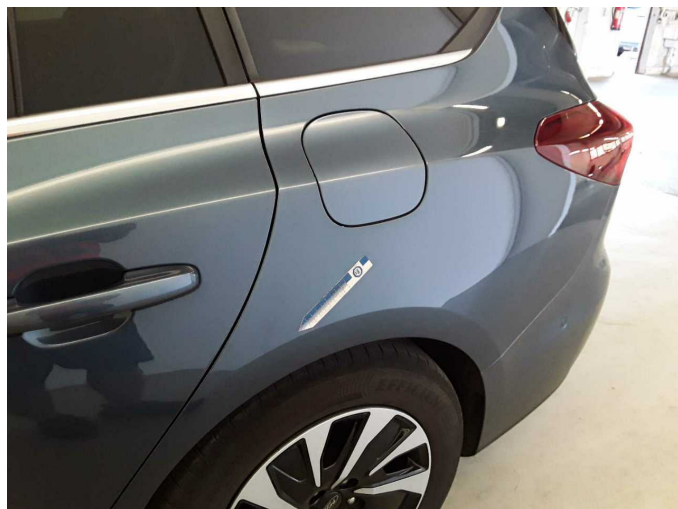
| No. | Component group | Description |
|---|---|---|
| 1 | Side panel - rear left side | Side panel - Scratch(es) - Cover / polish |

Damage 1: Side panel - rear left side: Side panel - Scratch(es) - Cover / polish

**Damage 1:** Side panel - rear left side: Side panel - Scratch(es) - Cover / polish

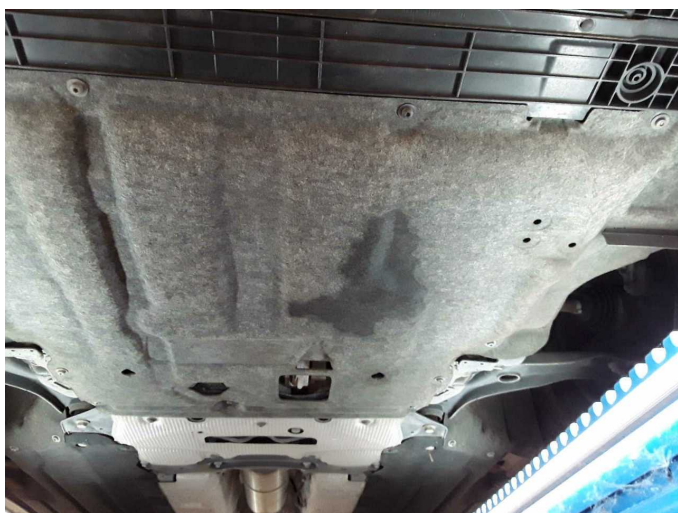
| No. | Component group | Description |
|---|---|---|
| 2 | Engine | Engine - Leaking - Perform diagnosis |

**Damage 2:** Engine: Engine - Leaking - Perform diagnosis

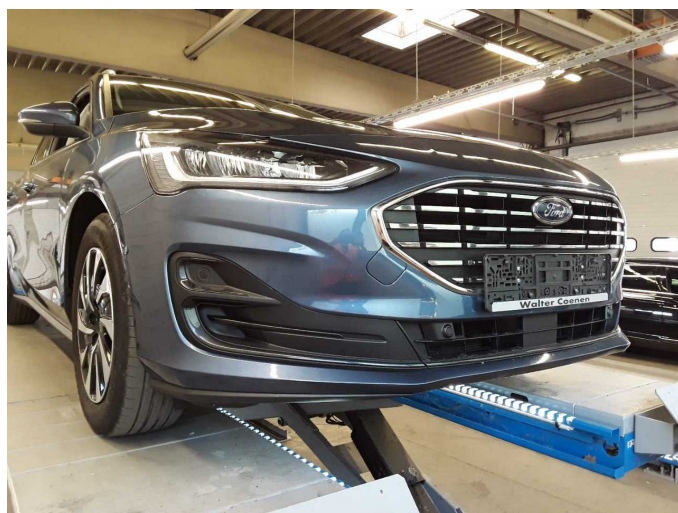
| No. | Component group | Description |
|---|---|---|
| 1 | Front bumper | Front bumper - Stone chips - No deduction |

**Wear and tear 1:** Front bumper: Front bumper - Stone chips - No deduction

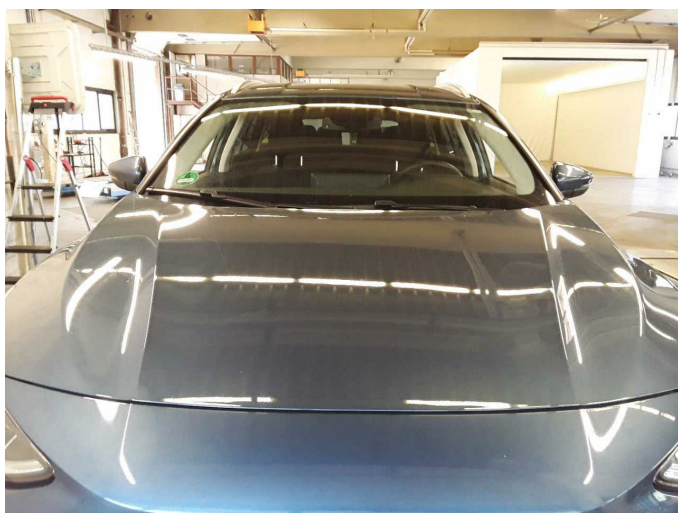
| No. | Component group | Description |
|---|---|---|
| 2 | Bonnet | Bonnet - Stone chips - No deduction |

**Wear and tear 2:** Bonnet: Bonnet - Stone chips - No deduction
