Expertise

Protocol number: 46782730  
Order No. / Reference: 26729162  
Inspection date: 30 Jul 2026

Manufacturer: Skoda  
VIN: TMBJW7NPXM7070281

Model: Superb Combi 1.4 TSI iV DSG Style

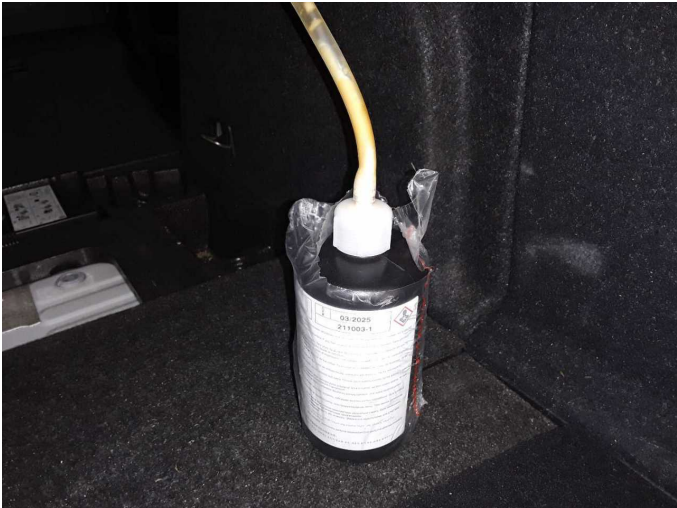
| No. | Component group | Description |
|---|---|---|
| 1 | Equipment | Tirefit filler - Empty - Replace |

Damage 1: Equipment: Tirefit filler - Empty - Replace

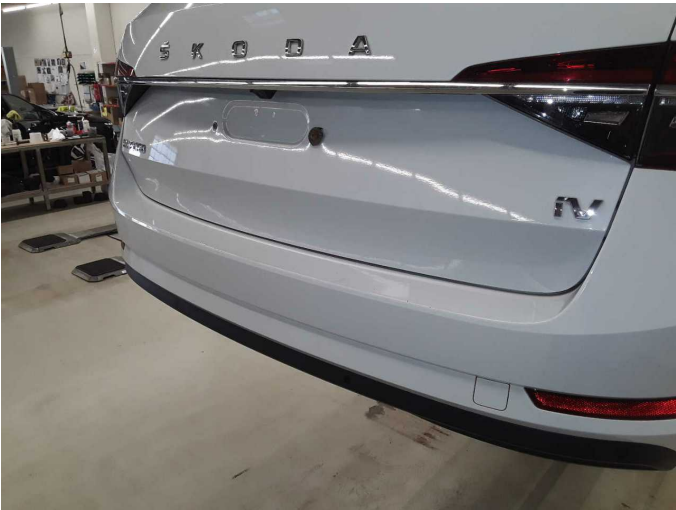
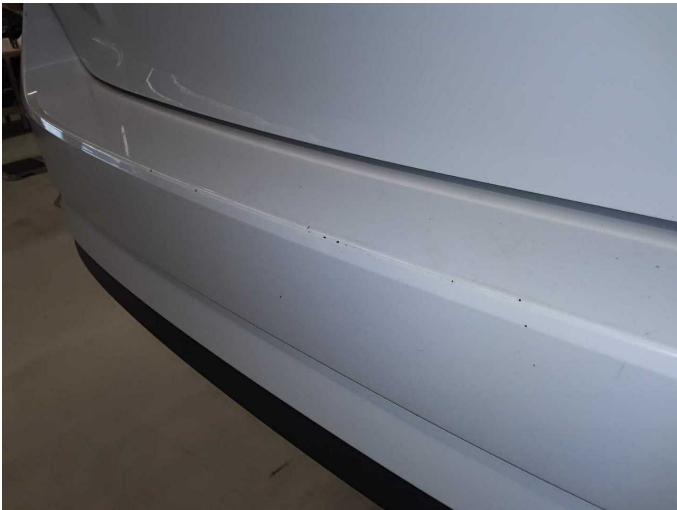
| No. | Component group | Description |
|---|---|---|
| 1 | Rear bumper | Rear bumper - Scratch(es) - No deduction |

Wear and tear 1: Rear bumper: Rear bumper - Scratch(es) - No deduction

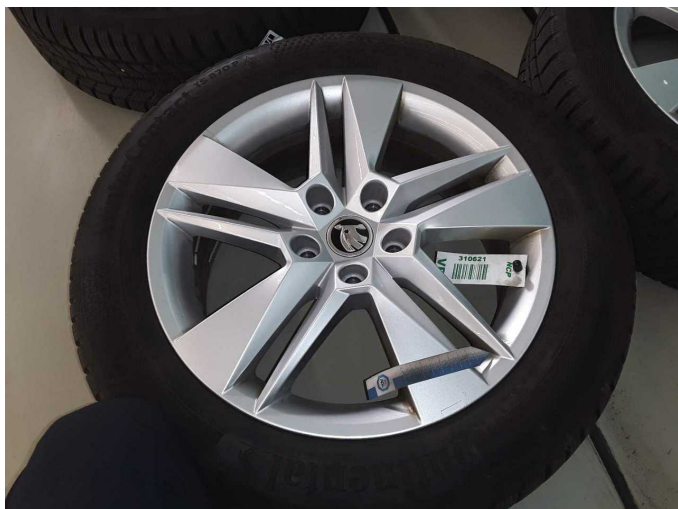
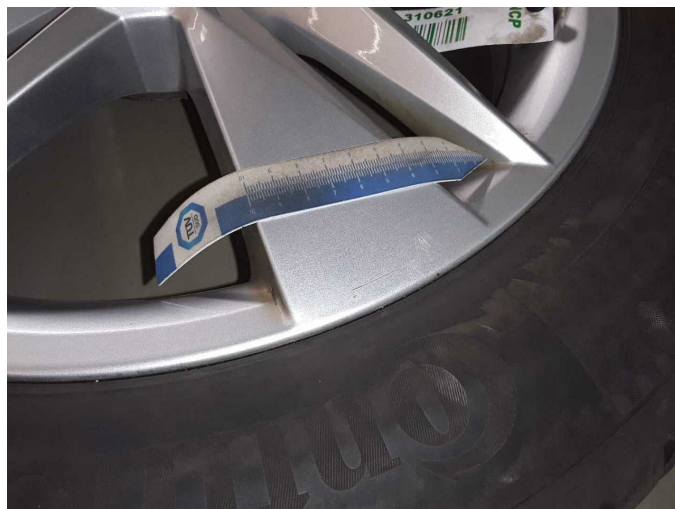
| No. | Component group | Description |
|---|---|---|
| 2 | 2nd wheel set | 1 alloy rim - Scratch(es) - No deduction |

**Wear and tear 2:** 2nd wheel set: 1 alloy rim - Scratch(es) - No deduction

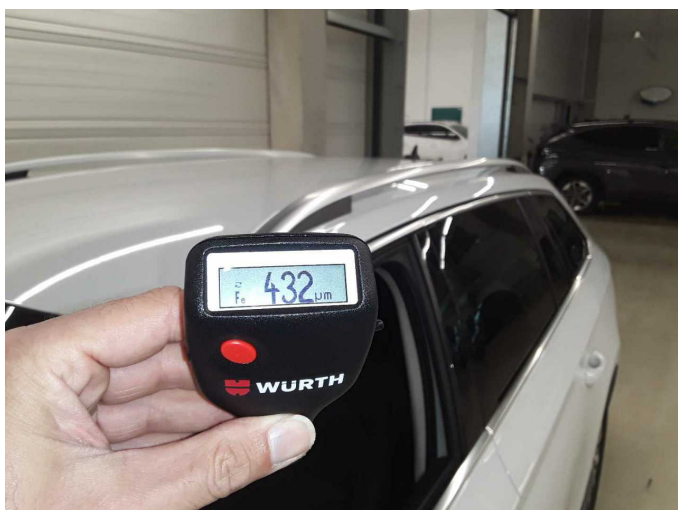
| Roof rail - left side | 432 µm | Mudguard - left side | 172 µm |

**Roof rail - left side:** 432 µm

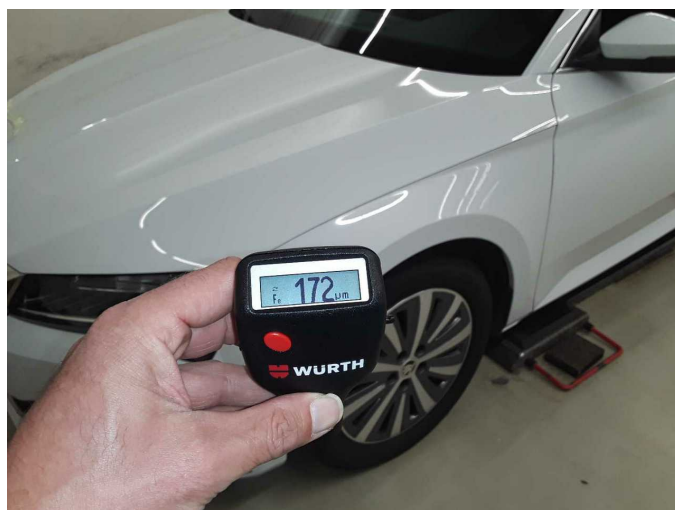
**Mudguard - left side:** 172 µm

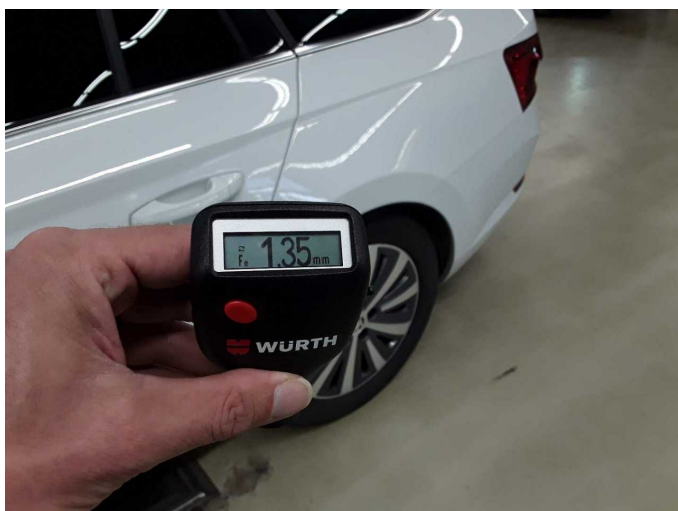
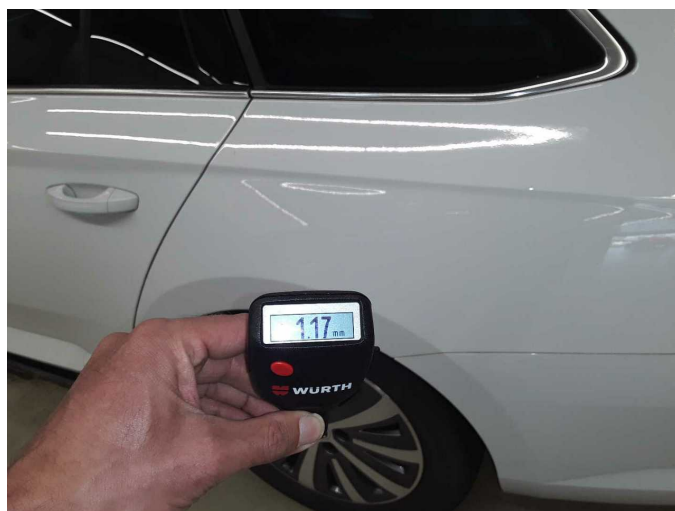
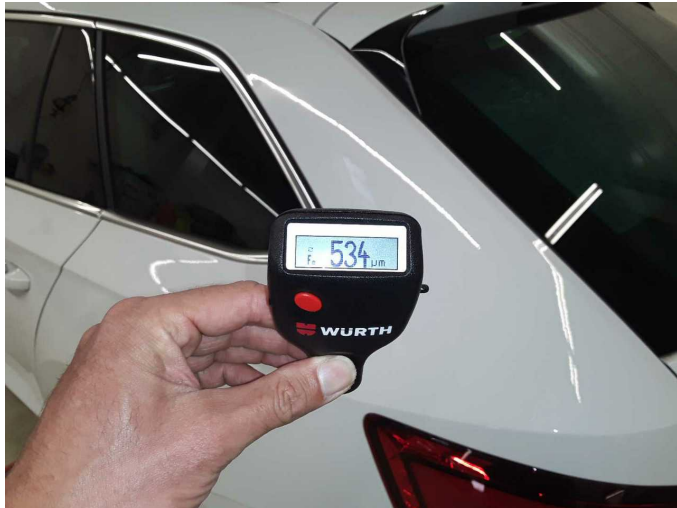
| Side panel - rear left side | 1,350 µm | Door - rear left side | 522 µm |

**Side panel - rear left side:** 1,350 µm

Side panel - rear left side: 1,350 µm

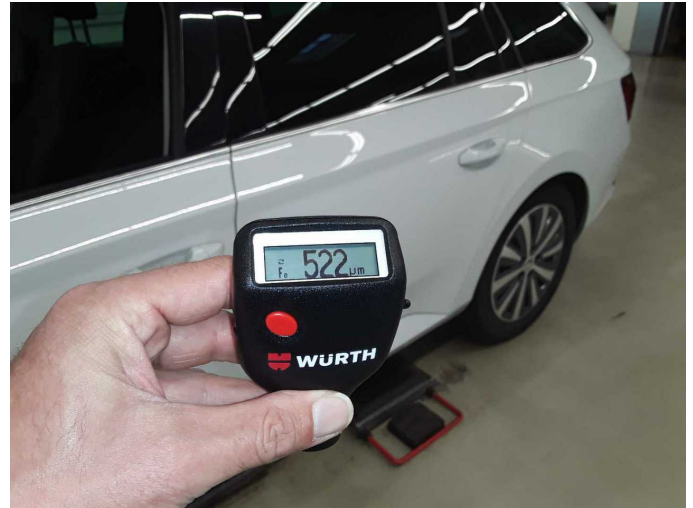
Door - rear left side: 522 µm

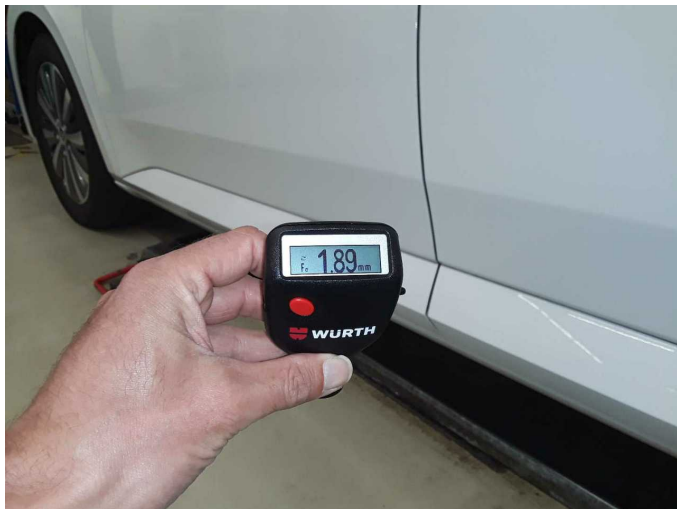
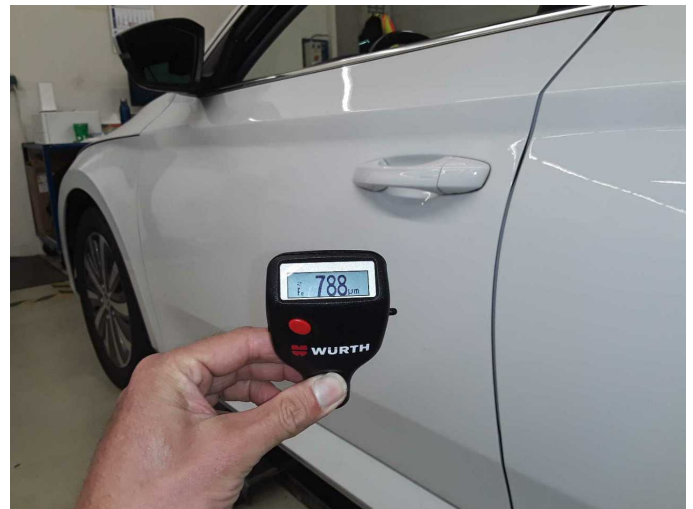
| Door - front left side | 1,890 µm | | |

Door - front left side: 1,890 µm
