Expertise

Protocol number: 46385404  
Order No. / Reference: 26612076  
Inspection date: 8 Jul 2026

Manufacturer: Volkswagen

Model: Multivan T7 2,0 TSI OPF KÜ Life

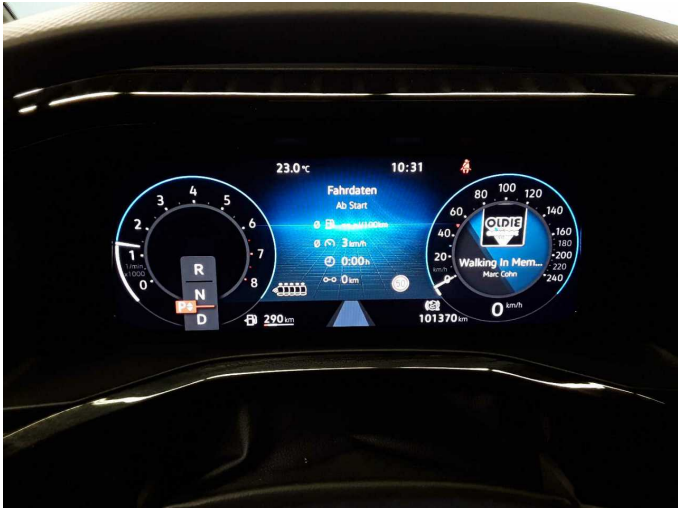
Figure 7: Instrument cluster

**Vehicle Identification number** WV2ZZZST4PH012867  
**Mileage (Read)** 101,370 km  
**First registration** 16 May 2023  
**Number of holders** 1  
**Next periodical technical inspection** 04/2028  
(Report on hand)

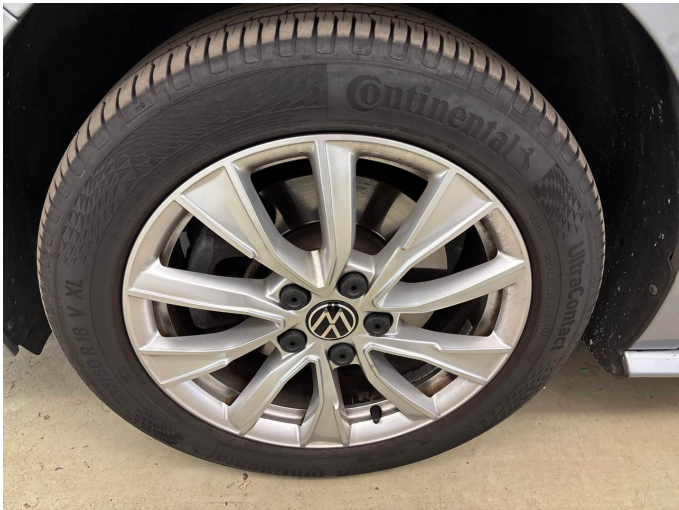
Figure 12: Mounted tyres

| # | Tyre size | Type of tyre | Manufacturer | Tread depth |
|---|---|---|---|---|
| 1) | 235/50 R18 101V | Summer tyres on Light alloy | Continental | 4mm / 4mm |
| 2) | 235/50 R18 101V | Summer tyres on Light alloy | Continental | 4mm / 4mm |

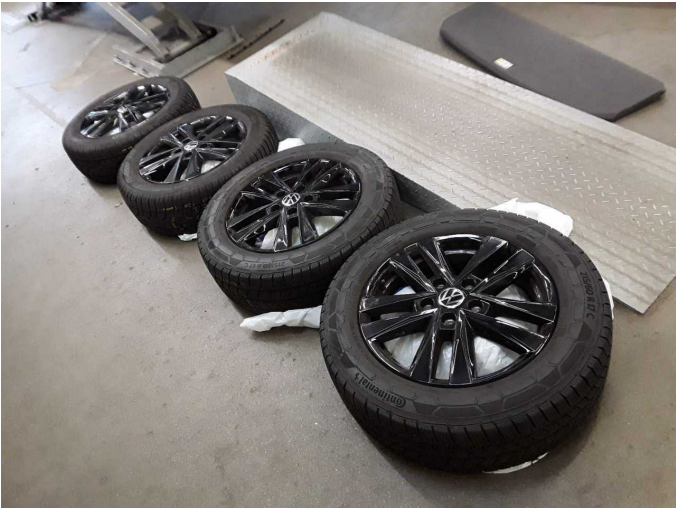
Figure 15: Additional tyres

| # | Tyre size | Type of tyre | Manufacturer | Tread depth |
|---|---|---|---|---|
| 1) | 215/60 R17 102H | Winter tyres on Light alloy | Continental | 5mm / 5mm |
| 2) | 215/60 R17 102H | Winter tyres on Light alloy | Dunlop | 5mm / 5mm |

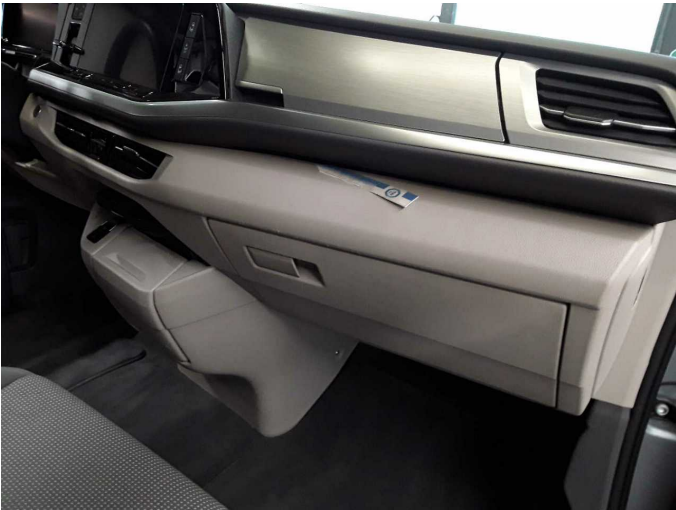
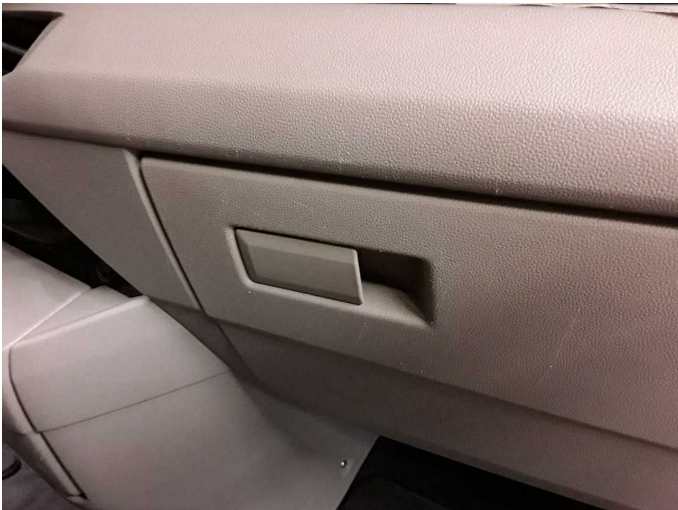
| No. | Component group | Description |
|---|---|---|
| 1 | Instrument panel | Centre console - front - Scratch(es) - Loss in value |

Damage 1: Instrument panel: Centre console - front - Scratch(es) - Loss in value

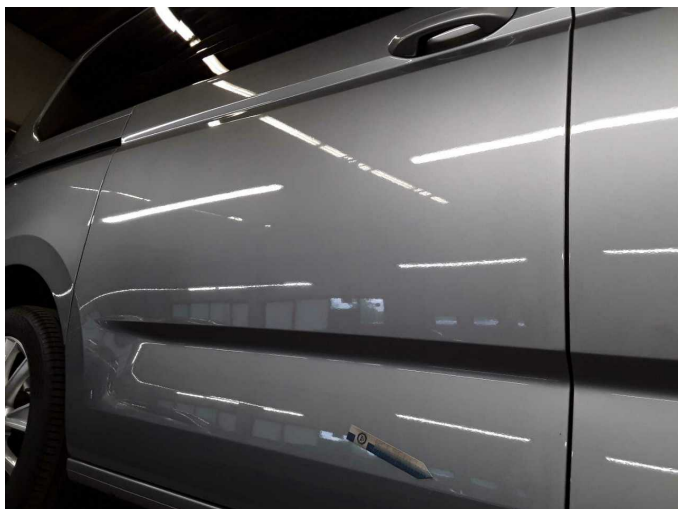
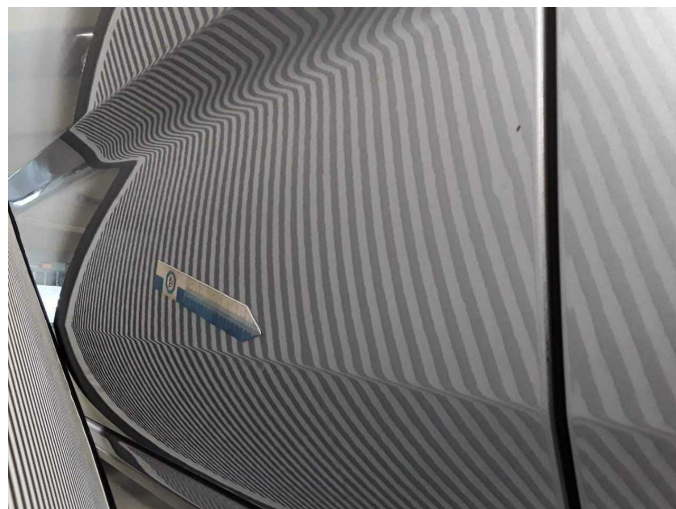
| No. | Component group | Description |
|---|---|---|
| 2 | Door - rear right side | Door - dent(s) - Smooth repair work |

**Damage 2:** Door - rear right side: Door - dent(s) - Smooth repair work

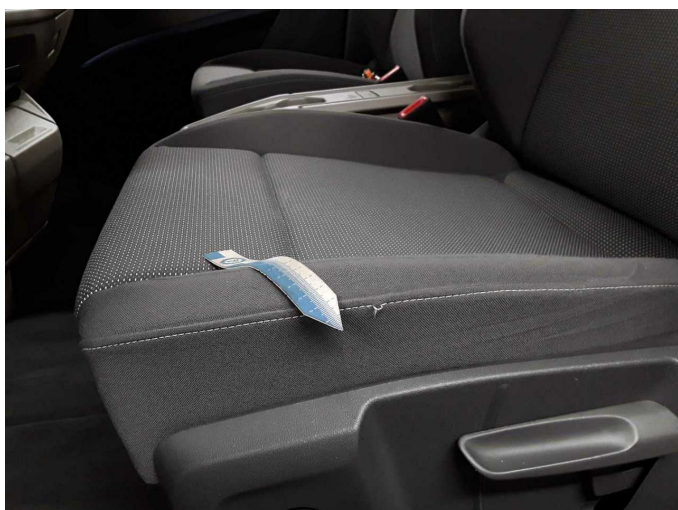
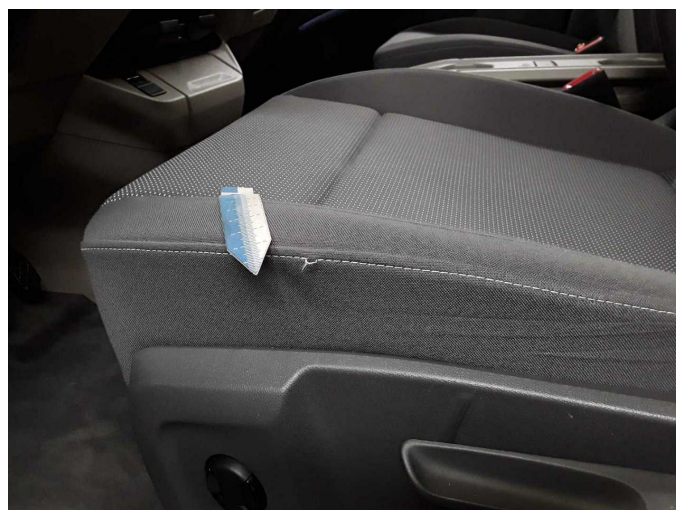
| No. | Component group | Description |
|---|---|---|
| 3 | Seat - front | Seat cover - left side - Worn - Smart repair |

**Damage 3:** Seat - front: Seat cover - left side - Worn - Smart repair

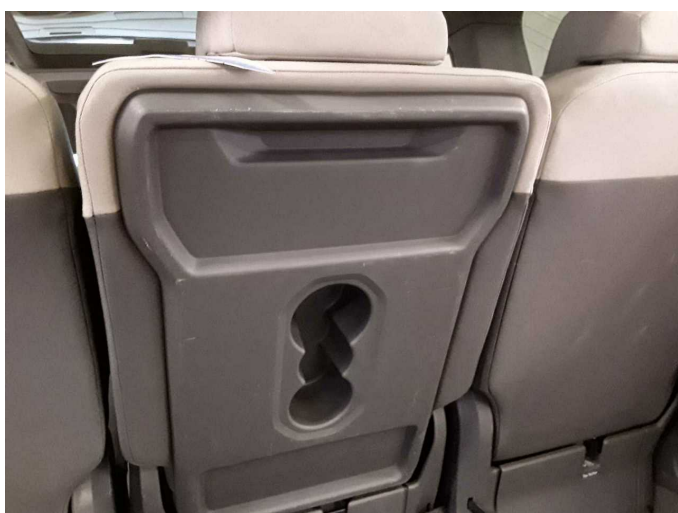
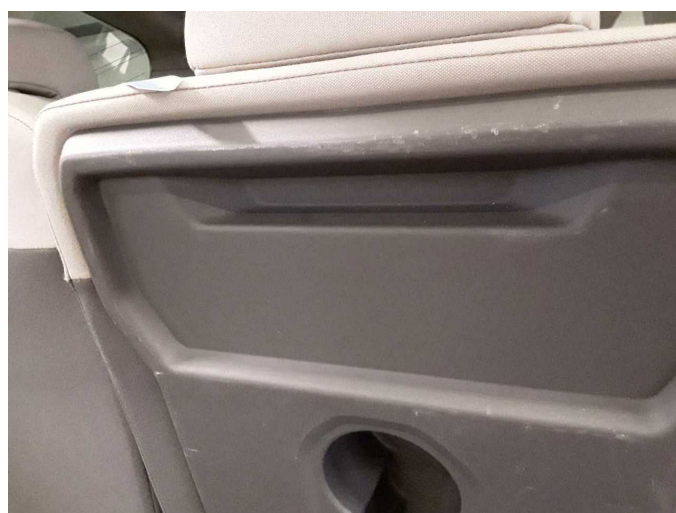
| No. | Component group | Description |
|---|---|---|
| 1 | Interior | Interior - Scratch(es) - No deduction |

**Wear and tear 1:** Interior: Interior - Scratch(es) - No deduction
