Expertise

Protocol number: 46467147  
Order No. / Reference: 26681134  
Inspection date: 9 Jul 2026

Model: Passat Variant 2.0 TDI SCR DSG Business

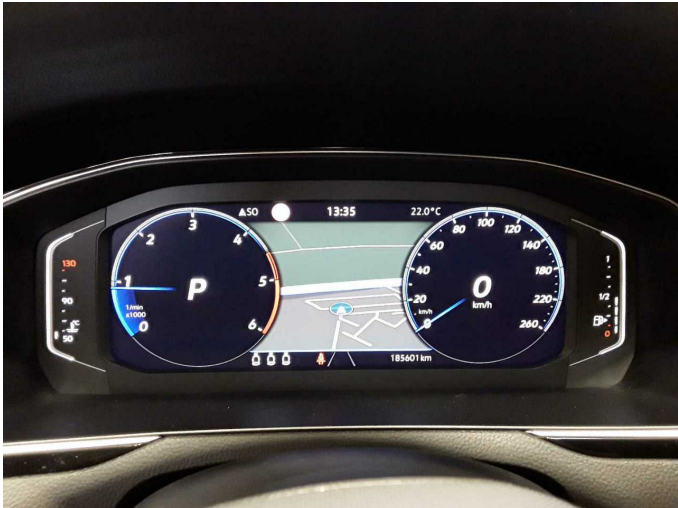
Figure 7: Instrument cluster

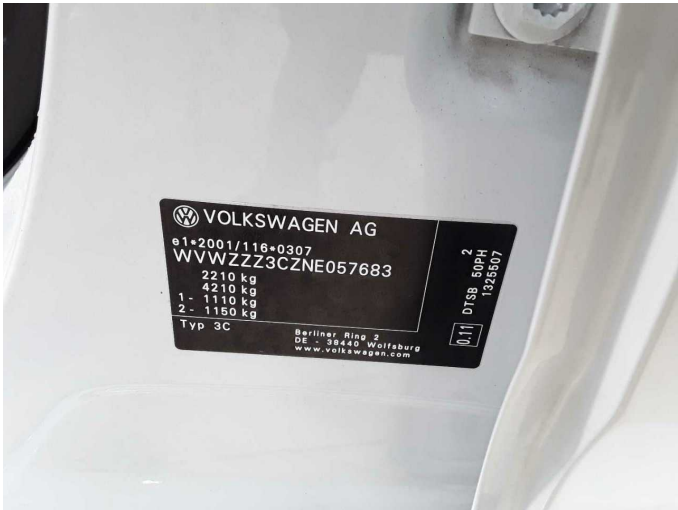
Figure 11: VIN

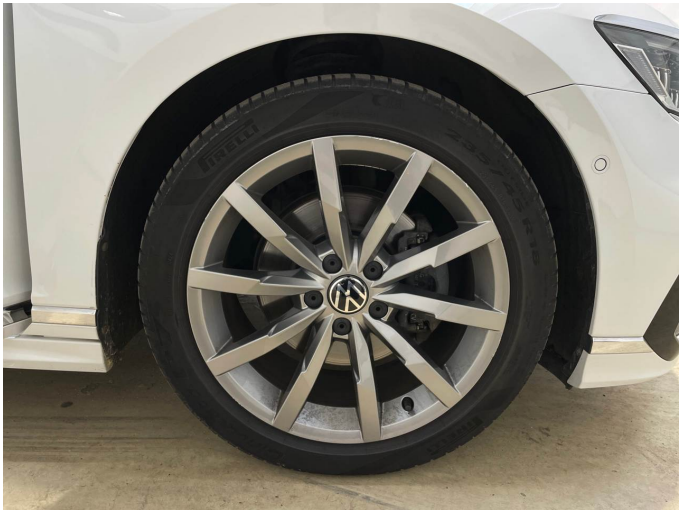
| # | Tyre size | Type of tyre | Manufacturer | Tread depth |
|---|---|---|---|---|
| 1) | 235/45 R18 94W | Summer tires (with run-flat tires) on Light alloy | Pirelli | 4mm / 4mm |

Figure 12: Mounted tyres

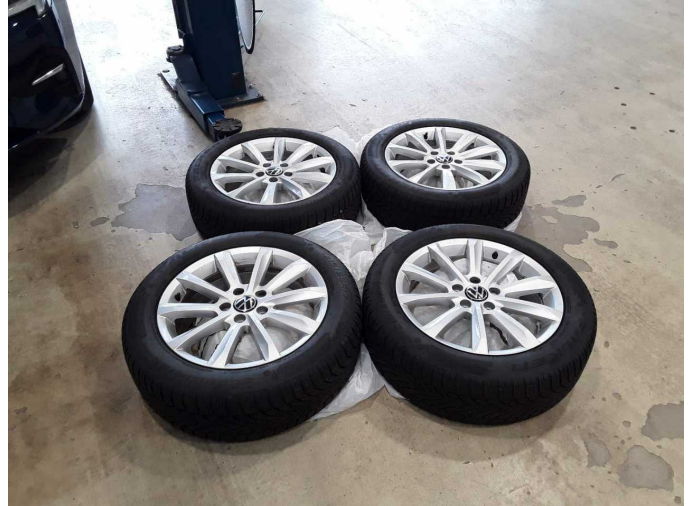
| # | Tyre size | Type of tyre | Manufacturer | Tread depth |
|---|---|---|---|---|
| 1) | 215/55 R17 98V | Winter tyres on Light alloy | Falken | 5mm / 5mm |

Figure 14: Additional tyres

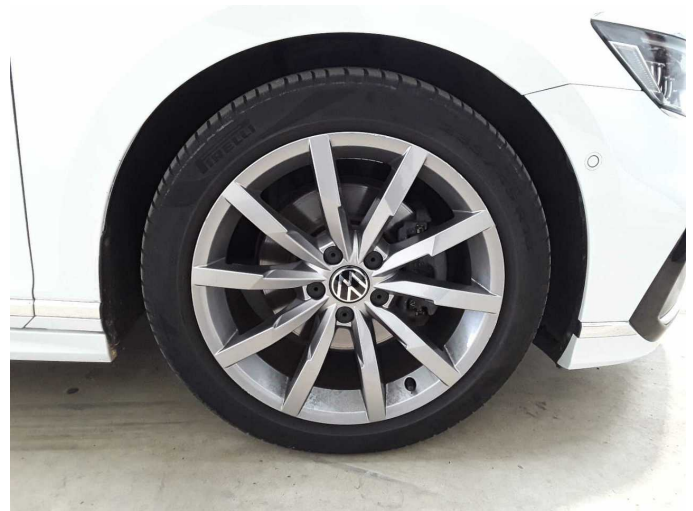
**Damage 3:** Wheel / tyres: Alloy rim - front right side - Scratch(es) - Loss in value

| No. | Component group | Description |
|---|---|---|
| 3 | Wheel / tyres | Alloy rim - front right side - Scratch(es) - Loss in value |

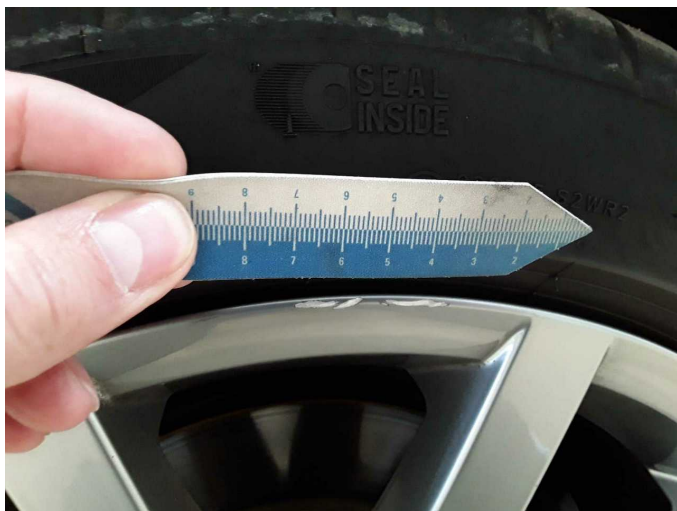
**Damage 3:** Wheel / tyres: Alloy rim - front right side - Scratch(es) - Loss in value

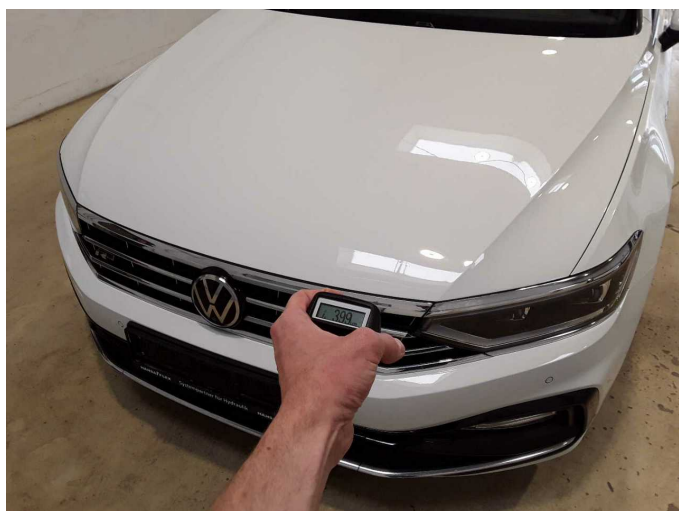
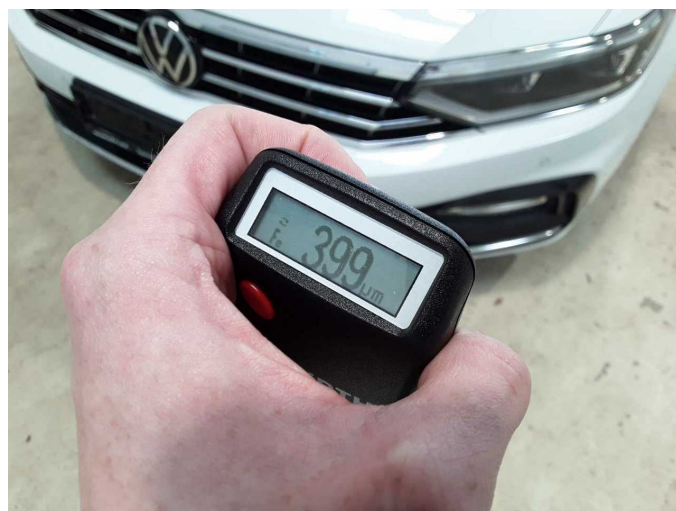
- 1 Bonnet, Professionally carried out, Invoice of repair done Non-existent

Bonnet 399  $\mu\text{m}$  |

**Repainting 1: Bonnet**
