Expertise

Protocol number: 46250566  
Order No. / Reference: 26528286  
Inspection date: 24 Jun 2026

| Manufacturer: Ford | Model: Focus 1.5 EcoBlue Start-Stopp-System Aut. TITANIUM X |

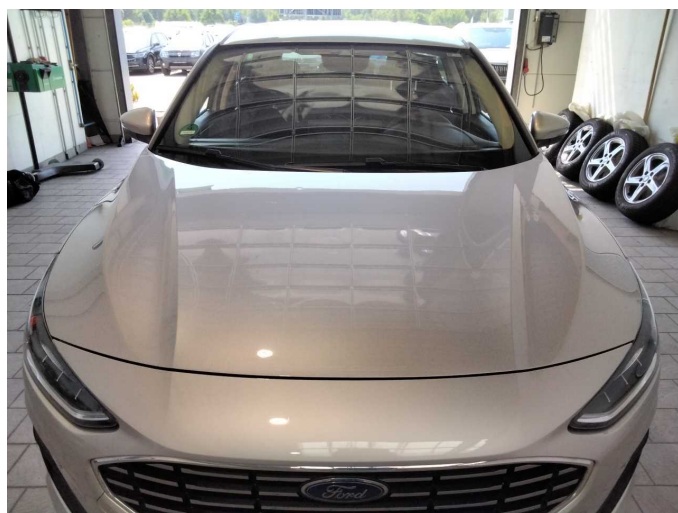
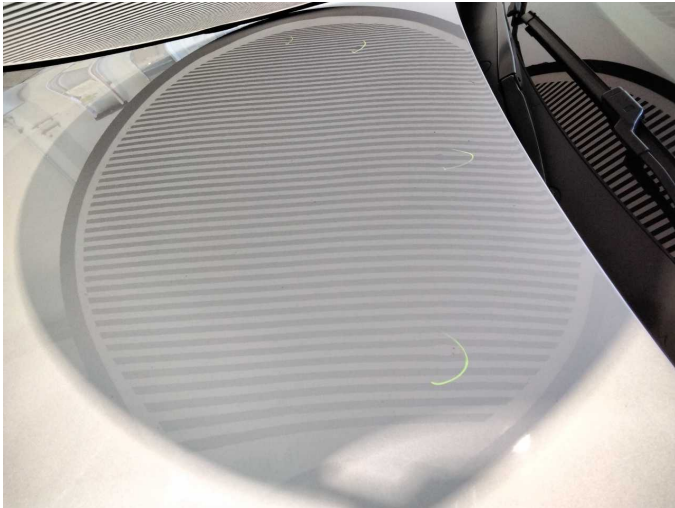
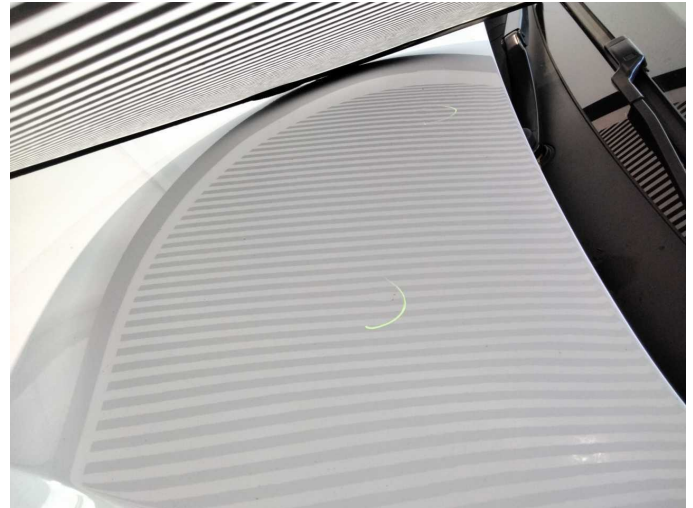
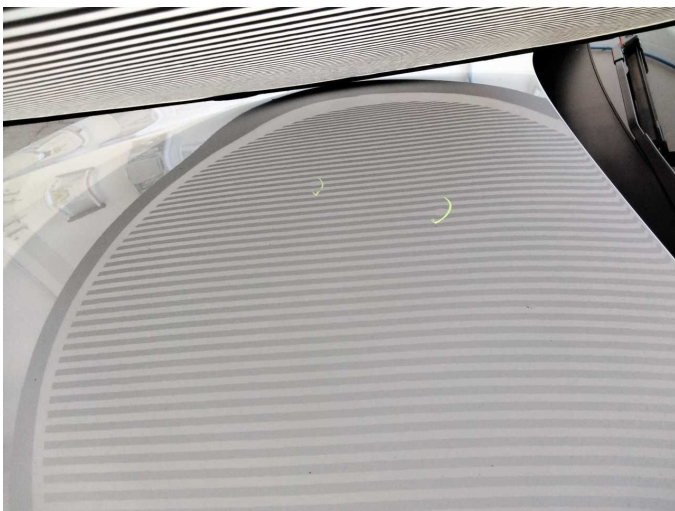
| No. | Component group | Description |
|---|---|---|
| 1 | Bonnet | Bonnet - dent(s) - Smooth repair work |

Damage 1: Bonnet: Bonnet - dent(s) - Smooth repair work

**Damage 1:** Bonnet: Bonnet - dent(s) - Smooth repair work

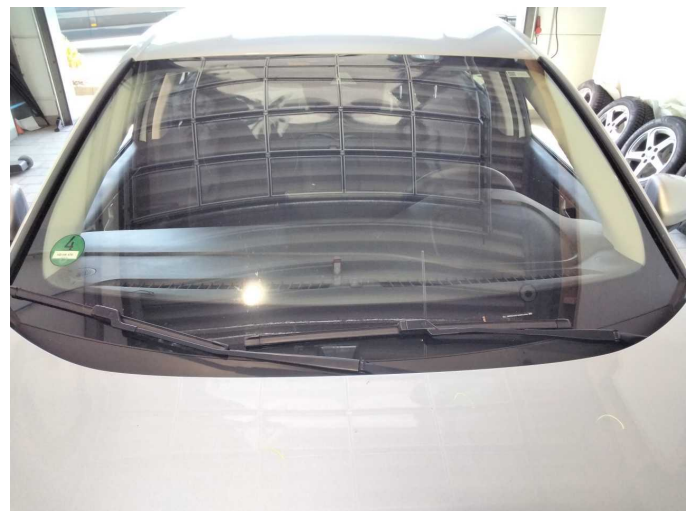
| No. | Component group | Description |
|---|---|---|
| 1 | Vehicle glazing | Windscreen - Stone chips - No deduction |

**Wear and tear 1:** Vehicle glazing: Windscreen - Stone chips - No deduction

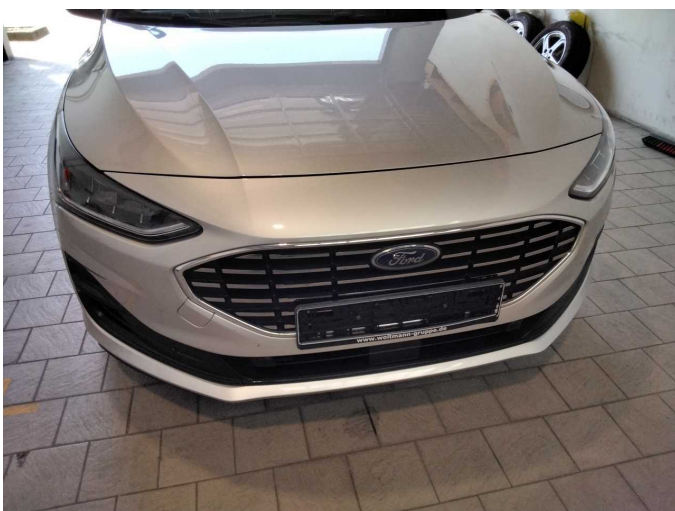
| No. | Component group | Description |
|---|---|---|
| 2 | Front bumper | Front bumper - Stone chips - No deduction |

**Wear and tear 2:** Front bumper: Front bumper - Stone chips - No deduction
