Expertise

Protocol number: 46463738  
Order No. / Reference: 26366976  
Inspection date: 13 Jul 2026

Manufacturer: Skoda  
VIN: TMBLN7NSXP8518260

Model: Kodiaq 2.0 TDI 4x4 DSG Style

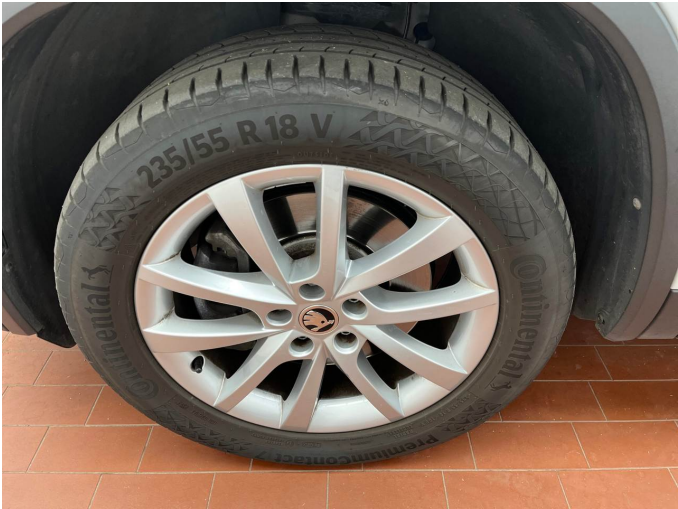
Figure 12: Mounted tyres

| # | Tyre size | Type of tyre | Manufacturer | Tread depth |
|---|---|---|---|---|
| 1) | 235/55 R18 100V | Summer tyres on Light alloy | Continental | 5mm / 5mm |
| 2) | 235/55 R18 100V | Summer tyres on Light alloy | Continental | 6mm / 6mm |

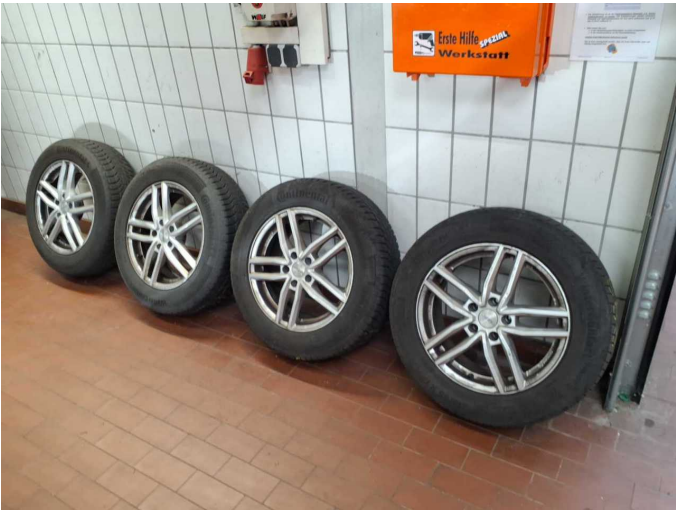
Figure 15: Additional tyres

| # | Tyre size | Type of tyre | Manufacturer | Tread depth |
|---|---|---|---|---|
| 1) | 215/65 R17 99H | Winter tyres on Light alloy | Continental | 7mm / 7mm |
| 2) | 215/65 R17 99H | Winter tyres on Light alloy | Continental | 7mm / 7mm |

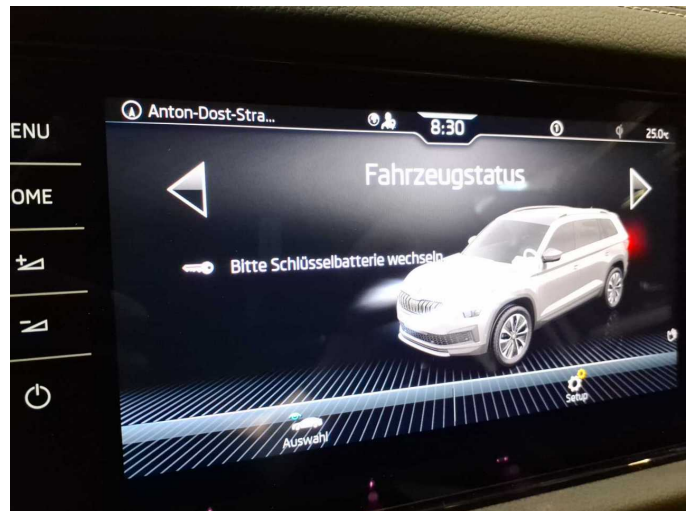
Damage 1: Equipment: Vehicle key (Batterie) - Non-operational - Replace

| No. | Component group | Description |
|---|---|---|
| 1 | Equipment | Vehicle key (Batterie) - Non-operational - Replace |

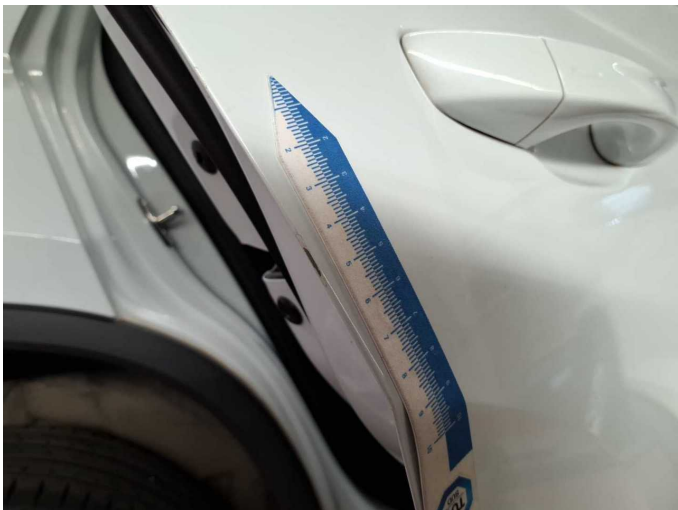
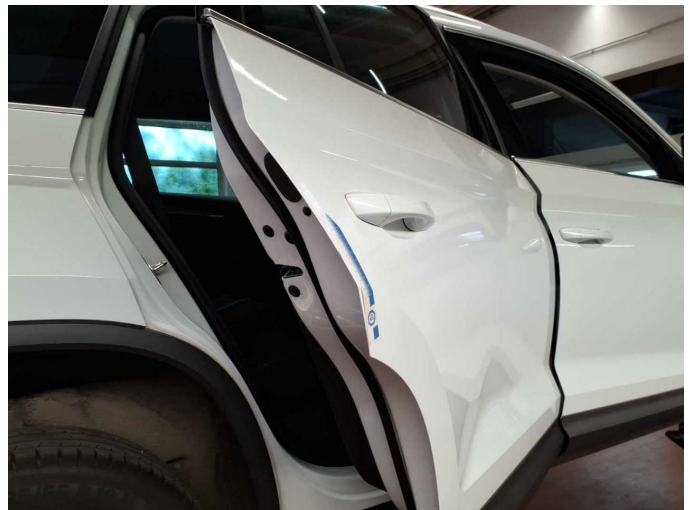
Damage 2: Door - rear right side: Door edge - Scratch(es) - Smart repair

| No. | Component group | Description |
|---|---|---|
| 2 | Door - rear right side | Door edge - Scratch(es) - Smart repair |

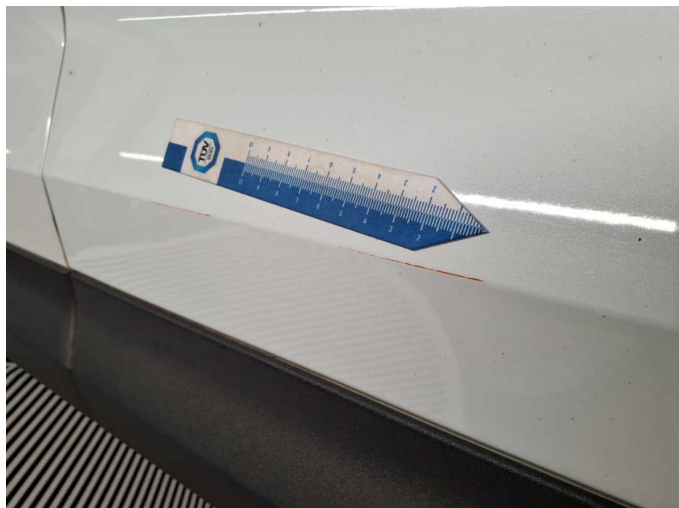
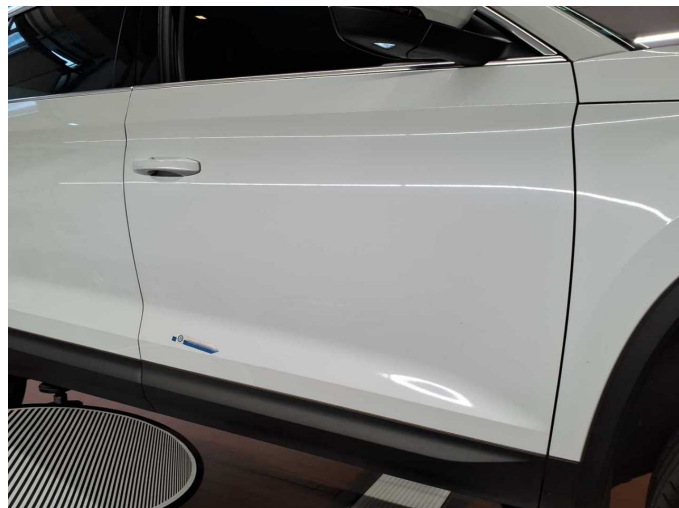
**Damage 3:** Door - front right side: Door - Scratch(es) - Smart repair

| No. | Component group | Description |
|---|---|---|
| 3 | Door - front right side | Door - Scratch(es) - Smart repair |
